Workers fatally injured from frac sand bin collapse  
May 7, 2019

This document reports the Alberta Occupational Health and Safety (OHS) investigation of a fatal incident that occurred in May 2019. It begins with a short summary of what happened. The rest of the report covers this same information in much greater detail.

F-OHS-169928

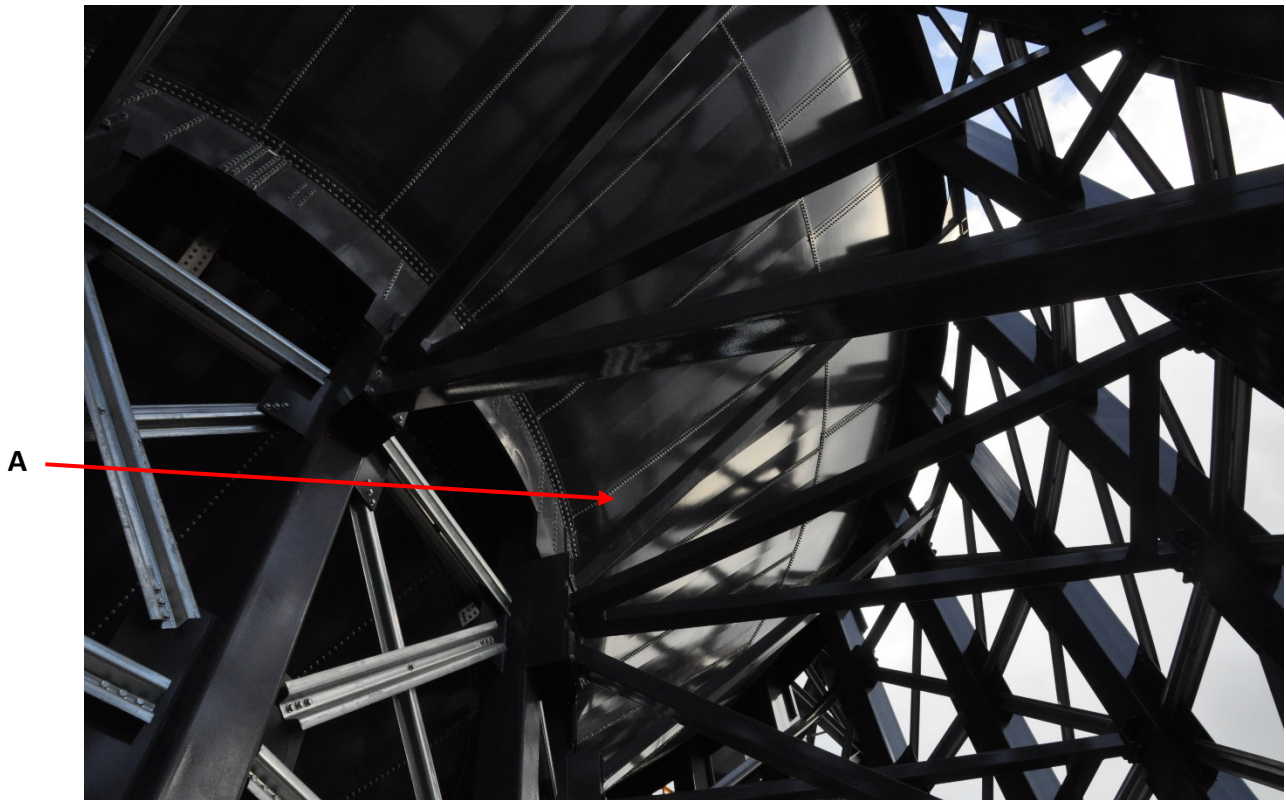
Figure 2.

May 3, 2019 at end of the day, Kaynic workers noticed bulging in the hopper sheets of both bins. The Kaynic Supervisor stopped filling the bins and reported the bulging to Source and Westeel (Figures 2 and 3).

A. *Bulging to the hopper sheets from bin 1.*

May 4, 2019, Kaynic contacted Source who then contacted Westeel. Westeel followed up with their engineering team.

May 6, 2019, Source conducted telephone conversations with Westeel regarding the bulging and received assurance from Westeel by email that it was safe to continue with the commissioning. No Westeel representative had come to the site to visually inspect the bins.

Kaynic was instructed by the Director of Construction to continue to fill the bins. No additional concerns regarding the bulging of the bins were reported to Source.

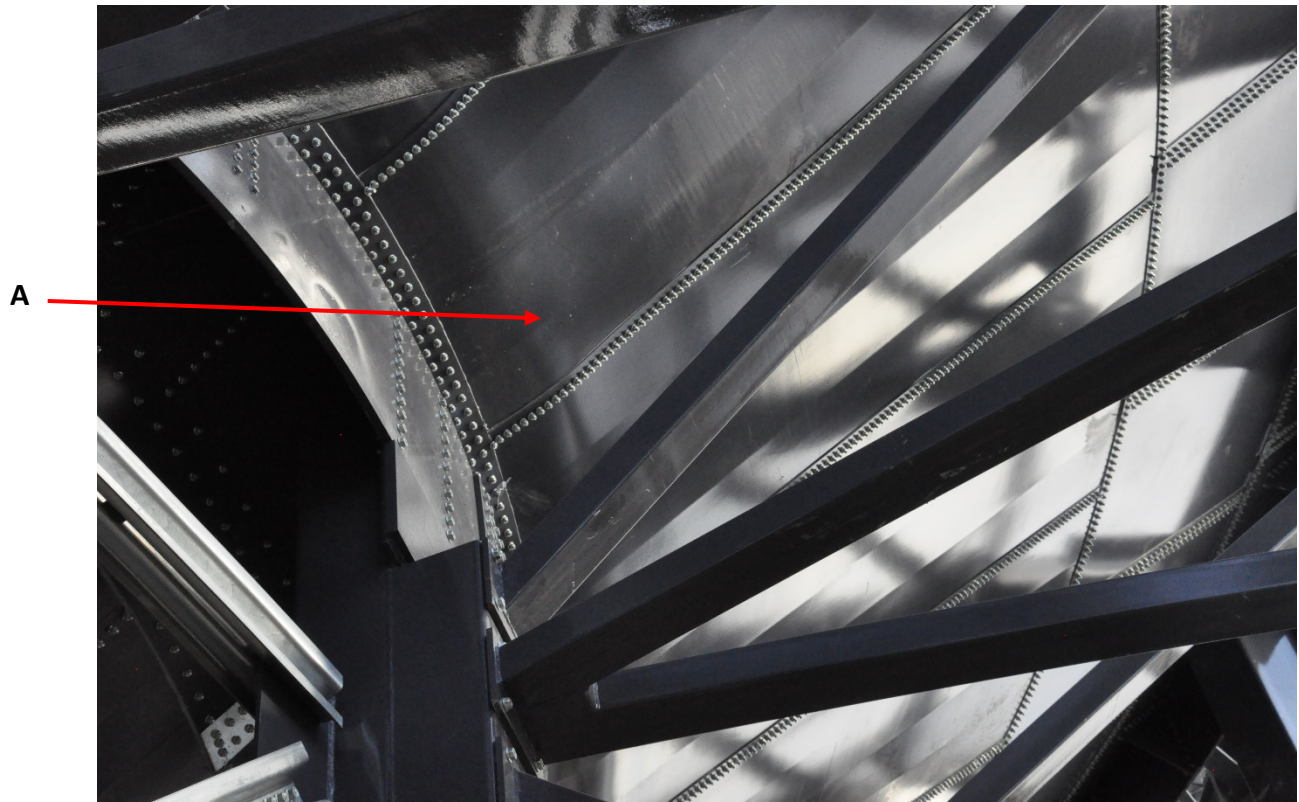
Figure 3.

A. *Bulging to the hopper sheets of bin 1.*

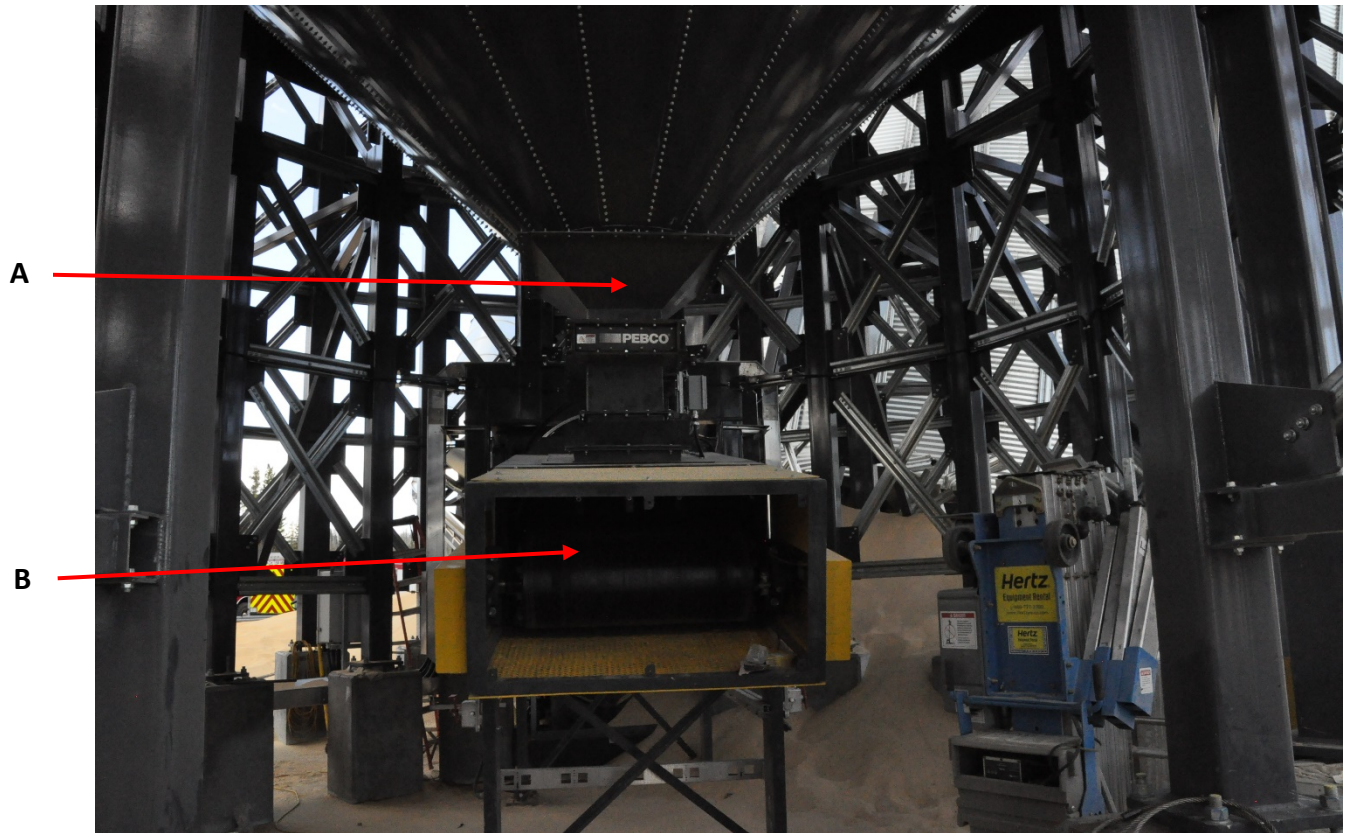
Figure 4. Underneath bin 1 which would have been the same as bin 2.

All equipment had been function tested without sand running through it (i.e. conveyors, slide gates, and bucket elevators) (Figure 4).

- A. Chute of bin 1 where the contents of the bin would flow out of
- B. Conveyor belt of bin 1 where it was designed to transport the frac sand into a waiting truck

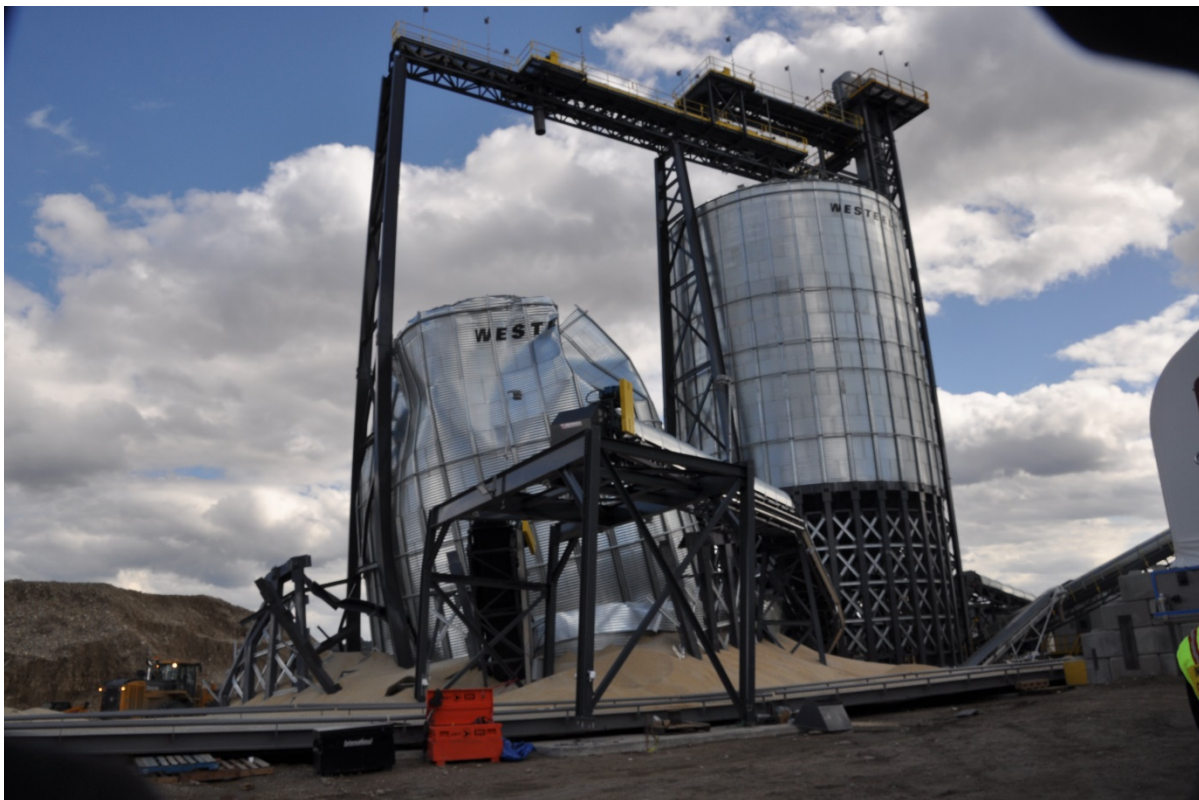
The frac sand flowed from bin 2, through the slide gate, onto the conveyor and into the loader bucket for approximately 5-10 seconds when workers stated they heard a loud noise and the structure was collapsing (Figures 4 and 5).

*Figure 5. Collapse of bin 2.*

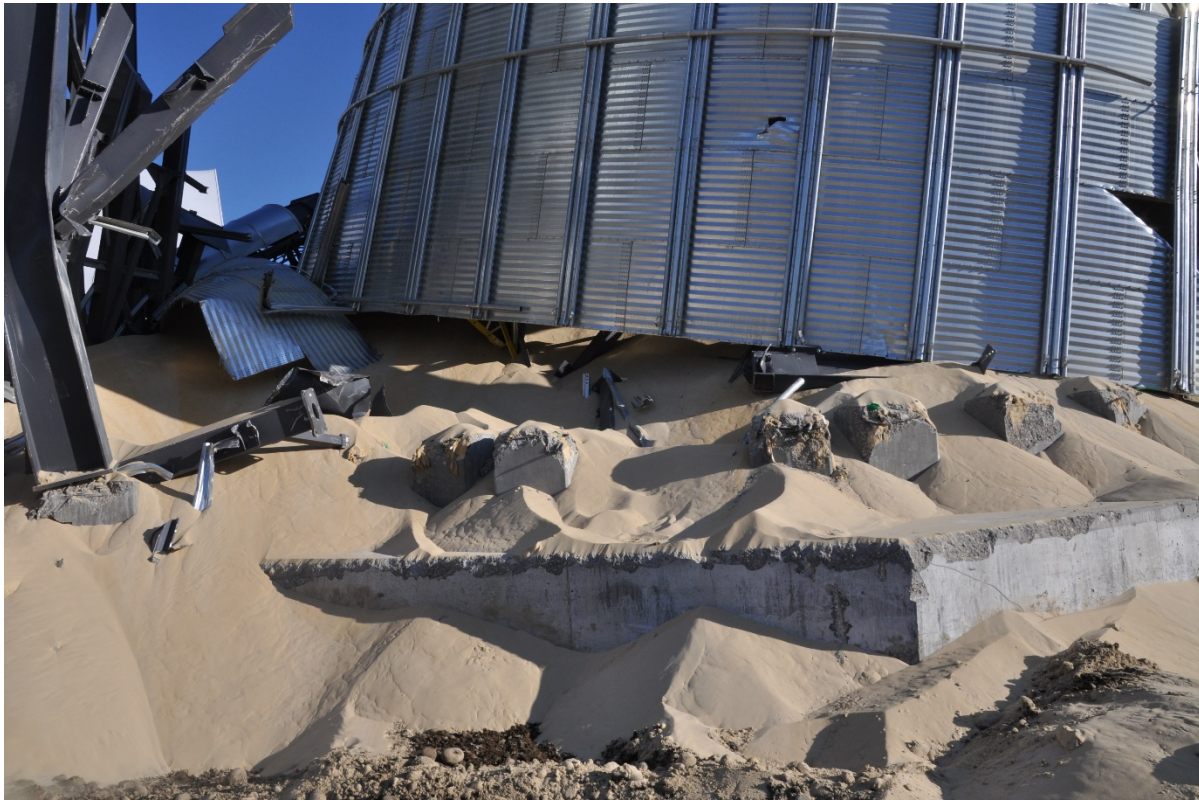
*Figure 6. Collapse of bin 2 where the sand ejected through to the bottom hopper panels.*

The Kaynic Supervisor was thrown from between the inner and outer rings, and someone yelled out “run”. All those in the area ran from the bin 2 structure. The frac sand ejected through the bottom hopper panels and bin 2 walls partly fell down while a portion of the roof collapsed inwards (Figure 6).
