Investigation Report

Worker fatally injured when run over by a telehandler

October 25, 2013

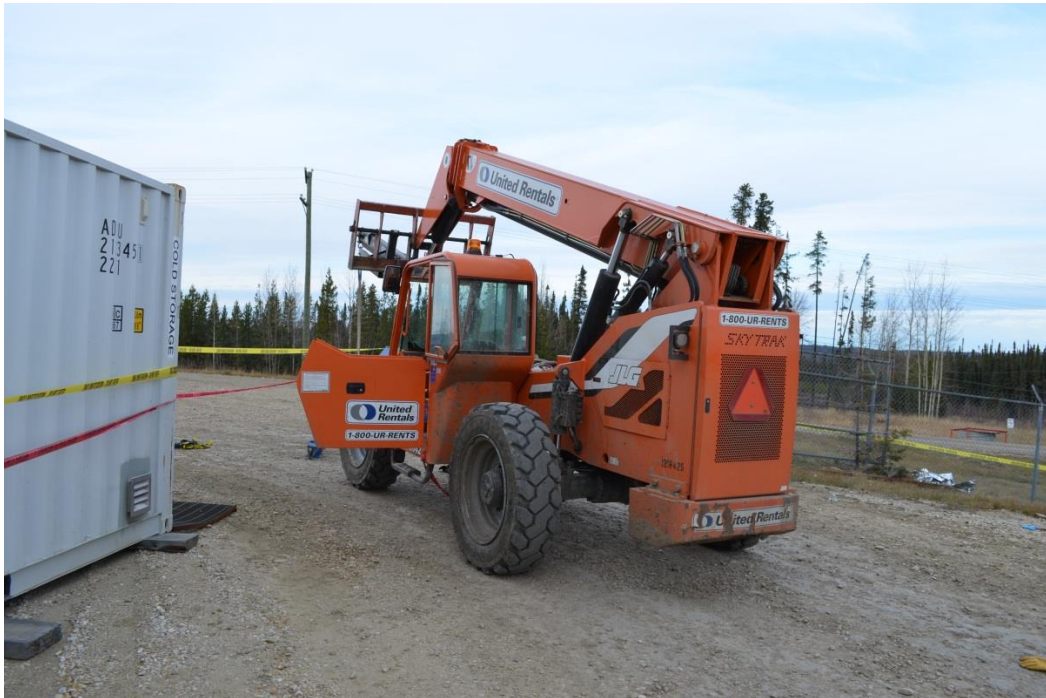
Figure 1. Photograph of zoom boom from left rear.

A JLG Skytrak Model 8042 telehandler (zoom boom) was involved in the incident. A fork lift and a heavy duty jib were attached to the boom. The zoom boom had an enclosed cab on the left side (Figure 1). The zoom boom was used to move materials and can lift the materials directly using the forks or by suspending loads using rigging attached to the jib. The maximum capacity was 3,629 kilograms (kg) and maximum lift was 12.78 metres (m). The equipment was owned and maintained by United Rentals of Canada and rented to Radium.

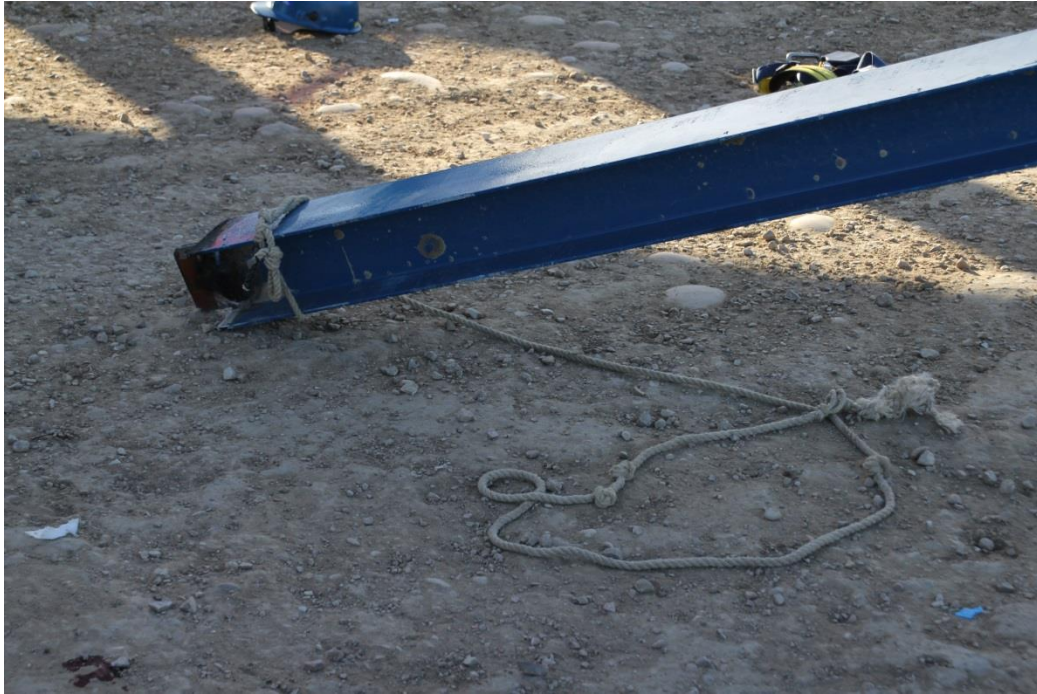
*Figure 2. Photograph of I-beam with tagline attached. Photograph provided by Radium*

A 15 centimetre (cm) wide and 4.4 m I-beam was attached to the zoom boom with a single choke configuration. The sling was placed near the centre of the I-beam. The I-beam needed to be moved from the laydown area to the tank farm. (Figure 2).

A single tag line of synthetic rope 3.5 m long with knots tied in it to act as hand grips was attached to the I-beam. The welder helper was holding the tag line to help control any movement of the I-beam. (Figure 2)

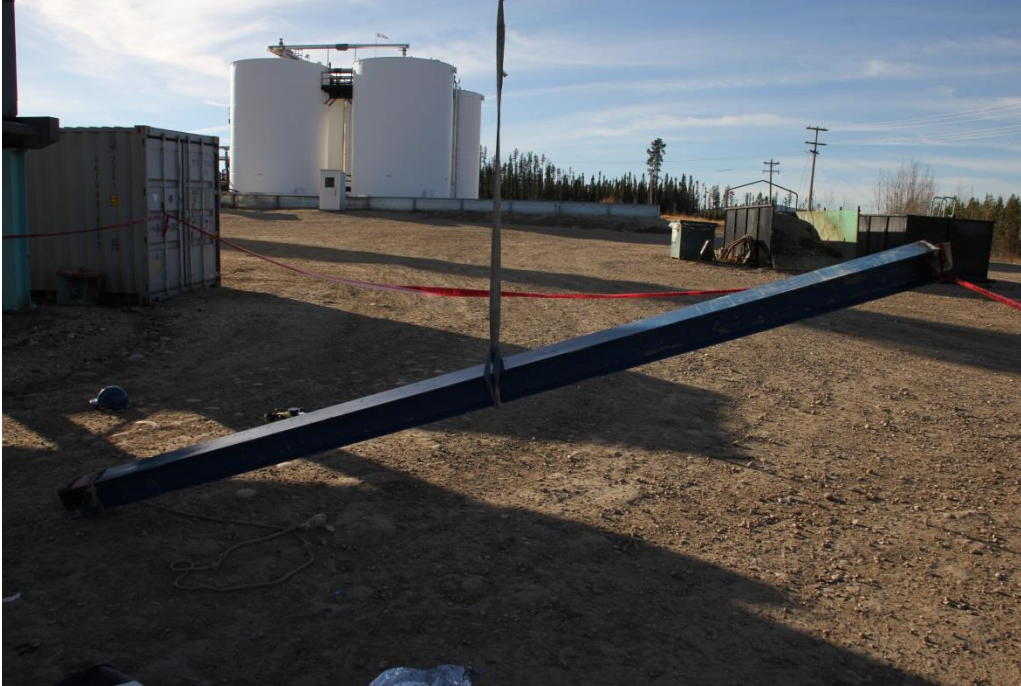
Figure 3. Photograph of I-beam suspended with sling. Photograph provided by Radium.

A 2.4 m certified sling (rated for 2812 kg) was used to suspend the I-beam using a single choke rigging configuration (Figure 3).

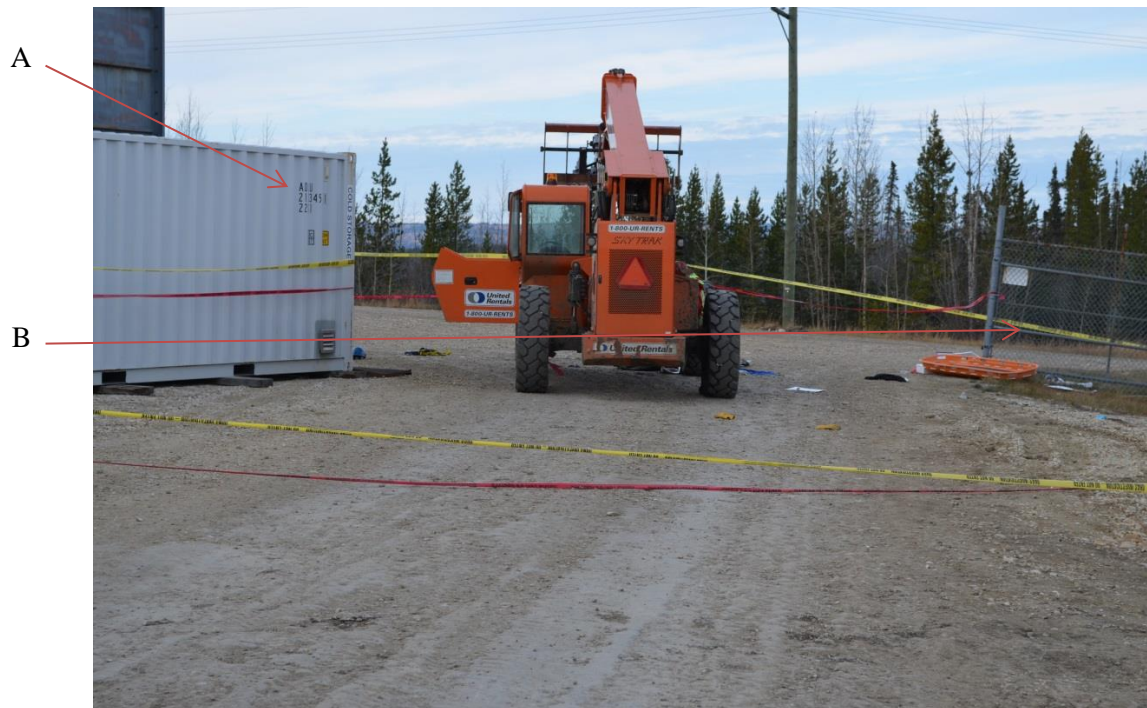
Figure 4. Photograph of zoom boom at location of incident.

At approximately 1:57 p.m., the zoom boom operator approached a gate and prepared to initiate a gradual left turn. The operator looked to his right and saw the welder helper on the right side of the zoom boom. The operator looked to his left and the path was clear. The zoom boom continued to move slowly forward (Figure 4).

- A: Sea-can (shipping container) structure to the left
- B: Gate and fence to the right

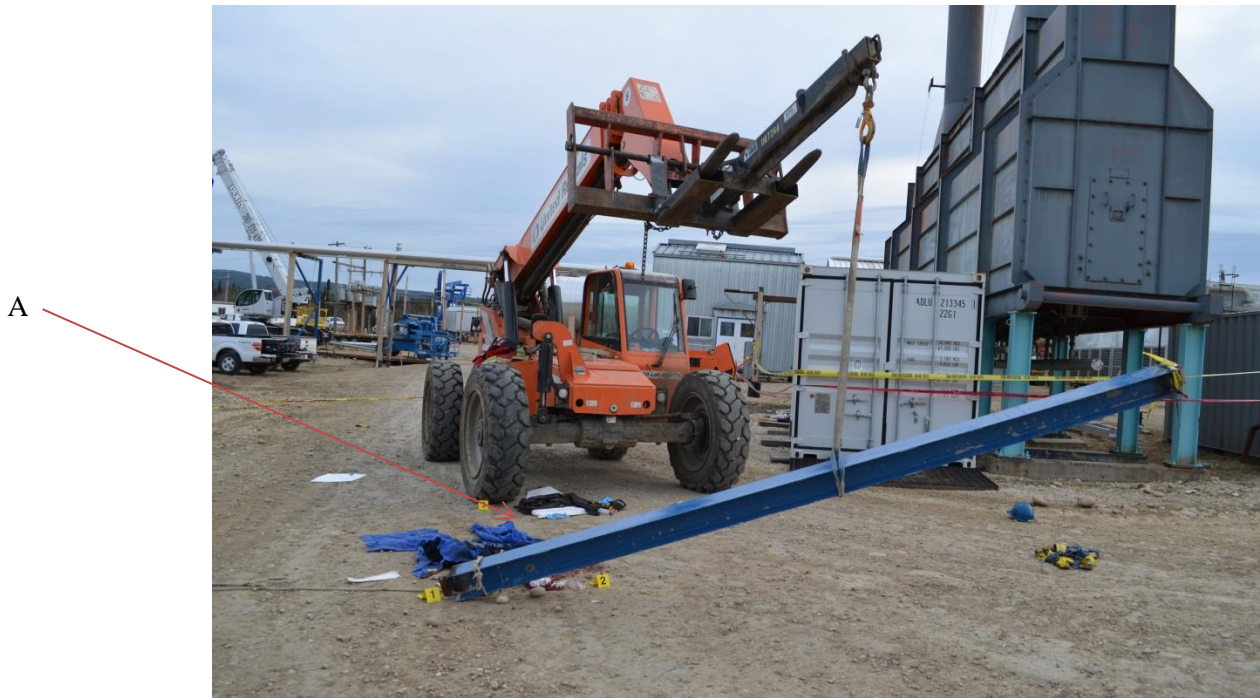
*Figure 5. Photograph of front view of zoom boom at gate between fence (out of view to the left) and sea-can (to the right)*

The welder helper was found face down on the ground in front of the right tire of the zoom boom (Figure 5). The zoom boom operator called for help and the Radium and Devon emergency response plans was initiated. First aid was started and contact with emergency medical services (EMS) was made. EMS transported the welder helper to Swan Hills Healthcare Centre where he was pronounced deceased.

*A: Location of welder helper immediately after the incident*
