**DUNVEGAN LOW-HEAD HYDRO PROJECT
HEADPOND SLOPE STABILITY ASSESSMENT
PEACE RIVER NEAR DUNVEGAN, ALBERTA**

**GLACIER POWER LTD.
CALGARY, ALBERTA**

AGRA EARTH & ENVIRONMENTAL LIMITED

April 2000

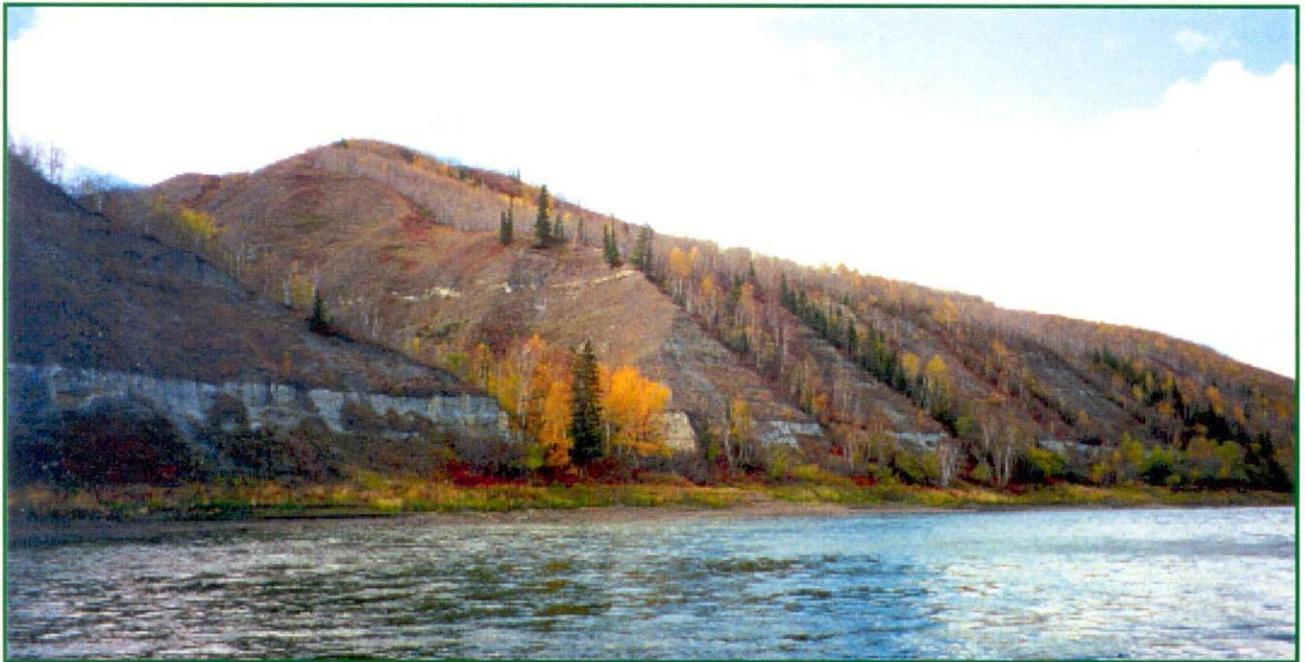
Figure 3.3 shows a photo of the typical slopes encountered in valley sediments as observed at the confluence of the Peace and Montagneuse River and taken by the author during the field visit on October 7, 1999. A photo of the typical slopes along the proposed headpond is provided for comparison as well.

TYPICAL VALLEY SLOPES WITHIN THE HEADPOND

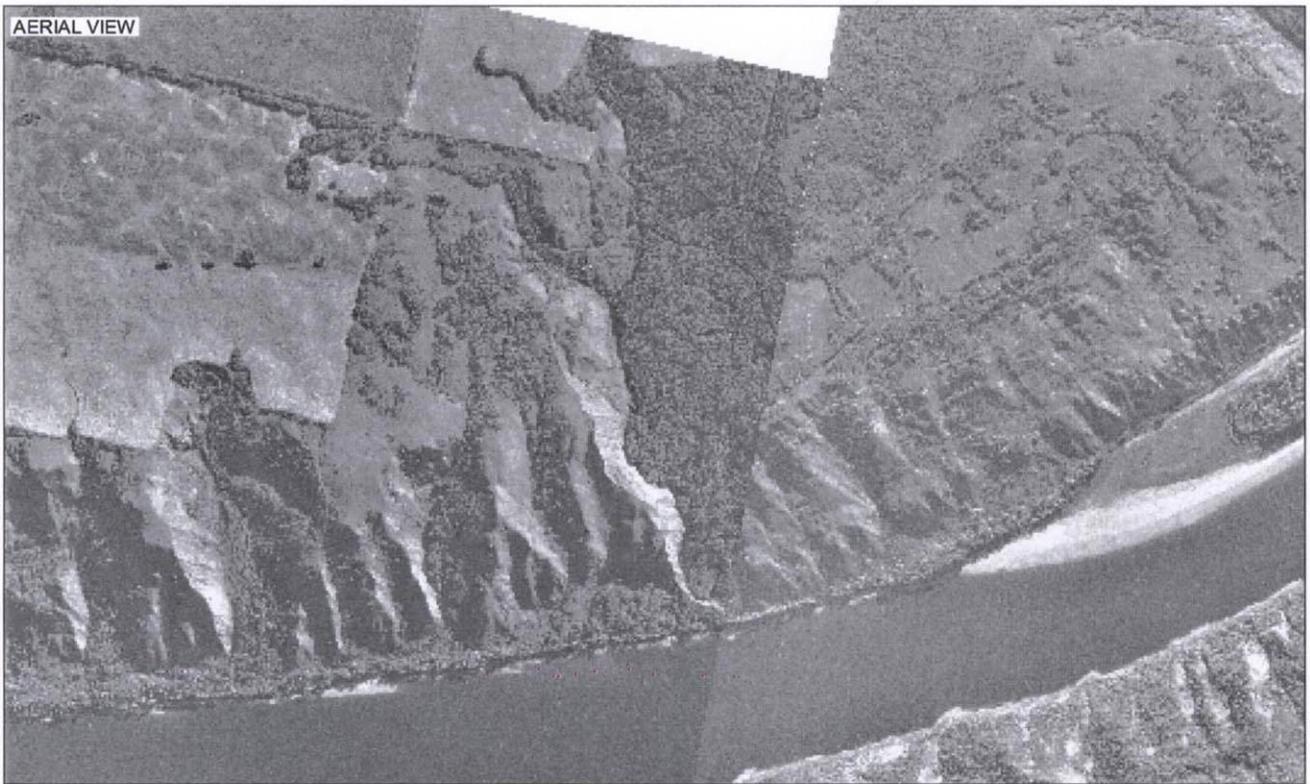
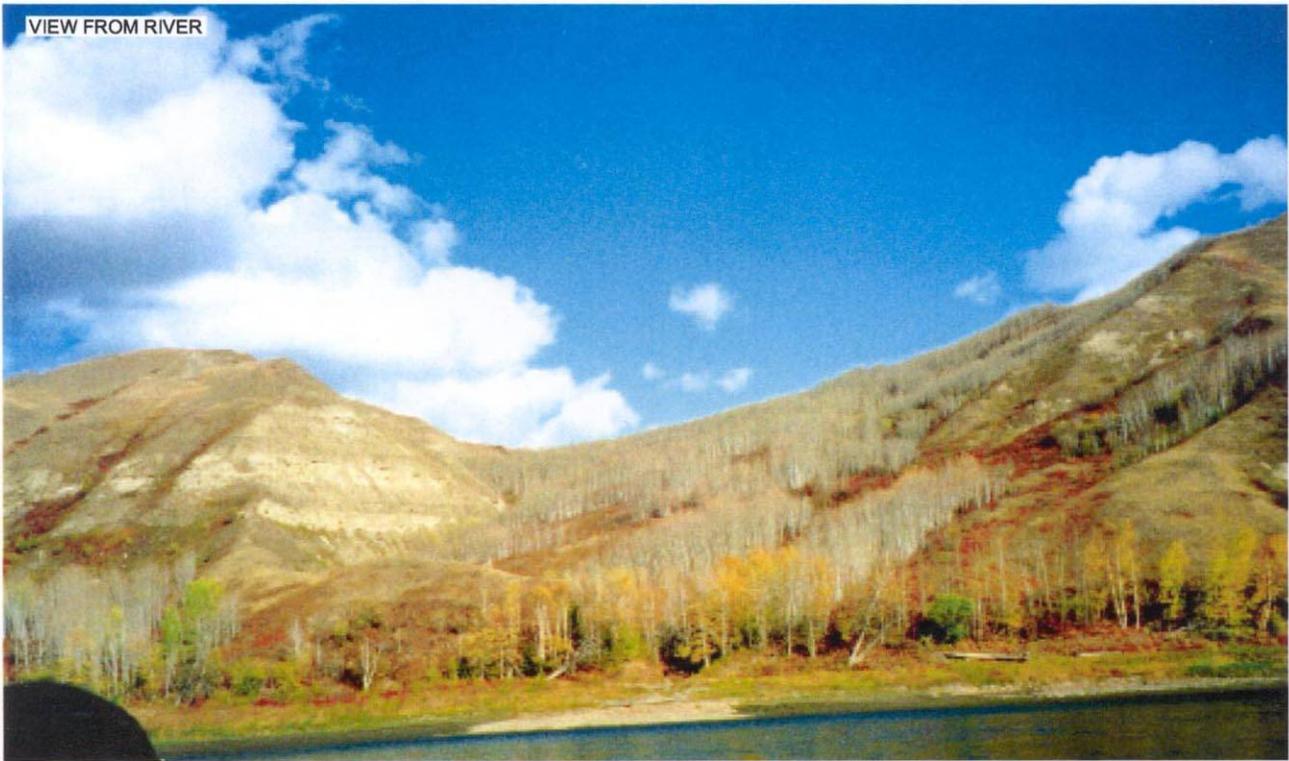
FIGURE 4.1

Large Gullies (Left and Right Slopes – Kilometres 9 to 12): Figure 4.1 provides both an aerial view and a view from river level of some of the large gullies with relatively thick, gently sloped colluvium infill. These features were highlighted due to their anomalous appearance with respect to the other slopes found in the valley. Subsequent investigation of these features in the field indicated that they were well drained and at relatively flat and stable slope angles and presented a low likelihood of sliding into the Peace River. These gully features are discussed in more detail in the discussion of slope types and processes in Section 4.5.

AERIAL VIEW

VIEW FROM RIVER

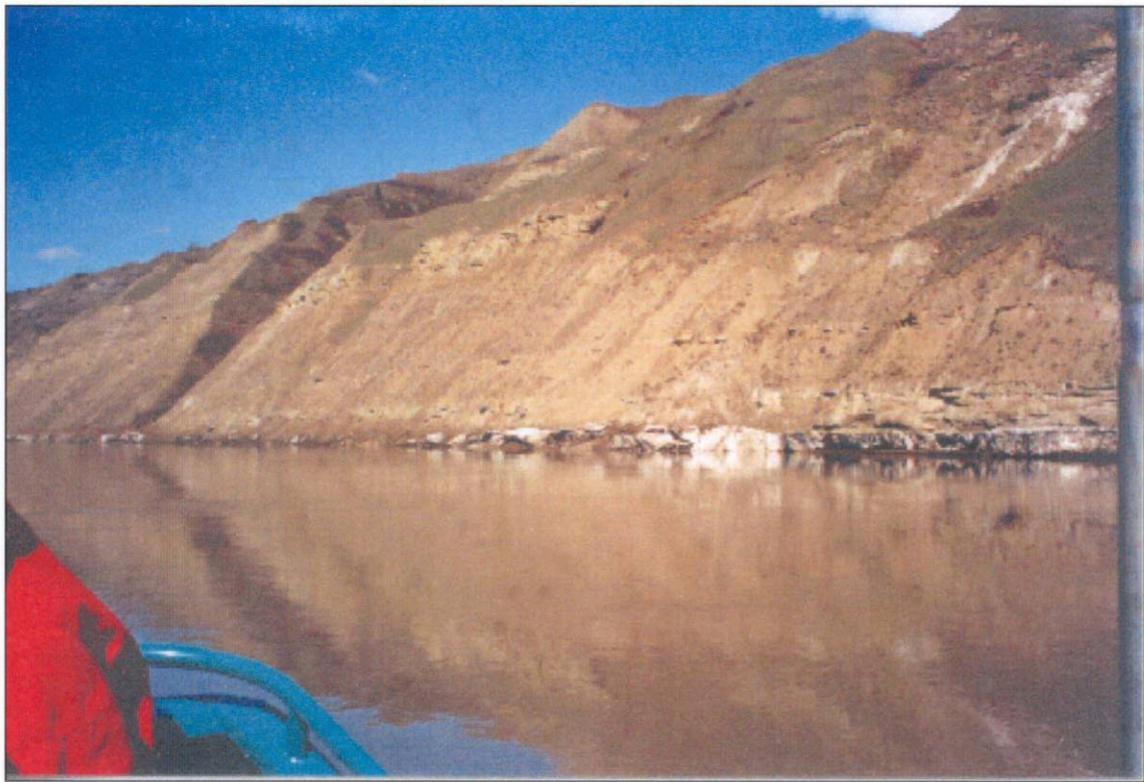
The term “Bluff slopes” is used to describe the slopes found predominantly within the lower 3.5 to 6.5 kilometres of the headpond on the north (left) slope of the Peace River. These types of slopes consist of intact exposures of interbedded sandstone and shale of the Dunvegan Formation that are periodically being eroded by the Peace River with minimal flood plain or debris protecting the toe of the slope. Figure 4.8a shows typical bluff slopes along the Peace River near Dunvegan. Typically the bluff slopes were an average of 100 metres high along the headpond with slopes at 45 ° to 50 °. The slope in the overlying Kaskapau shale and Pleistocene till and lacustrine sediments are relatively shallow and undulating, indicative of previous landsliding activity.

4.8a TYPICAL BLUFF SLOPES (LEFT SLOPE AT 5+100km)

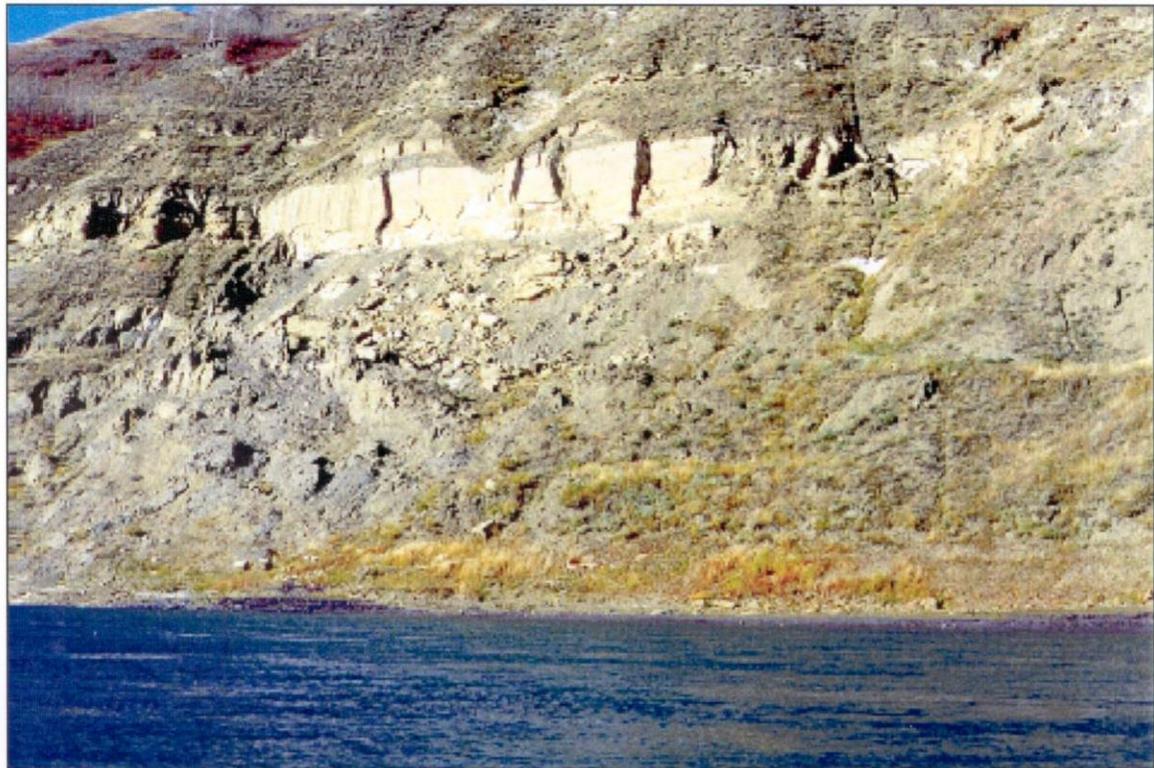
4.8b BEDROCK TOPPLES WITH UNDERMINED SANDSTONE ON BLUFF SLOPE AT 5+800km

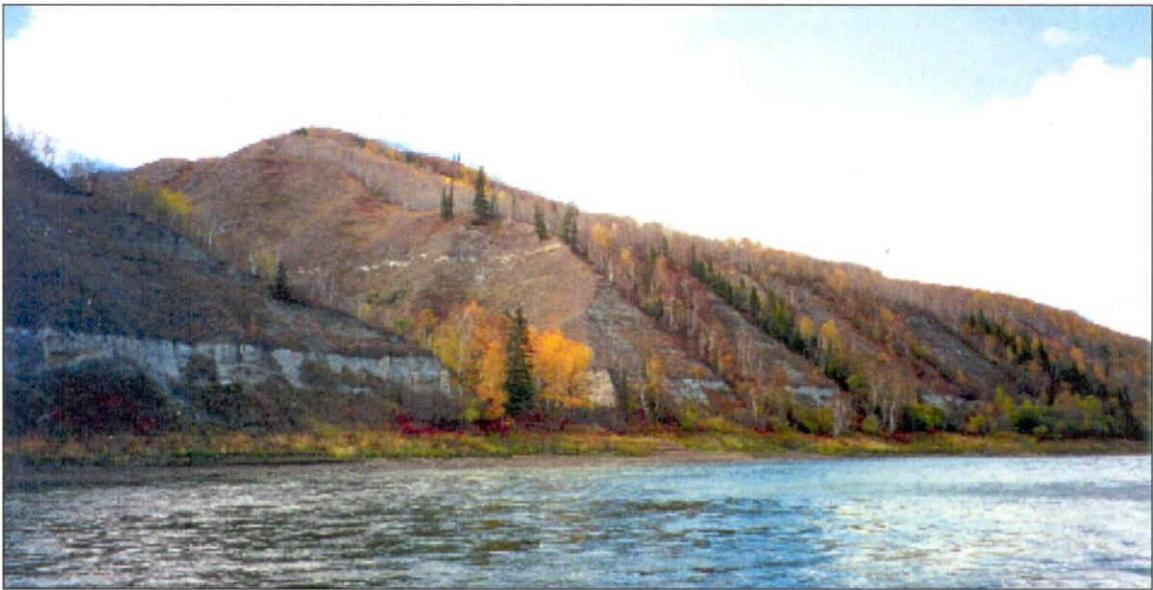
4.9a VALLEY TYPE SLOPE WITH INCISED GULLY AT 13+500 km

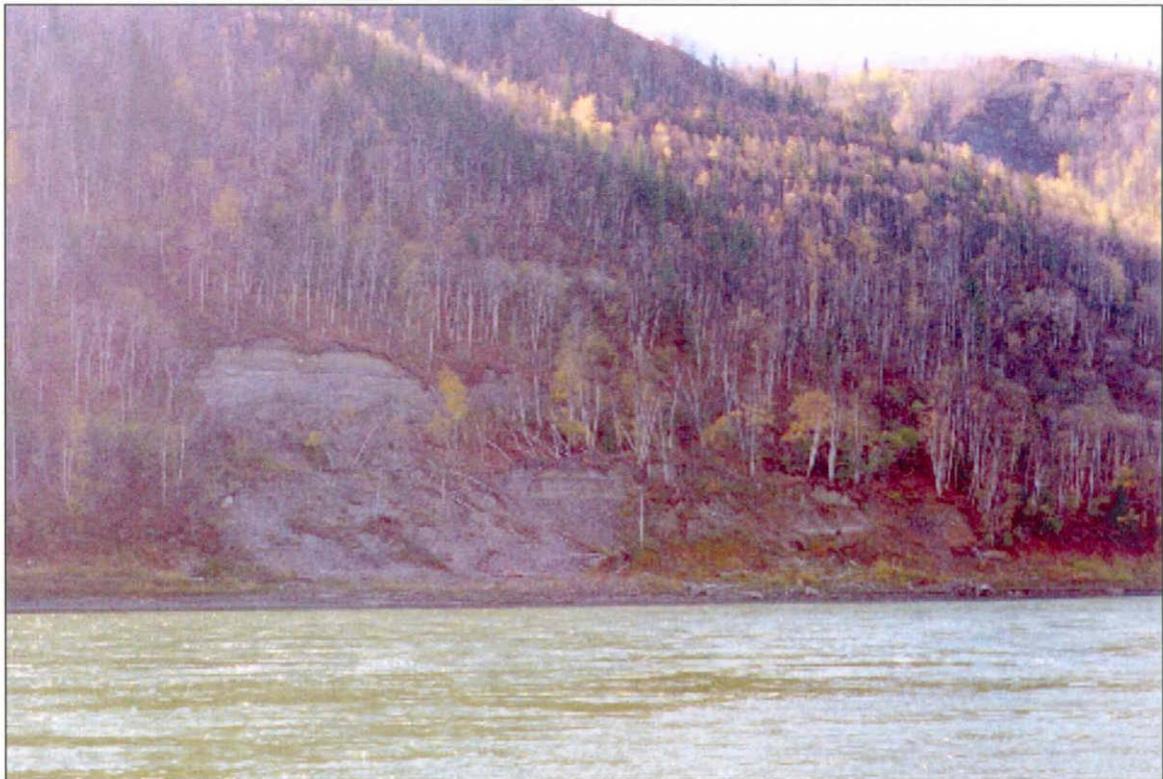
The slopes designated as “Valley Slopes” are characterized by a small terrace and/or fan below the toe of the outcropping sandstone beds of the Dunvegan Formation. Figure 4.9.b. provides a good example of this type of section with the distinct layer of sandstone visible above the fan at the toe of the slope. Above the sandstone outcrop are slopes consisting of weathered bedrock, covered with a well-established growth of mature trees and ground cover. Slopes in the weathered bedrock typically are found to sit at approximately 40° on north facing slopes and up to 45° on south facing slopes.

4.9b SLIDING IN VALLEY TYPE SLOPE IN AREA OF ACTIVE LATERAL EROSION AT 7+000km

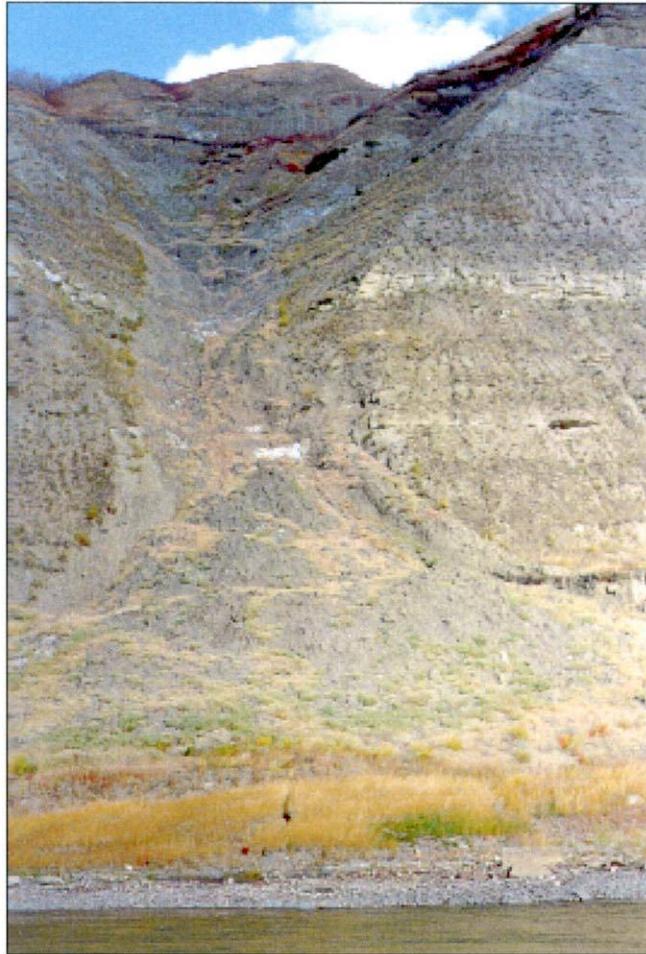
4.10b ACTIVE SLIDING IN STEEP GULLY WITH SHALLOW COLLUVIUM AT 5+800km

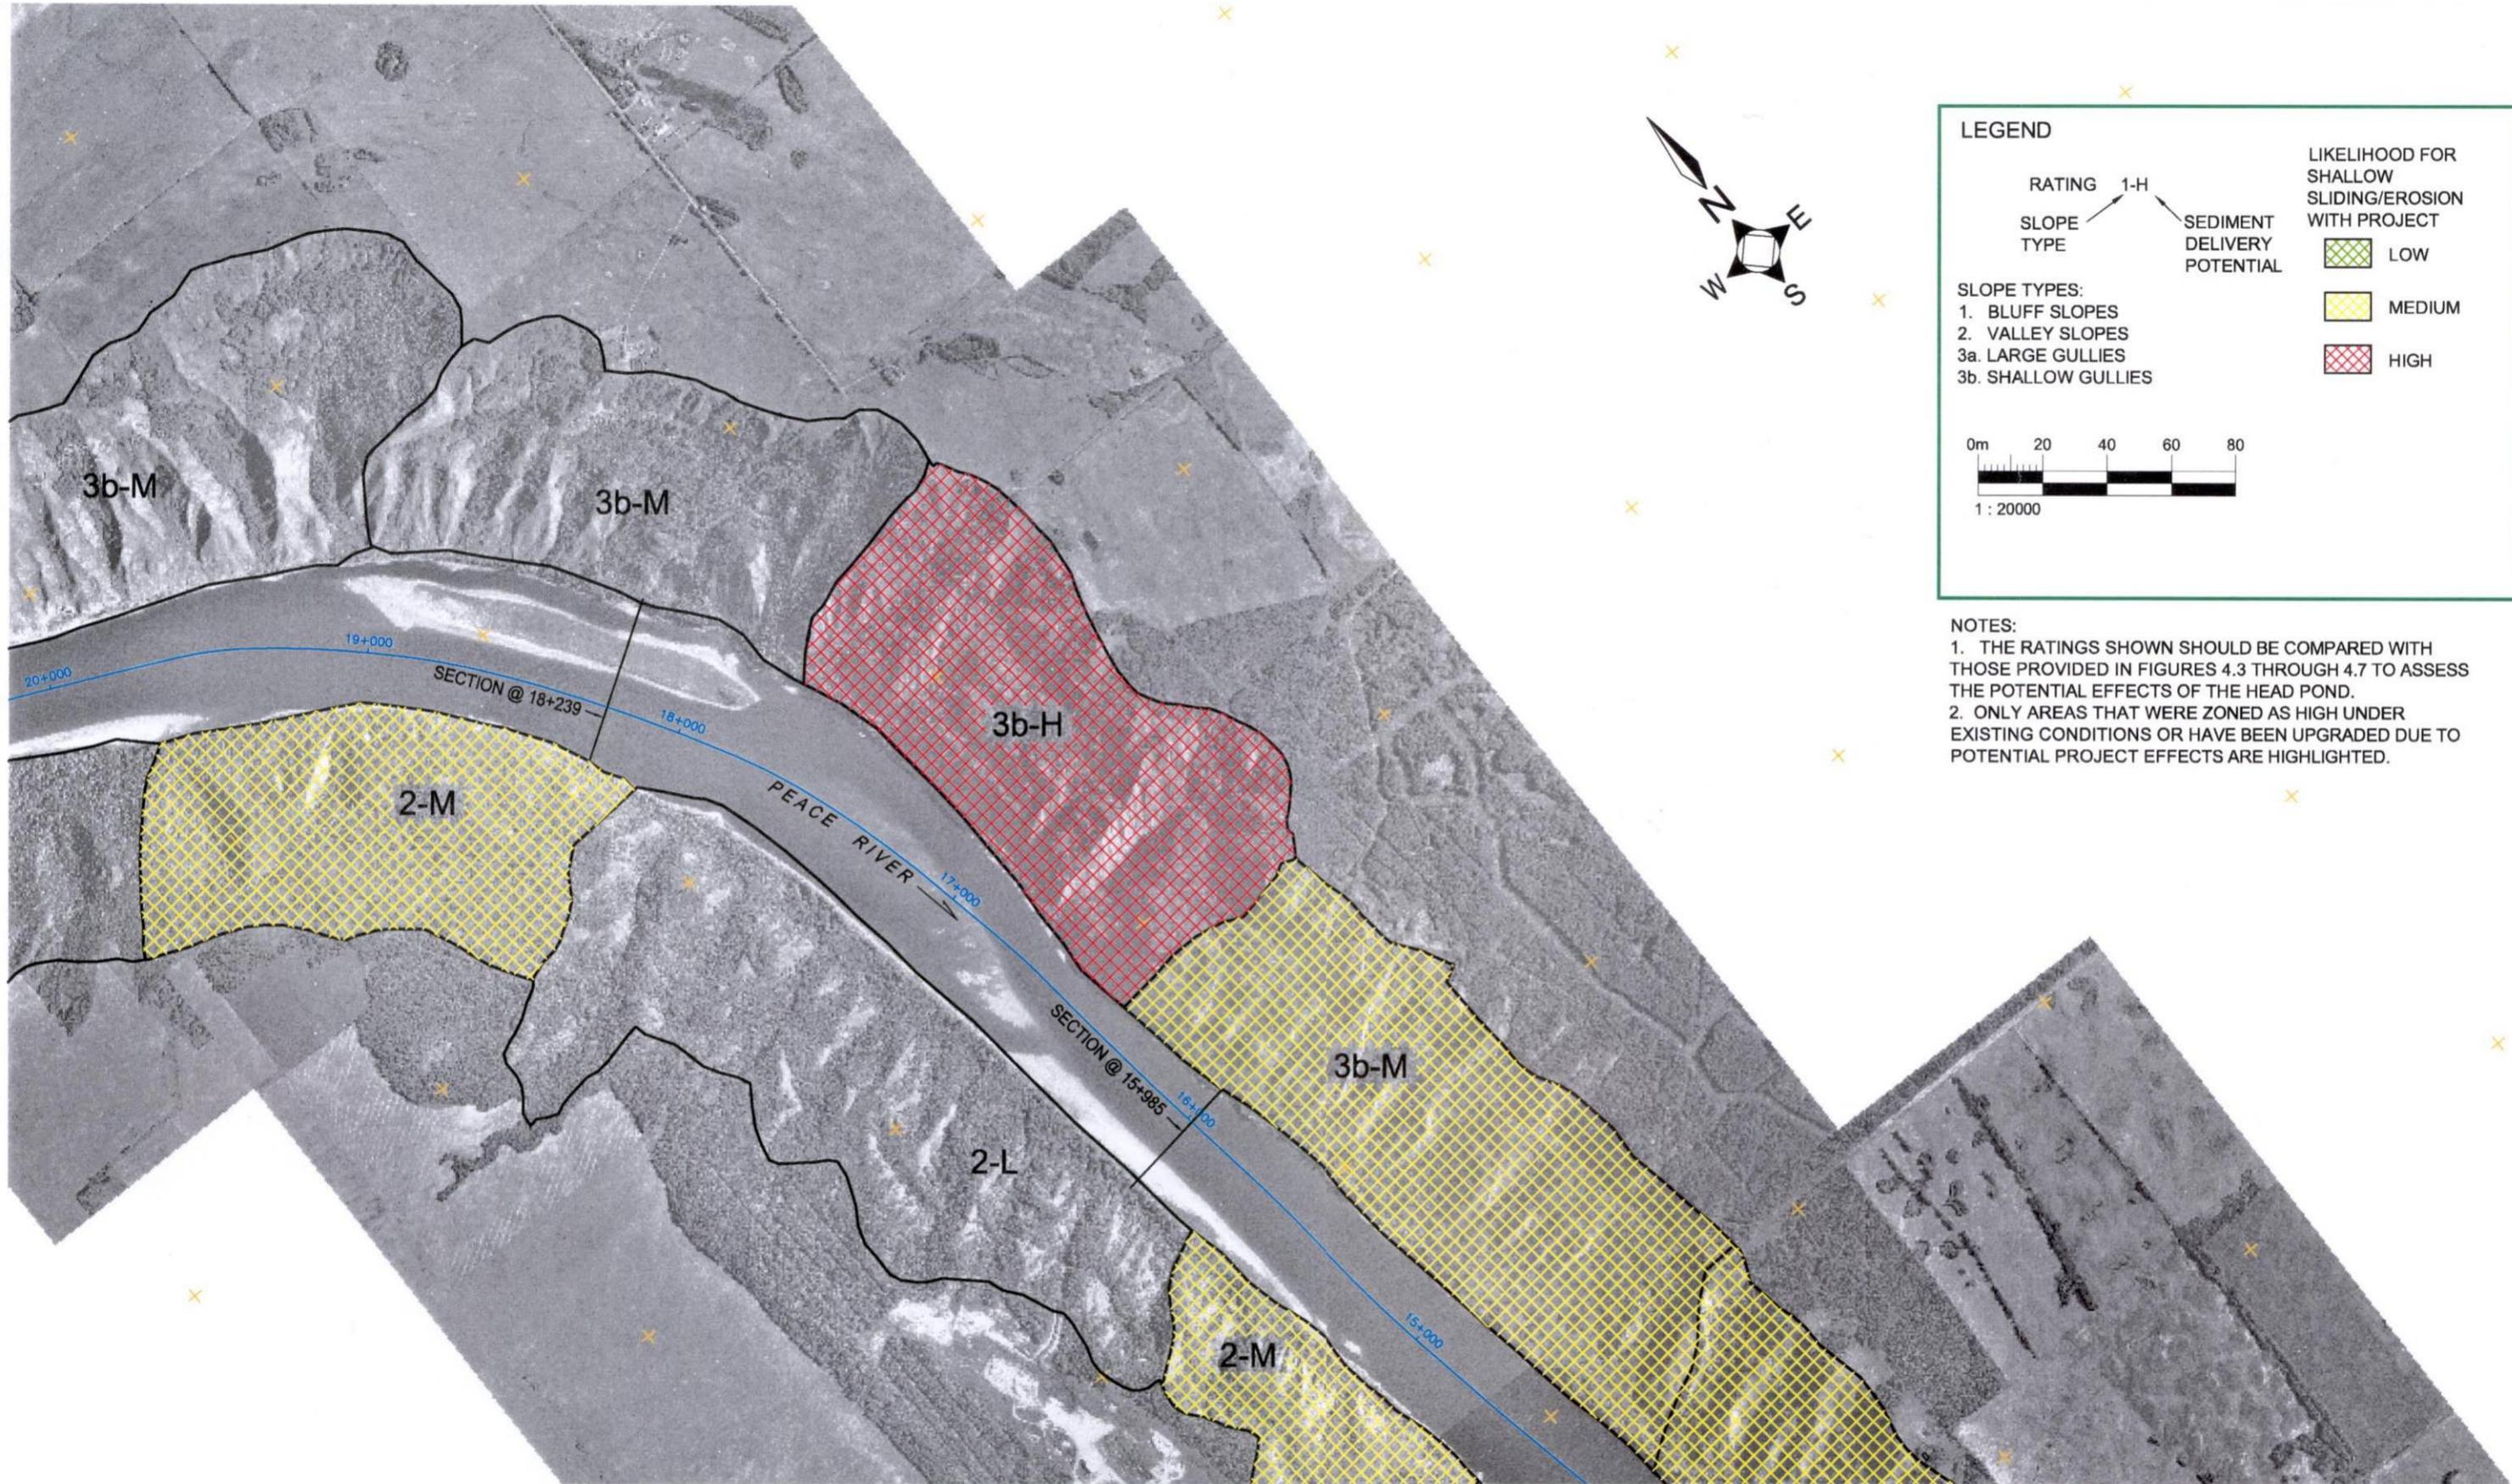
AEE PROJECT NO: EG08542
REV. NO: -
FIGURE 5.4

1. THE RATINGS SHOWN SHOULD BE COMPARED WITH THOSE PROVIDED IN FIGURES 4.3 THROUGH 4.7 TO ASSESS THE POTENTIAL EFFECTS OF THE HEAD POND.
2. ONLY AREAS THAT WERE ZONED AS HIGH UNDER EXISTING CONDITIONS OR HAVE BEEN UPGRADED DUE TO POTENTIAL PROJECT EFFECTS ARE HIGHLIGHTED.

**HEAD POND SLOPE STABILITY
LIKELIHOOD FOR SHALLOW SLIDING/EROSION
WITH PROJECT**
