Investigation Report
Worker Fatally Crushed by Equipment
August 30, 2016

Incident summary

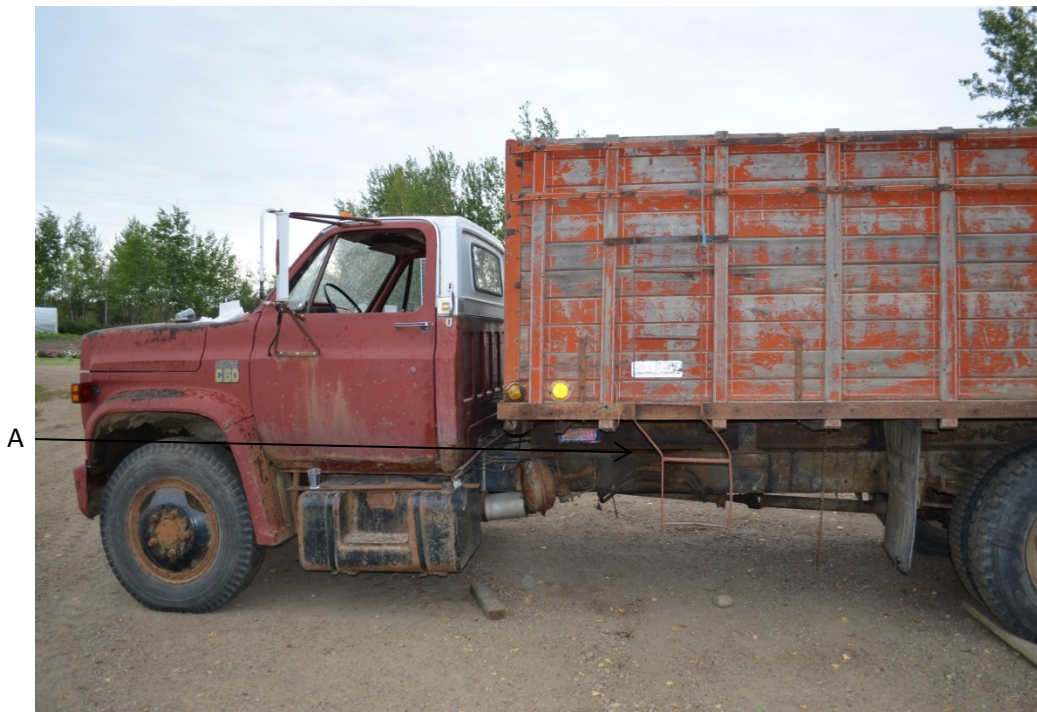
Figure 1. Driver's side of the grain truck the worker was operating at the time of the incident. Arrow A indicates the location of the worker when found.

At approximately 3:15 p.m., the employer drove into the farm yard and parked his vehicle. The employer stated he could hear the auger running but could not see the worker. The employer walked over to driver's side of the grain truck and saw the worker trapped between the frame of the grain truck and box. The employer could not recall if the grain truck was running when he arrived on the scene.
