# **Worker fatally crushed under portable classroom**

October 9, 2020

## **Incident summary**

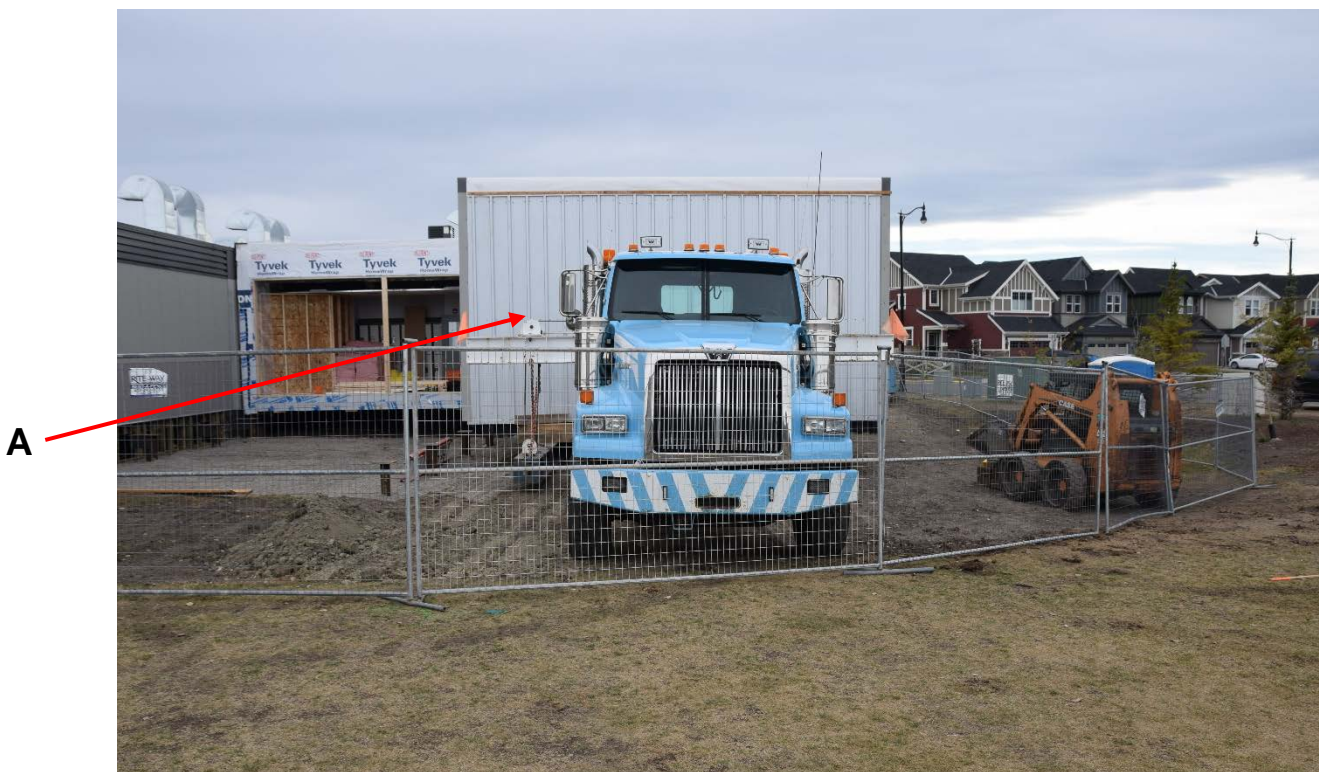
*Figure 1. The truck and portable classroom that were being moved into place at the time of the incident.*

*A. Portable classroom being moved into place at the time of the incident*

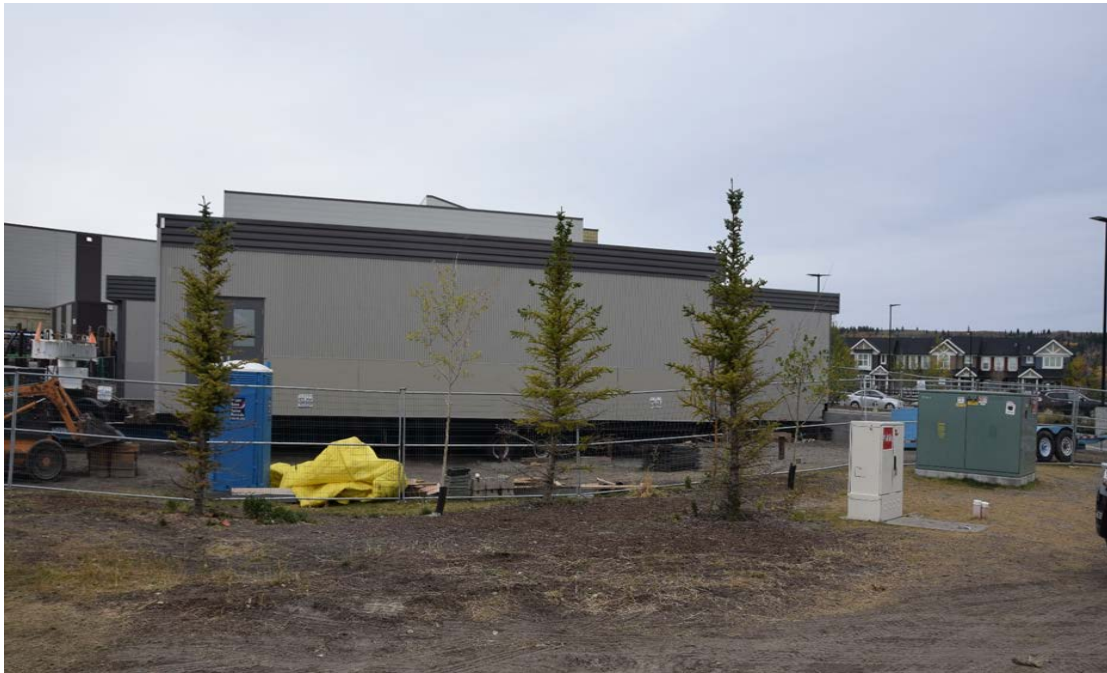
The portable classroom measured approximately 15.5 metres x 7 metres and weighed 2948 kilograms. The portable classroom was transported on a flatbed trailer. At location, the flatbed trailer was backed into spot in alignment with steel pylons that the portable classroom would eventually be placed on. Once in place, the portable classroom was to be constructed to the existing portable.

*Figure 2. Side view of the portable classroom that was being moved into place at the time of the incident.*

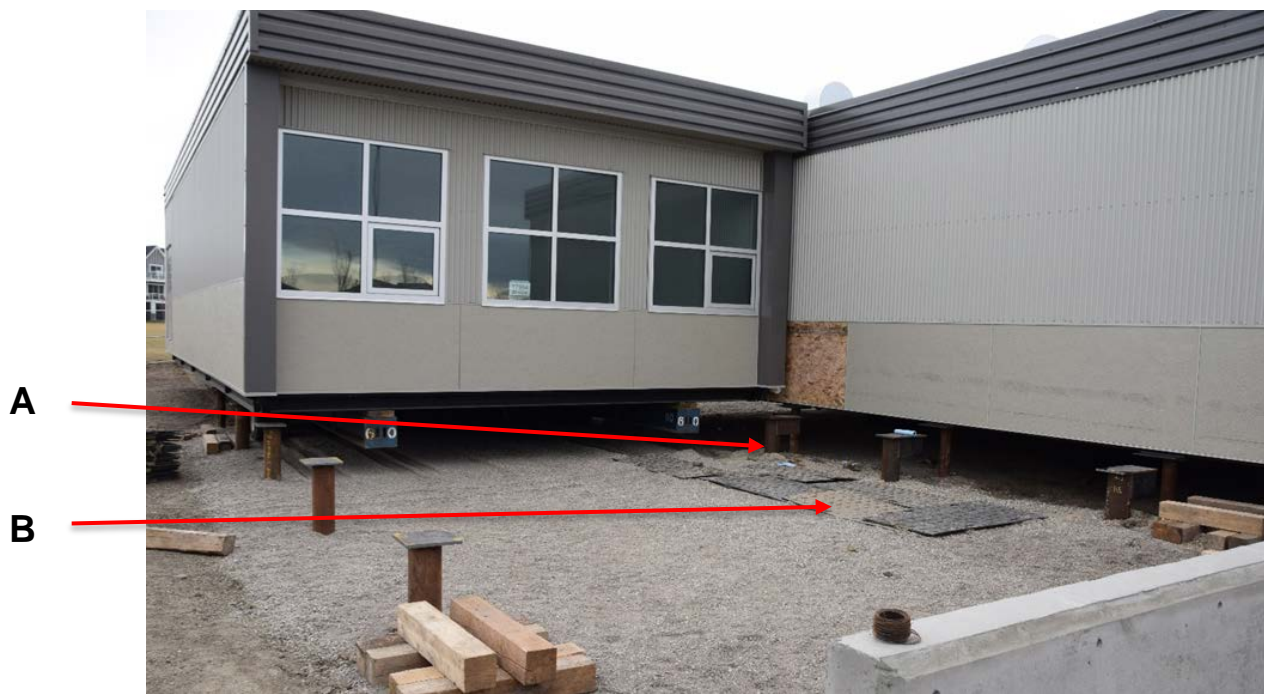
The work was stopped at this point, and a decision was made to place rubber rig mats underneath the tires on the right side of the flatbed trailer to provide a more stable surface to be backed onto (Figure 3).

*Figure 3. View of the back end of the portable classroom. This location of the portable classroom is not in situ, as the flatbed trailer was moved to extricate Worker 1. At the time of the incident, the portable classroom would have been further back.*

*A. The steel pylon where Worker 1 was crushed*

*B. Rig mats that were placed for the flatbed trailer to back onto*

The Site Supervisor yelled to the crew from the front of the truck that they were moving the truck. When the Truck Driver drove forward, Worker 1 was caught and crushed in between the cross beam on the underside of the flatbed trailer and a steel pylon sticking out of the ground. Workers heard a noise and looked under the trailer and saw Worker 1 was trapped. The flatbed trailer was moved so Worker 1 could be assisted.
