CHRISTINA LAKE REGIONAL PROJECT
FISH AND FISH HABITAT
ENVIRONMENTAL SETTING REPORT

Prepared For:
MEG Energy Corp.

Prepared By:
Golder Associates Ltd.

January 2005

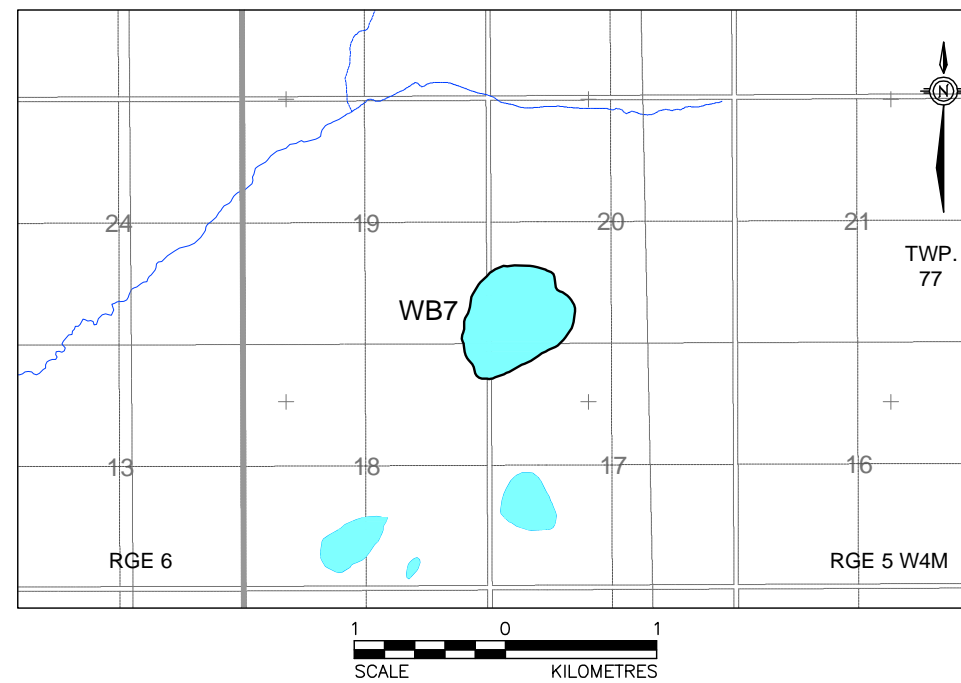
Photo 1 - Aerial view of Unnamed Waterbody 7 (May 2004).

The winter survey determined that overwintering habitat in Unnamed Waterbody 7 was limited. The ice thickness was 0.6 m and the maximum under-ice water depth was 0.6 m. The winter dissolved oxygen concentration was low at 1.9 mg/L (Table 3-9). The waterbody would only provide suitable overwintering habitat for species, such as brook stickleback, that are tolerant of low dissolved oxygen concentrations. The shallow depths and near anoxic conditions make it not suitable as overwintering habitat for sport fish.

Data from the open-water seasons show that water quality conditions in Unnamed Waterbody 7 are suitable to support fish during the spring and late summer (Table 3-9), with dissolved oxygen levels > 6 mg/L in both seasons.

Although no fish were captured during baseline sampling, Unnamed Waterbody 7 was considered to have suitable habitat for use by forage fish species. However, due to the small size, shallow depth (<1.2 m) and lack of inlet or outlet streams, the habitat potential for use by suckers and sport fish species, such as northern pike, was considered nil to low. Although the waterbody may provide suitable shallow water nursery, rearing and feeding habitat during open-water seasons, the waterbody did not have suitable conditions for suckers and sport fish overwintering.

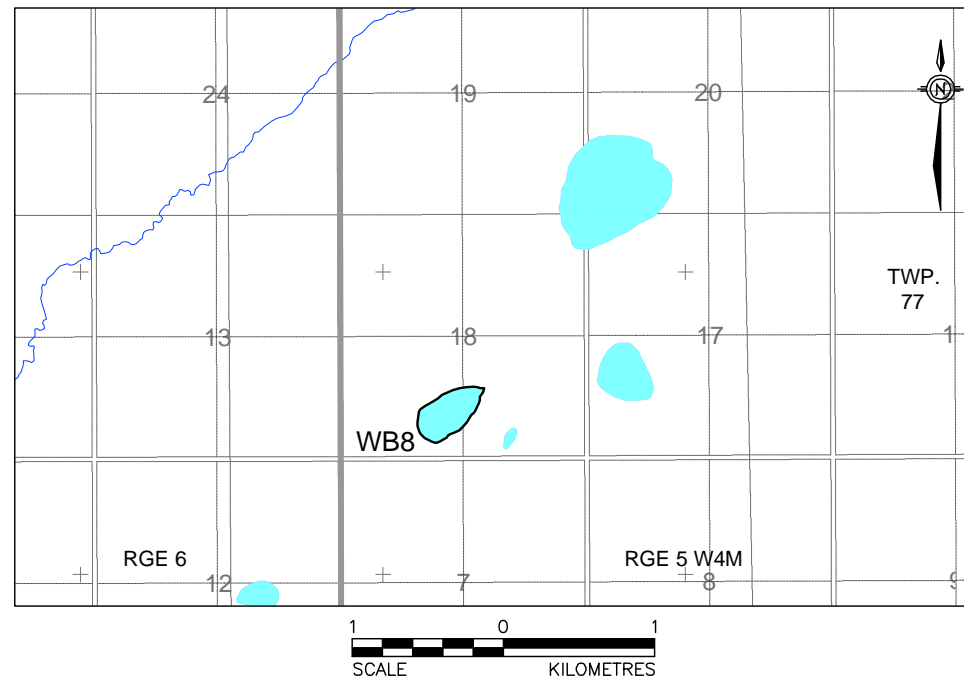
Photo 1 - Aerial view of unnamed Waterbody 8 showing abundant aquatic vegetation (August 2004).

The winter survey determined that overwintering habitat in Unnamed Waterbody 8 was limited. The ice thickness was 0.6 m and the maximum under-ice water depth was 0.6 m. The winter dissolved oxygen concentration was low at 1.8 mg/L (Table 3-10). The waterbody would only provide suitable overwintering habitat for species, such as brook stickleback, that are tolerant of low dissolved oxygen concentrations. The shallow depths and near anoxic conditions would not make it suitable as overwintering habitat for suckers and sport fish (northern pike).
