# Worker fatally injured in fall from scaffold

September 1, 2021

## **The contents of this report**

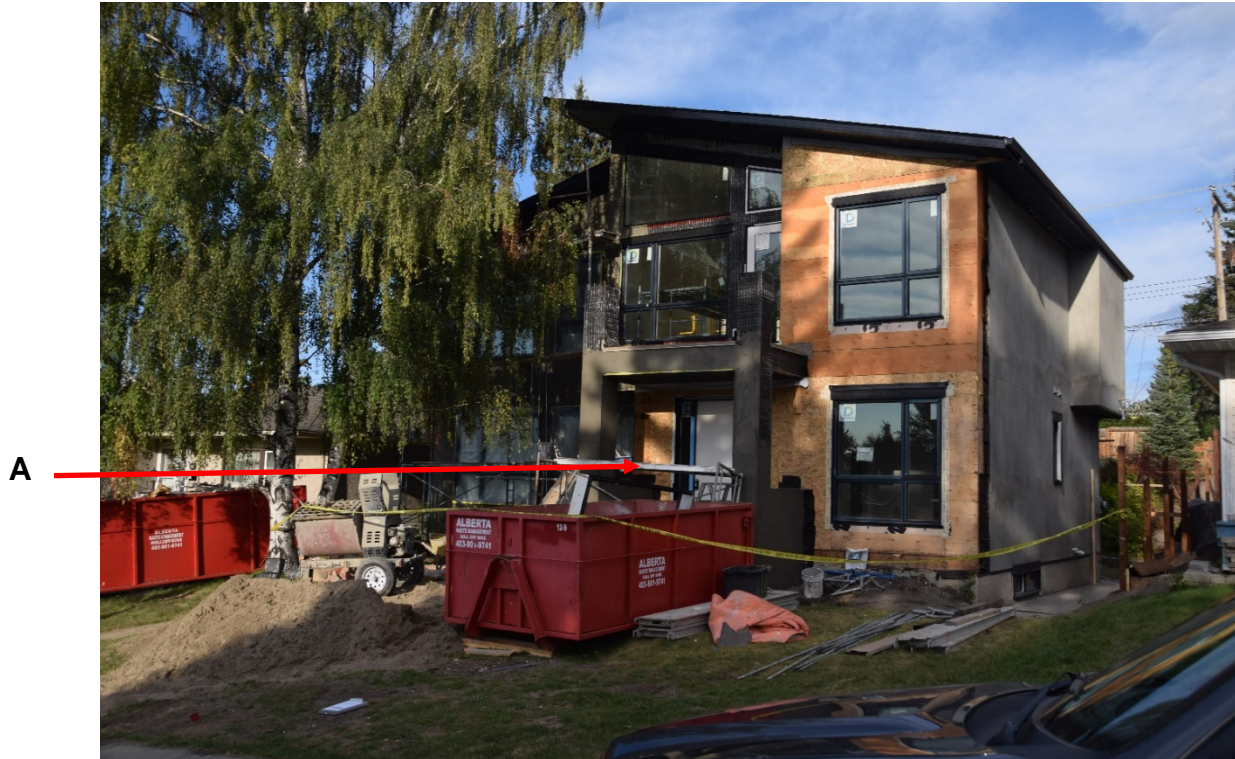
The work site was a single-family detached home located in the Charleswood community of Calgary, Alberta. The front of the home faced east, and was located at or near a standard residential roadway (Figure 1).

Figure 1. The front of 104 Cheyenne Crescent NW, Calgary, Alberta.  
A. The incident scaffold, work area and incident location

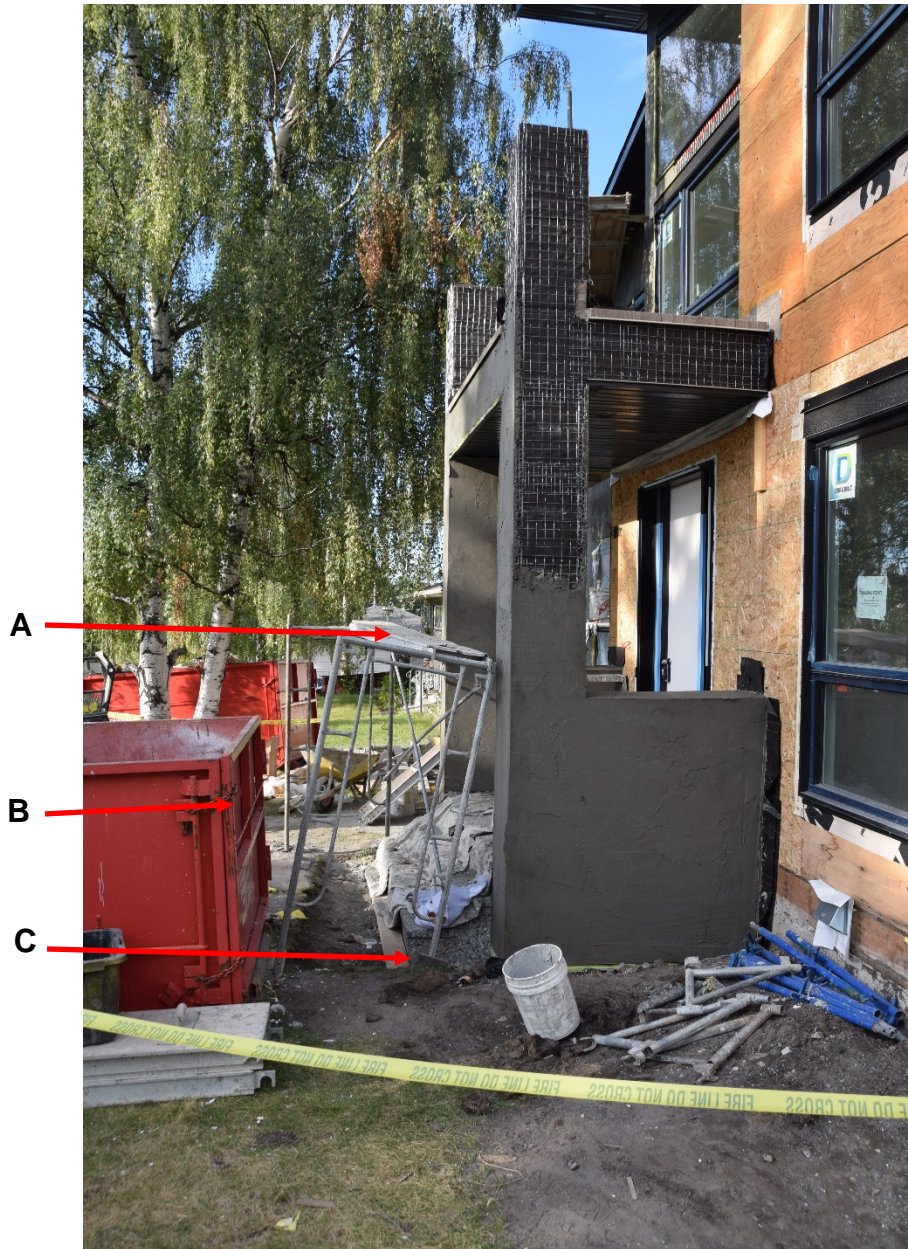
The incident occurred at or near the front entrance to the home (Figure 2).

Figure 2. The incident location, east side of the home.

- A. The location of the Worker pre-incident
- B. The dumpster at or near the location where the Worker struck their head
- C. A scaffold leg that shifted near the pillar where the Worker was working

Upon commencement of work, the Worker positioned themselves on the top of a section of double pole scaffolding located at or near the north front porch pillar. A steel dumpster was positioned at the rear of the work area (Figures 1 and 2).

At approximately 6:10 p.m., the front footing of the north side section of the scaffold shifted into an open trench measuring 20 centimetres in depth. The Worker lost their balance and fell backward, striking their head on the dumpster.
