Occupational Health and Safety

Fatality Report

Worker Electrocuted

Date of Incident: March 21, 2007

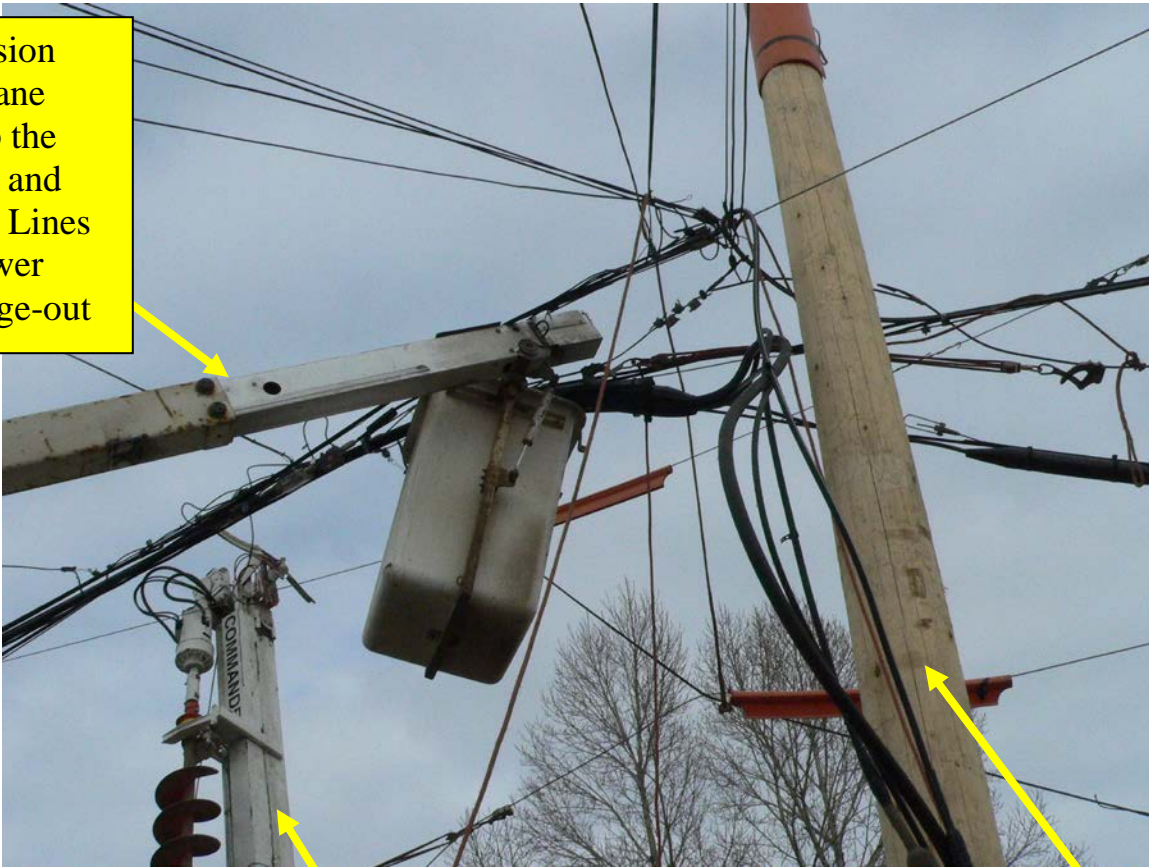
Top of the Radial
Arm Digger Crane

Looking up from
the base of the new
Power Pole

Shows a closer view looking northeast up from the base of the new Power Pole that was installed. This view exemplifies the difficulty for the Power Linemen and other service personnel to complete the removal and installation of power poles with the many different services along with the Power Lines.

The Boom Angle Indicator Shows that the Crane Boom has nearly reached the limit of its rise

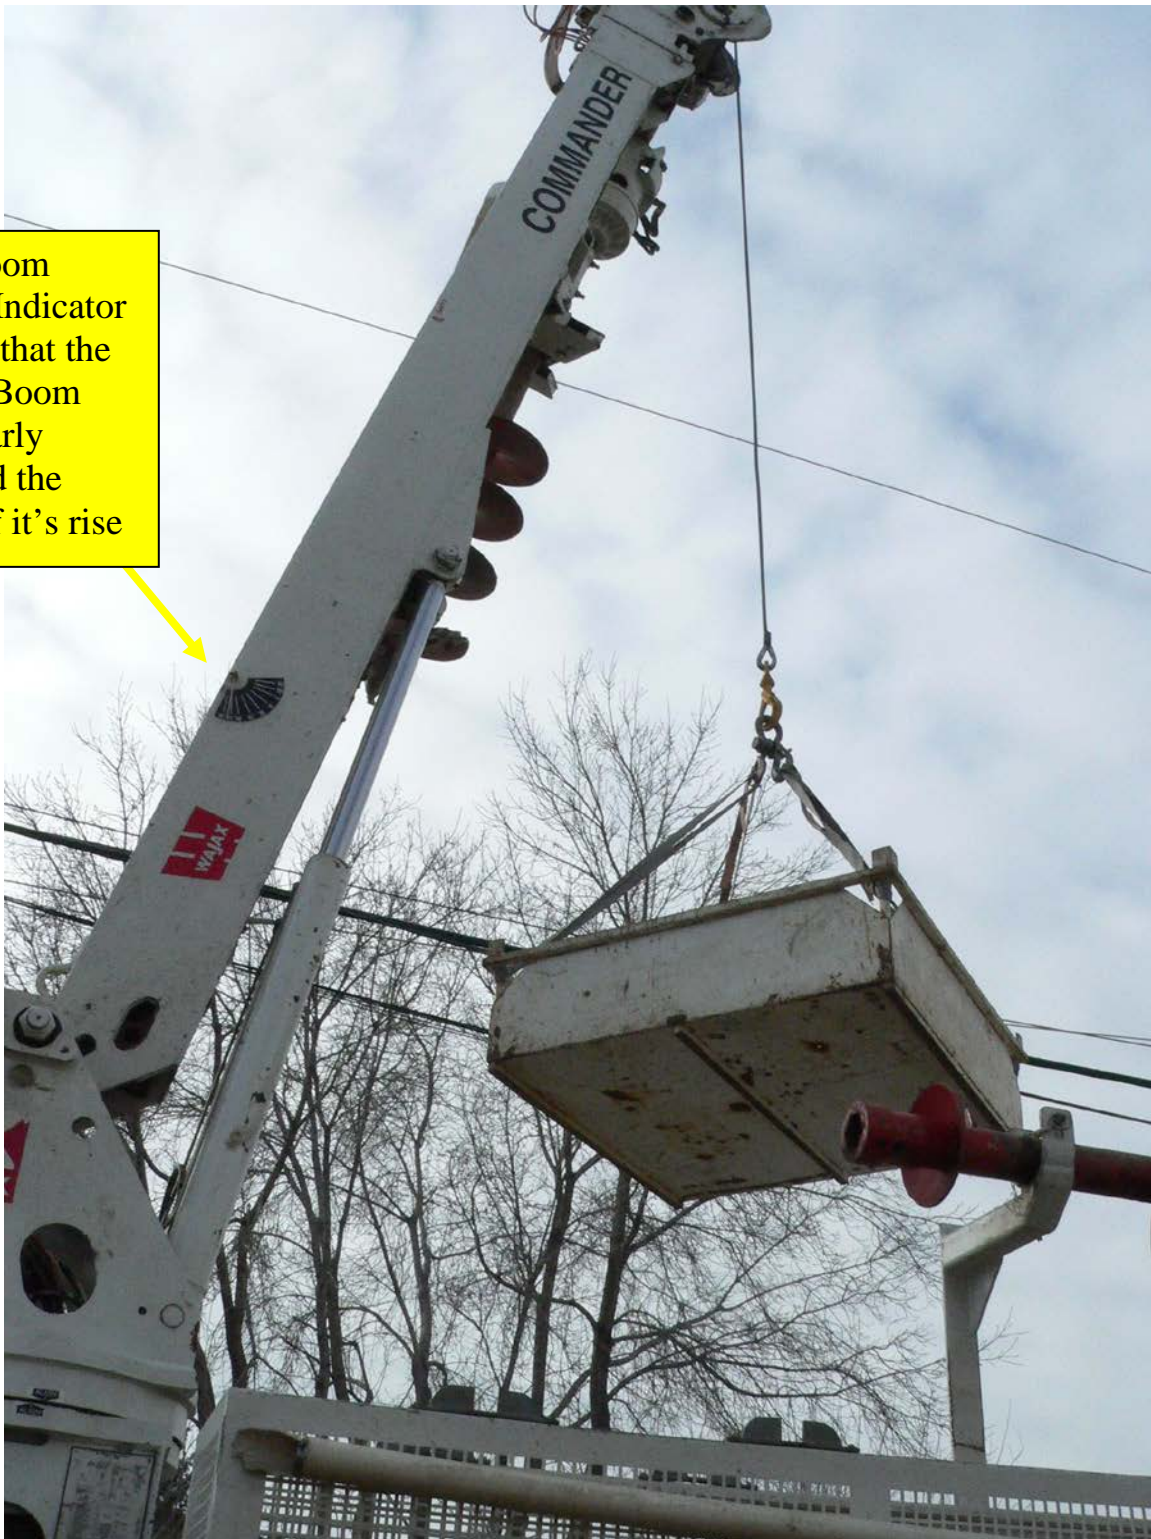
Photograph #3 Shows the position of the Radial Arm Digger Crane Boom and the empty Gravel Tray hanging in the air looking in a northwesterly direction from the passenger side of the truck. The operator would have been looking towards the rear of the truck to operate the Crane controls.

- 5.1 **Terex – Telelect Inc. Radial Arm Digger Crane**
 - 5.1.1 Commander 4050
PG Winch
Series L4000
Serial # 2031022829
Load Chart Number E04F-8496
Retracted sheave height 9.05 m (Attachment "A", Photographs 3, 4)

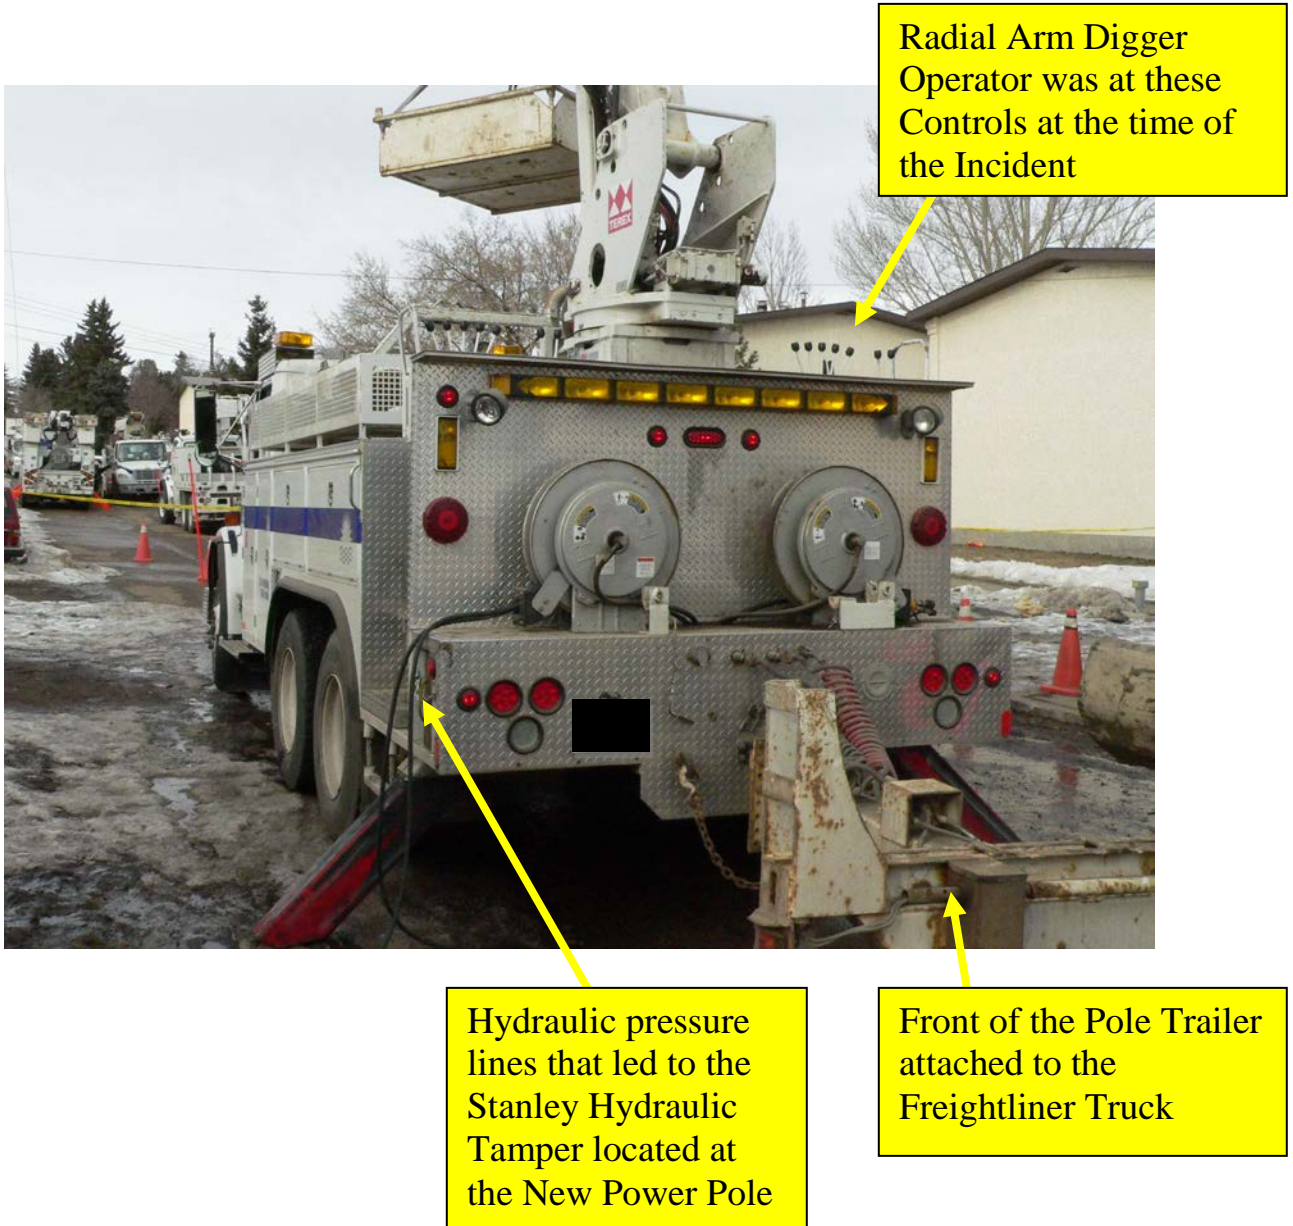
Photograph #4 Shows the Freightliner Truck (with license identifier) depicting the Radial Arm Digger mounting arrangement and the perspective of where the Gravel Tray is when looking north, north-east from the rear of the unit. The operator was at the controls on the rear passenger side of the truck. The normal operating position would be facing to the rear.

5.2.1 Model FL80, Extended Cab
Utility Body/Digger
Serial # [REDACTED]
Unit # E3750
License # [REDACTED]
(Attachment "A", Photograph 4)

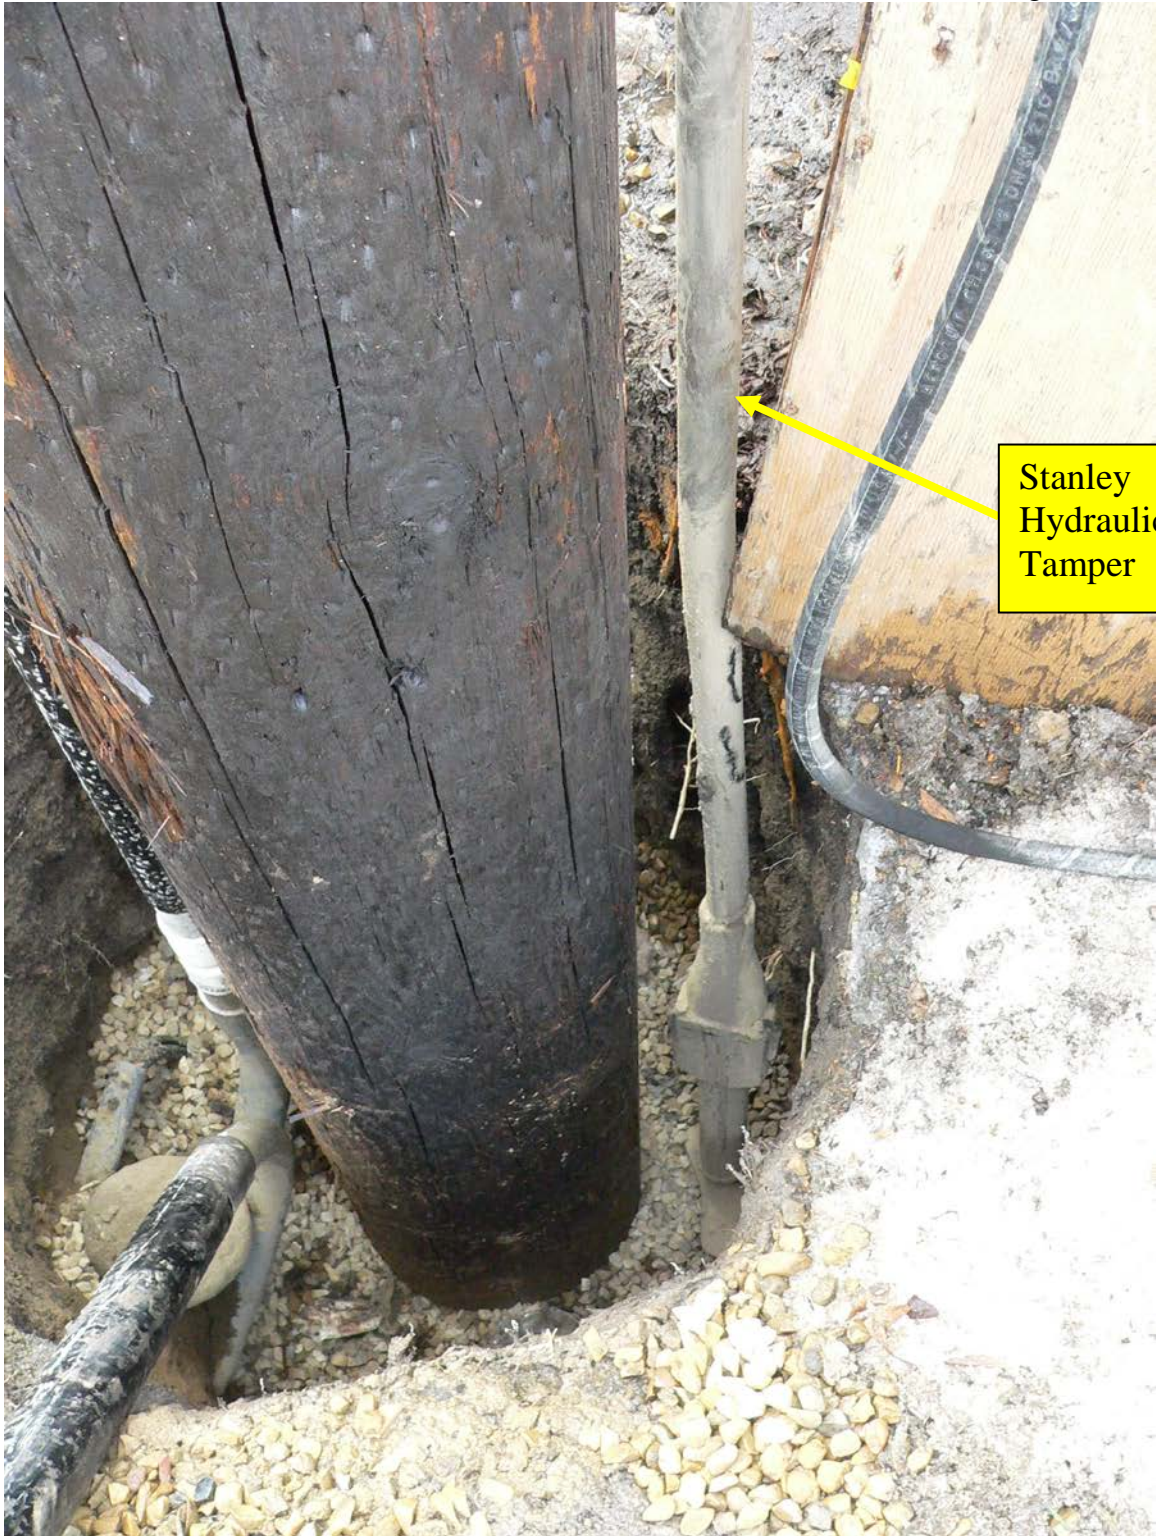
Stanley
Hydraulic
Tamper

Photograph #5 Shows how the base of the new Power Pole looked from the alley side. The Power Pole is singed from the fire that erupted due to grounding of the 8 Kv Power Line. The Stanley Hydraulic Tamper in the hole was a main source of grounding from the Freightliner Truck with Radial Arm Digger Crane.

Freightliner Truck Unit E3750
with the Radial Arm Digger
Crane mounted on it

5.3.1 Model TA54
Attached to Freightliner power unit with hydraulic lines
(Attachment "A", Photographs 5, 6)(Attachment "C", Stanley Hydraulic Tamper Drawing)

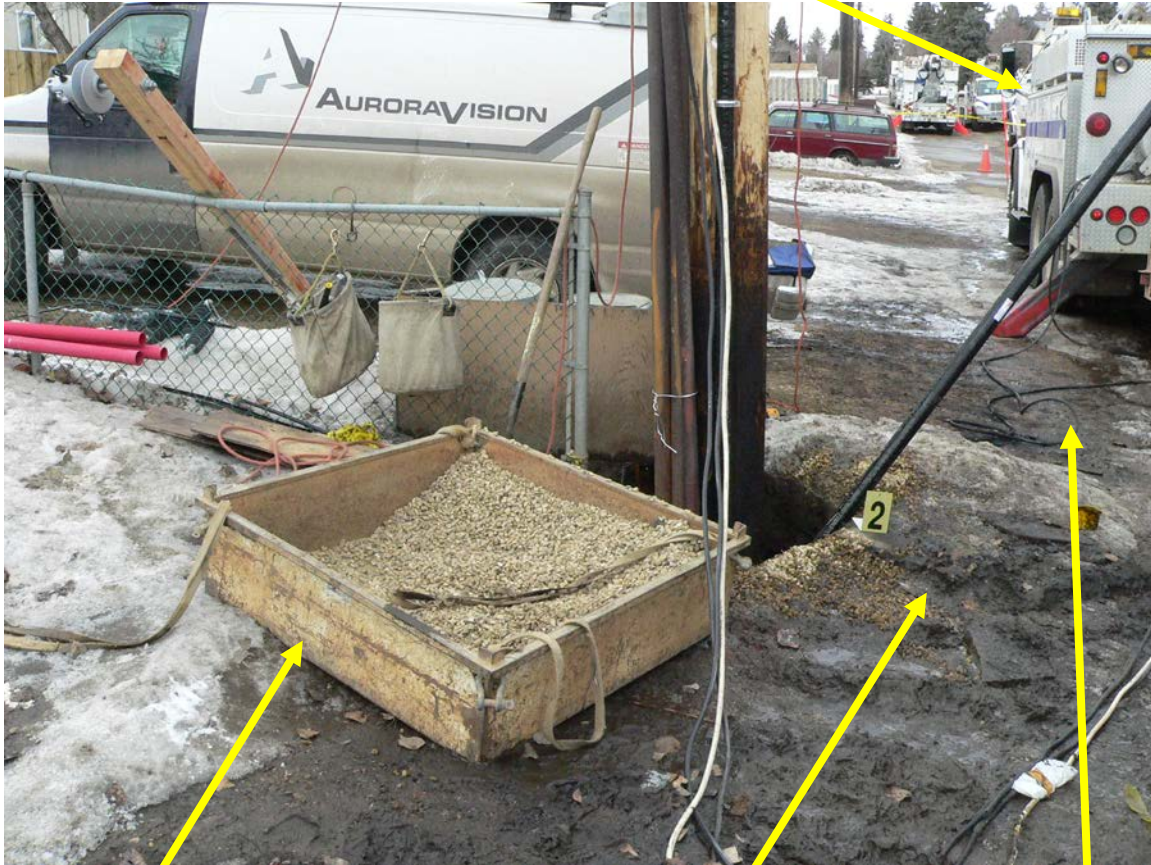
Shows one of two
Gravel Trays that were
placed near the Power
Pole excavation. This
Gravel tray is located
directly south of the
new Power Pole.

This is the location of the Gravel
Tray that was taken away by the
Radial Arm Digger Crane. This is
also the location where 3 workers
were at the time fire erupted from the
hole at the base of the Power Pole.
One of the workers exiting the scene
was electrocuted.

Hydraulic Hoses
leading to the
Stanley Hydraulic
Tamper

Photograph #6 Shows the base of the Power Pole from the alley, looking in a
northerly direction.

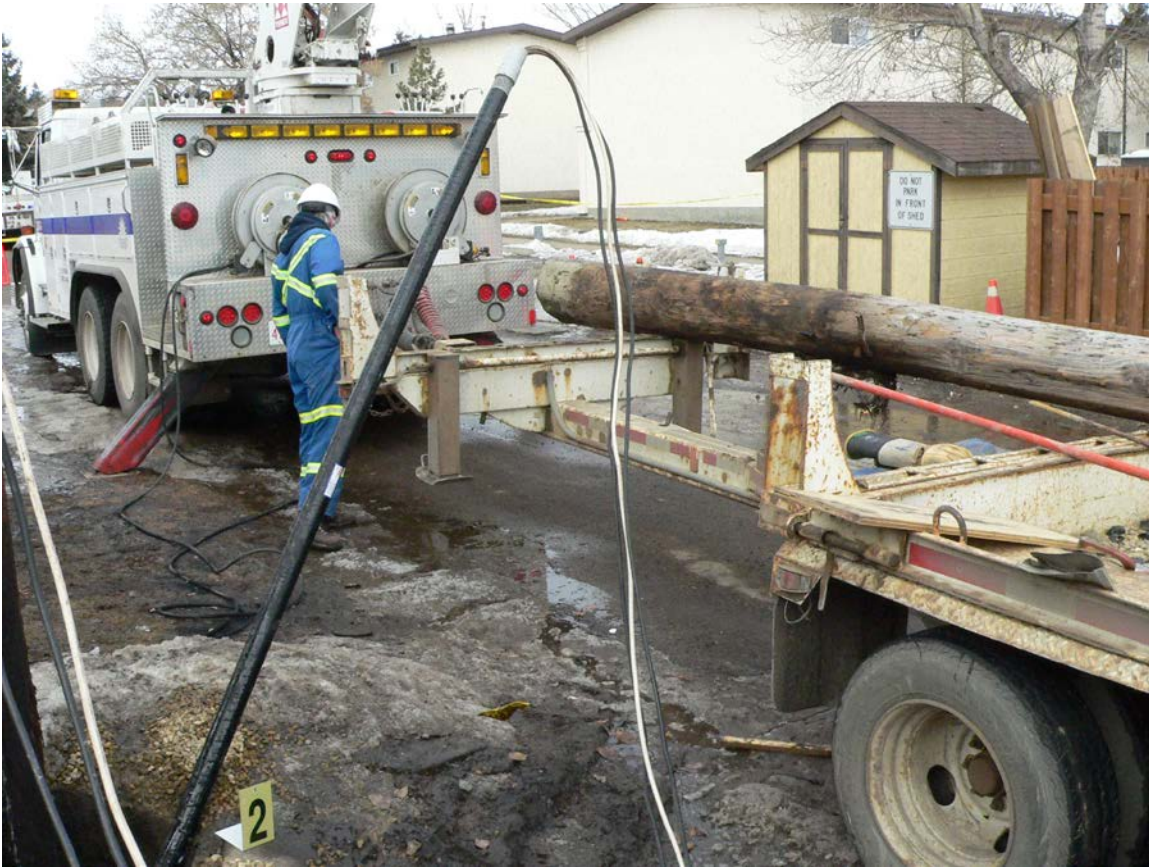
Photograph #7

Shows a view of the scene from the same location where Photograph 6 was taken, looking in a northeasterly direction. This indicates how the Freightliner Truck and Pole Trailer were attached and became an integral part of the conducting system for the electrical current dispersal once the energized Power Lines had been hit by the Radial Arm Digger Crane Pole Claw.

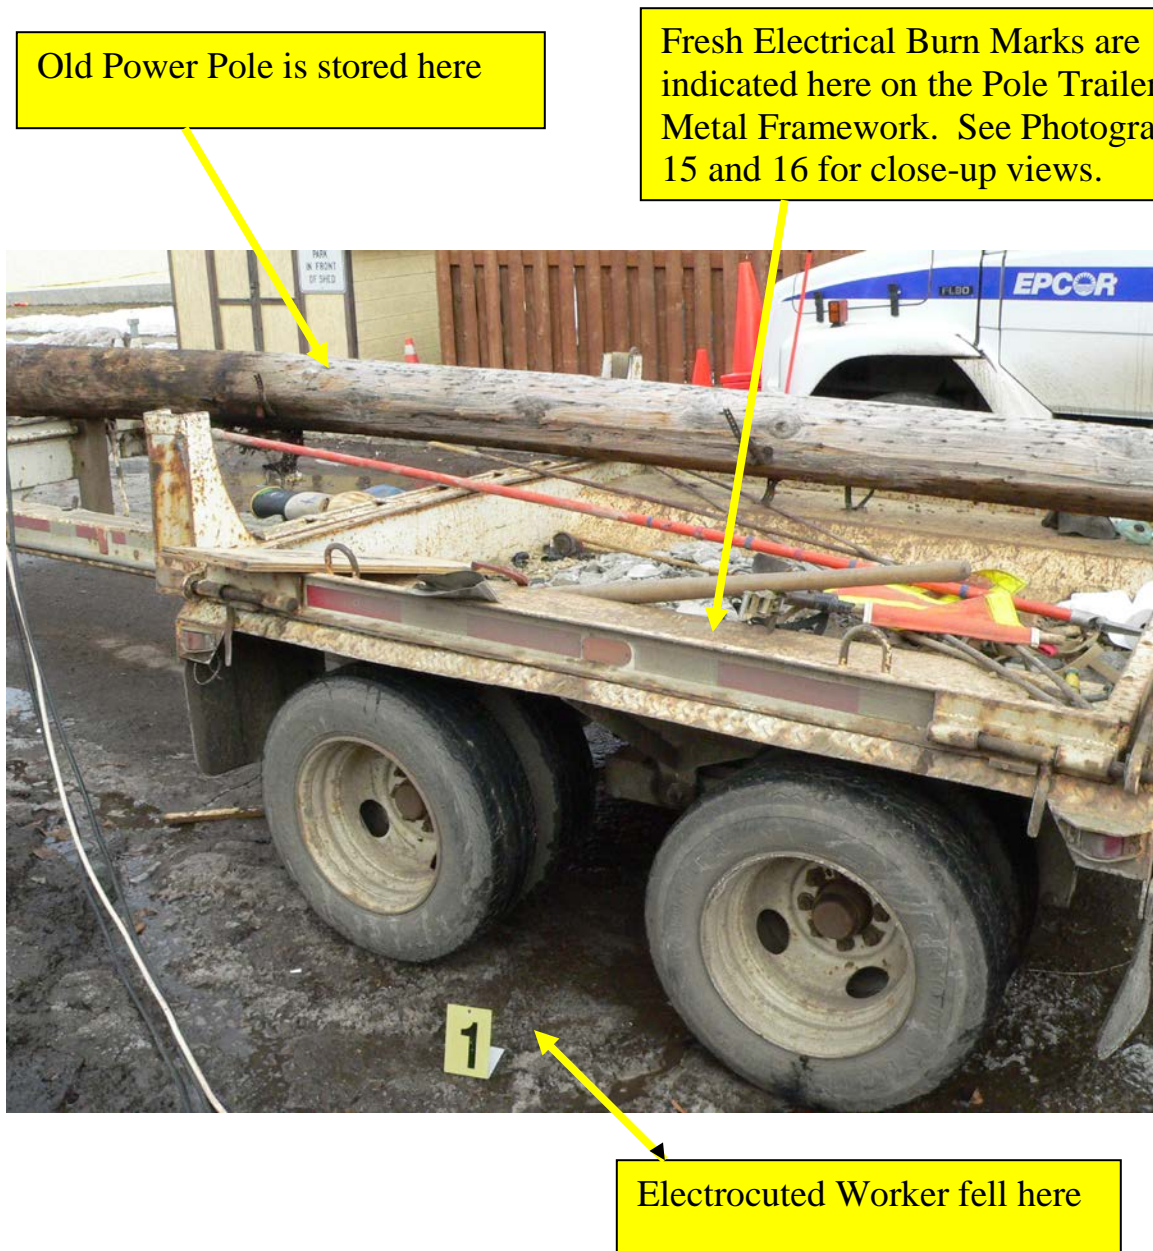
Photograph #8 Shows a view taken from the same position as Photographs 6 and 7, while turning in a rotation on the landscape. The number 1 marker indicates where the electrocuted worker fell to the ground beside the driver's side of the Pole Trailer wheels.

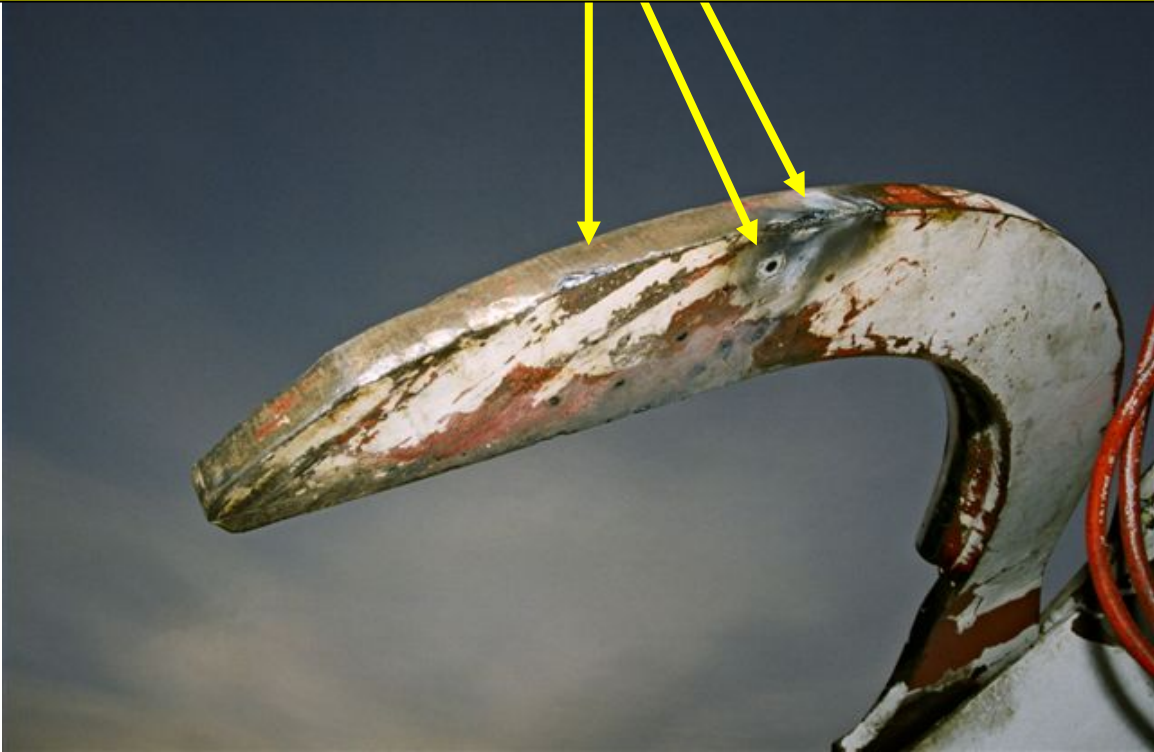
Fresh Electrical Burn and Melting Marks on this outer side Rim of the Pole Claw

Photograph #9 Shows the electrical arc marks and melting on the left, driver's side, bottom, of the Pole Claw that is located at the top of the Radial Arm Digger Crane Boom. This is one of the areas that made contact with the 8 Kv energized Power Line. See Photograph 10 for a close-up view of the arc marks.

- 7.1.1 The Direct cause of the electrocution of the Power Lineman was the Radial Arm Digger Crane's open Pole Claw making contact with an 8 kV energized Power Line and energizing the Radial Arm Digger Truck and Pole Trailer at the same time as the Power Lineman touched the Pole Trailer and ground. There were distinctive arc marks on this trailer. (Attachment "A", Photographs 8, 15, 16) The Medical Examiner's photographs showed distinct electrical current entry marks and exit marks on the victim's body.

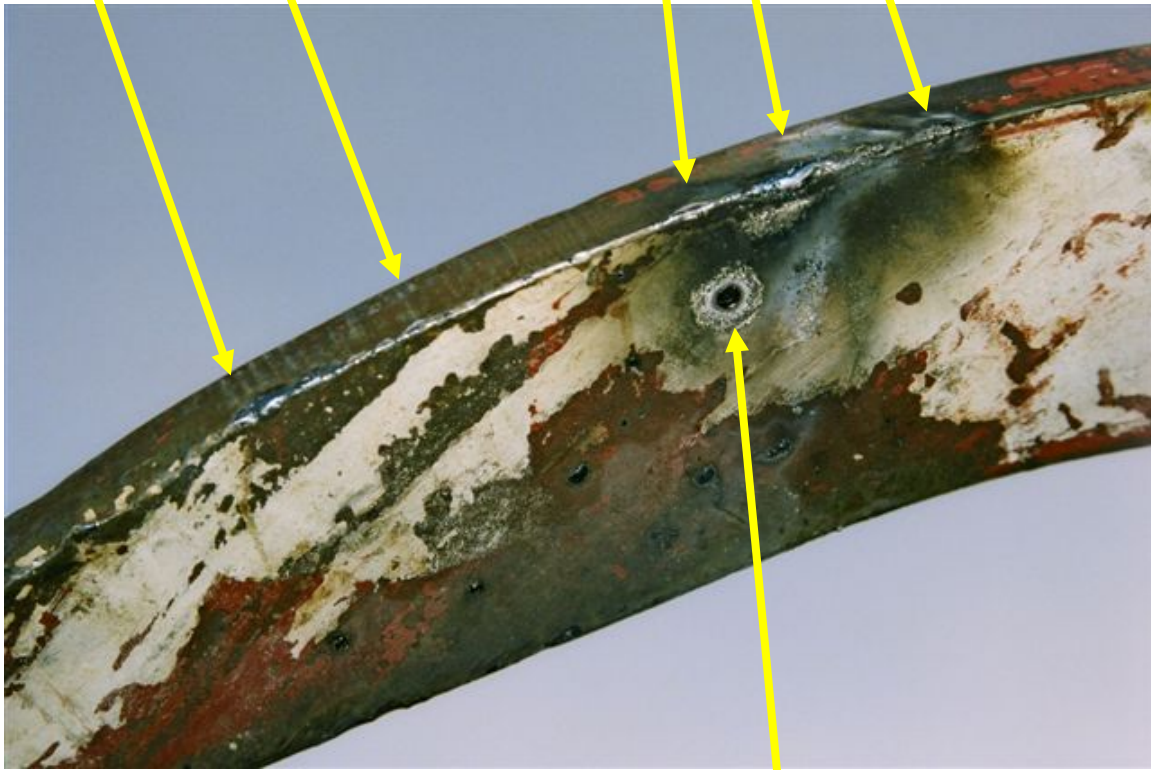
A Second Tracking Burn Mark with a Deposit of Metal Welded to the Pole Claw

A Tracking, High Temperature Burn Mark with a deposit of Metal Welded to the Pole Claw

Fresh Electrical Arc Depression in the Steel

Photograph #10 Shows a closer view of the Pole Claw depicted in Photograph 9.

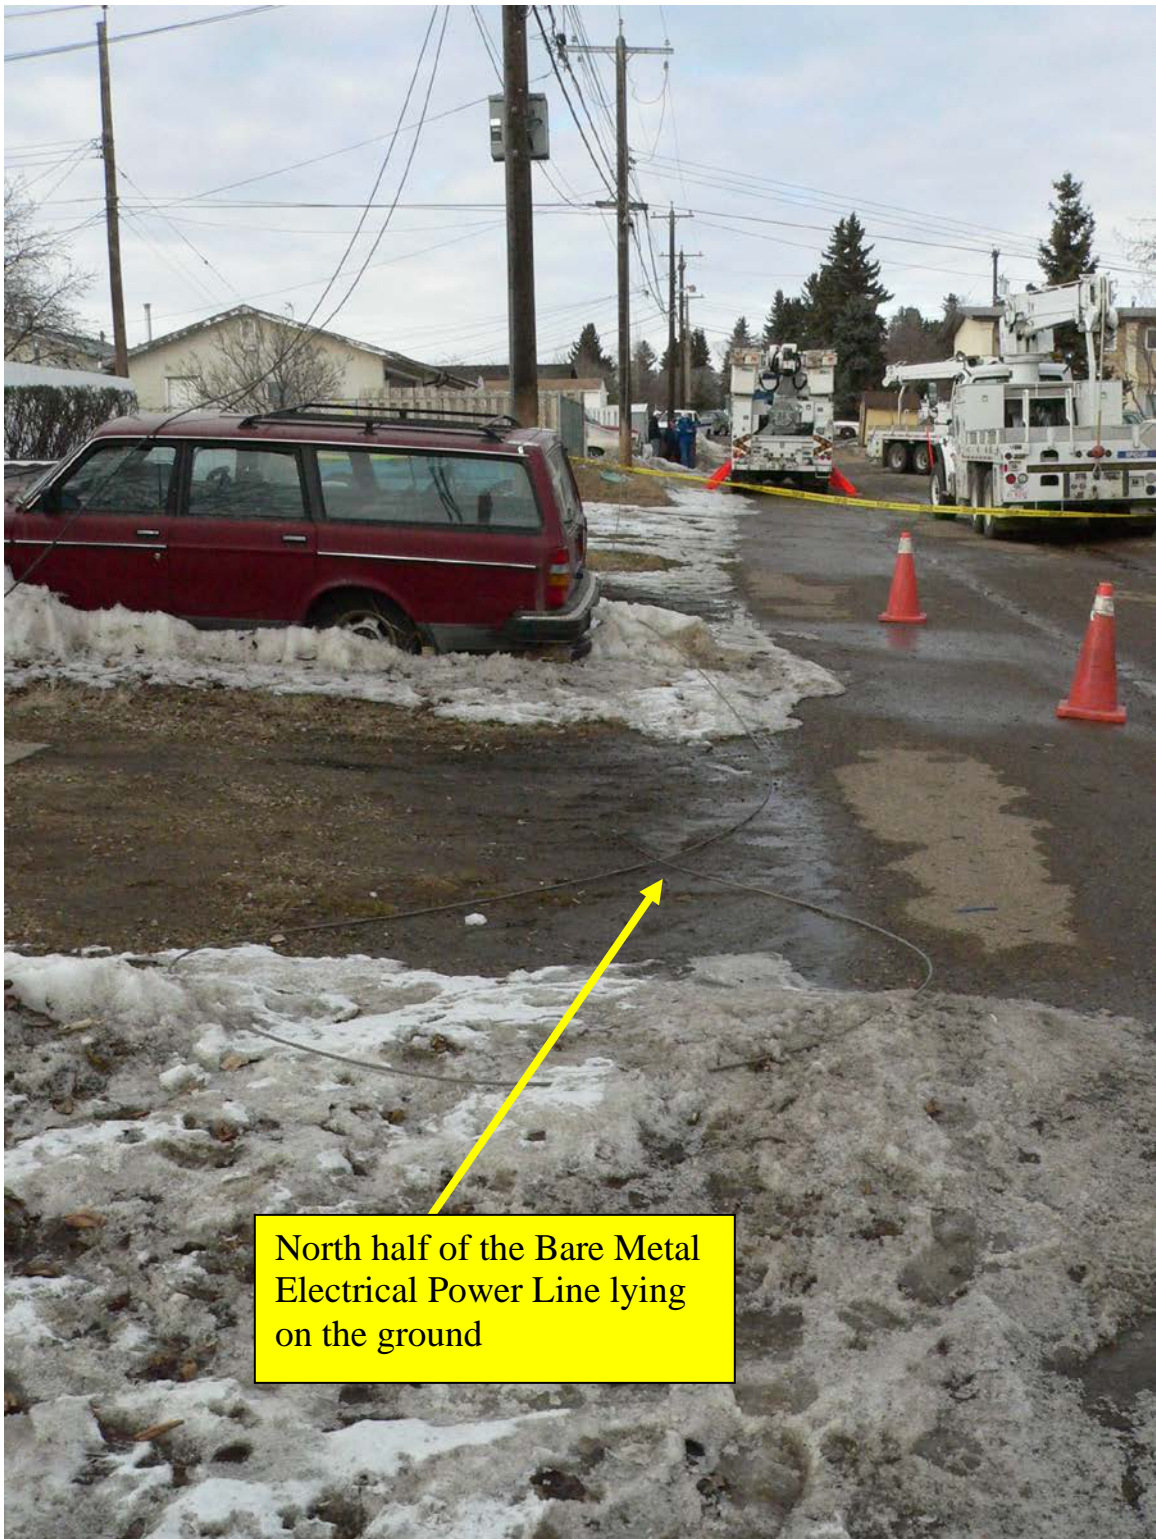
North half of the Bare Metal
Electrical Power Line lying
on the ground

Photograph #11 Shows the severed end of the Power Line between the front of the Radial Arm Digger Truck and the second pole in the alley going north. This line ended up on the ground after being severed.

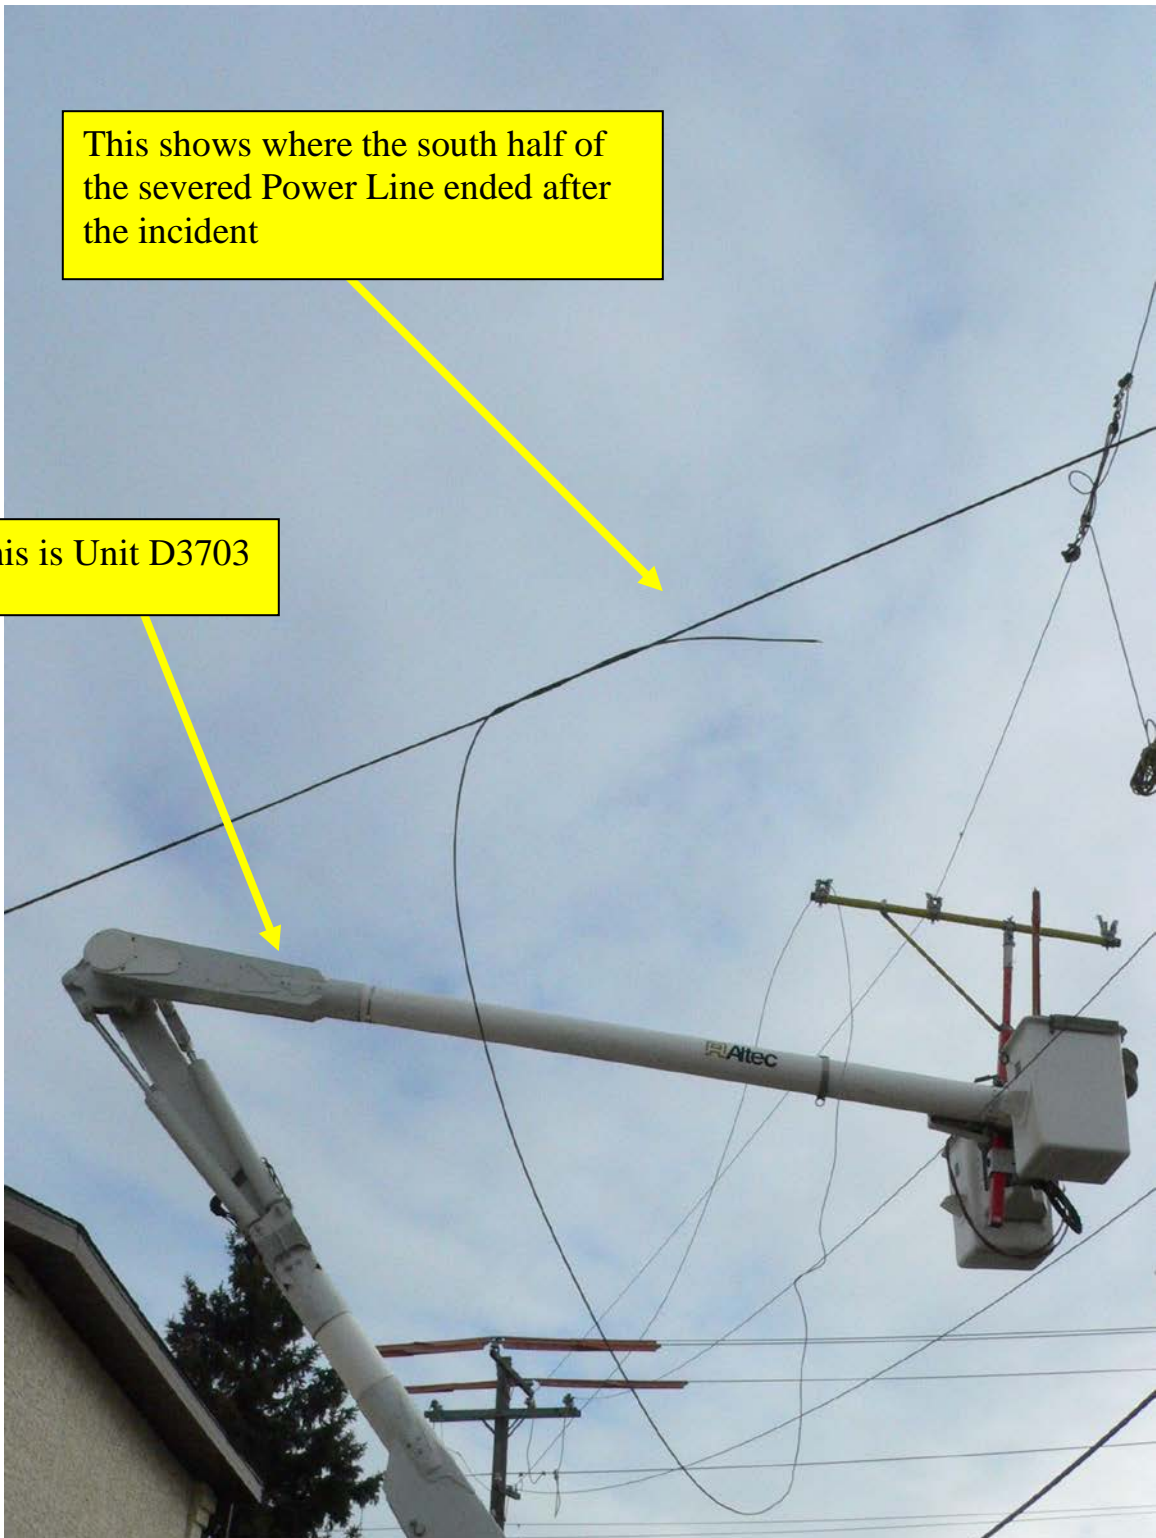
This shows where the south half of the severed Power Line ended after the incident

This is Unit D3703

Photograph #12 Shows the south half of the Power Line after it was severed. This photograph is taken looking south from the alley towards 51 Avenue. The electrical Power Line severed end wrapped around a utility line traversing the alley to the east side dwellings.

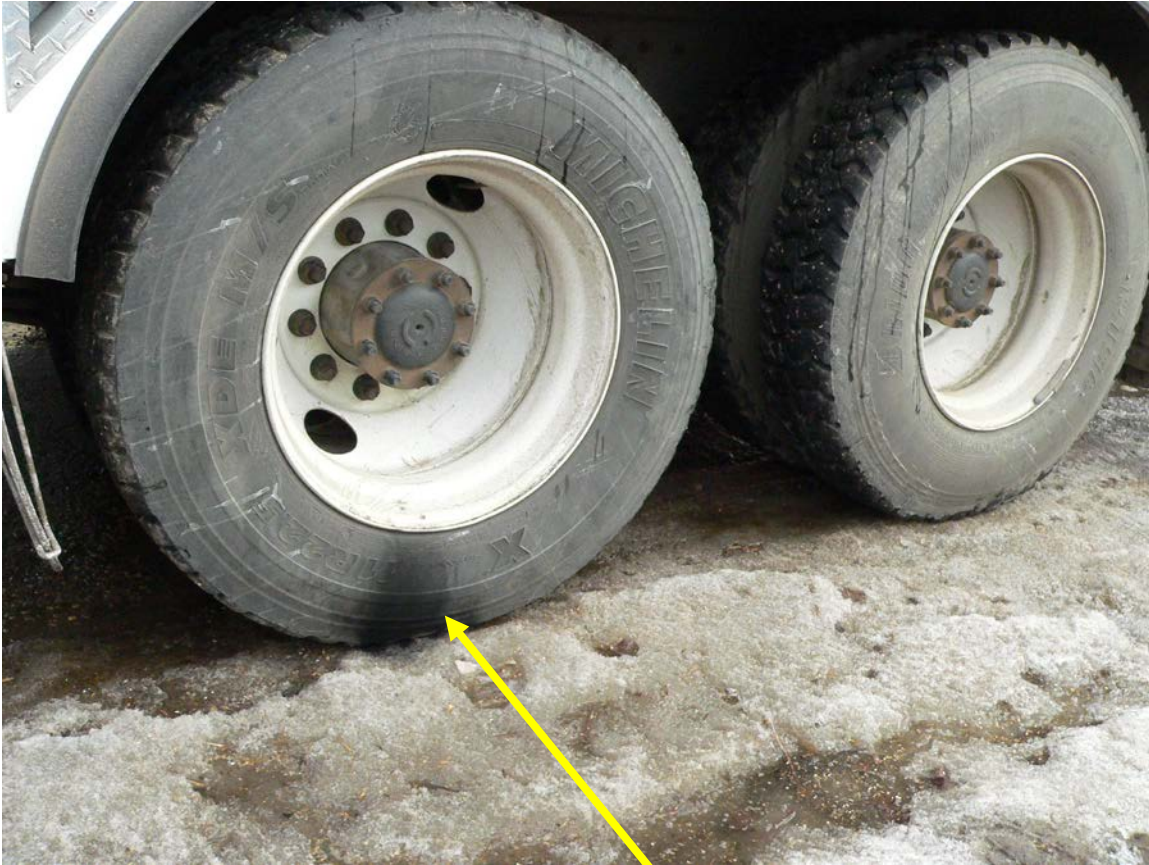
Electrical Arcing indicated by the blackened rubber on the Freightliner Truck Tire. Unit E 3750

Photograph #13 Shows how the electrical current from the Power Line contact by the Pole Claw, traveled through the Radial Arm Digger Truck frame and into the ground through the driver's side rear tires.

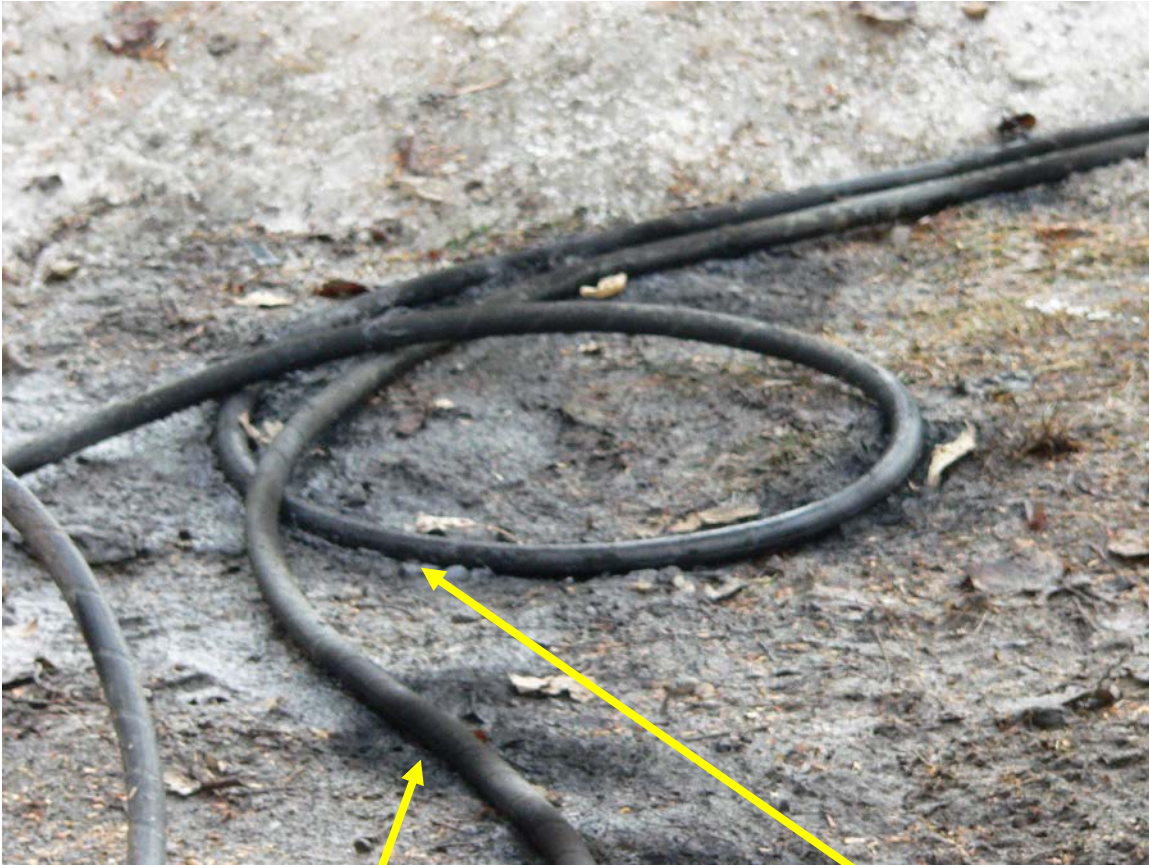
Burned Rubber
Coating indicated

Hydraulic Hoses are
melted into the ice from the
heat of High Voltage
Electrical Current flow

Photograph #14 Shows a closer view of how the heat from the high-voltage electrical current following the hydraulic hoses (also shown in photograph 6) burned the rubber coating and melted the hose into the ice.

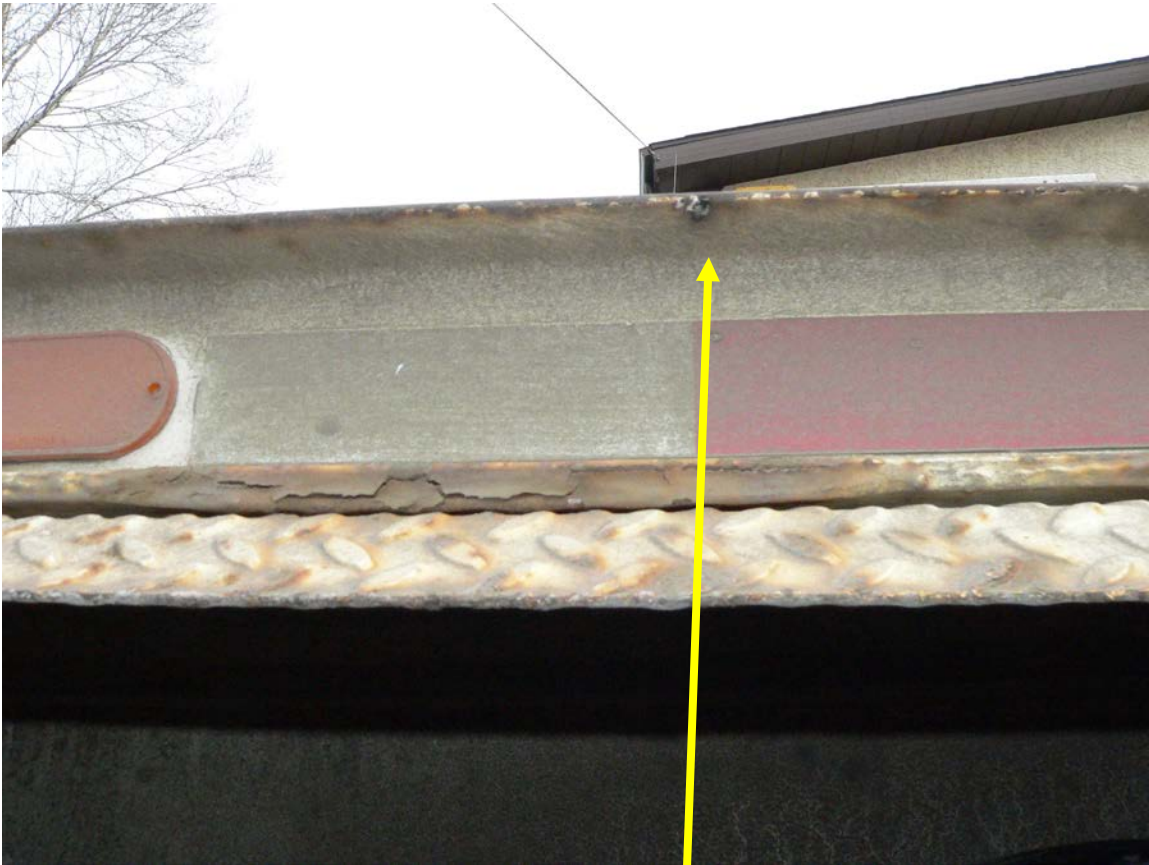
Fresh Electrical arc marks under the top lip of the channel-iron frame of the Pole Trailer. See Photograph 8 for orientation of where this area is located on the Pole Trailer.

Photograph #15 Shows where the Power Lineman contacted the Pole Trailer and was electrocuted from the current of the 8 Kv Power Line that was contacted by the Radial Arm Digger Crane's Pole Claw.

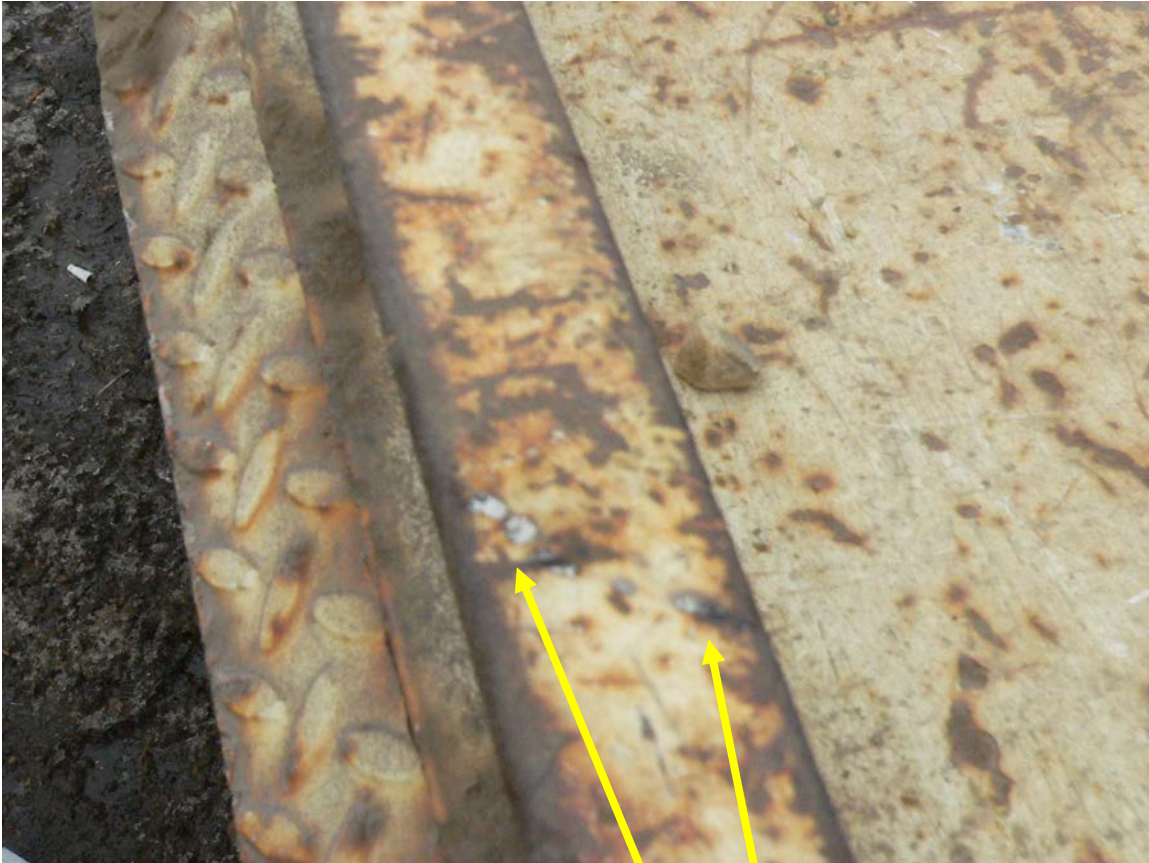
Fresh Electrical arcing marks where the Power Lineman touched the top edge of the Pole Trailer and was electrocuted

Photograph #16 Shows the top of the channel-iron frame of the Pole Trailer that the worker was touching when the Radial Arm Digger Crane Pole Claw contacted the high voltage Power Line and conducted electrical current through it.

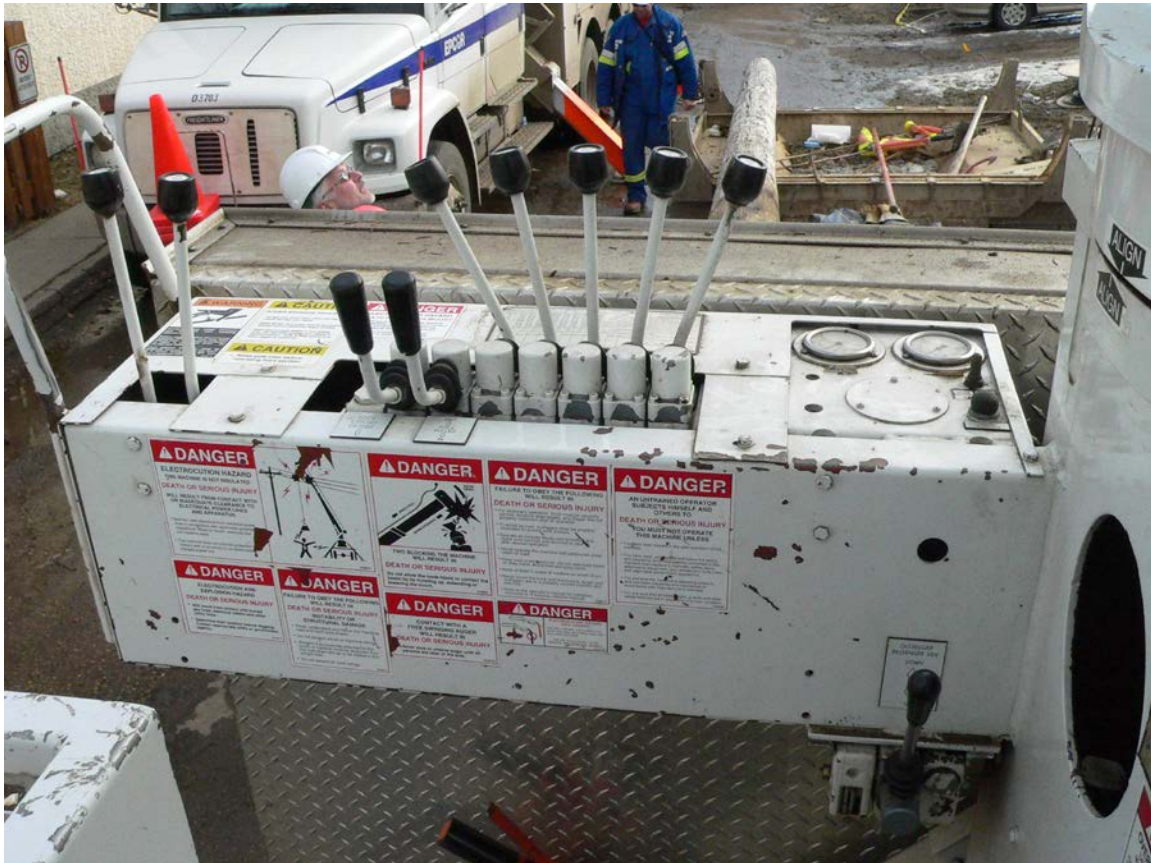
Photograph #17 Shows a view from the Radial Arm Digger left side control panel for the Crane. This is taken looking south and off the left side of the Radial Arm Digger Truck frame. The operator would have been facing the rear and the boom of the Crane was elevated and behind him. See the next two photographs for a closer view of the warnings related to the precautions around electrical hazards.

A closer view of Warning Posters on the Operator Control Panel for the Radial Arm Digger Crane

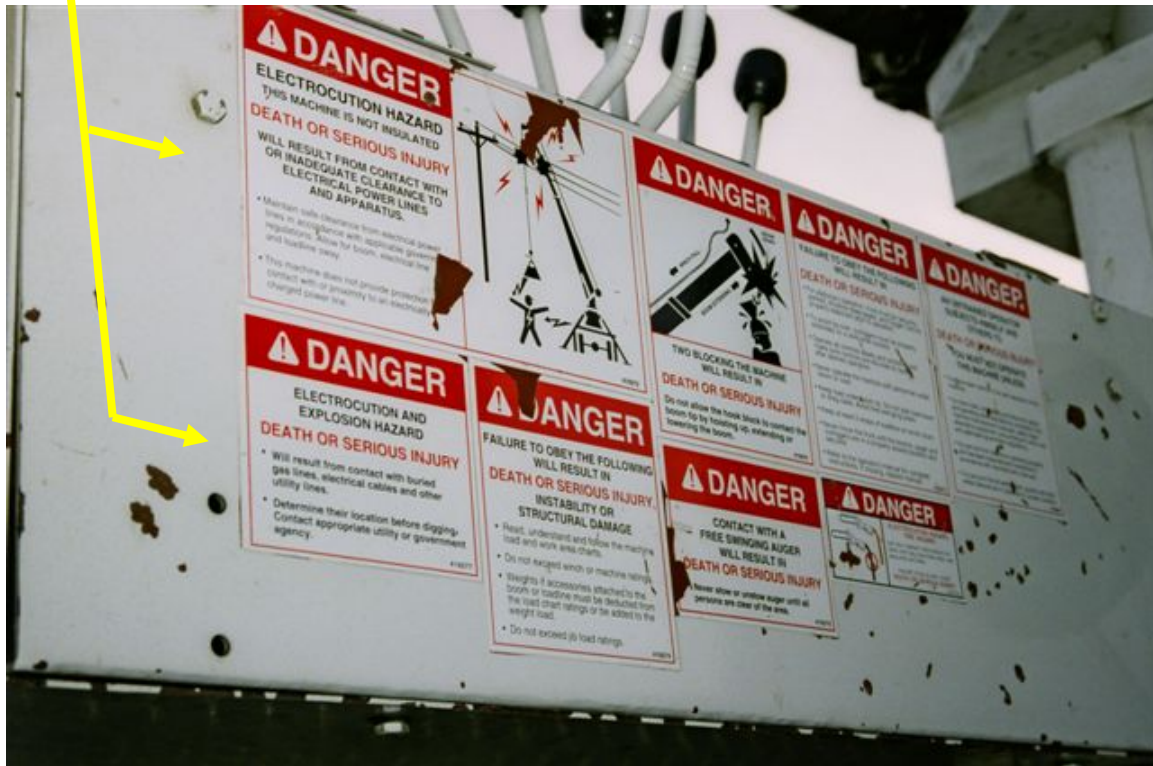
Photograph #18 Shows a close-up of the warning posters on the front side facing the operator at the control panel where the Radial Arm Digger Truck operator was located during the time of the incident.

Electrocution Hazard
Warnings on the top side
of the Operators Control
Panel
