Occupational Health and Safety

Fatality Report

Worker Electrocuted

Date of Incident: March 21, 2007

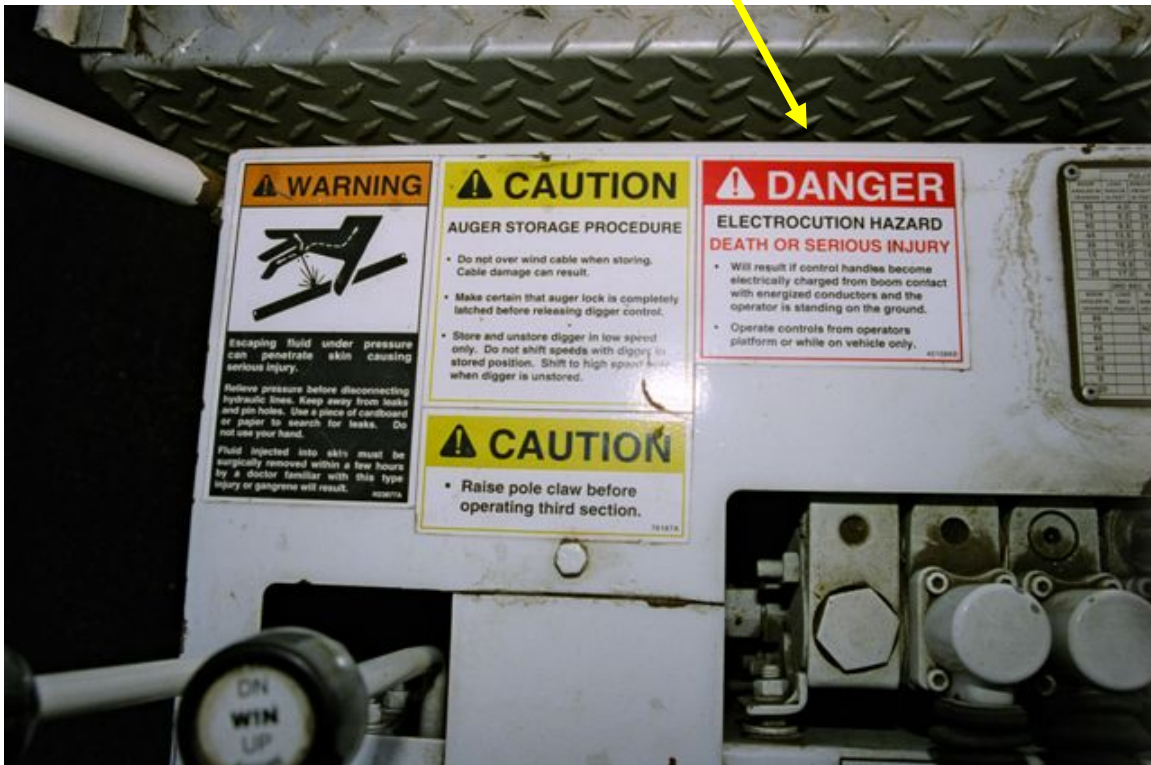
Photograph #19 Shows a view looking down directly onto the warning posters on the left-side control panel for the Radial Arm Digger Crane.

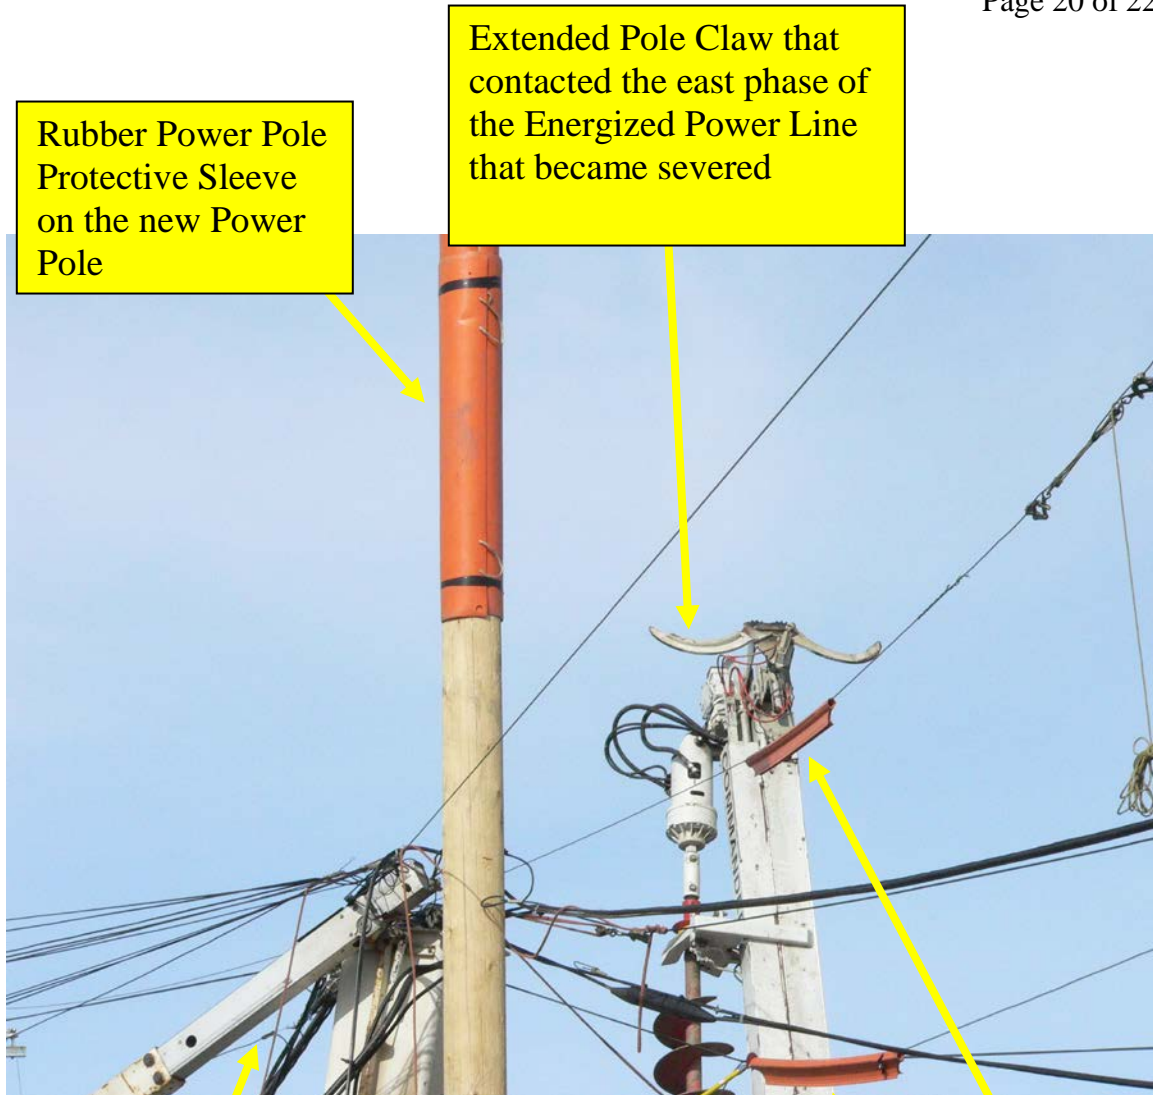
Rubber Power Pole Protective Sleeve on the new Power Pole

Extended Pole Claw that contacted the east phase of the Energized Power Line that became severed

Photograph #20 Shows the proximity of the Radial Arm Digger Crane's Boom and Pole Claws to the rubber Power Line Protectors on the two lines that remain in the air after the incident.

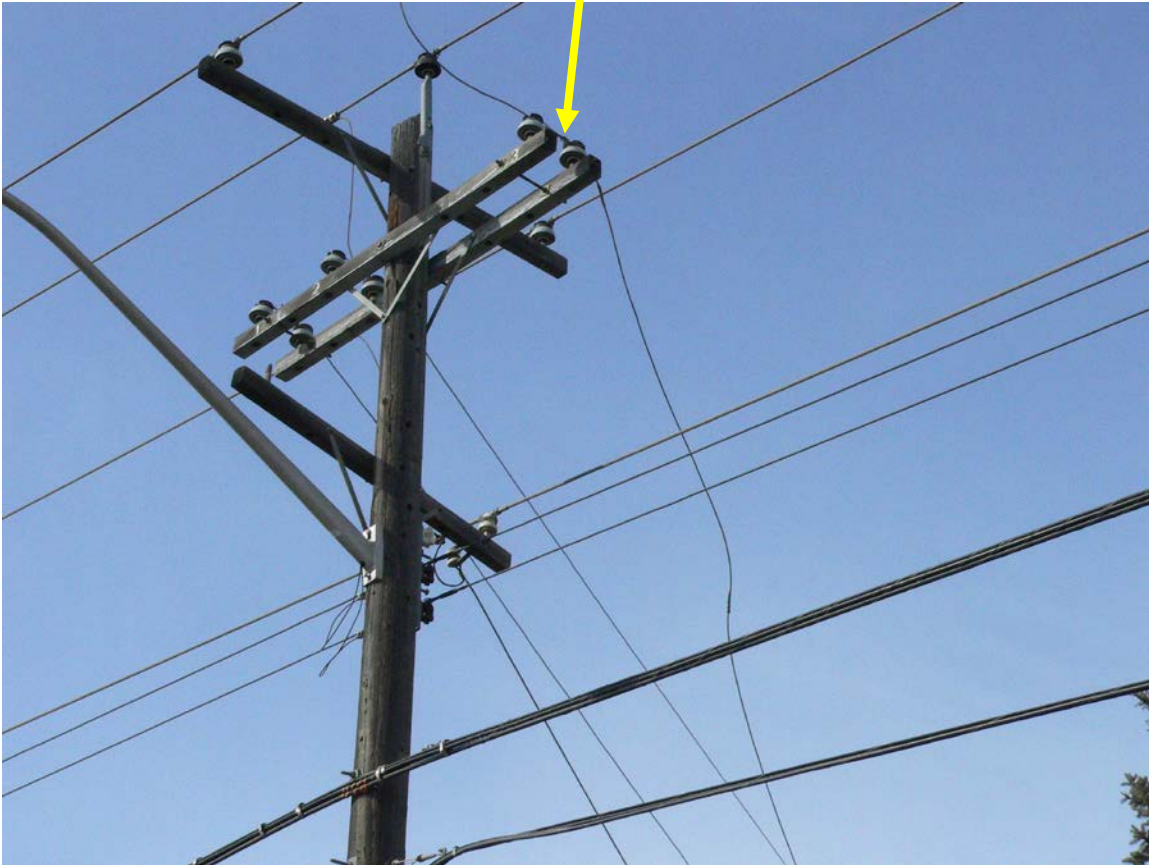
Wooden cross-arms with insulators
that are the junction from the Main
Power Line Pole on 51 Avenue

Photograph #21 Shows a view of the Main Power Line Junction to the three-phase Power Lines leading into the alley north of 51 Avenue. This indicates that they are well aged, wooden, and may have allowed the insulators to break loose if the Power Lines were lifted too high by the D3703 Boom Truck with the Auxiliary Arm.

- 7.2.13 The Main Line Junction Power Pole was old, and had deteriorating cross-arms that posed a hazard of failure with the procedures used for the Power Pole change-out. The Main Line junction Power Pole had not been moved to be in alignment with the alley in a project prior to the change-out of the Power Pole in the alley. A new metal pole structure had been installed in line with the alley Power Poles and between the Main Line and the first Power Pole, as a guy support for the first Power Pole along the alley. (Attachment "A", Photograph 22)

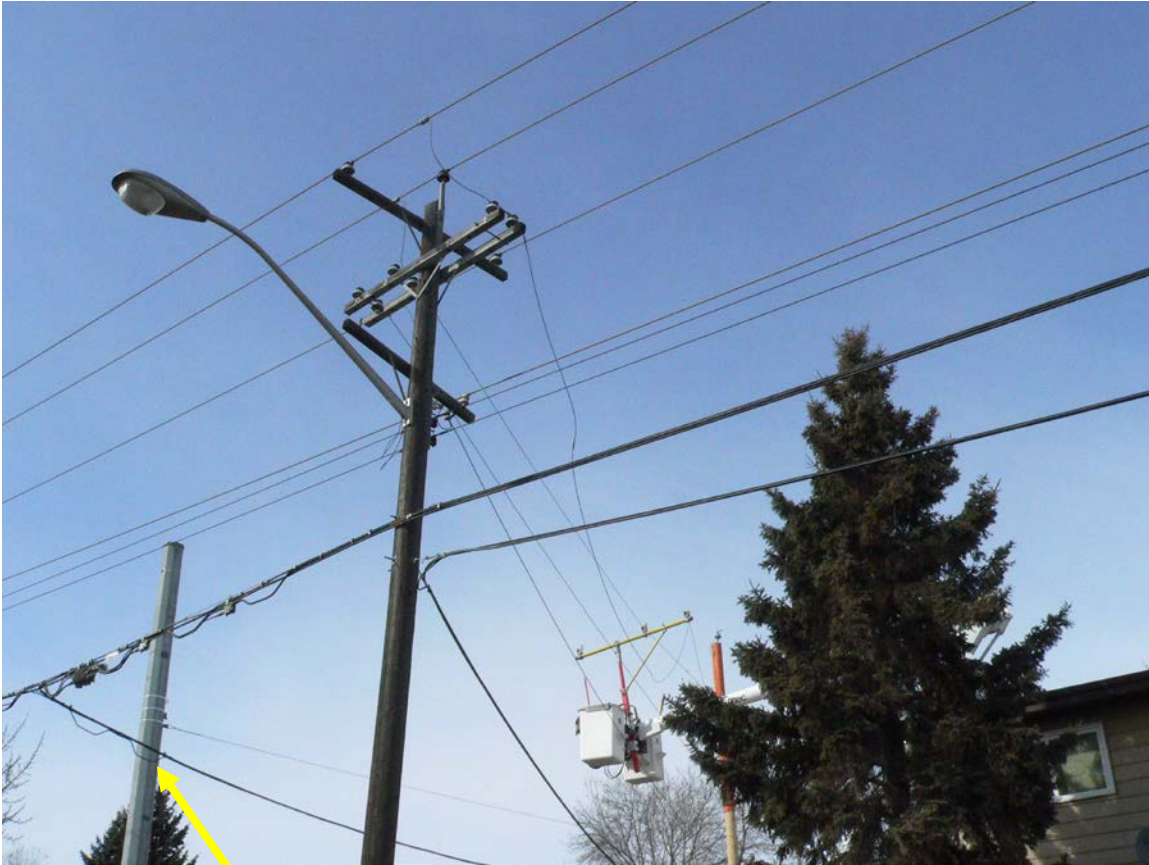
This is the Metal Support Pole that was installed as a part of the project to give stability to the Power Poles along the alley. This Metal Pole is in line with the Power Poles along the alley.

Photograph #22 Shows a view from 51 Avenue looking northwest depicting how the Power Lines from the Main Line Junction were held up by the Auxiliary Arm on Unit D3703. Also shown in this view is the Metal Support Pole installed in line with the alley Power Poles.

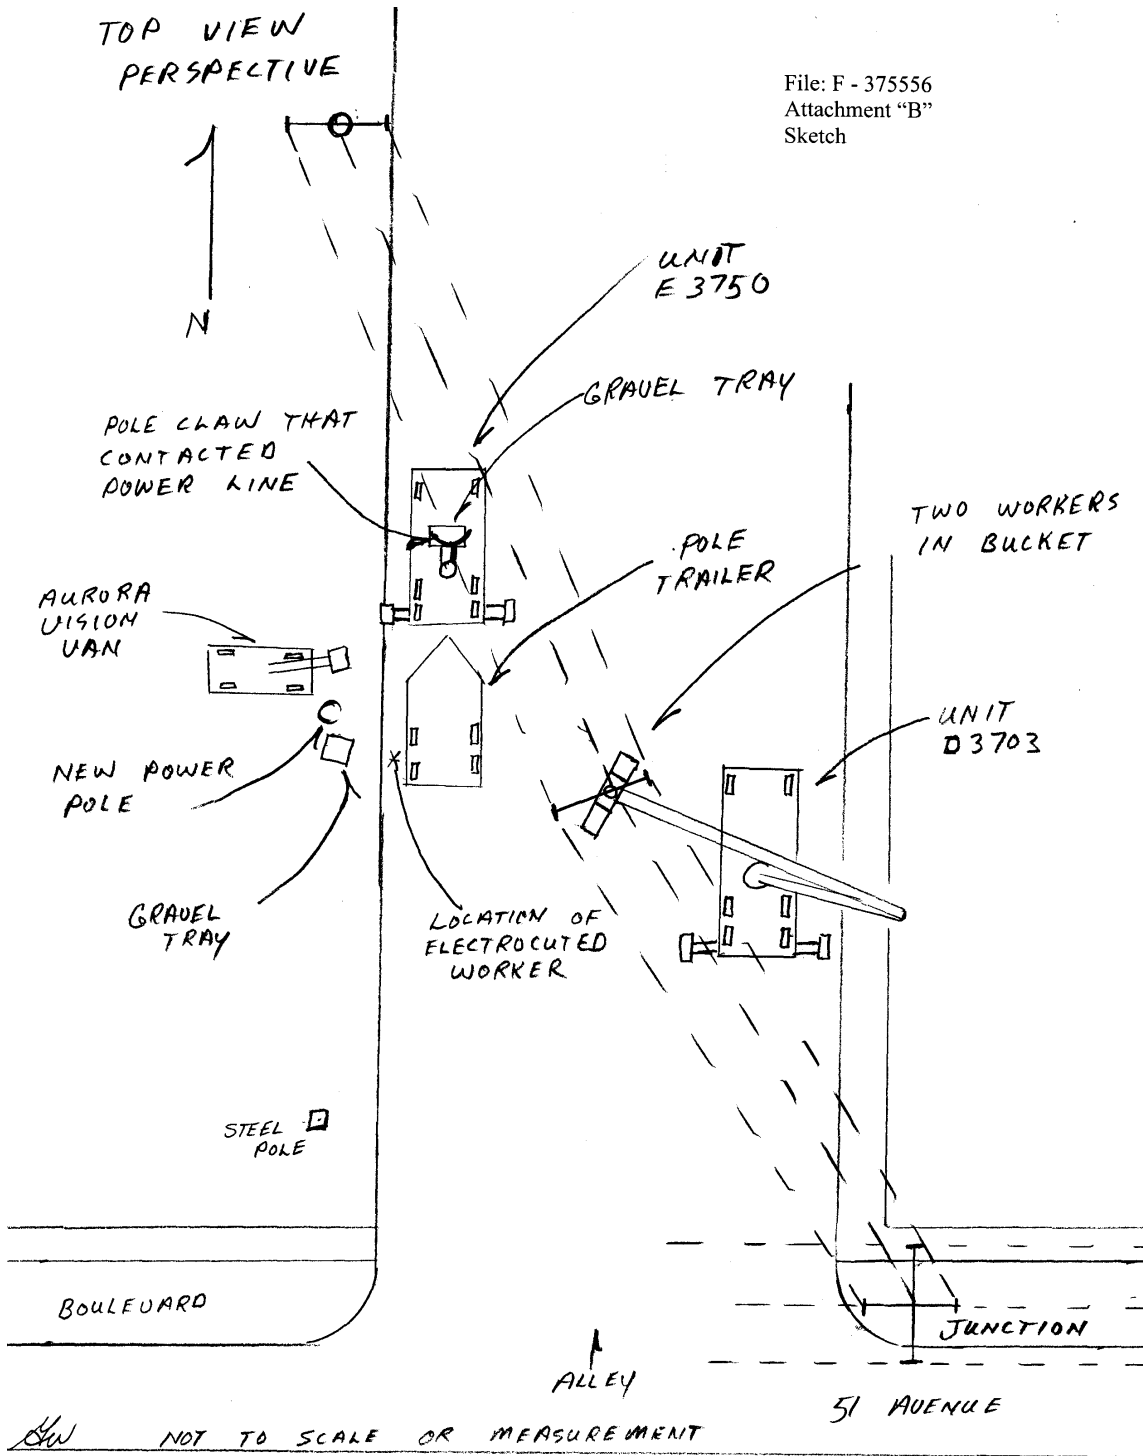
File: F - 375556
Attachment "B"
Sketch

TOP VIEW
PERSPECTIVE

- 4.1 In the back alley north of 51 Avenue and between 106 and 107 Streets in Edmonton, Alberta. (Attachment "A", Photograph 1)(Attachment "B", Sketch)

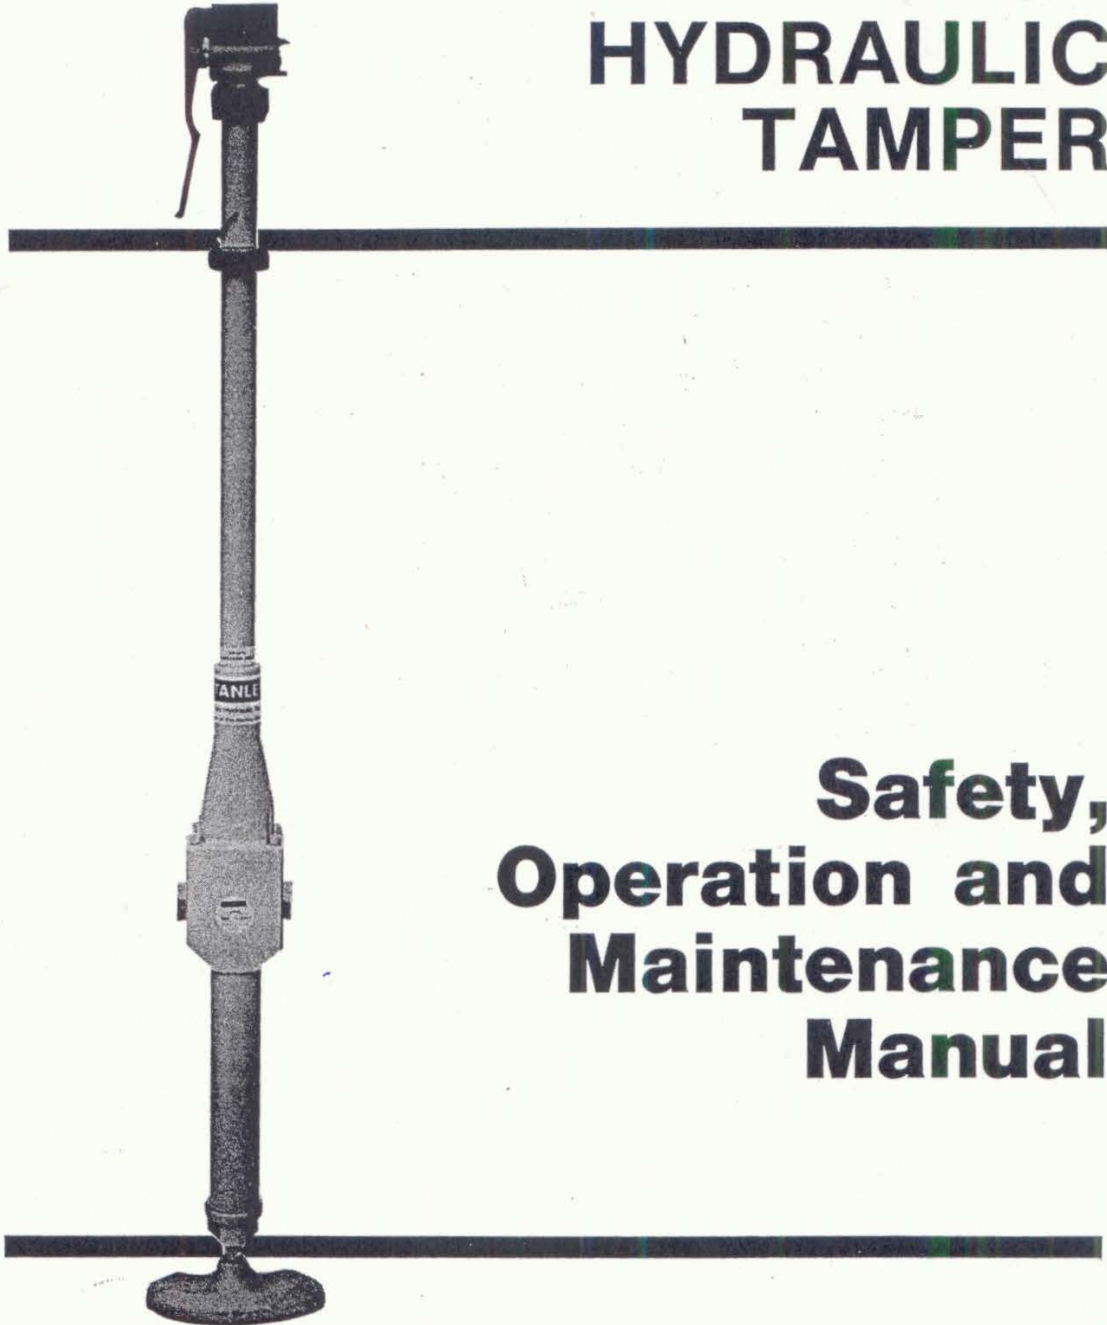
TA54 HYDRAULIC TAMPER

5.3.1 Model TA54
Attached to Freightliner power unit with hydraulic lines
(Attachment "A", Photographs 5, 6)(Attachment "C", Stanley Hydraulic Tamper Drawing)
