Investigation Report
Low Voltage Electrocution

Report No-031199-9A1A8

Final Report

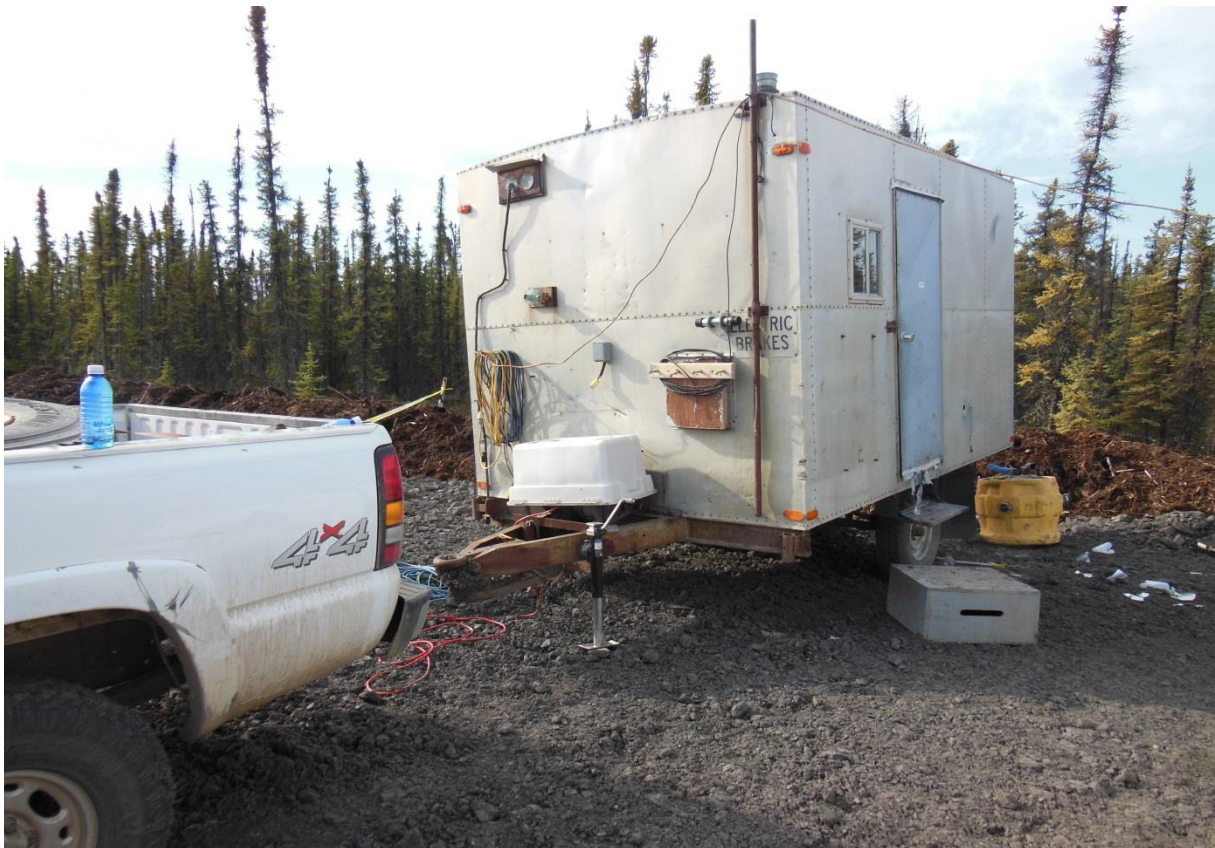
Figure 2

*Trailer 5, 1960 PSV Trailer, manufacturer ATCO VIN *****, License Plate ******

The trailer 5 was owned and used by Dale's Trucking and was brought onto the Strategic new well site on September 28, 2012 to be used as onsite accommodation/office.

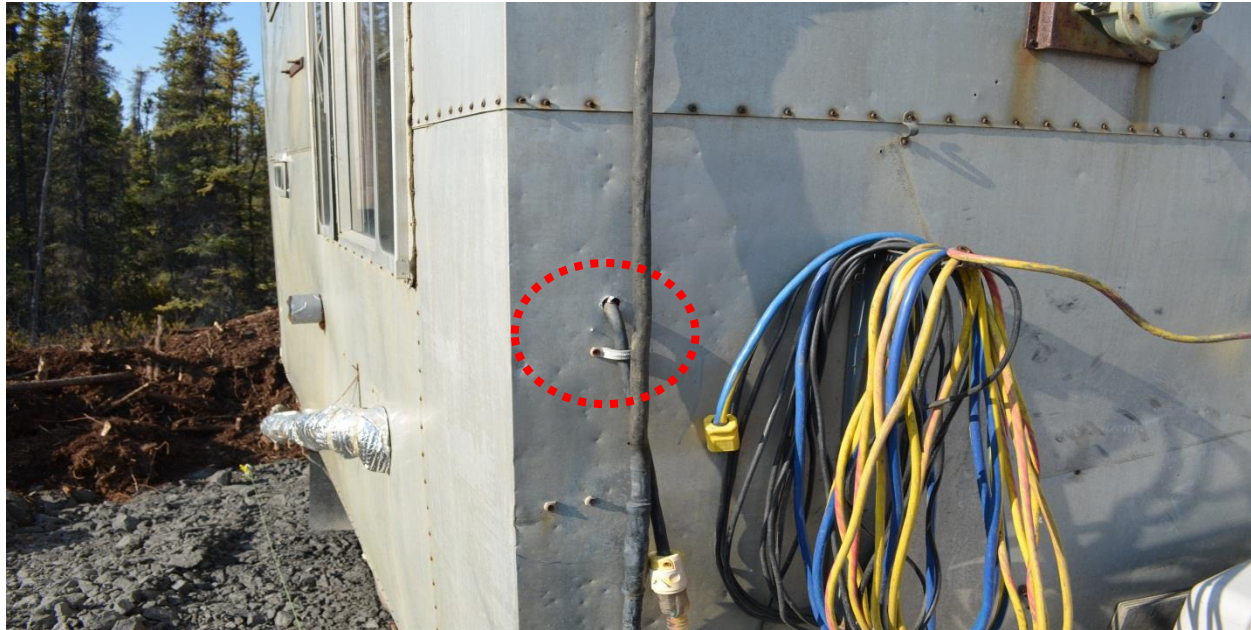
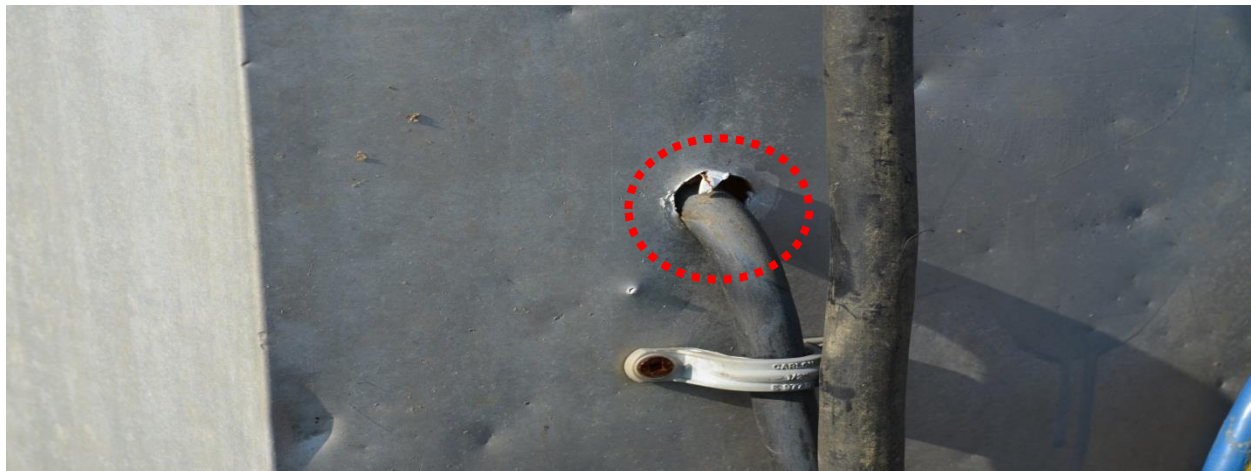
Figure 3 & 4

Electric cable fed externally through metal trailer wall

The purpose of this electric cable was to provide power to trailer 5 from the main electrical source. This electrical cable was connected externally to the yellow extension cord that was run and plugged into the main electrical source; the yellow extension cord was connected to the electric cable, then run through the metal wall of the trailer 5, with no protection against sharp edges.

The red circle indicates the black cord run through the wall of the trailer.

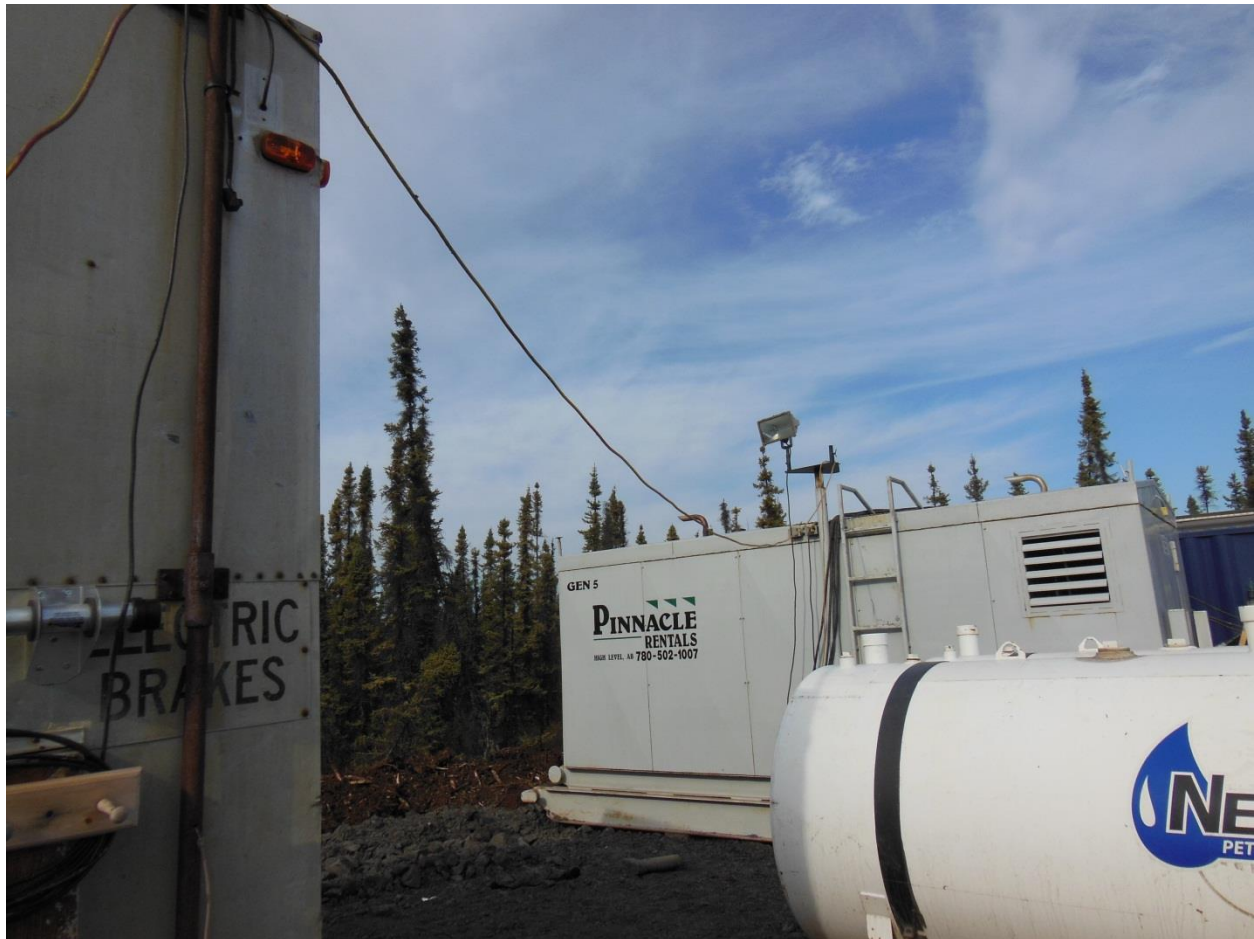
Figure 5

This generating set was assembled by Pinnacle and supplied to Strategic with one ground rod.

Pinnacle Rentals Stamford AC Generator Set the main electrical source (generator unit 5).

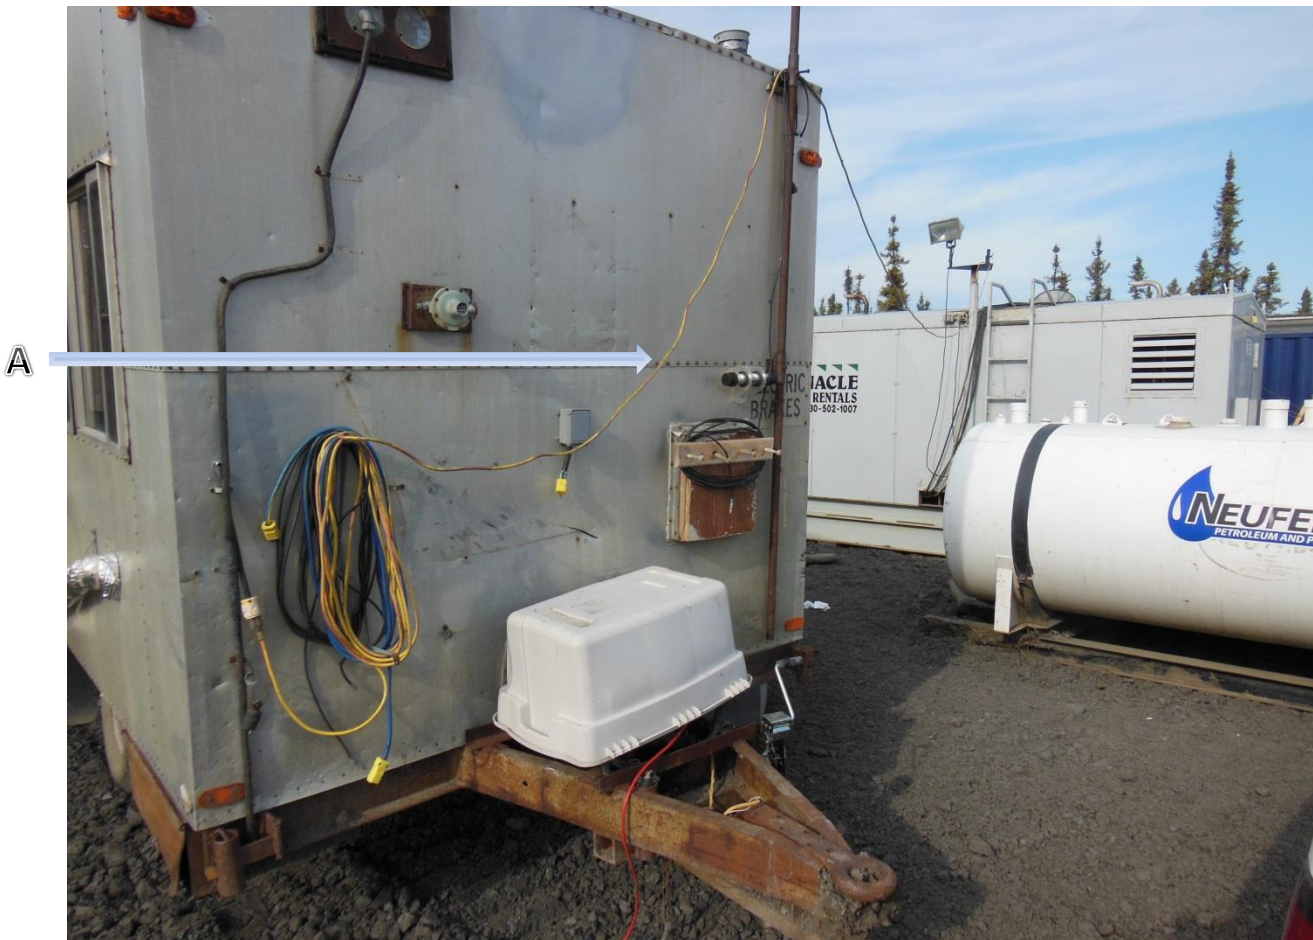
Figure 6

At 7:00 p.m., the water truck hauler drove in and set up trailer 5 at the new well site. The water truck hauler then connected trailer 5 with a yellow extension cord directly into generator unit 5.

A indicates the yellow extension cord that was used to connect trailer 5 to generator 5

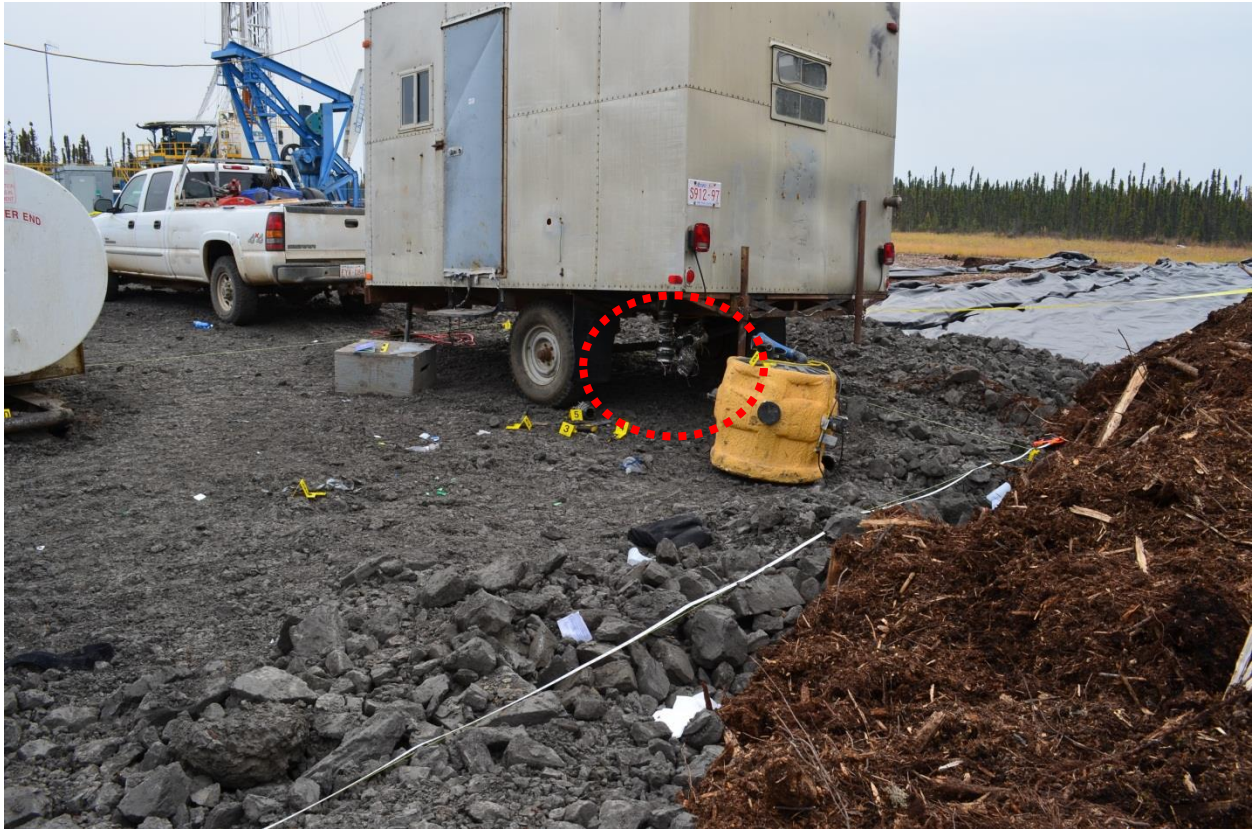
Figure 7

Within a matter of minutes, the water truck hauler found worker 1 under the trailer 5, unresponsive. The water truck hauler notified Worker 2 and the Akita rig manager. Worker 2 attempted to pull worker 1 out from under the trailer with the help of the Akita rig manager. The Akita rig manager directed another worker to drop the power in generator 5.

Red circle indicates the location where worker 1 was found, under trailer 5.
