Investigation Report  
Worker Fatally Injured When Entering Confined Space  
April 27, 2016

## Incident summary

A tower mechanic was entering a fractionation vessel at a gas facility to prepare a final inspection of the vessel. The interior of the vessel was under a nitrogen purge, and the worker was using supplied air. Shortly after entering the vessel, the worker went into distress. The on-site emergency response team extracted the worker and provided first aid. The incident resulted in a fatality.

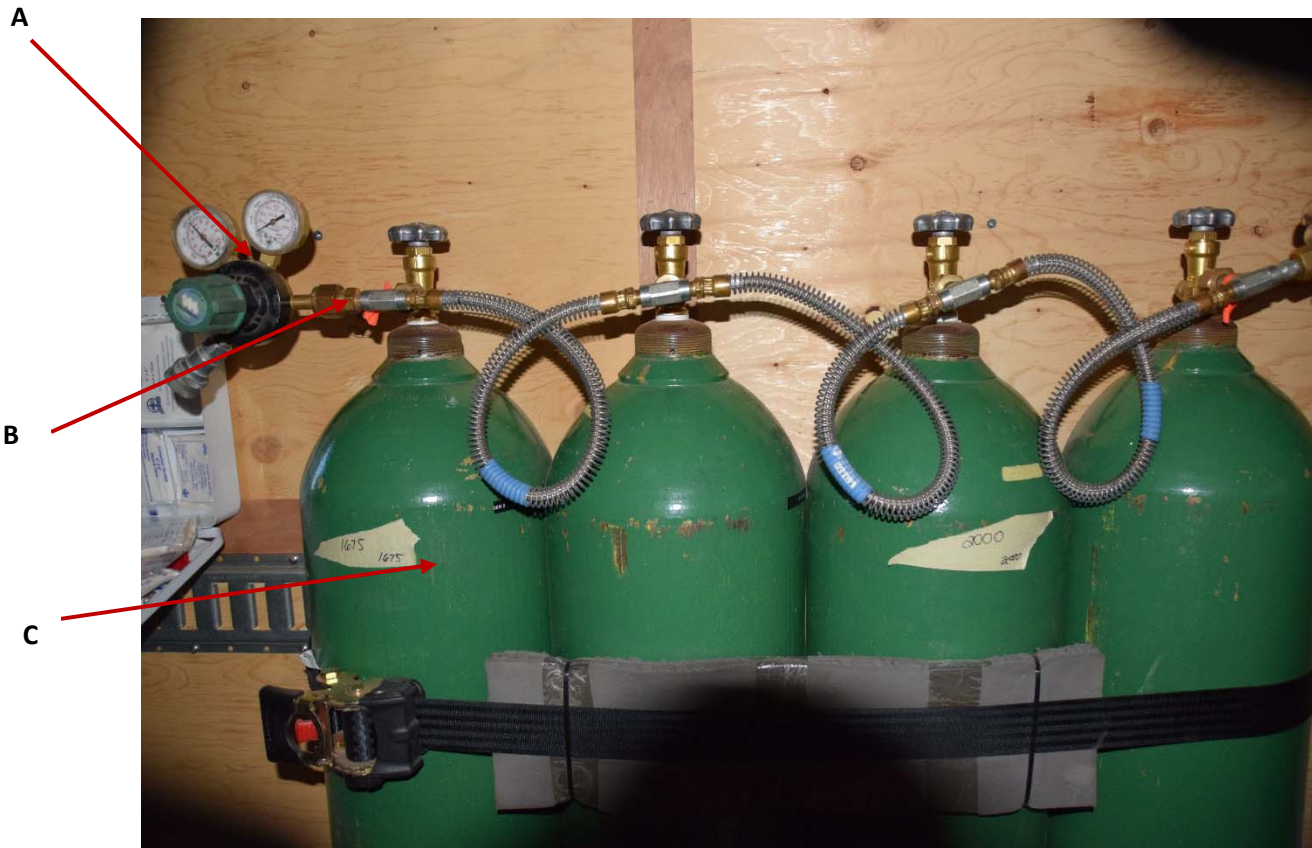
*Figure 1. (A) The supplied air cascade system included a first stage regulator, which reduced the cylinder pressure of 2250 psi down to an operating pressure which varied depending on the workers' regulators and masks. The manifold (B) linked all of the cylinders together and equalized the cylinders to one pressure. Each of the cylinders, (C) when filled to operating capacity, contained 300 ft<sup>3</sup> of air at 2250 psi. This was the system that provided air to the workers including the tower mechanic.*

The cascade system that was used to supply air to the workers was owned by Sulzer; however, the cylinders were filled through a contract with Air Extreme. The system consisted of 2 air banks of 4300 cubic foot (ft<sup>3</sup>) cylinders that were initially filled to approximately 2250 pounds per square inch (PSI) (Figure 1). The last air analysis was conducted on April 13, 2016, by AGAT Laboratories and met the standards as per the CS z180.1-13 Breathing Air Analysis.

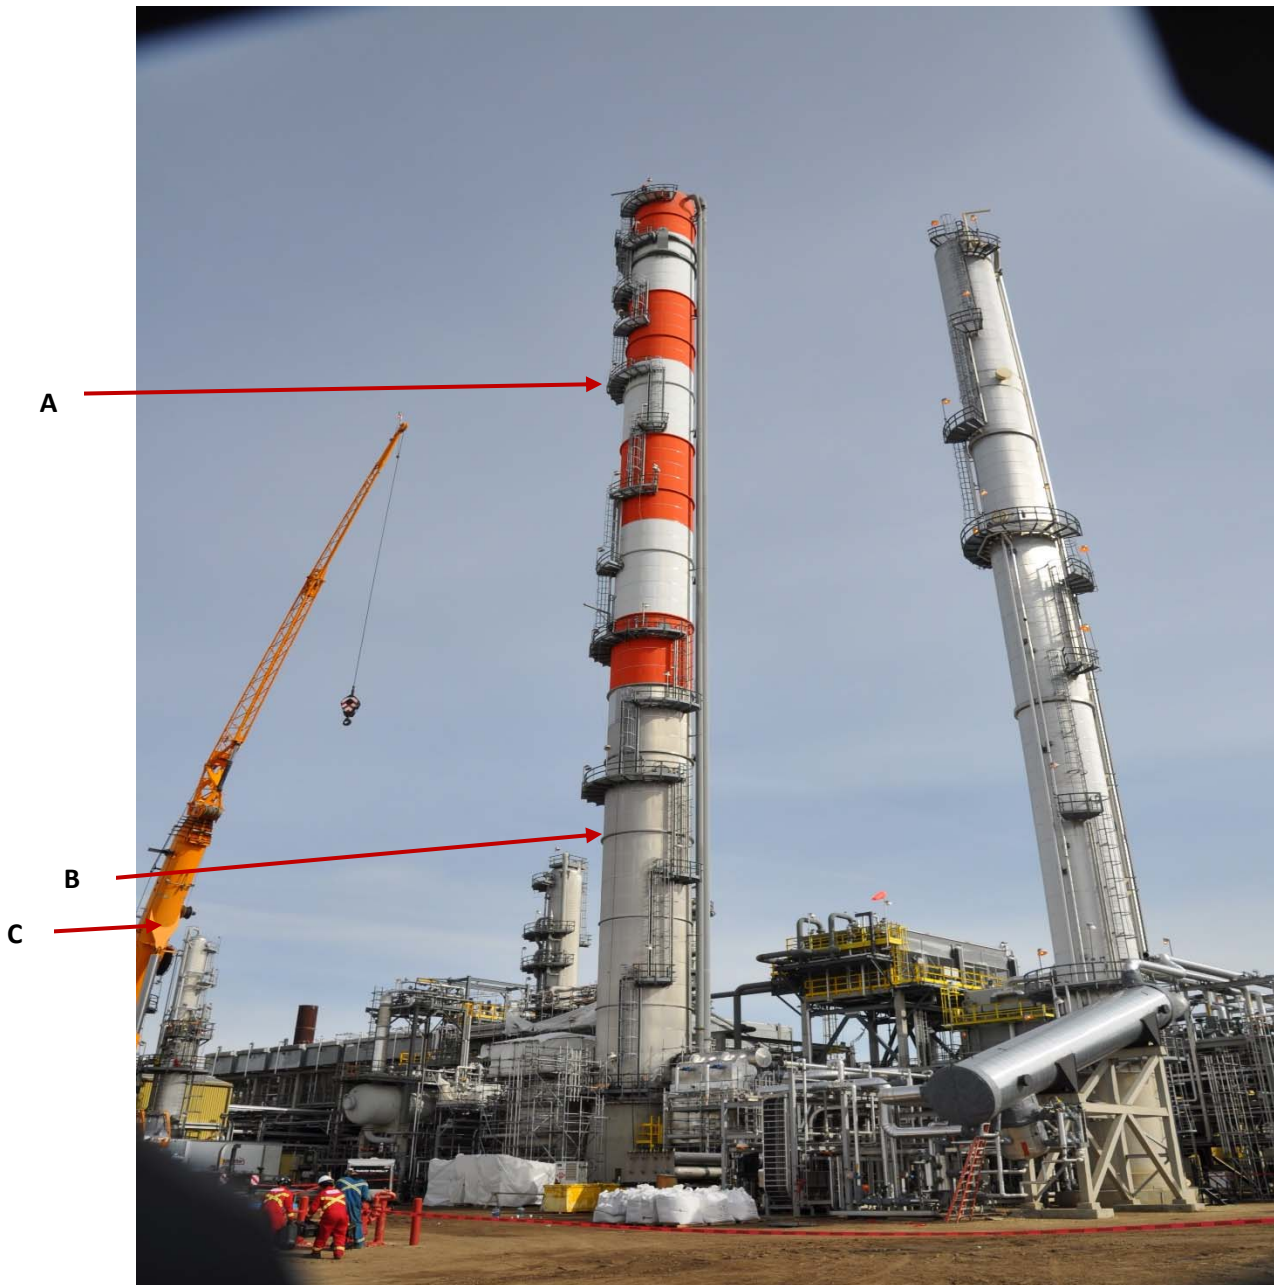
Figure 4. PV-403 (A) was the fractionation vessel where the incident took place. The manway into the confined space was located at (B), and (C) was the crane used to raise and lower the manbasket.

The pressure vessel 403 (PV-403) (Figure 4), which was the vessel being cleaned and inspected, was used to fractionate propane from propylene. Propylene was second in importance to ethane as a lefin raw material for petrochemical manufacture of plastics, fibres, lubricants and gels. The pressure vessel used the process of distillation via heat and an internal mechanical design to provide a high grade product. PV-403 was 94 m in height. The entrance to the manway was located 40 m above ground level.
