# Fall Creek Reclamation Project

## North Central Native Trout Recovery Program

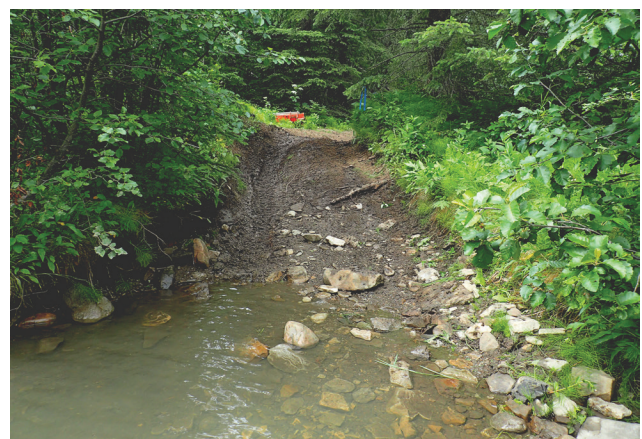
Illegal OHV crossing at Fall Creek before remediation.

Undesignated off-highway vehicle (OHV) use around Fall Creek resulted in significant habitat degradation (Zee 2017) due to approximately 54 illegal watercourse crossings within a nine kilometers section of creek. OHV crossings are a double threat to bull trout and other fish present in the creek, including stocked cutthroat trout and mountain whitefish. Crossings act as sediment chutes, dumping large amounts of fine silt and clay into the creek when driven over by OHVs and during rain events. Increased sediment in streams smothers incubating bull trout eggs, renders spawning gravels unsuitable and reduces habitat for invertebrates and algae, the base of the aquatic food chain. Additionally, bull trout eggs can be crushed when OHV riders illegally enter the watercourse. At Fall Creek, 20 crossings are located near or right through known spawning habitat.

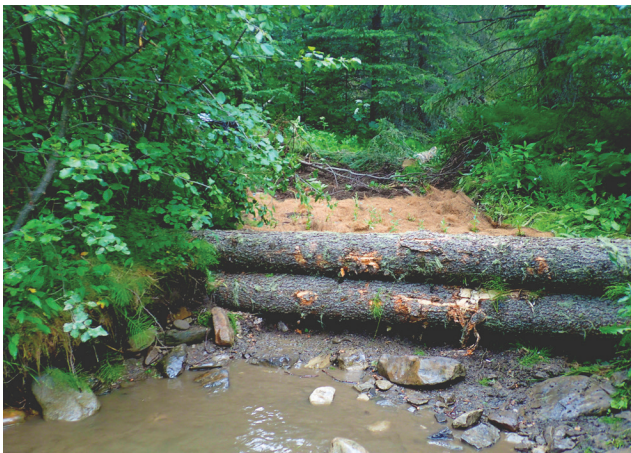
Illegal OHV crossing at Fall Creek after remediation. A log crib wall, soil wrap, coconut matting and willows were used to rebuild the bank and reduce sedimentation. Over time, natural processes will transform this crossing back into properly functioning riparian habitat.

- Reclamation plan development and implementation of bio-engineering methods at 54 OHV crossings over nine kilometers of Fall Creek
- AEP and Trout Unlimited Canada volunteer events to plant willows
- Restriction of illegal motorized access into the watercourse by downing trees, tree planting and installing enforcement signage at key access points
- Increased enforcement presence
- Installation of educational signage at high visitor-use areas in the watershed, project brochures, print materials, etc.

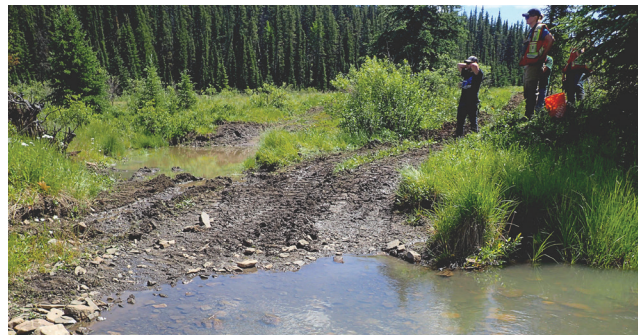
OHV trail damage at Rocky Creek.

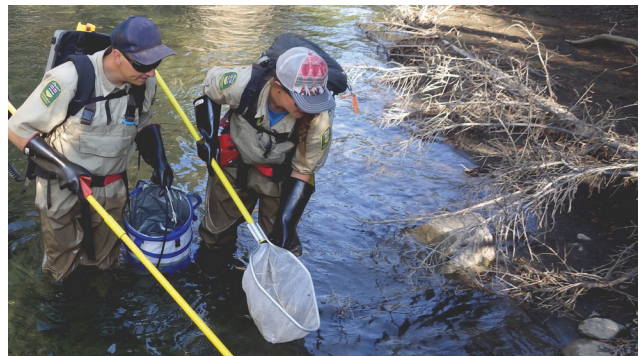
AEP staff using electrofishing to inventory fish populations.
