Worker Run Over by Pickup Truck
Type of Incident: Fatality
Date of Incident: October 14, 2010

4.1 The incident occurred at the CNRL Chip River Compressor Station (1-16-92-21 W4) located approximately 120 km west of Fort McMurray (Attachment A – Map).

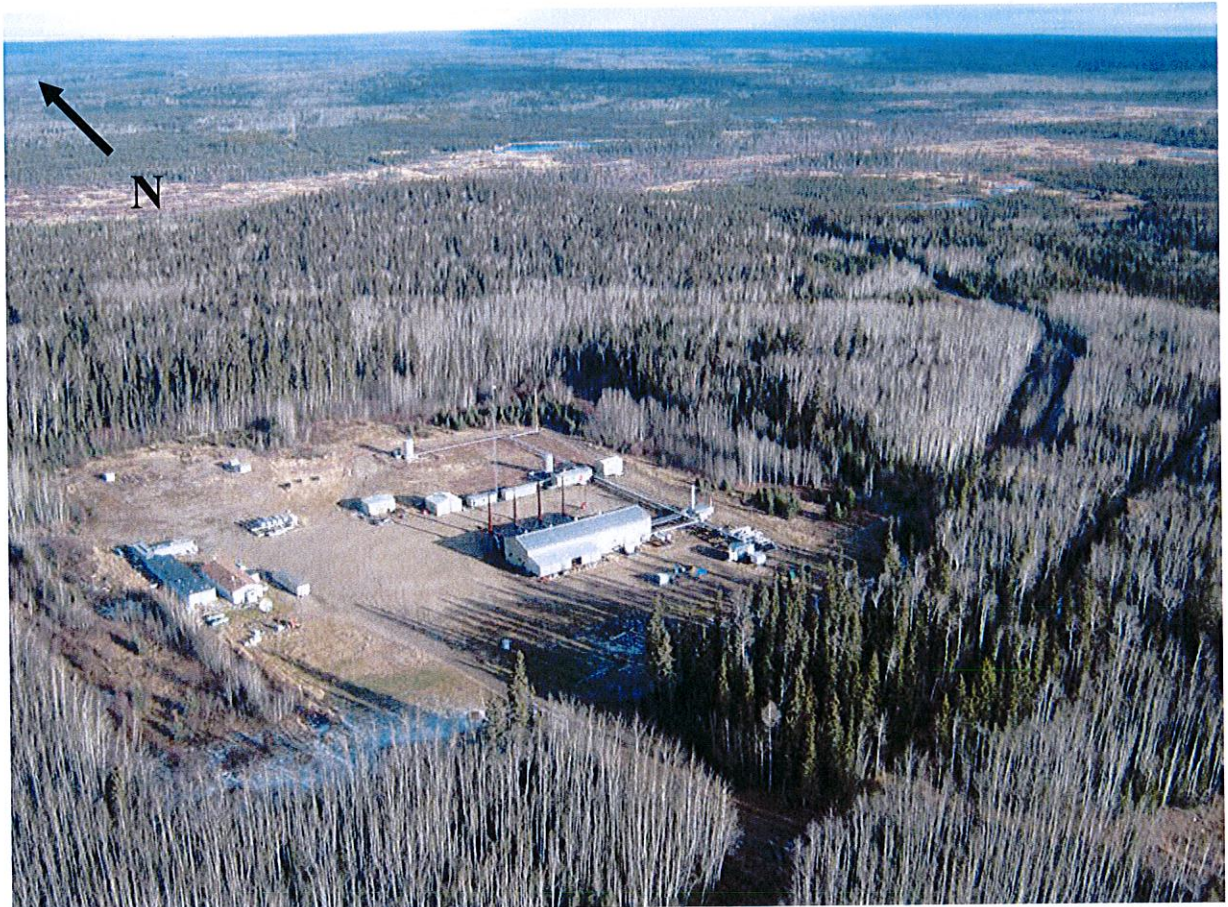
Photograph #1

Chip River Compressor Station 1-16-92-21 W4M

Incident location overview

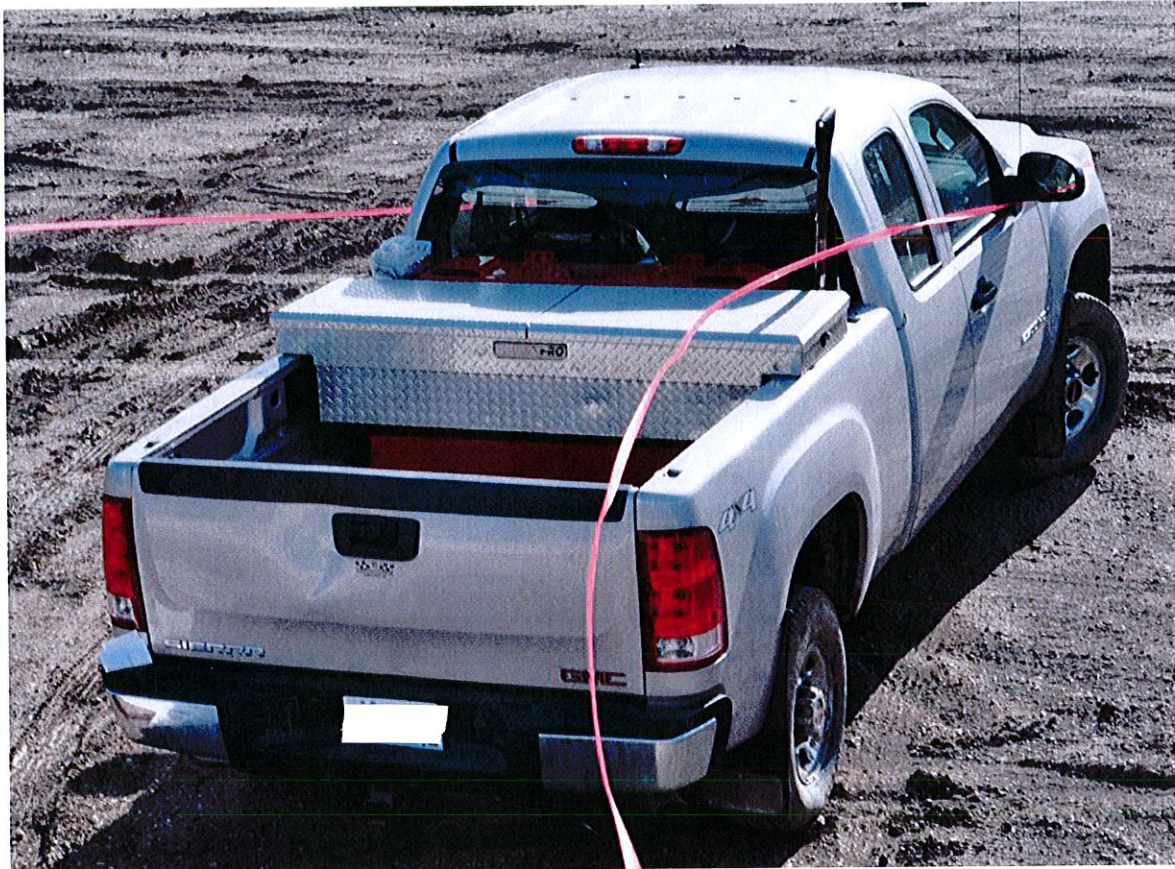
Photograph # 2

- 5.1.1 Pickup Truck
GMC Sierra
VIN 1GTHK29K37E564803
Model K20753
(Attachment C – Photographs 2)

- 7.2.1 The pickup truck involved in the incident was not equipped with a back up alarm.
- 7.2.2. The Chip River Operator () was not wearing reflective clothing.

Pick-up truck (GMS Sierra VIN 1GTHK29K37E564803) involved in incident.

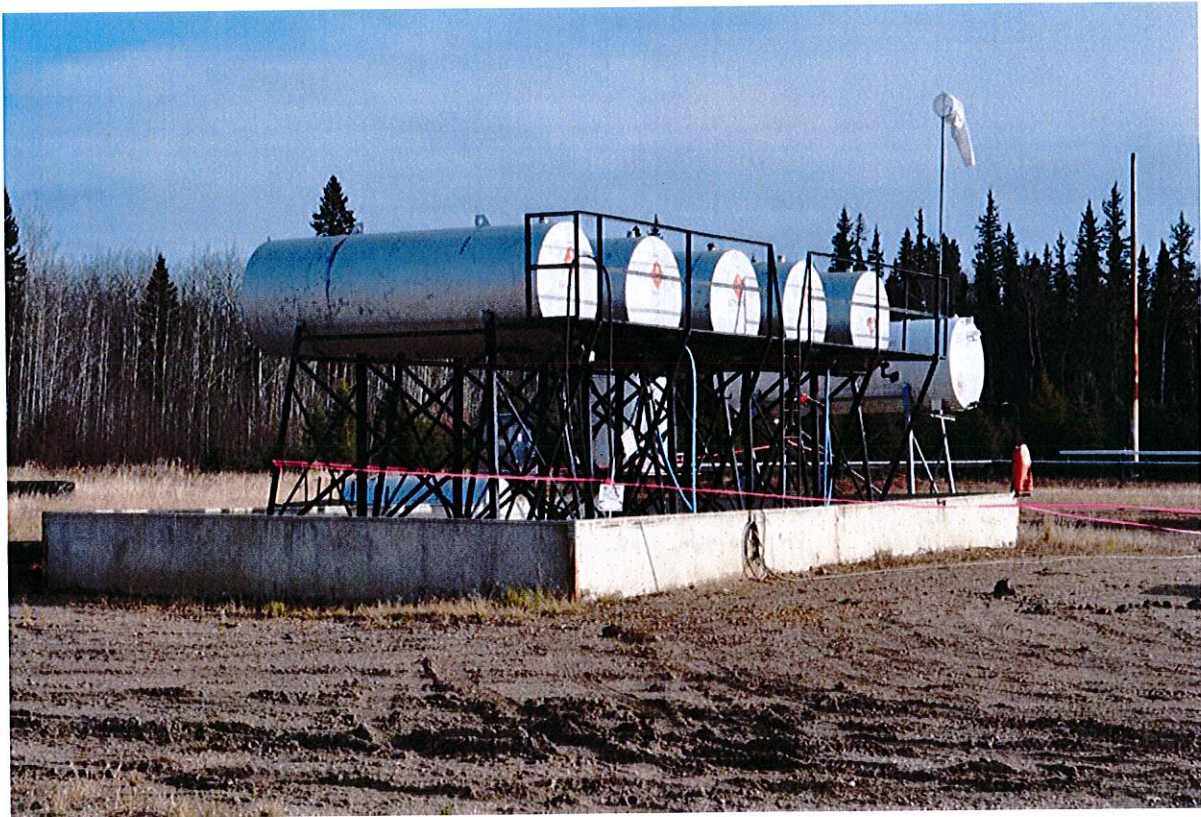
Photograph #3

- 6.8 The Liege Gas Plant Operator () stopped the pickup truck beside the bulk fuel tank and pumped some fuel into the pickup truck.
- 6.9 After refueling, the Liege Gas Plant Operator 1 () got in the pickup truck and turned the pickup truck towards the living quarters. As he started to drive he observed the Chip River Operator () lying on the ground on the driver's side of the pickup truck.

Bulk fuel tank used to fuel pick-up truck.
