**WORKER STRUCK BY PIPE**

Type of Incident: Fatality

Date of Incident: February 2, 2012

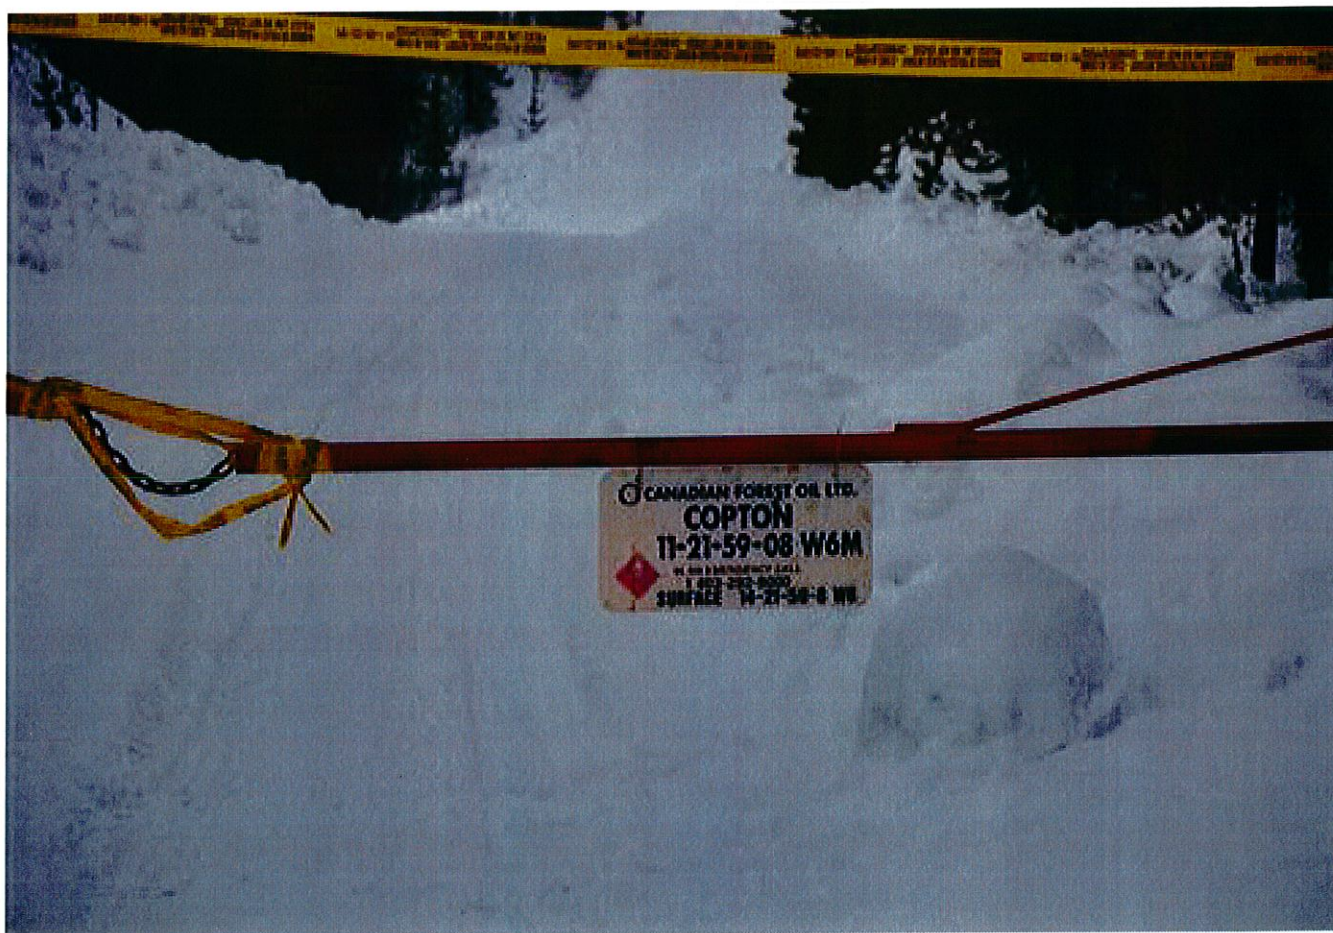
**Photograph #1**

This photograph shows the Copton well location sign at the well site entrance to the 11-21-59-8W 6M.

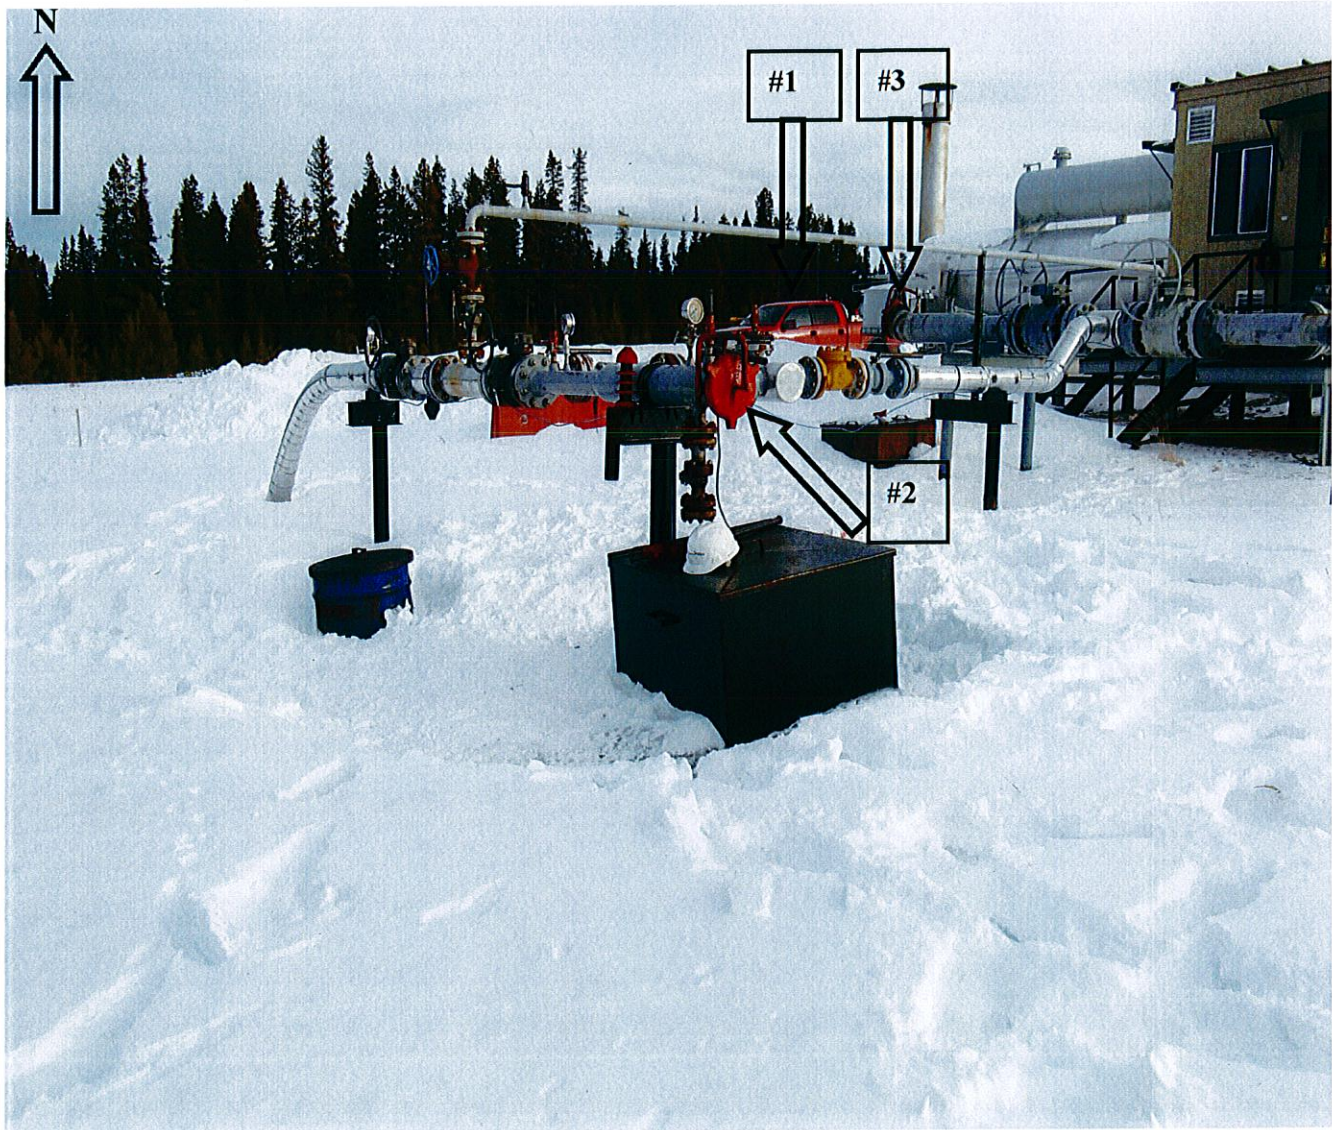
**Photograph #2**

- #1. Shows location of the Lead Operators (Gordon Cinnamon) truck.
- #2. Shows the pig receiver at the 11-21-59-8W 6M, which receives pigs sent from the 9-27 well site.
- #3.. Shows the pig sender at the 11-21-59-8W 6M, which launches the pig to the 15-17-59-8W 6M receiver.

- 5.1.2.1 The incident location, 11-21-59-8W 6M, consists of a 273.0 mm pig sender for launching 219.1 mm pigs to the 15-17-59-8W 6M location and a 168.3 mm pig receiver for catching 114.3 mm pigs coming from the 09-27-59-8W 6M. (Attachment C, Photograph # 1)
- 5.1.2.2 The pipeline pig (pig) is a solid cylindrical or spherical shaped tool that is introduced into the line via a pig trap, which includes a launcher. The pig is then forced through the line by product flow, sweeping the line by scraping the sides of the pipeline and pushing debris ahead and arriving in a pig receiver.

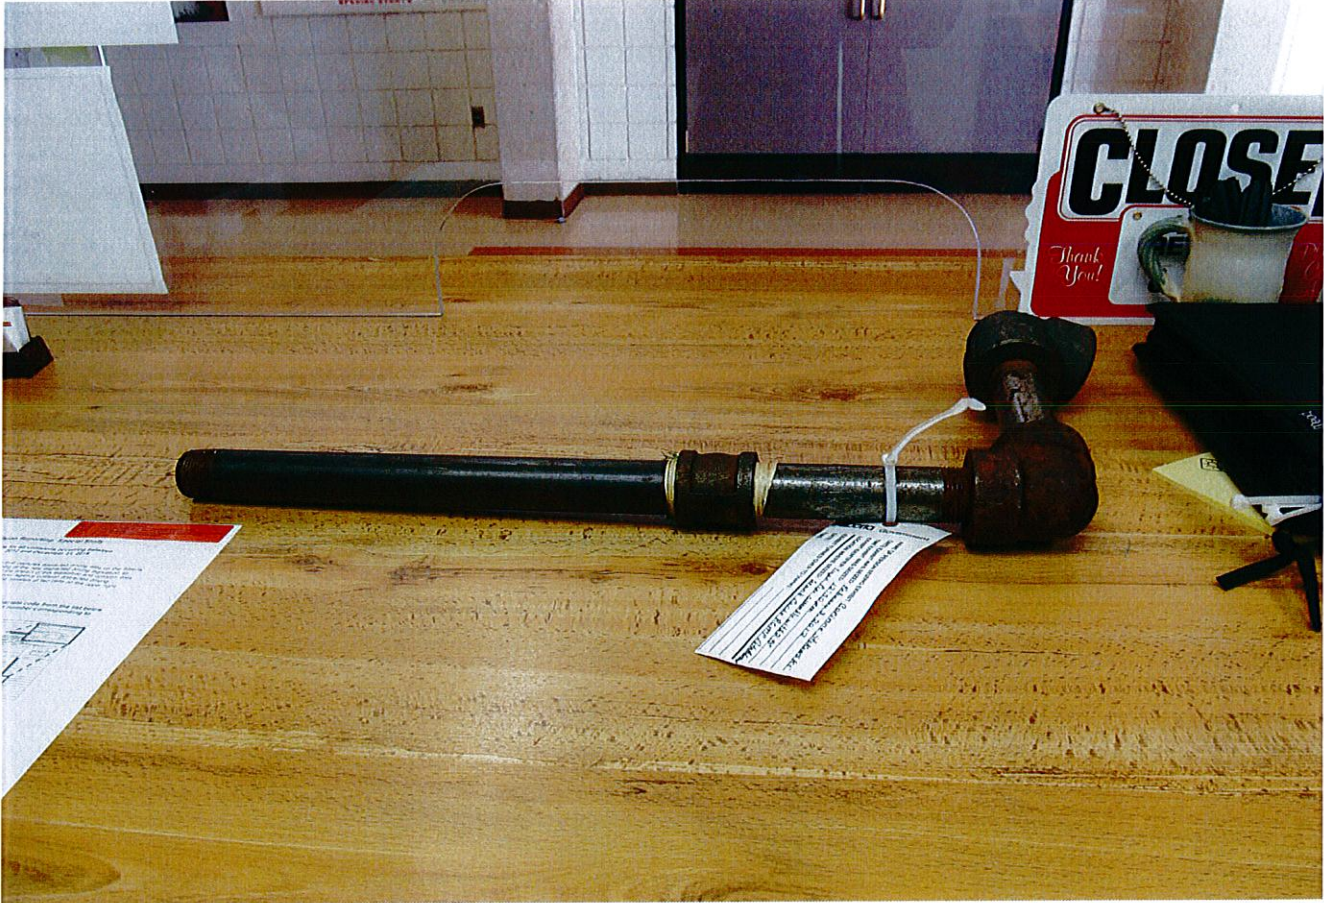
**Photograph #3**

The blow down pipe assembly that was attached to the ball valve. (see Photograph# 3)

5.1.3.2 The blow down pipe assembly (304.8 mm long) attached to the pipe line at the 11-21- 59-8W 6M consisted of two 90 degree elbows, two short pipe nipples threaded at both ends, one iron coupling, and one long pipe threaded at both ends. (Attachment C, Photograph# 2) The blow down pipe assembly was screwed to the open threaded pipe nipple of the 33.4 mm ball valve located near the end cap of the pig receiver prior to the incident. (Attachment C, Photograph# 3) The blow down pipe assembly was not part of the engineered design of the piping system at the 11-21 59-8W 6M, which was designed for an operating pressure of 9930 kPa.

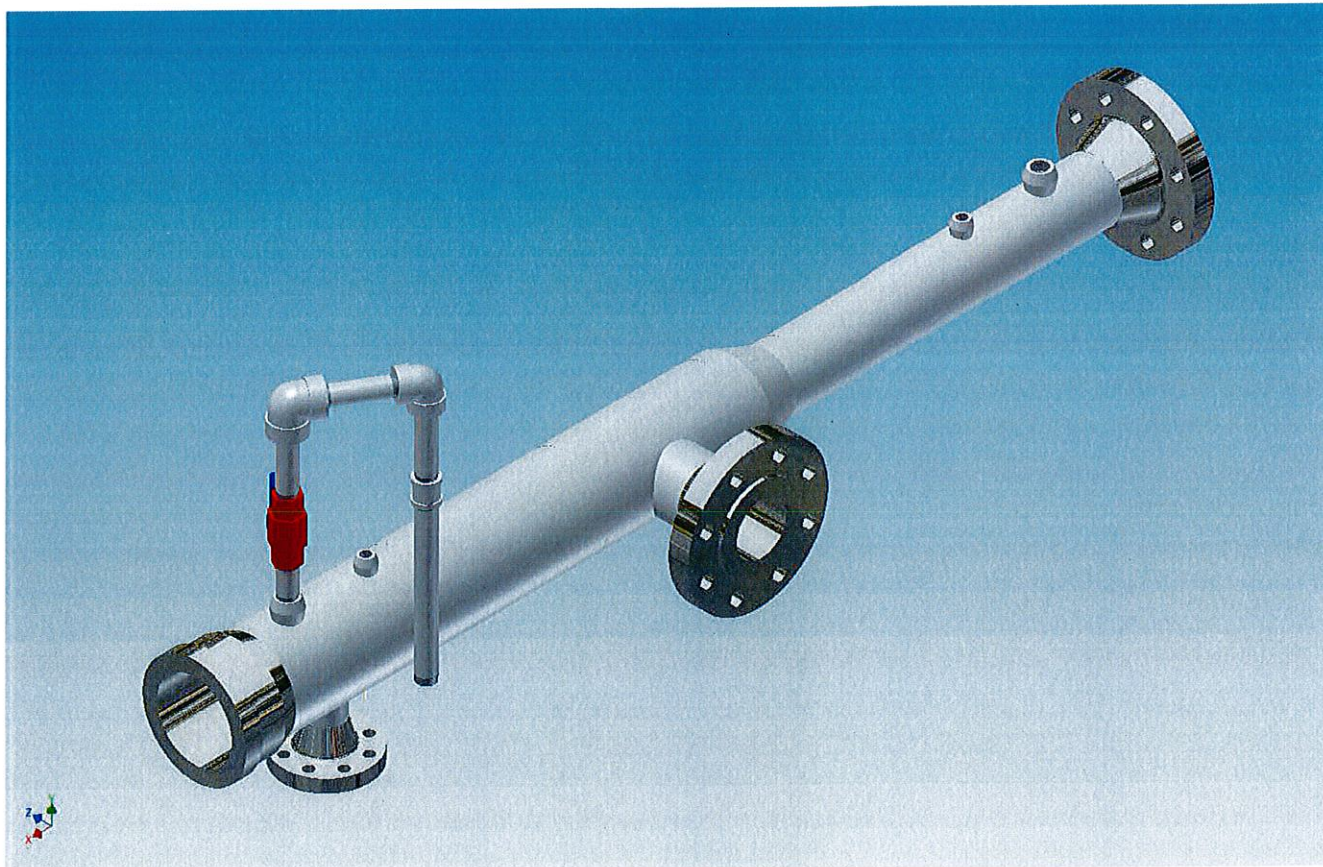
**Photograph #4**

This is a 3D model of the pig receiver at the 14-21-59-8W 6M site showing how the threaded pipe assembly may have been attached prior to the incident. This 3D model was completed by Anderson Associates Consulting Engineers Inc.

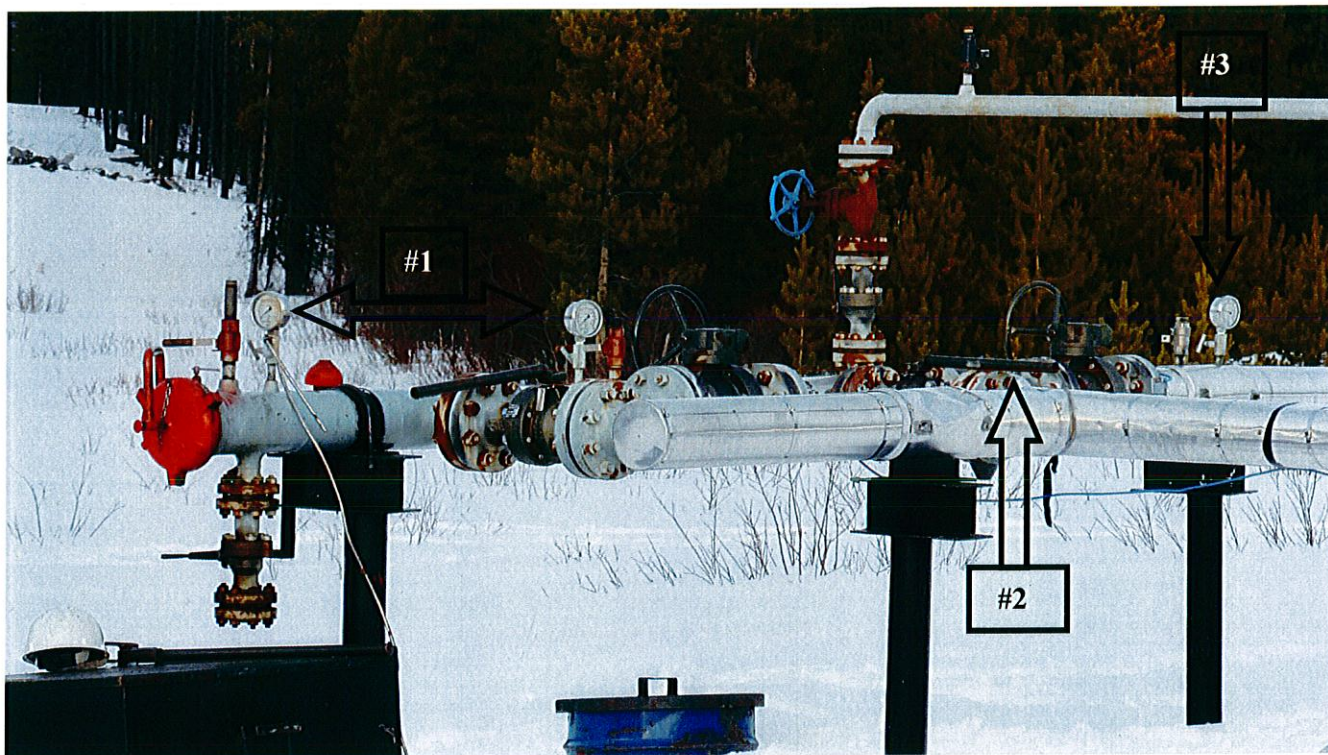
**Photograph #5**

- #1. The pressure gauges near the pig receiver.
- #2. The valve in the closed position, which blocks and traps the pressure to the pig receiver.
- #3. The pressure gauge and pressure reading in the line (4800 kPa).

5.1.5.1 Two Wika brand pressure gauges, with a 114.3 mm face and male stainless steel connection, were connected to the 11-21-59-8M W6 section of the pipe assembly that was shut in. The two pressure gauges were mounted to a needle valve that included a close nipple on the opposite side. Each pressure gauge had a range of 0 to 20,600 kPa. The one pressure gauge, closest to the pig receiver, was used to read the pressure in the receiver. The other pressure gauge was used to measure the pressure up stream of the receiver. (Attachment C, Photograph# 5)

5.2.3 The Occupational Health and Safety Investigators observed that the pipe line to the 11-21-59-8 W6 header was shut in and the pressure gauge, attached to the pipeline assembly near the end cap of the pig receiver, indicated a line pressure of 0 kPa. The pipeline pressure upstream of the receiver was observed to have a pressure of 4700 kPa. This pressure was seen over the entire length of the pipeline. (Attachment C, Photograph# 5)

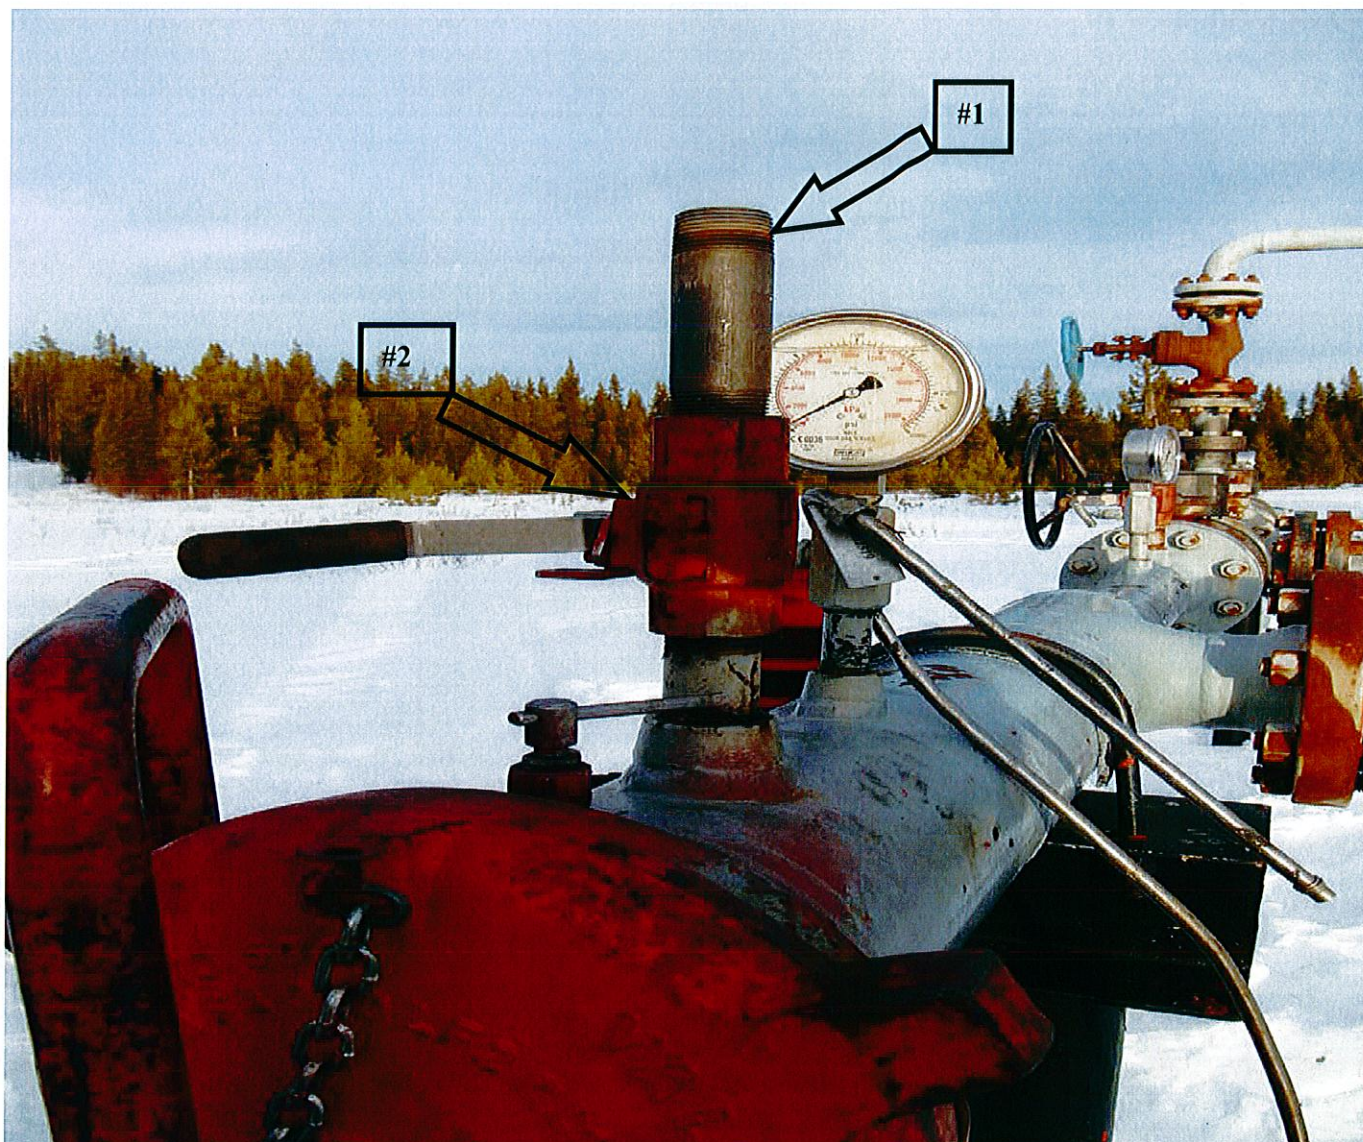
**Photograph #6**

- #1. Where the blow down pipe assembly was attached.
- #2. Ball valve assembly.

- 6.7 The Lead Operator ( ) started to open the 33.4 cm ball valve to depressurize the pig receiver. When the valve was opened to approximately 20% the blow down pipe, attached to the 33.4 cm ball valve, spun off and struck the Lead Operator ( ) in the head. The Lead Operator ( ) fell back onto the ground with a fatal head injury.

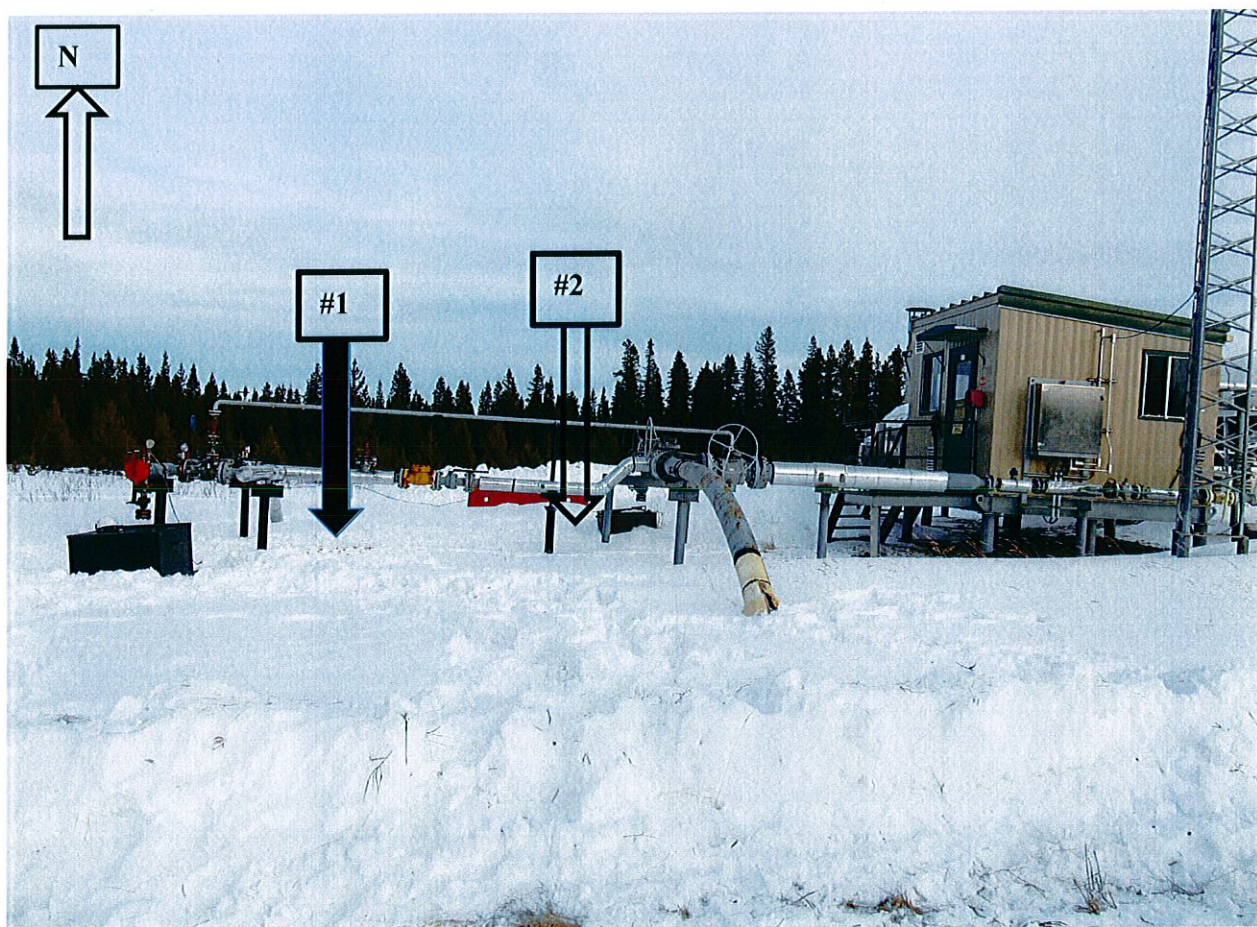
**Photograph #7**

- #1. Shows the location the lead operator was found.
- #2. Shows the location where the blow down pipe was found.

- 6.11 On February 2, 2013 at approximately 09:30 a.m. the Backhoe Operator ( ) arrived at the wellsite and he radioed to the Water Truck Operator ( ) that he saw the Lead Operator's ( ) truck parked on the North side of the well site, facing West, with the driver's truck door open. The Backhoe Operator ( ) stopped his backhoe and got out. As the Backhoe Operator ( ) was walking up to the well site, he saw the Lead Operator ( ) laying face up on the snow, approximately 30 cm away from the 11-21-59-8M W6 pig receiver. (Attachment C, Photograph #6)
