**WATER ACT**

**ENFORCEMENT ORDER NO. EO-WA-35159**

Bowen Contracting Ltd.  
PO Box 1022  
Jasper, Alberta  
T0E 1E0

WHEREAS the Maskuta Creek (the "Creek") transects the north east portion of the Parcel with a west to east flow direction in a meandering pattern;

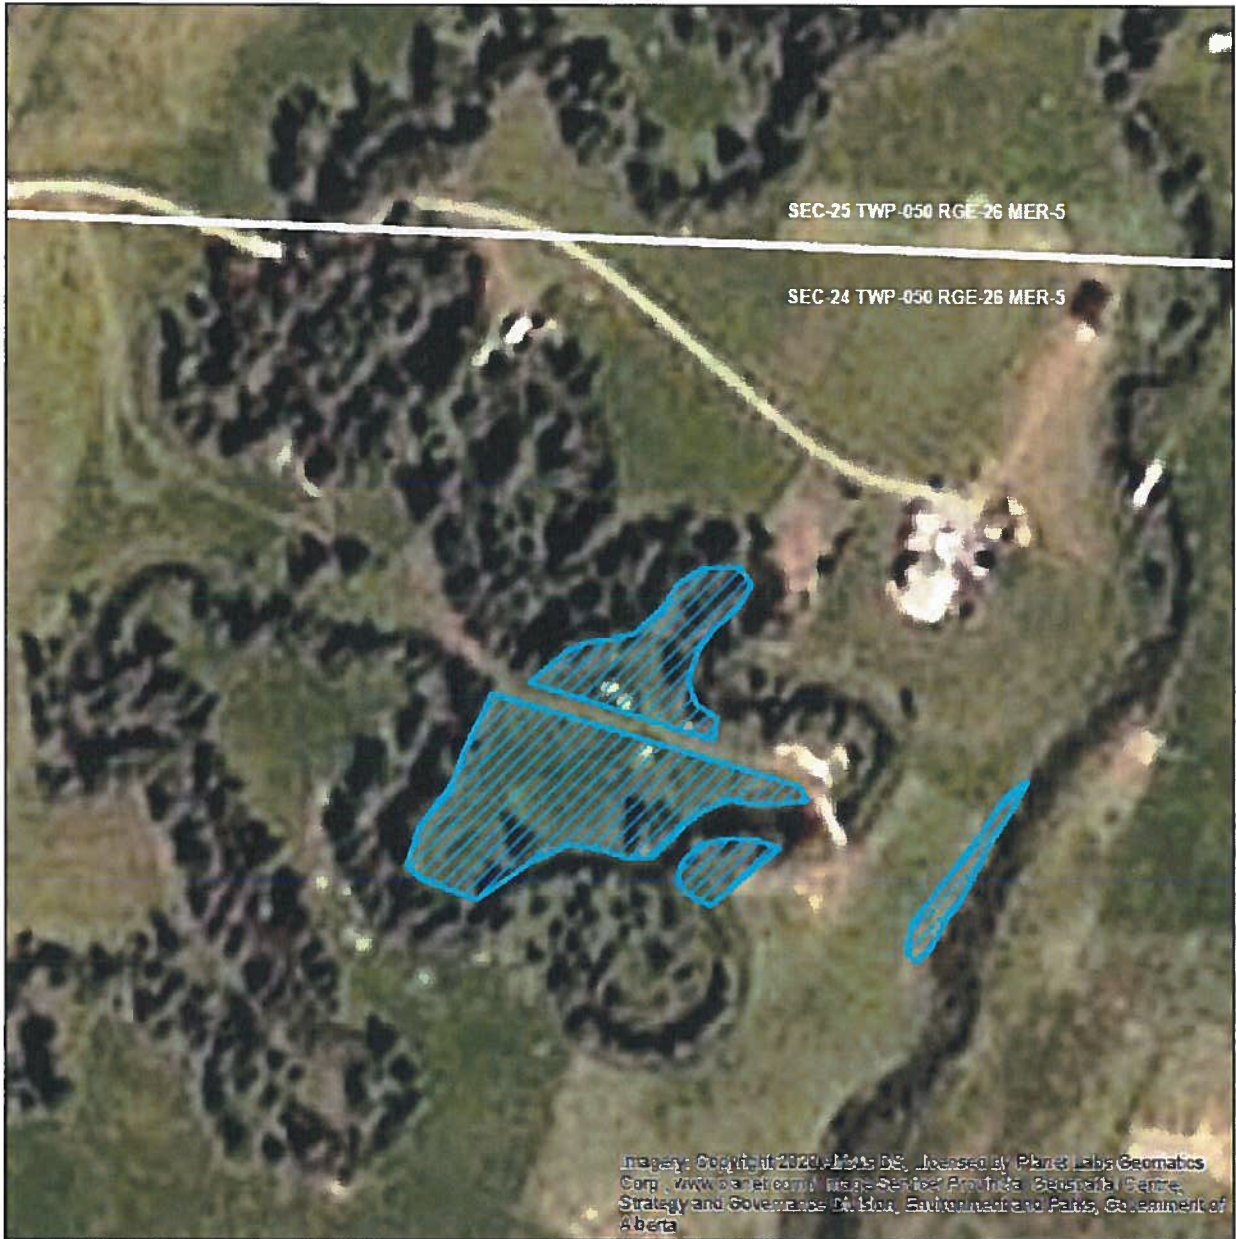
# Appendix A

Blue Hatching - Silt Fencing
-

- b. Install silt fencing within one meter of the Creek and the Stream in the areas shown in Appendix A- hatched in blue. The silt fencing must be:
    - i. installed without the use of heavy equipment and machinery;

- ii. rated for and of sufficient strength and size for erosion and sediment control and the prevention of the Materials from migrating into the Creek or the Stream; and

- iii. installed in accordance with manufactures specification.
  - c. Temporarily cap and stabilize the exposed surface of the Material in the areas shown in Appendix B- hatched in red. The temporary cap must be:

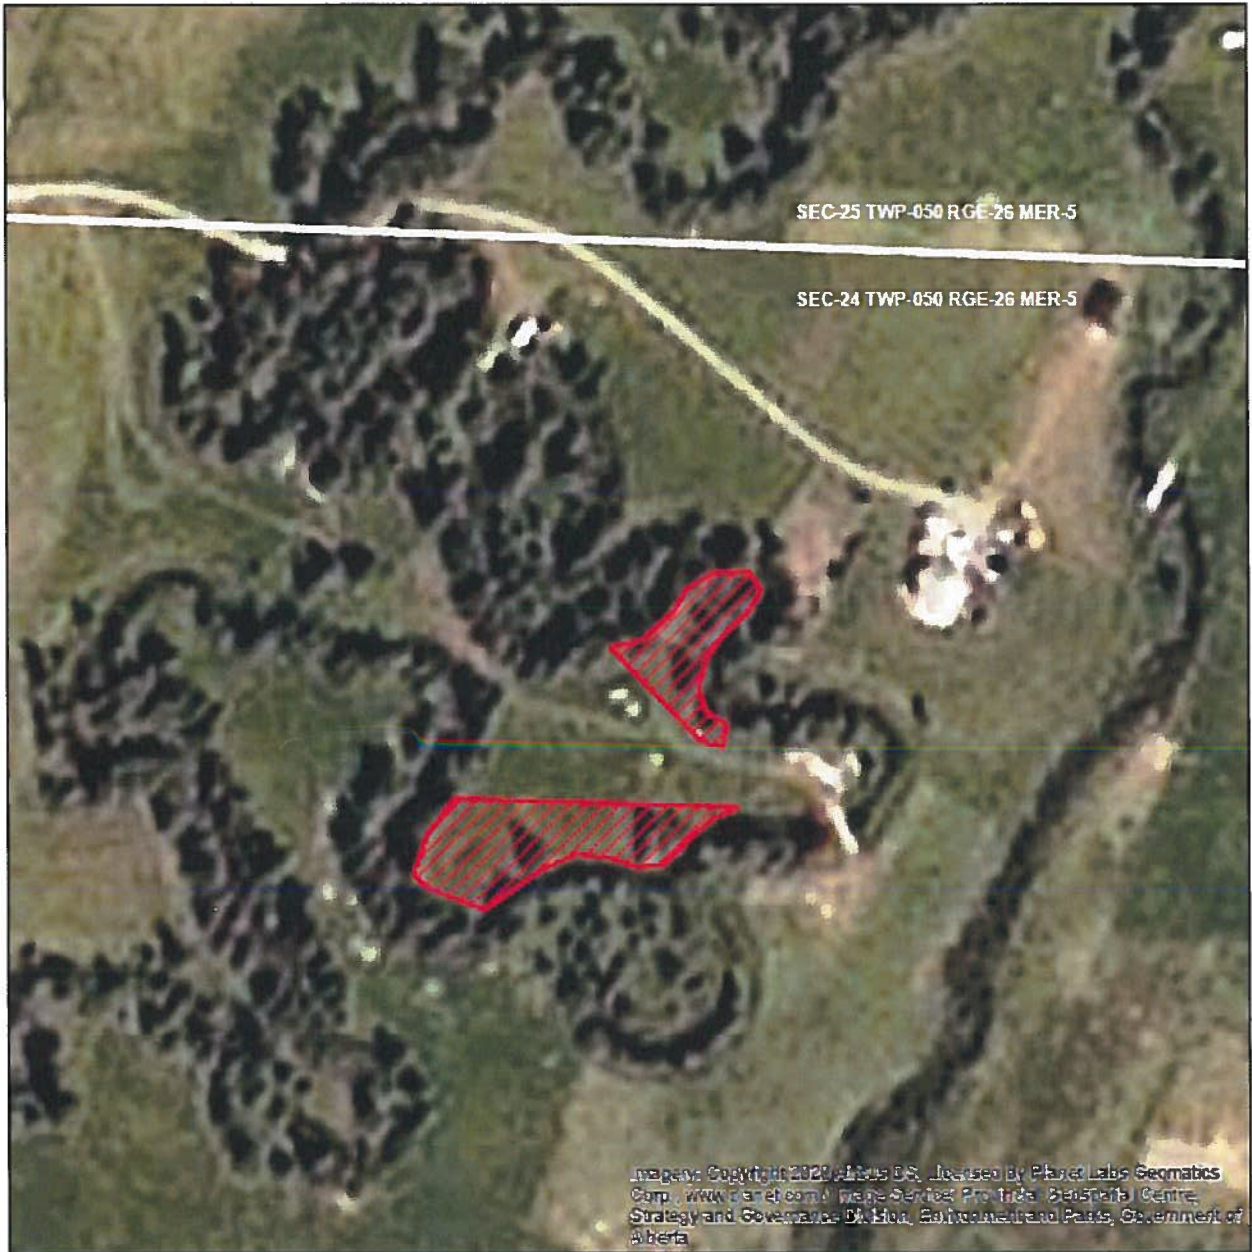
# Appendix B

- Red Hatching - Erosion Cap
- ATS Section

- i. readily removable;
    - ii. sufficient to protect the exposed surface of the Materials from wind erosion, water erosion and water infiltration; and

- iii. placed to extend over the crest of the Materials on a descending slope.
  - d. Document the measures taken under 1 b. and 1 c. with photographs, including date(s) of the photographs.
