# **Worker fatally injured falling into an excavation**

September 10, 2020

## **Incident summary**

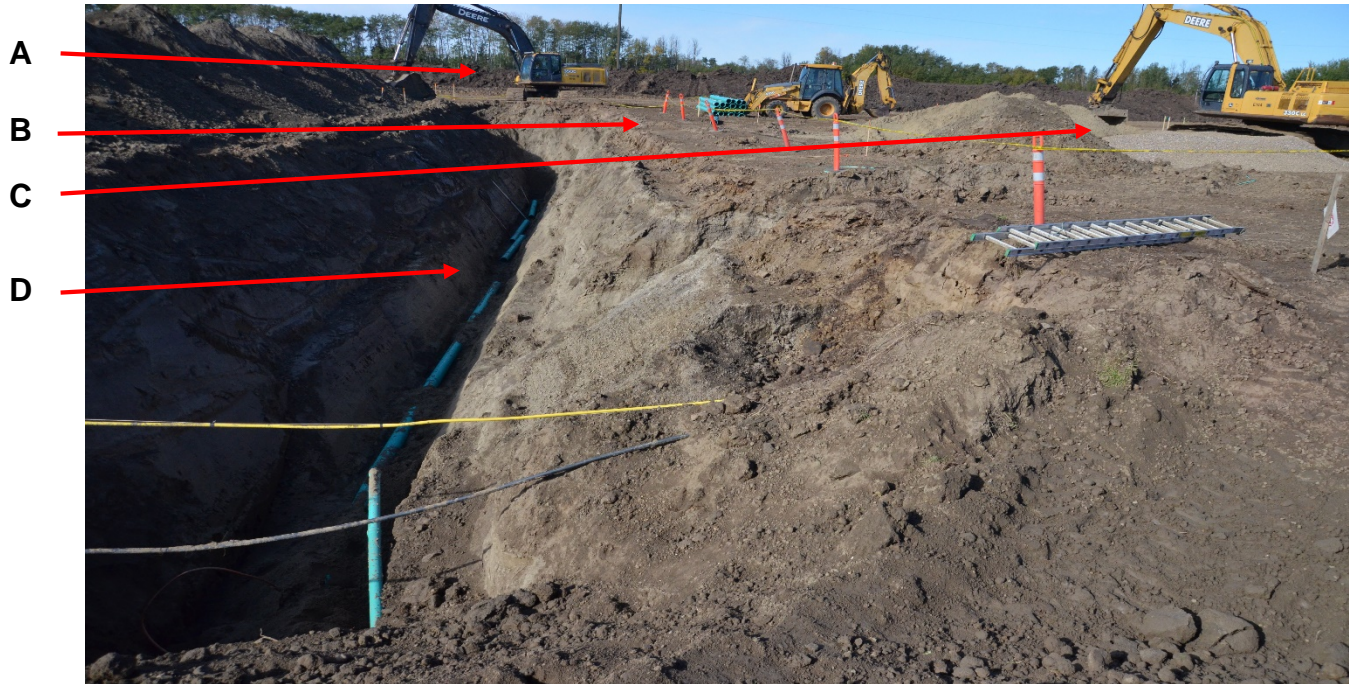
*Figure 1. Photograph of the work site showing excavation, piping and power mobile equipment.*

- A. John Deere 350D LC E108 excavator.*
- B. Location of piping next to excavation and BH-401/410 G backhoe/dozer.*
- C. John Deere 330C LC E-104 excavator.*
- D. Location in the excavation where the work crew (Labourers 1, 2, 3) was positioned.*

The John Deere 350D LC E108 excavator with a V-bucket attached, was positioned on the north side of the trench in order to excavate dirt and create a trench for the PVC waterline installation (Figure 1A and Figure 2A).

The John Deere 330C LC E-104 excavator was positioned adjacent to the trench. It was used to backfill the trench with sand and dirt. It was also to be used for bedding the pipes (the pipe bedding was placed underneath the pipeline and used to provide full support for the pipe and its connections) (Figure 1C and Figure 2C).

The BH-401/410 G backhoe/dozer was used to level the lot topsoil adjacent to the excavation. (Figure 1B and Figure 2B).

After the Crawler Operator completed the task of levelling the lot, they inquired with the Lead Hand with respect to what the next task was to be completed. The Lead Hand instructed the Crawler Operator to pass PVC pipe by hand to the workers who were located at the bottom of the excavation (Figure 1D and Figure 3A). The Crawler Operator and Lead Hand walked over to a pallet adjacent to the trench where PVC water-fitted blue-casing pipes (each measuring approximately 20 cm in diameter, 4 m in length and approximately 22 kilograms in weight) were located in order to prepare the pipes for movement to the trench.

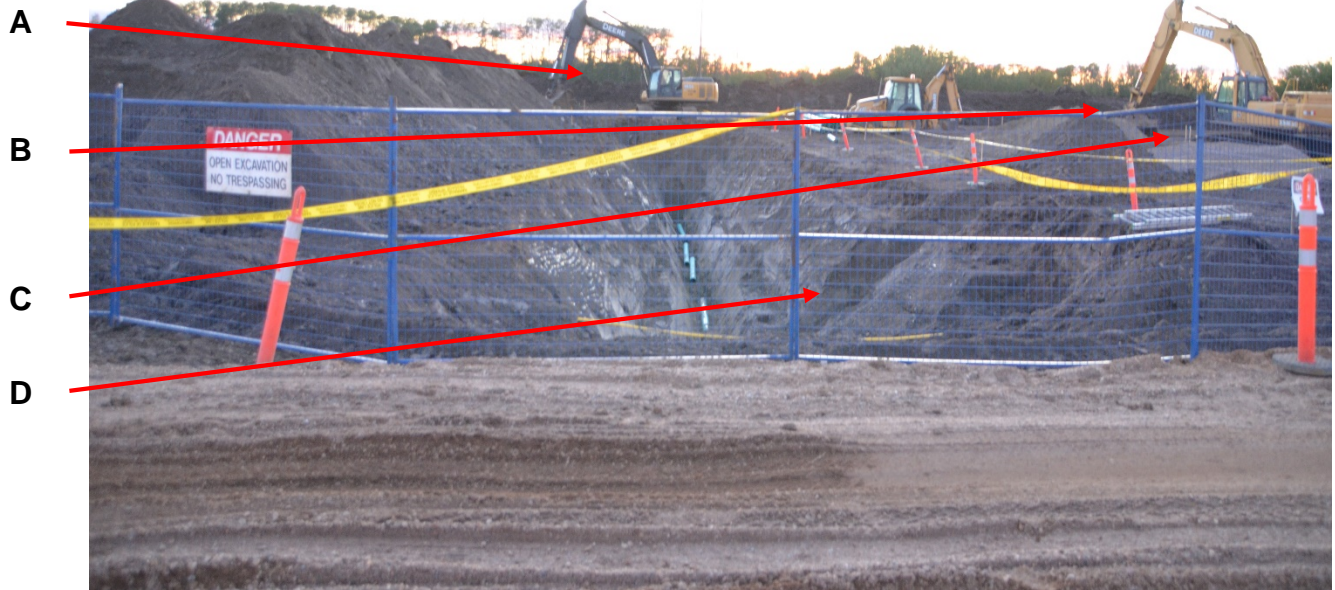
*Figure 2. Photograph of work site, taken from the security fence which was behind securing fencing, showing piping, excavation and power mobile equipment.*

- A. John Deere 350D LC E108 excavator.*
- B. Location of piping material next to excavation and BH-401/410 G backhoe/dozer.*
- C. John Deere 330C LC E-104 excavator.*
- D. Location where workers (Labourers 1, 2, 3) accessed the excavation.*

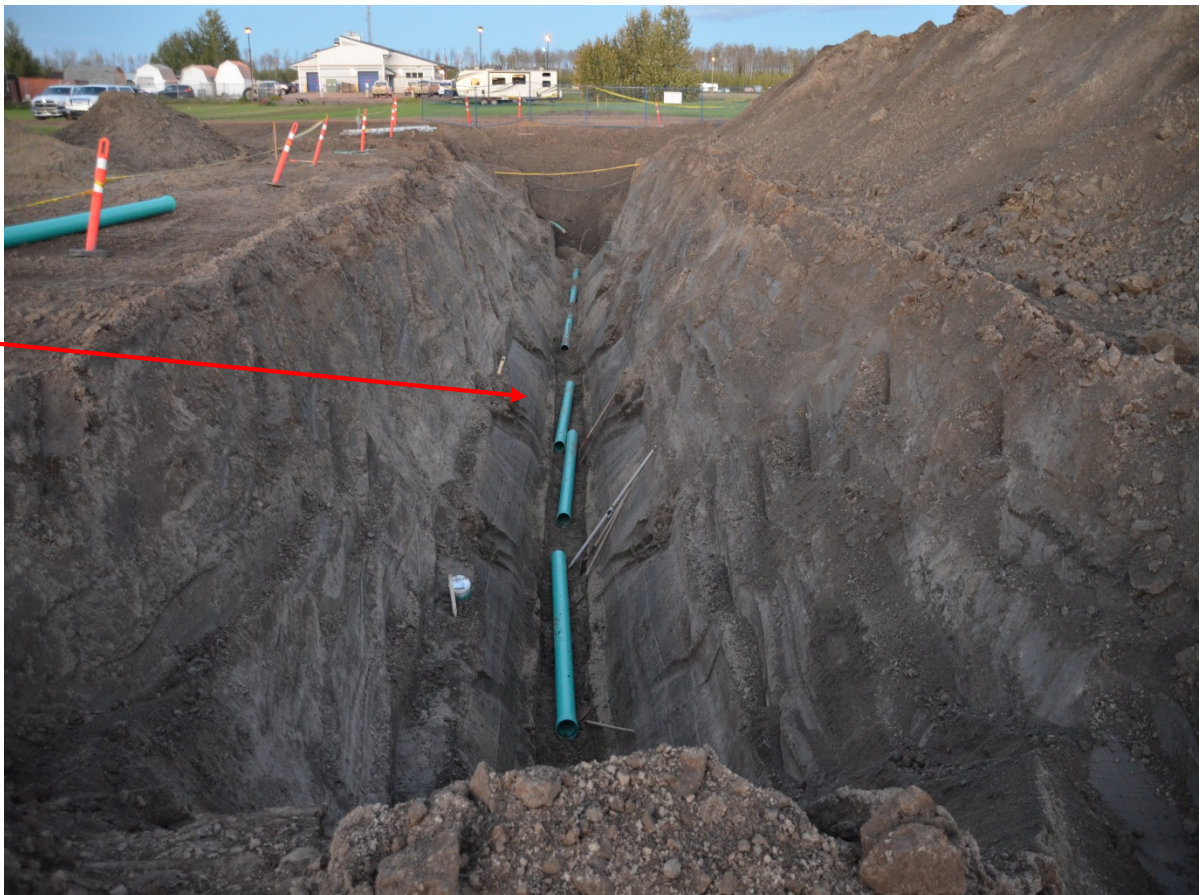
*Figure 3. Photograph of the excavation where PVC waste waterline was placed.  
A. Approximate location where the workers were positioned while connecting pipe.*

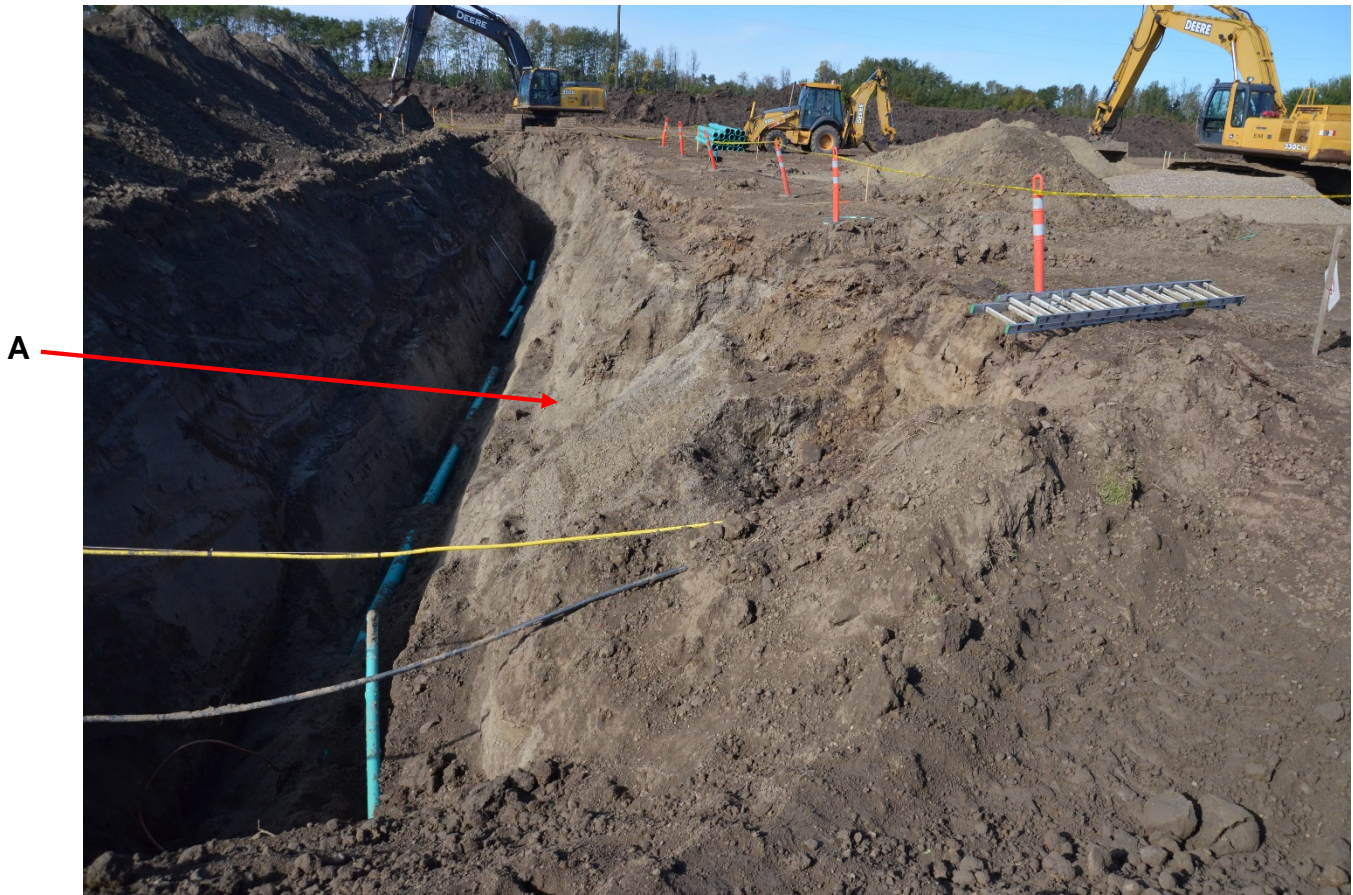
*Figure 4. Photograph of the excavation.  
A. Entrance into the excavation.*
