Fatality - worker drowned in dugout

March 18, 2019

This document reports the Alberta Occupational Health and Safety (OHS) investigation of a fatal accident that occurred in March 2019. It begins with a short summary of what happened. The rest of the report covers this same information in much greater detail.

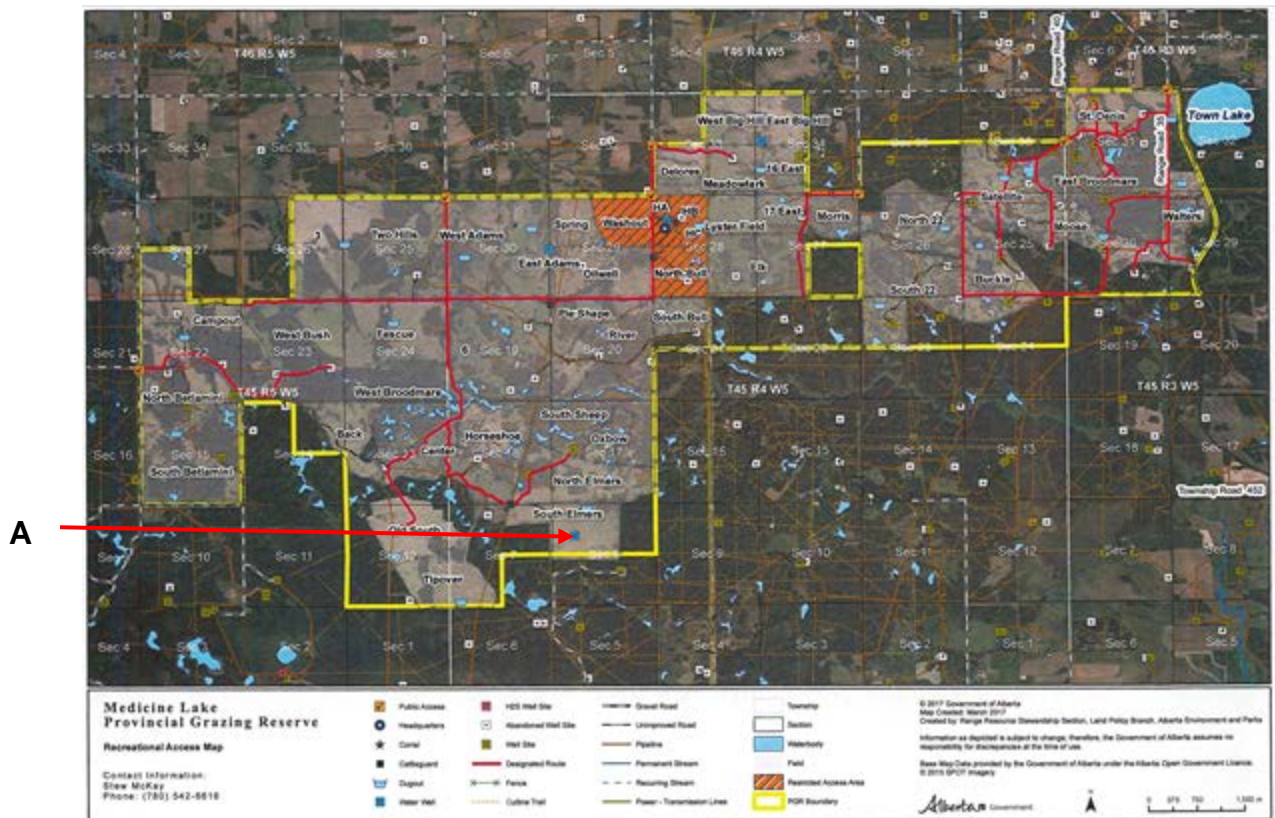
Figure 1. Medicine Lake Provincial Grazing Reserve – yellow border identifies the grazing lease.

The dugout was used as a source of water for the grazing cattle to drink. The exact size and depth of the dugout was unknown at the time of the incident as there was no record available (Figure 1).

A. The location of the dugout in the South Elmer's quarter section where the incident occurred in relation to the grazing lease.

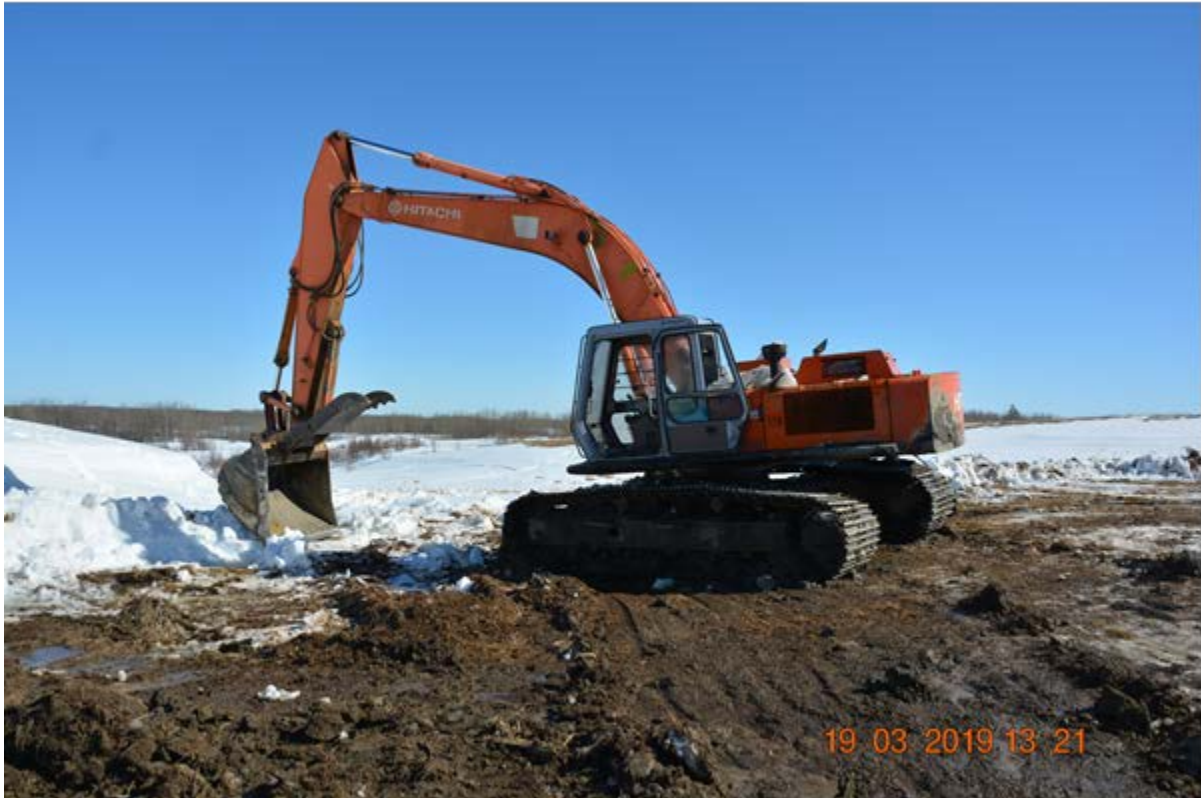
Figure 2. The excavator after extrication from the dugout.

The Hitachi excavator was a Model EX270LC that was operated during the incident. The excavator was manufactured in Japan in 1997 by the Hitachi Construction Machinery Co. Ltd.

The excavator was owned by the Farm for approximately five to six years prior to the incident. The excavator was primarily used on the Farm property for farm use (Figure 2).

Early in the morning of March 19, 2019, the submerged excavator was retrieved from the dugout in the South Elmer's quarter section, and the unresponsive Operator was recovered from inside the cab of the excavator.

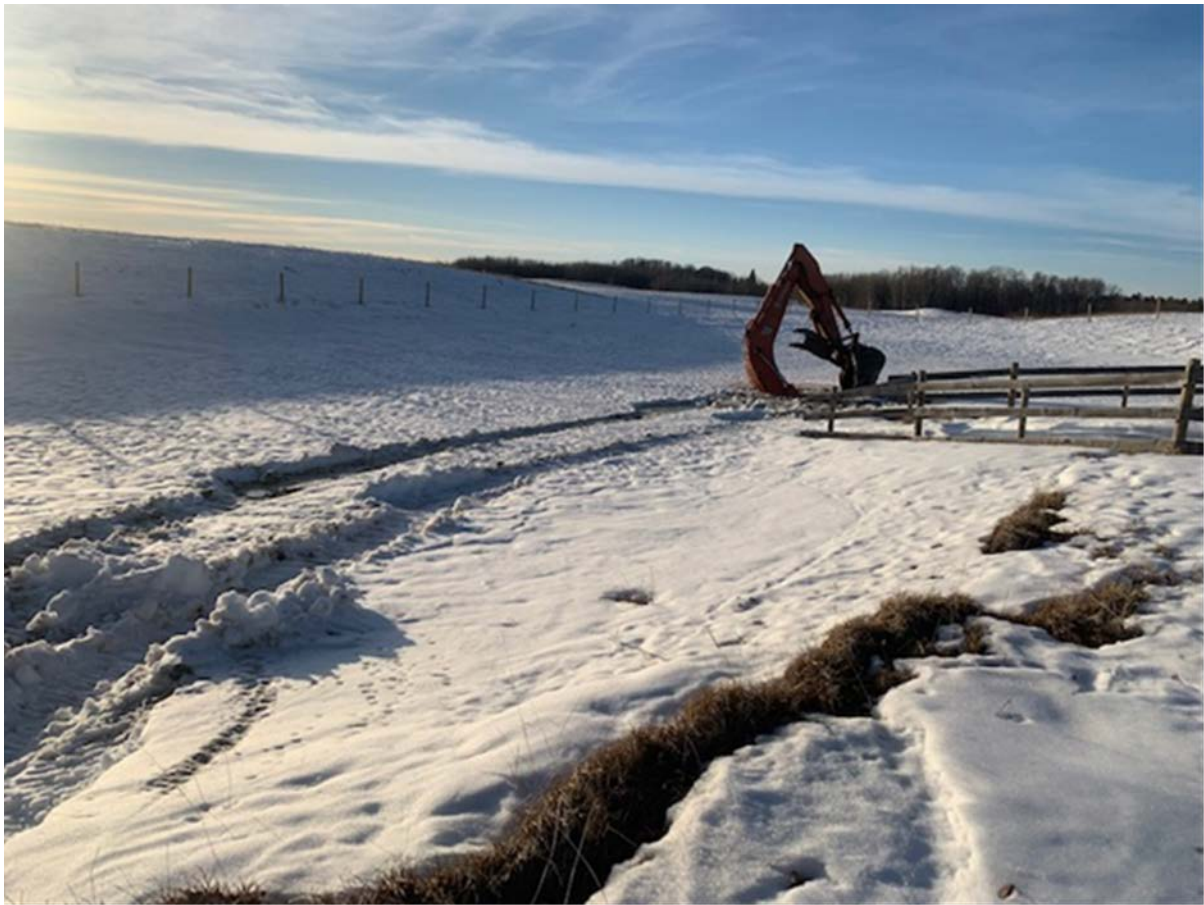
Figure 3. South Elmer's quarter section dugout of the grazing lease on March 18, 2019 (Royal Canadian Mounted Police (RCMP) photo).

The excavator was located approximately in the middle of the dugout with only the boom exposed above the ice (Figure 3).

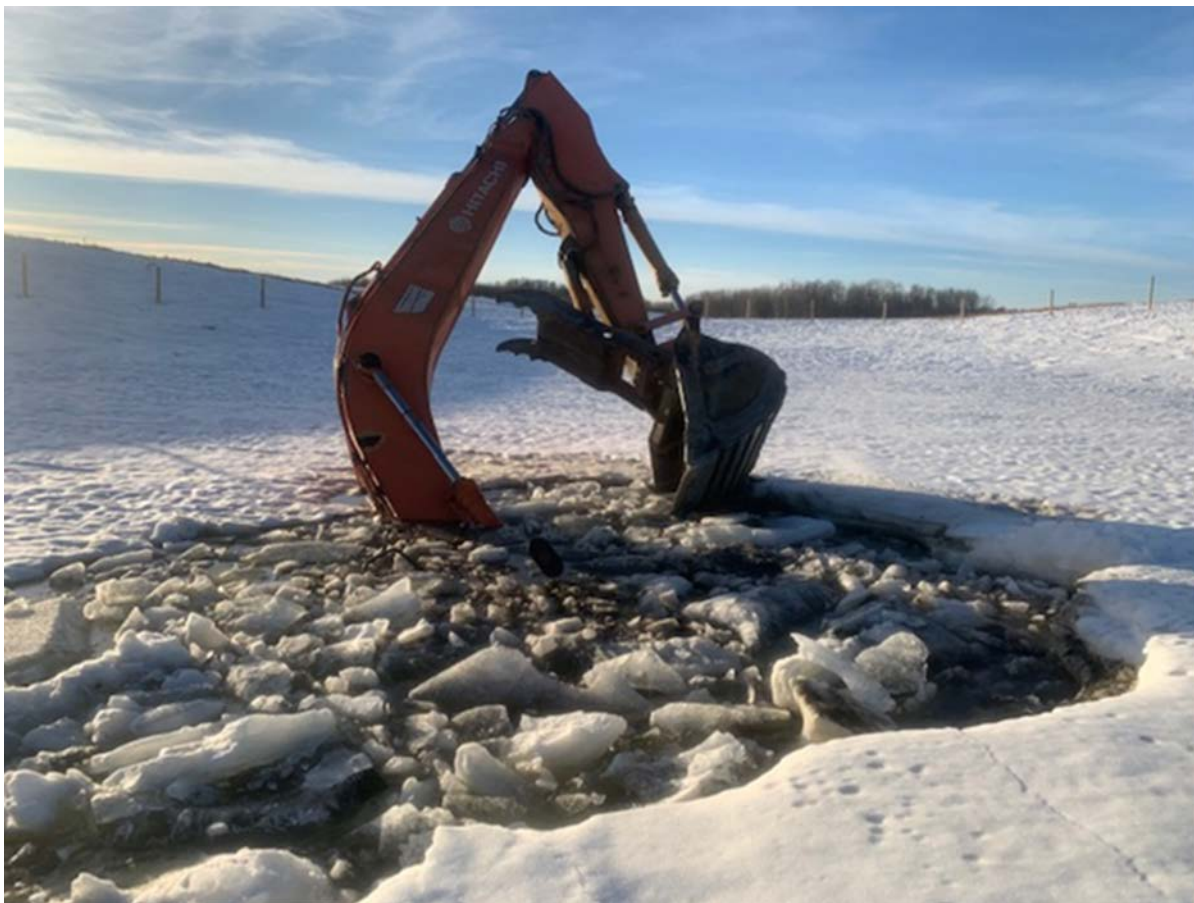
Figure 4. Submerged excavator in the dugout March 18, 2019 (RCMP photo).

Emergency services were dispatched to assist and worked to remove the submerged excavator (Figure 4).

The owner of the Farm contacted a construction company to bring in appropriate equipment to blade a vehicle path in the snow and assist with the extrication of the submerged excavator from the dugout.
