WATER ACT

ENFORCEMENT ORDER NO. WA-EO-37959

WHEREAS **John Beck** is the registered owner of lands legally described as NE 19-36-6 W5M located in Clearwater County, in the Province of Alberta (the "Lands");

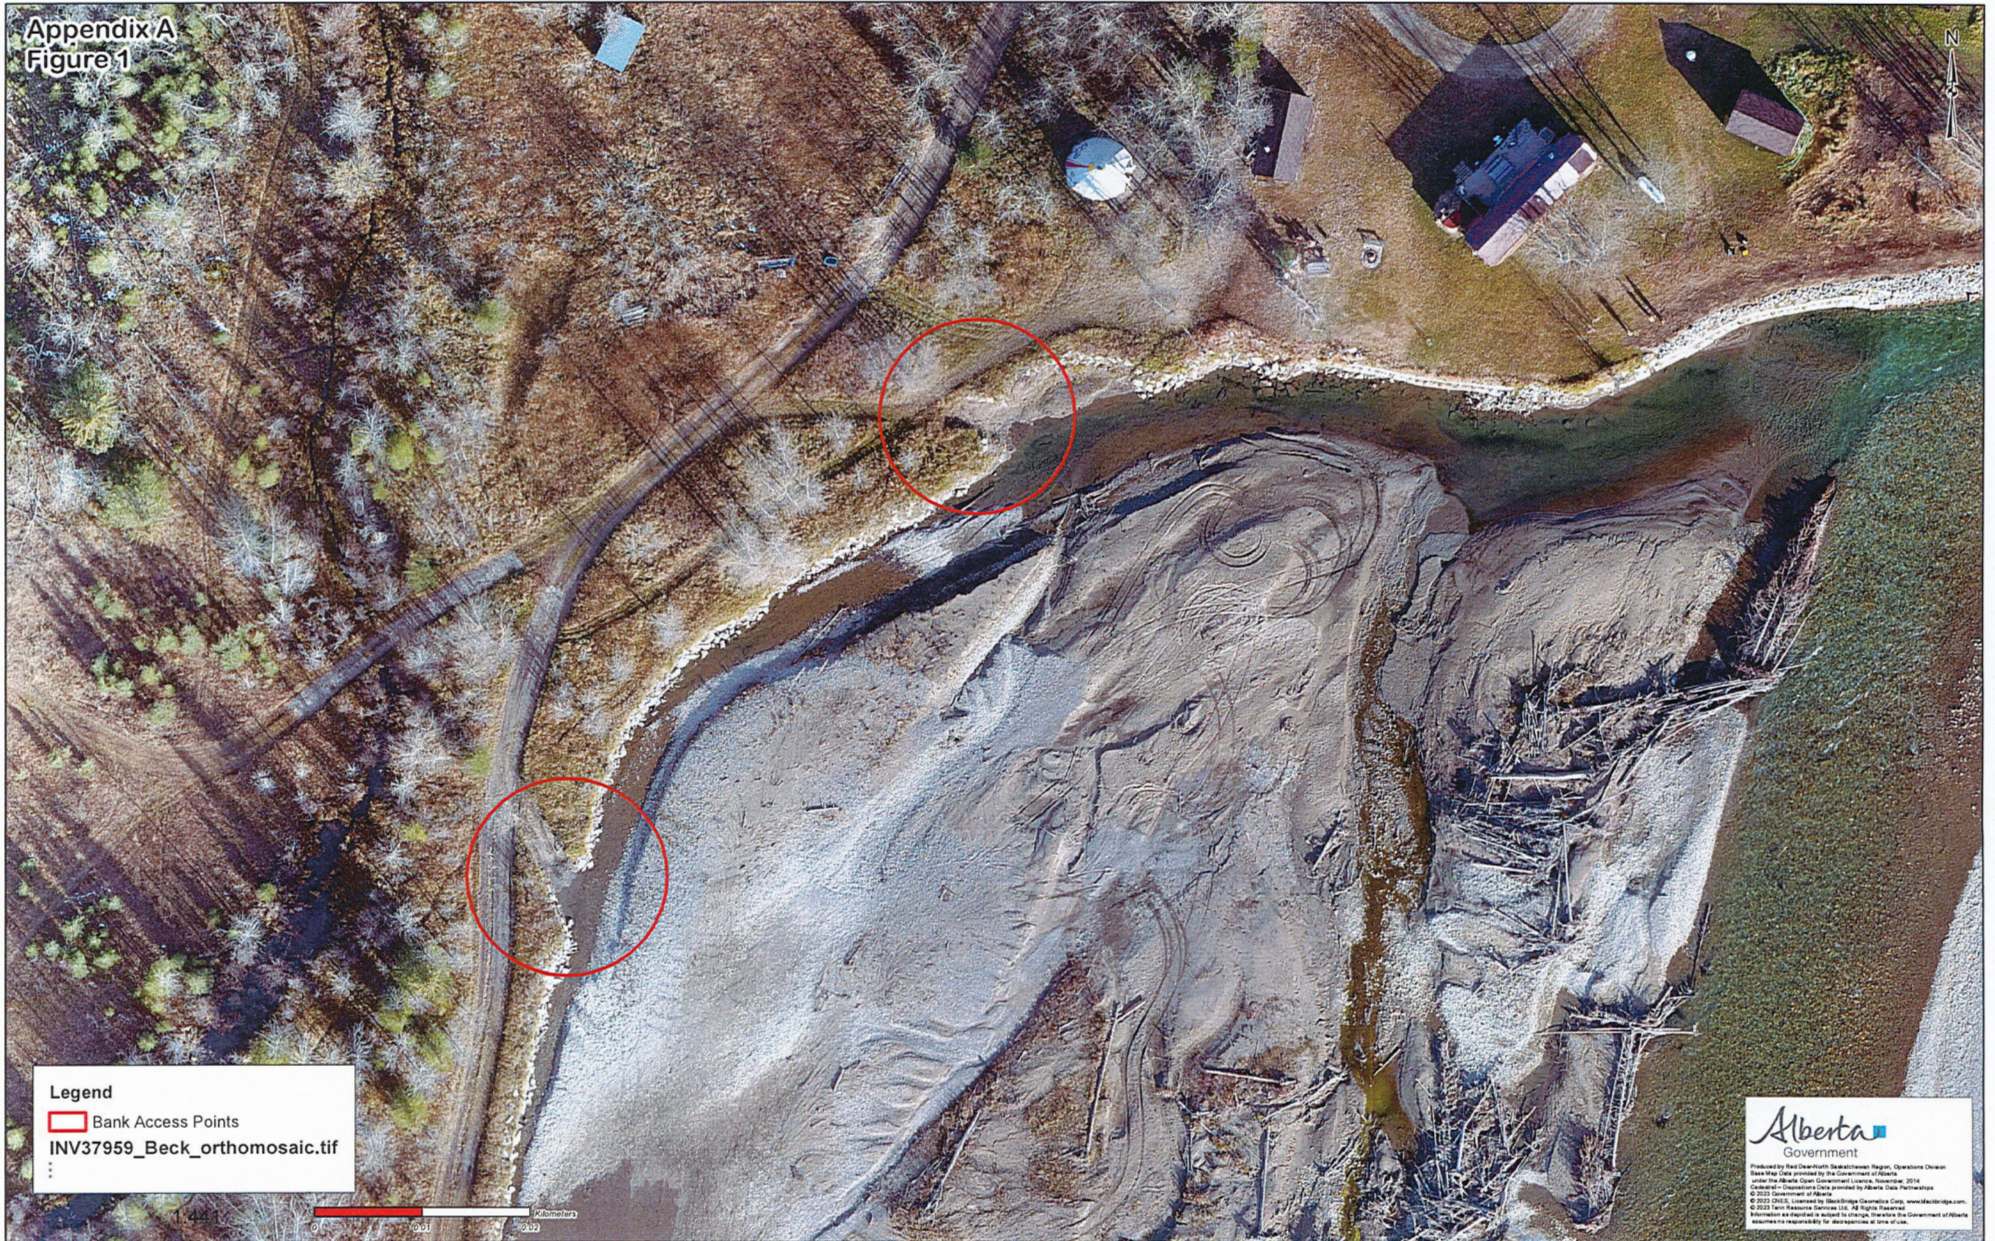
- Concrete "Lego Blocks" and large rocks had been placed along the bank of the Clearwater River (See Appendix A Figure 2) adjacent to the Lands,
- Two locations where the bank had been cut into in order to provide access to the bed and shore of the Clearwater River (See Appendix A Figure 1),
- Approximately 5 concrete "Lego Blocks" were visible on the bottom of the Clearwater River in the area adjacent to the Lands.

- additional rock and concrete blocks placed in and on the bank of the Clearwater River compared to the May 6, 2021 inspection, and
- additional concrete blocks were observed within the active channel of the Clearwater River;
(see Appendix A, Figures 1 and 2)
(collectively, all of the installed concrete blocks, rocks, and construction at the site are hereinafter referred to as the "Unauthorized Works")

- b) Remediation of the riverbank where access points were created as identified in Appendix A Figure 1 back to their pre-disturbance condition;
 - c) A detailed description of the measures to prevent all erosion, siltation, and other adverse effects to the Clearwater River during all of the work carried out in the implementation of the Remedial Plan;

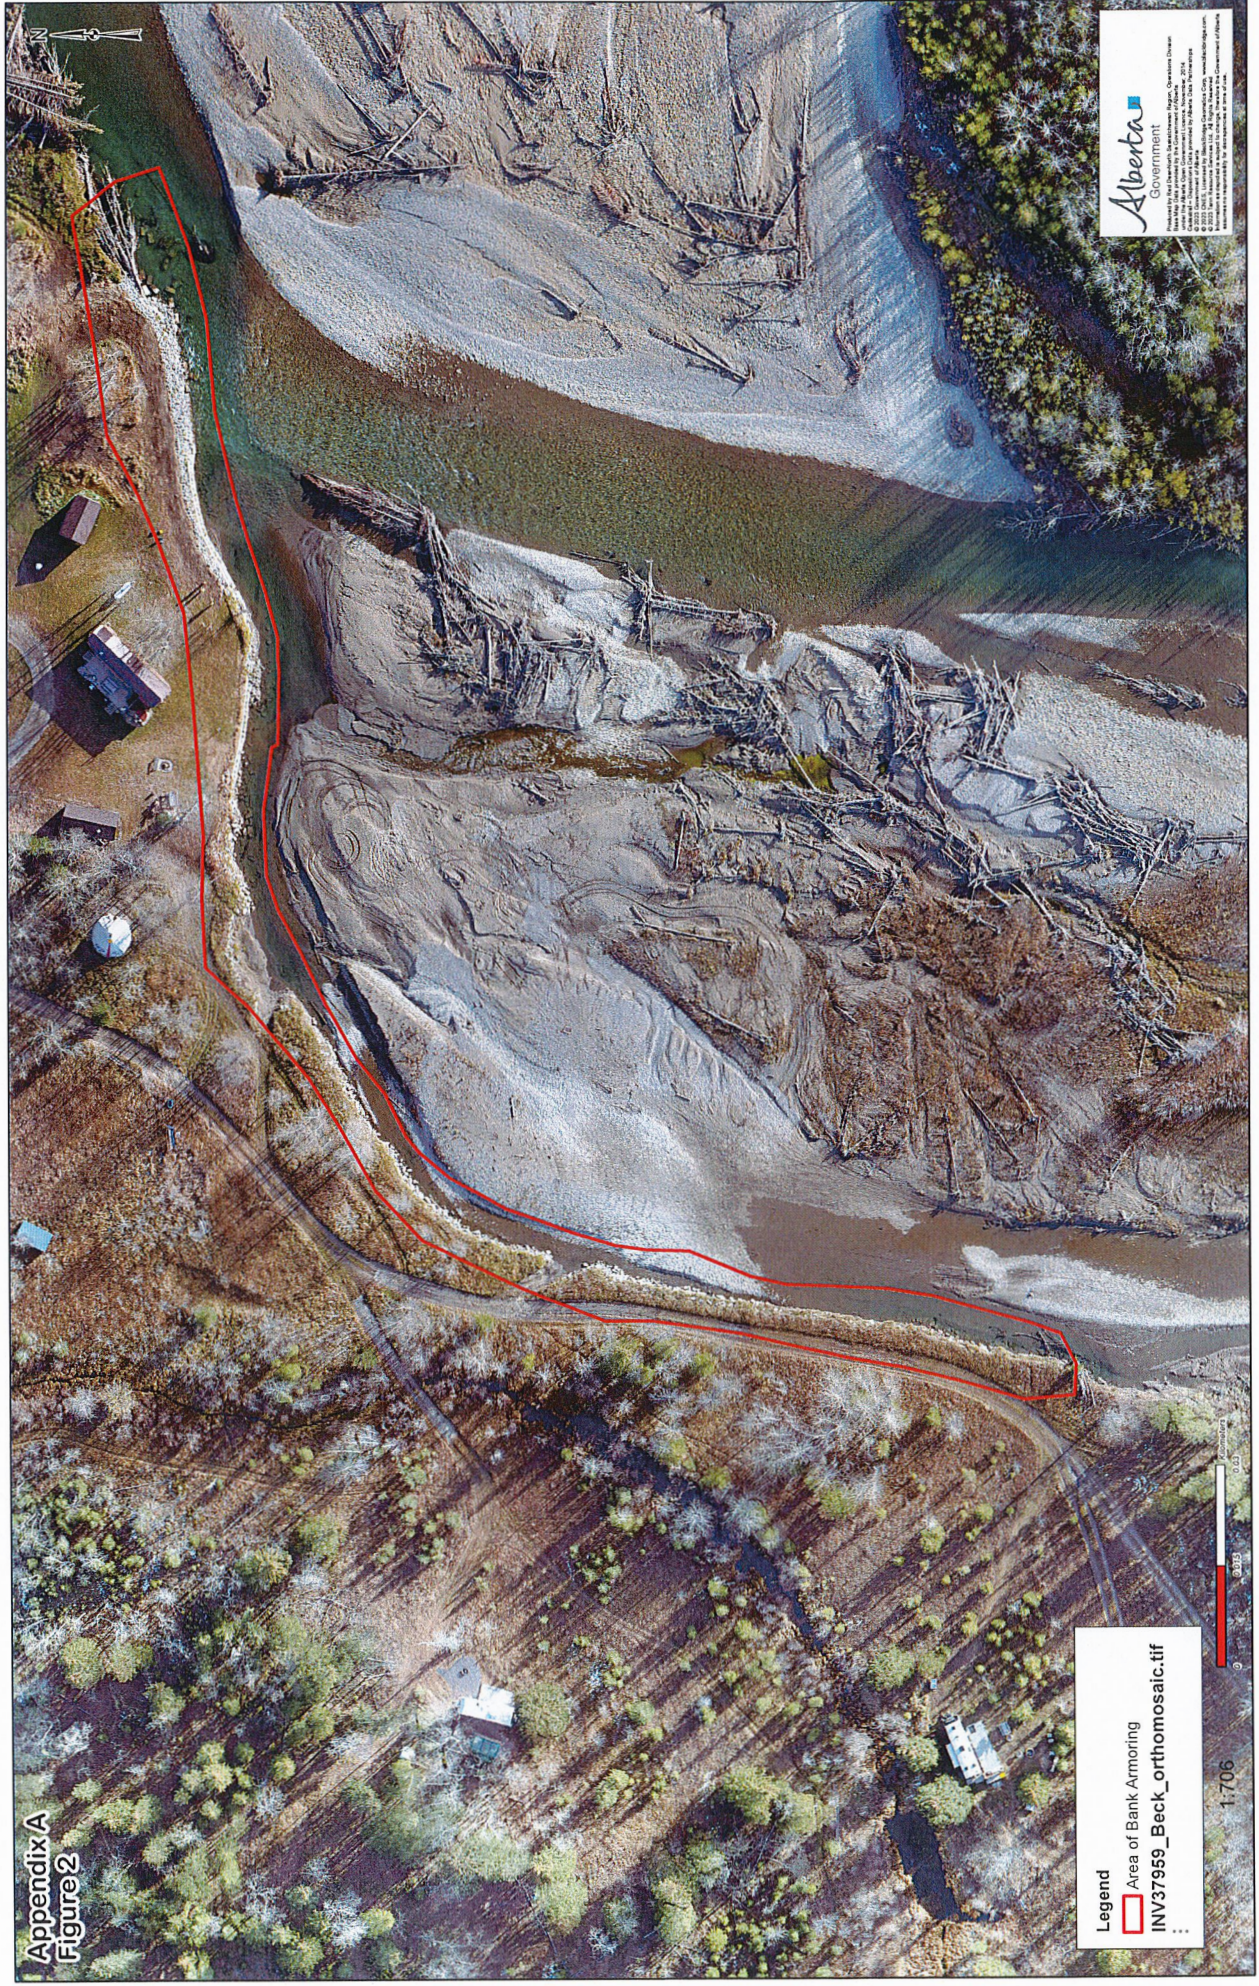
Appendix A
Figure 2

- Based on the supplied photos [of the Lands and adjacent areas of the Clearwater River], none of these necessary features exists at the site;

- The armoring was likely installed without proper design;
- The concrete blocks were placed without any side slope or toe apron;
- It is unlikely that the concrete blocks and limestone rocks, as placed, will enhance bank stability;

- The Unauthorized Works installed by Beck, are focused on localized erosion adjacent to the Lands rather than erosion susceptibility of the entire site outside of the Unauthorized Works. While the Unauthorized Works provide some limited short-term protection, they may accelerate erosion elsewhere along the banks of the River.

- The Unauthorized Works are not expected to function appropriately over the long term, leading to continued concrete block instability and river erosion at this location.

- The disturbance from the Unauthorized Works has the potential to create local erosion (scour), increased turbidity, and subsequent downstream siltation. As concrete blocks tip over, a rapid release of silt, causing increased turbidity would be expected.

- (2) a summary of how the Professional Engineer meets all the requirements of Clause 2 of this Order.
- 4) Beck shall, on or before **October 31, 2023**, submit to the Director for the Director's written approval, a written Remedial Plan (the "Remedial Plan") authenticated by the Professional Engineer, which shall have at its objective, **ONE** of the **THREE** following options:

- Option #1: Removal**
Removal of the Unauthorized Works and restoration of the impacted areas of the bed and shore back to their pre-disturbance condition;

- Option #2: Abandonment**
Abandonment of the Unauthorized Works in place, with installation of additional protections that provide silt and erosion stabilization; or

- Option #3: Reconstruction**
Reconstruction or modification of the Unauthorized Works at the site to bring them to an engineered state that would be acceptable to the Director;
