Connacher Great Divide SAGD Expansion Project: Surface Aquatic Resources Report

CONNACHER GREAT DIVIDE SAGD EXPANSION PROJECT: SURFACE AQUATIC RESOURCES REPORT

HATFIELD CONSULTANTS
200 - 850 HARBOURSIDE DRIVE
NORTH VANCOUVER, BC
V7P 0A3

MAY 2010

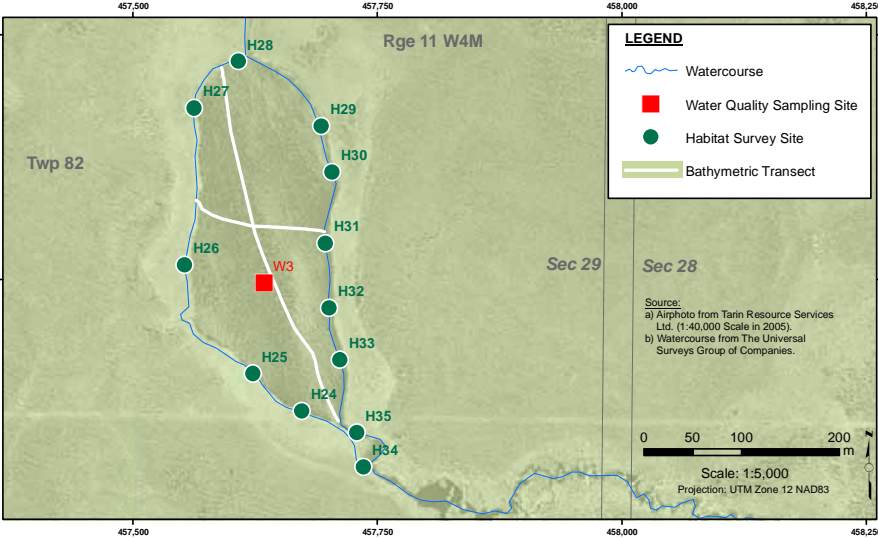
Figure A4.3 Results of habitat surveys for C04 (Unnamed Lake-4.)

Fall Lake Habitat Assessment				
Location Code	Water Depth (m)	Secchi Depth (m)	Aquatic Vegetation	Extent from Shore (m)
H24	0.8	0.7	sedges, small willows to black spruce	35
H25	0.6	0.6	sedges, buck bean	32
H26	0.6	0.6	sedges, buck bean	42
H27	0.6	0.5	sedges, buck bean, aquatic cinquefoil	30
H28	0.7	0.5	sedges, buck bean, aquatic cinquefoil	140
H29	0.6	0.5	sedges, buck bean, aquatic cinquefoil	65
H30	1.5	0.6	sedges, buck bean, aquatic cinquefoil	35
H31	1.2	0.5	sedges, moss spp., small shrubs	30
H32	1.3	0.6	sedges, small willows to mature black spruce	25
H33	0.5	0.5	sedges, small willows to black spruce	40
H34	0.6	0.6	sedges, small willows to black spruce	5
H35	0.8	0.7	sedges, small willows to black spruce	n/a
