Workplace Health and Safety Fatality Report

WORKER EXPOSURE TO CARBON MONOXIDE

Type of Incident: Fatality

Date of Incident: January 3, 2008

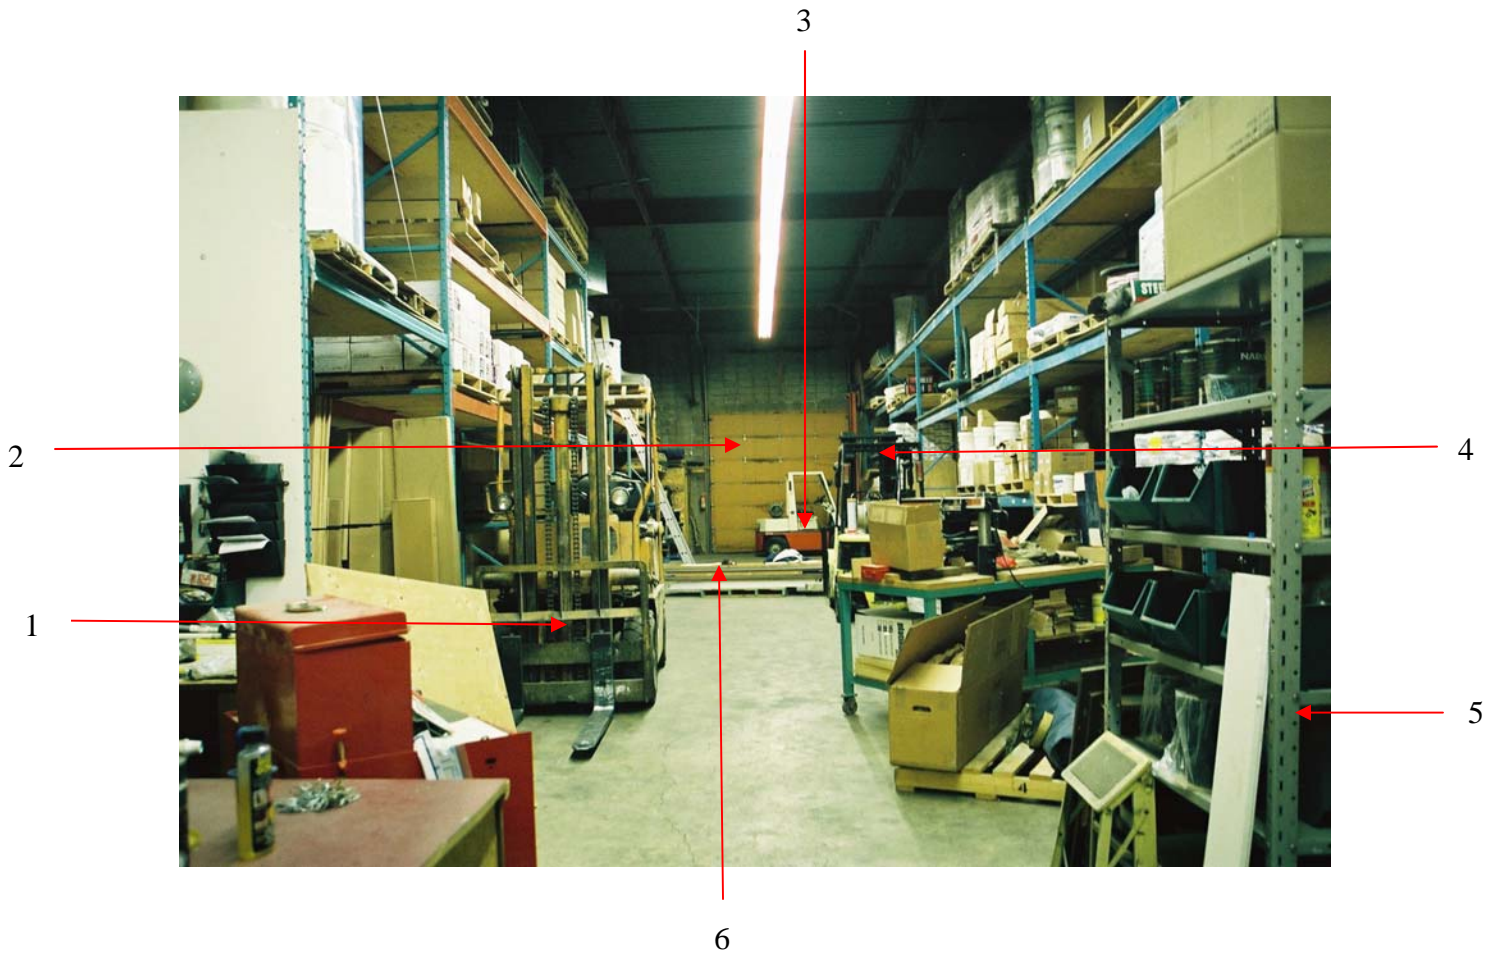
Photograph 1: Shows the warehouse where the incident occurred

1. Komatsu forklift
2. Bay door
3. Nissan forklift
4. Mitsubishi forklift
5. Racking
6. Folded tables on which the owner collapsed

- 5.1.2 Industrial racking was used to store paint supplies and equipment on the north and south sides of the warehouse. The owner and the worker were in the process of adjusting the racking and rearranging the material and equipment at the time of the incident (Refer to Attachment B – Photograph 1).

- 5.1.3 There was no mechanical ventilation system in the warehouse and air was circulated using three ceiling fans. The bay door was kept in the closed position when the propane-powered forklifts were operated in the warehouse (Refer to Attachment B – Photograph 1).

7.2.1 There was no mechanical ventilation in the warehouse. The bay door was kept closed due to cold weather conditions.

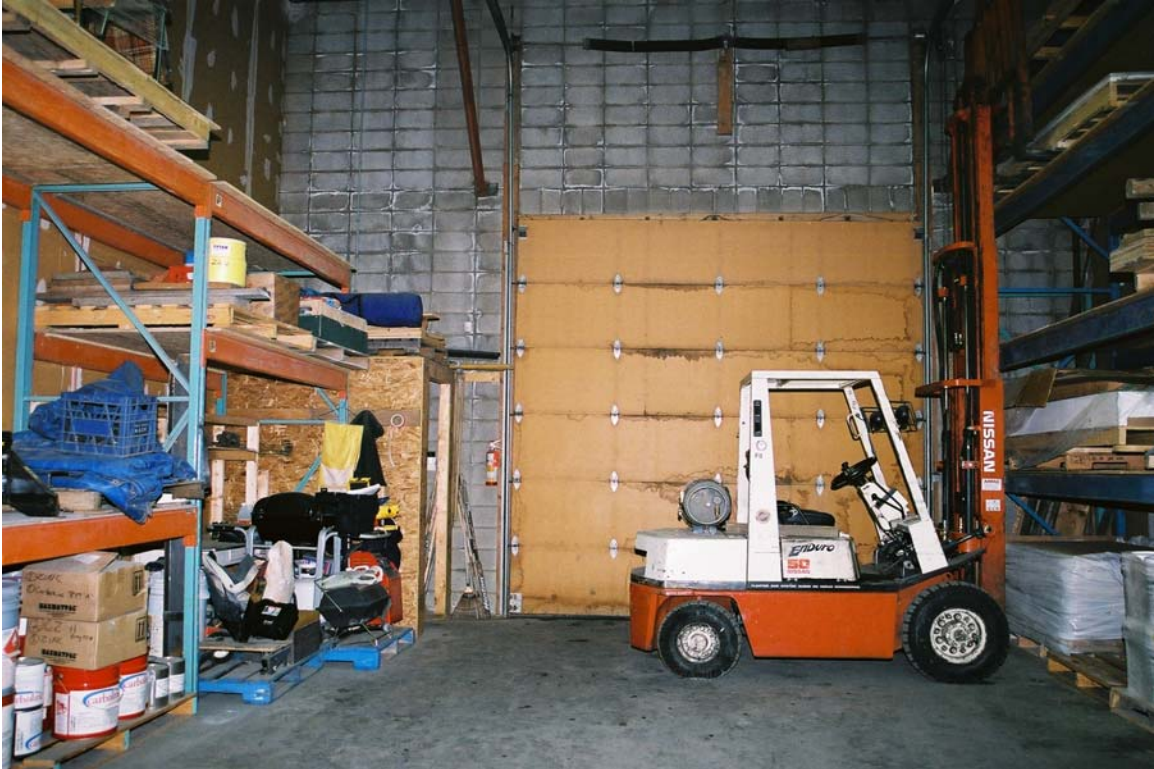
Photograph 2: Shows the Nissan forklift parked at the east side of the warehouse

- 5.1.1 Three propane-powered forklifts, a Nissan, a Kamatsu and a Mitsubishi were involved in the incident. These forklifts were operated on an individual basis between January 2 and 3, 2008 (Refer to Attachment B – Photographs 1, 2, 3, 4 and 5).

Maintenance records indicated that the three propane-powered forklifts were not maintained in good operating condition and required tune-up. There were no manufacturer's specifications for the three propane-powered forklifts available at the worksite.

7.2.2 The Nissan, Mitsubishi and Komatsu forklifts were not maintained in good operating condition and required tune-up. After the incident, on the same day at approximately 3:40 p.m., the City of Calgary, Fire Department measured the atmospheric concentration of carbon monoxide in the range of 116 to 570 ppm in the warehouse.

- stop work order for indoor use of all propane-powered forklifts until causes of the incident were determined and control measures were implemented
- stop use order for the Nissan forklift until it was inspected and repaired in accordance with the manufacturer's specifications
- conduct an incident investigation and prepare a report

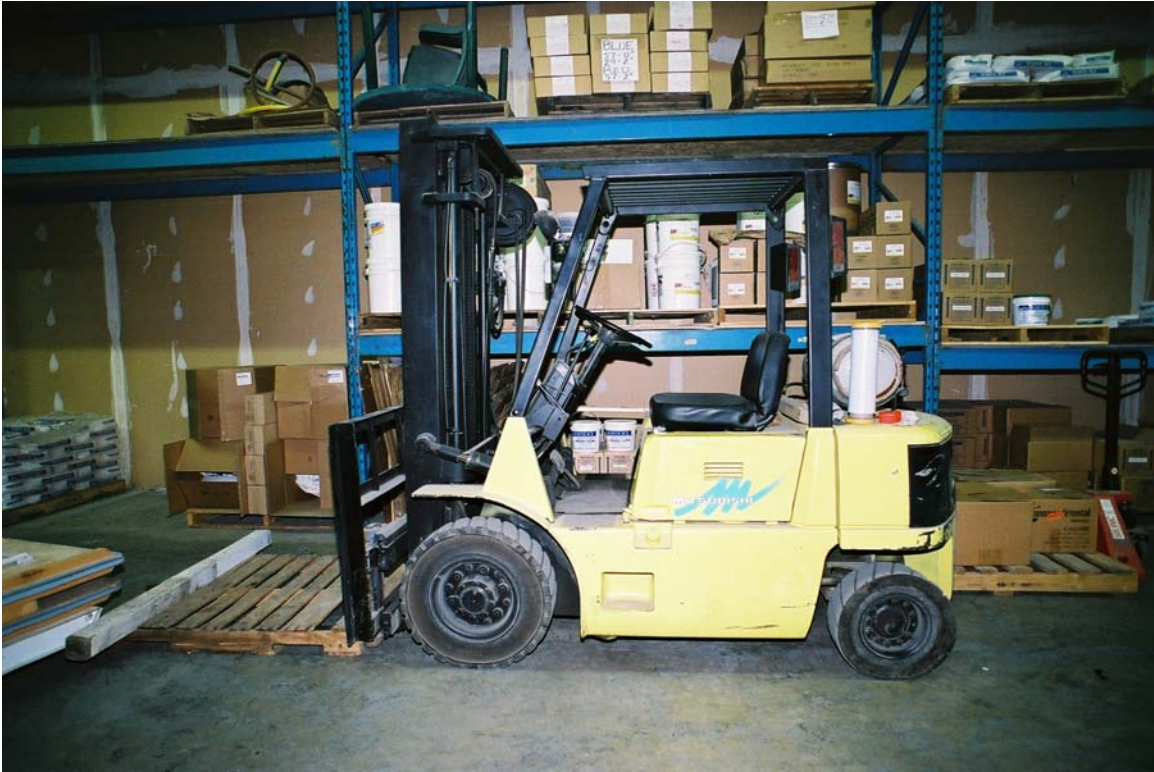
Photograph 3: Shows the Mitsubishi forklift parked on the south side of the warehouse

8.1.3 On January 4, 2008, WHSC issued stop use orders on the Mitsubishi and Komatsu forklifts.

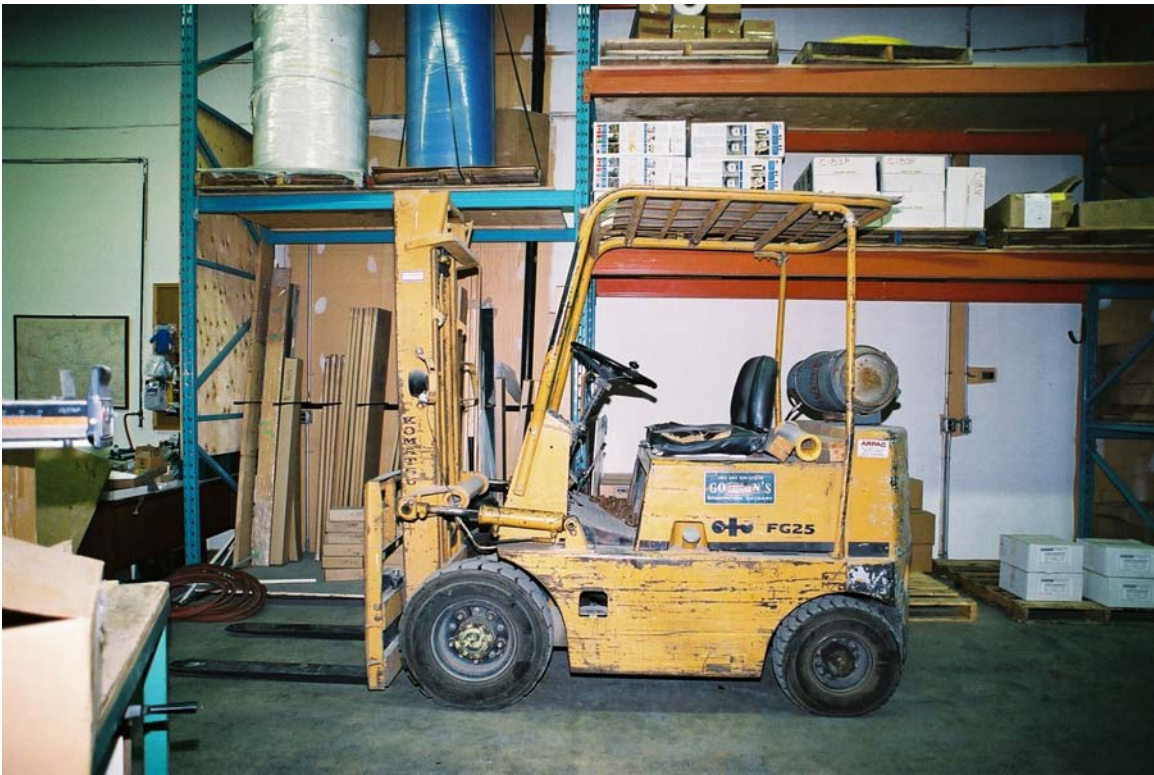
Photograph 4: Shows the Komatsu forklift parked on the north side of the warehouse

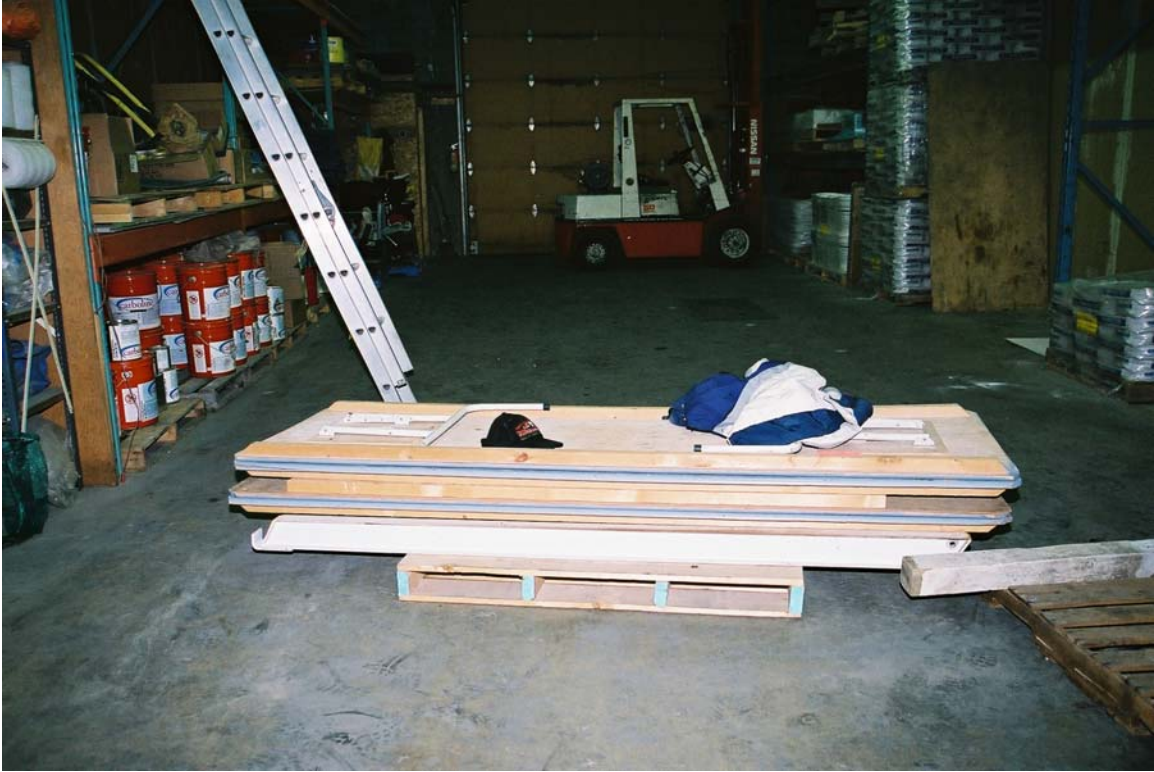
Photograph 5: Shows the folded tables on which the owner collapsed

- 6.7 The owner asked the worker to come down and sit with him on the folding tables at the centre of the warehouse.
- 6.8 At approximately 3:20 p.m., while they were sitting on the folding tables, the owner collapsed.
