Backcountry Trail Flood Rehabilitation Program

Table Mountain Trail

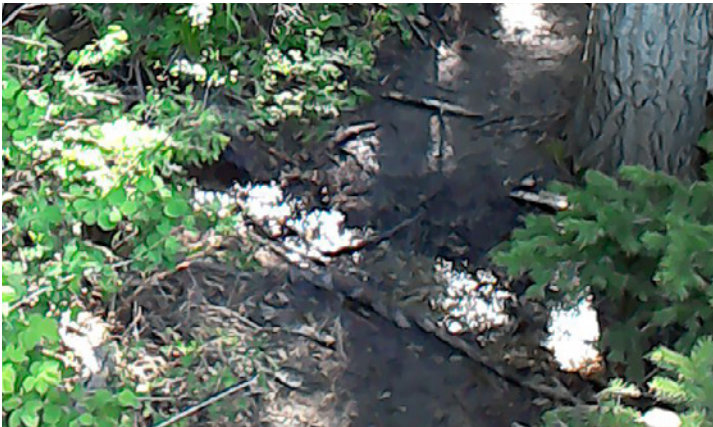
Before photo of the bridge location

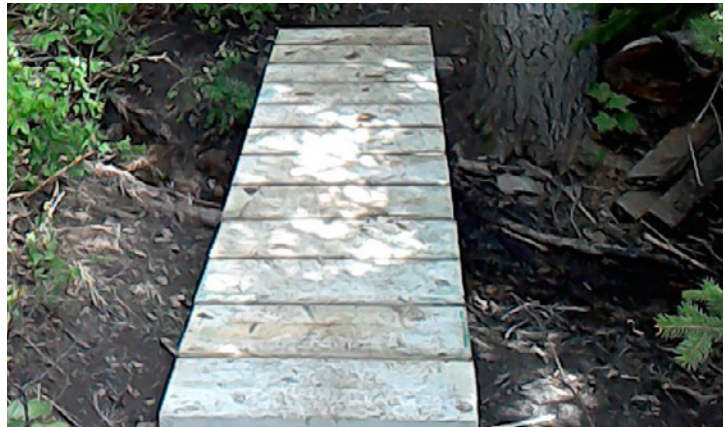
After photo of the bridge location

In June 2015, a group of volunteers and a trail crew worked together to complete this project. The volunteer day was in partnership with Ed Gregor Stewardship Days (organized by the Crowsnest Forest Stewardship Society). Volunteers also completed a reroute around a heavily eroded area, installed drainage features, built a small pedestrian bridge and stabilized the slumped slope.

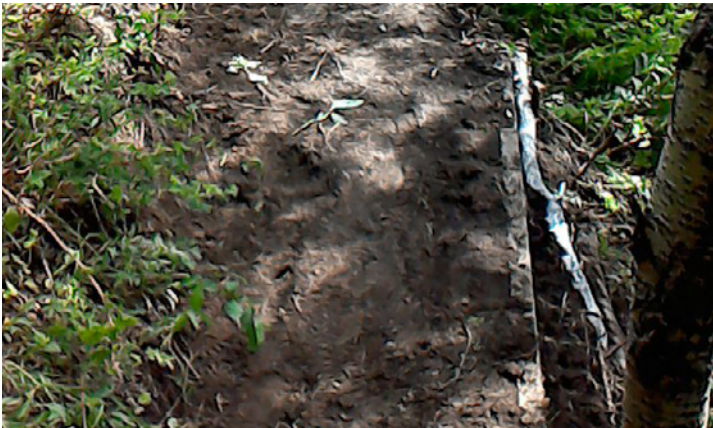
Trail stability feature of a slumped area

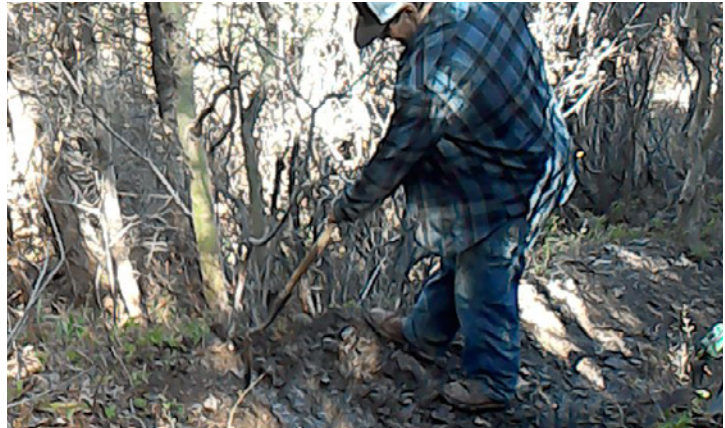
Staff completing a water drainage feature

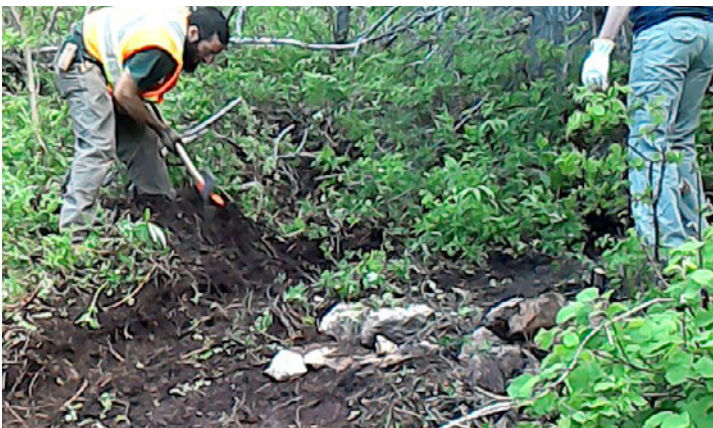
Staff and volunteers constructing steps on a reroute
