Investigation Report  
Worker Fatally Injured After Fall from Roof  
December 4, 2014

## **Incident summary**

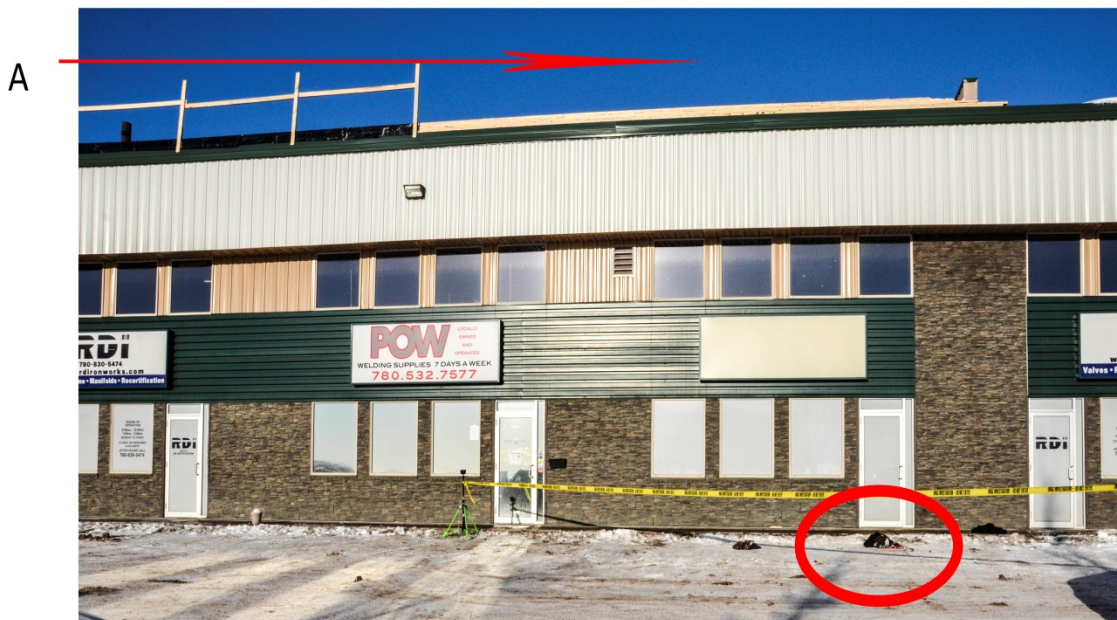
*Figure 1. A indicates the unguarded south edge of the building where the worker fell from. The red circle indicates the location where the worker landed. (Photo taken by OHS)*

The injured worker had been clearing the snow from the south edge of the roof. At some point during this task, it is believed that the worker had turned away from the edge and was walking north when the worker lost footing and fell 8.23 m to the ground below. Emergency services were contacted, and the worker was transported to the Queen Elizabeth II Hospital in Grande Prairie where the worker later died from injuries received in the fall.

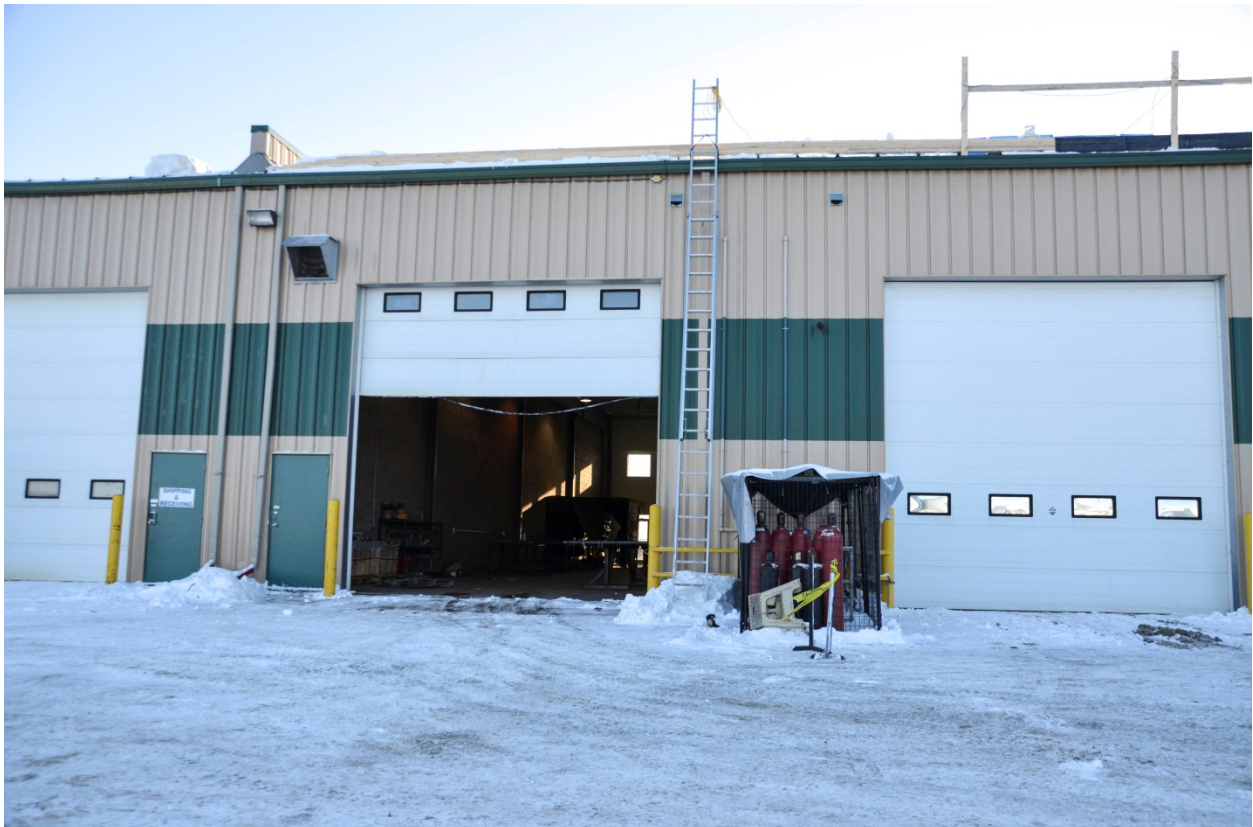
Figure 2. This is the north side of the building and shows the unguarded edge that measures 13.11 m in length. (Photo taken by OHS)

Heritage Commercial Roofing started the re-roofing job on the commercial building in early November 2014. The workers started the re-roofing at the west end of the building. The workers built and installed wooden guardrails along the south, west and north edges of the building. There were two 13.11 m sections on the north and south sides that did not have any guard rails installed. The building measured 8.23 m from the roof edge to location where the worker fell to the ground.

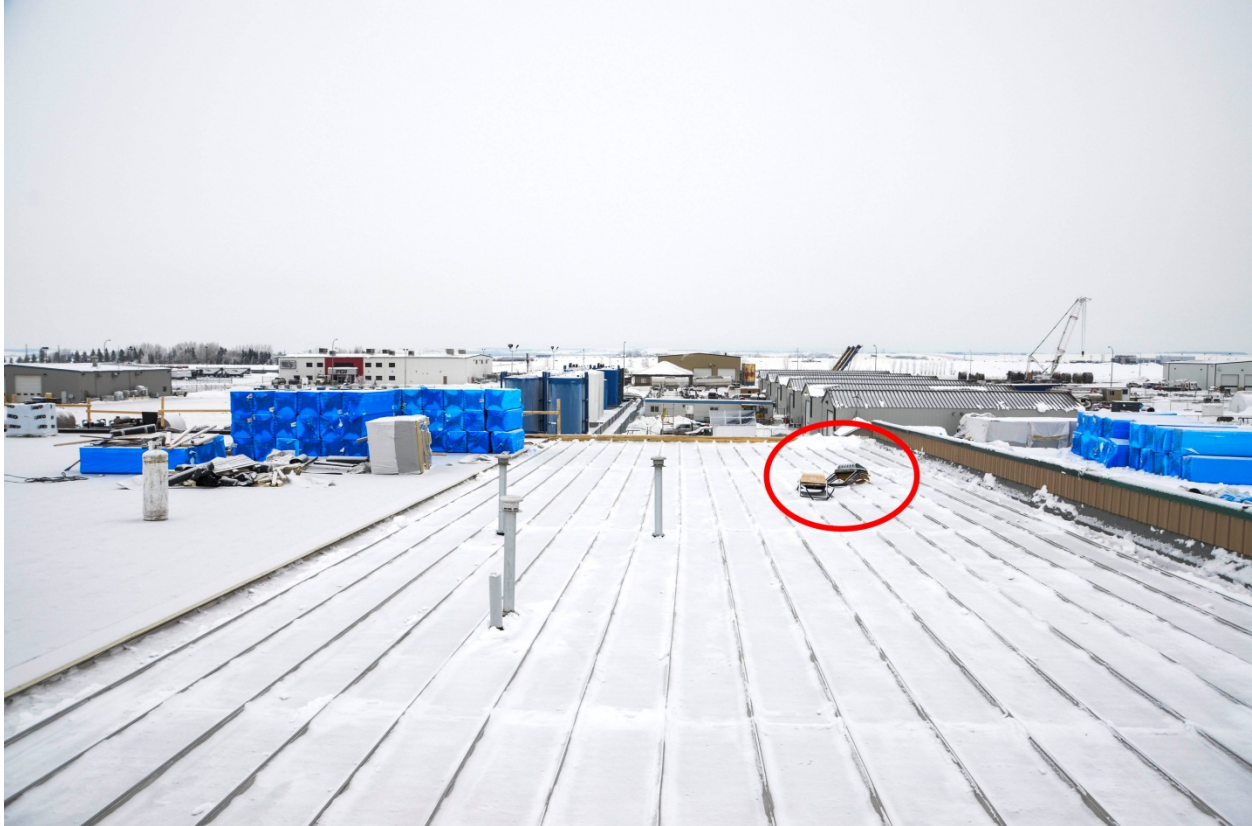
*Figure 3. This is looking to the north side of the building. The red circle indicates the shovels that the workers were using to remove the snow from the tin roof. This was not the original location of the shovels; they were stacked together after the incident. (Photo taken by OHS)*

The task for the six workers on the date of the incident was to clear the snow from the tin roof in preparation for this section to be re-roofed. The work started at approximately 8:30 a.m. The workers would each clear a row of the roof from one end to the other, pushing the snow off the north end of the roof. Both the south and north sections of the roof were not guarded and the workers did not have any fall protection system in place.

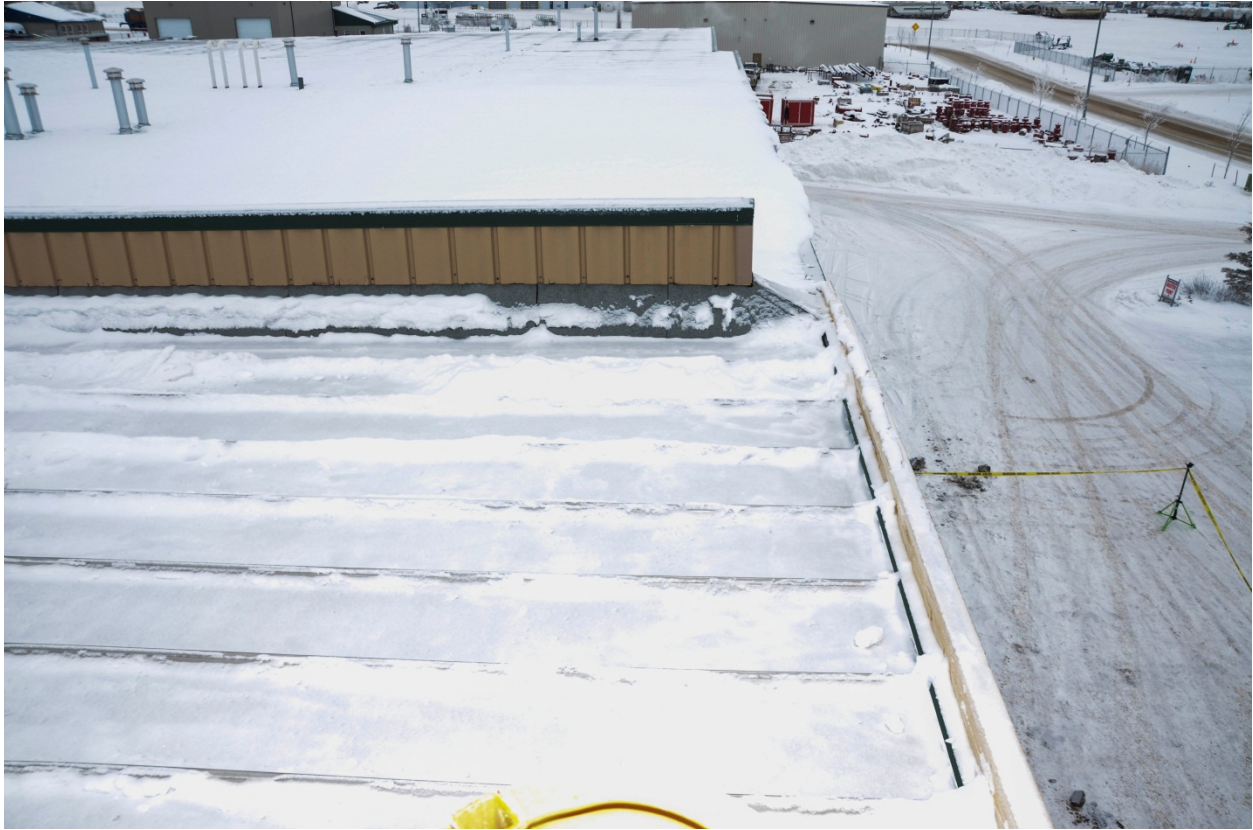
*Figure 4. This is the south edge of the roof top where the worker fell from. The distance from the parapet to the ground was measured at 8.23 m. (Photo taken by OHS)*
