Worker fatally injured in trench collapse

September 1, 2020

This document reports the Alberta Occupational Health and Safety (OHS) investigation of a fatal incident that occurred in September 2020. It begins with a short summary of what happened. The rest of the report covers this same information in greater detail.

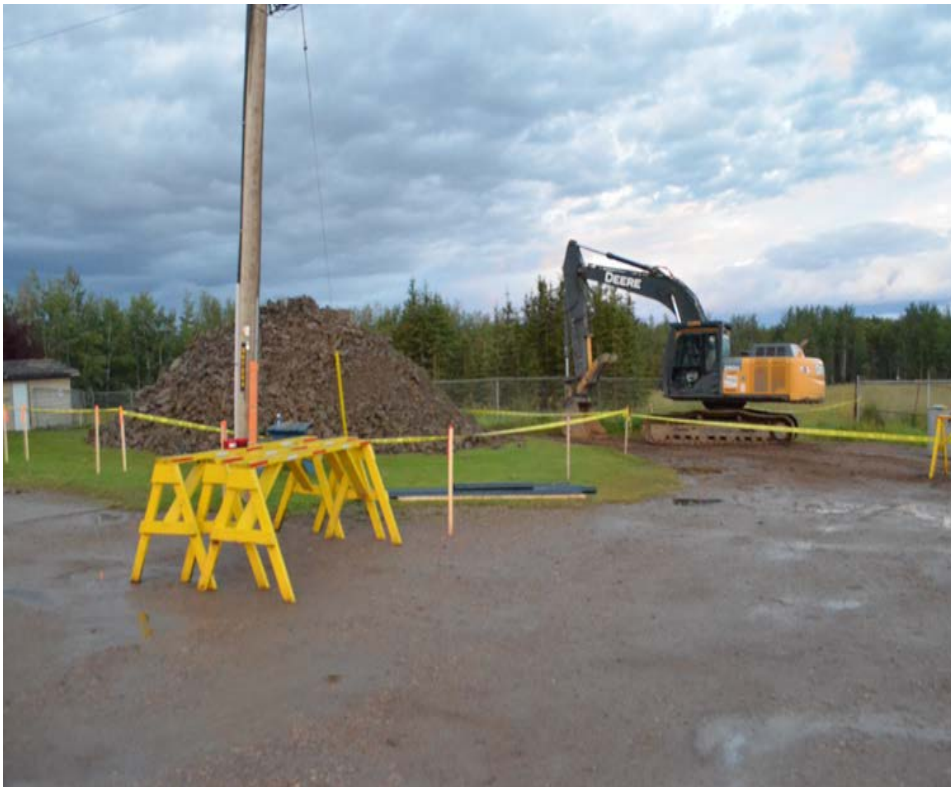
The excavator (Figure 1), a John Deere 250 G mid-size excavator, was used to dig the excavation and place the septic tank into the excavation. It had the net power of 140 kilowatts (kW), maximum digging depth of 7.61 metres (m) and operating weight of 25 436 kilograms (kg).

Figure 1. The excavator was owned and operated by Pinnacle Services.

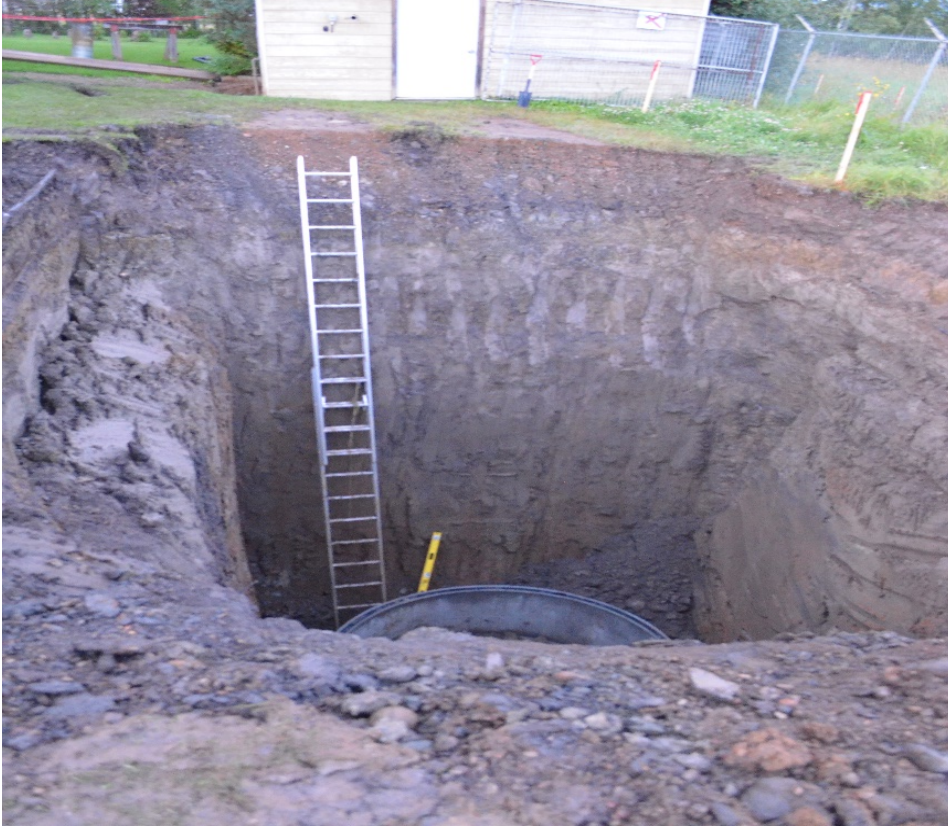
The ladder (Figure 2), a Louisville aluminum two-section extension ladder, was placed into the north side of the excavation. The Northern Services workers used the ladder to enter and exit the excavation. The ladder was extended to approximately 6.1 m. The ladder had a weight capacity of 102.05 kg and maximum extension length of 7.3 m.

Figure 2. The ladder that the two labourers used to access the excavation.

A ladder was placed into the excavation and the Plumber and Apprentice Plumber utilized the ladder to go down into the excavation.

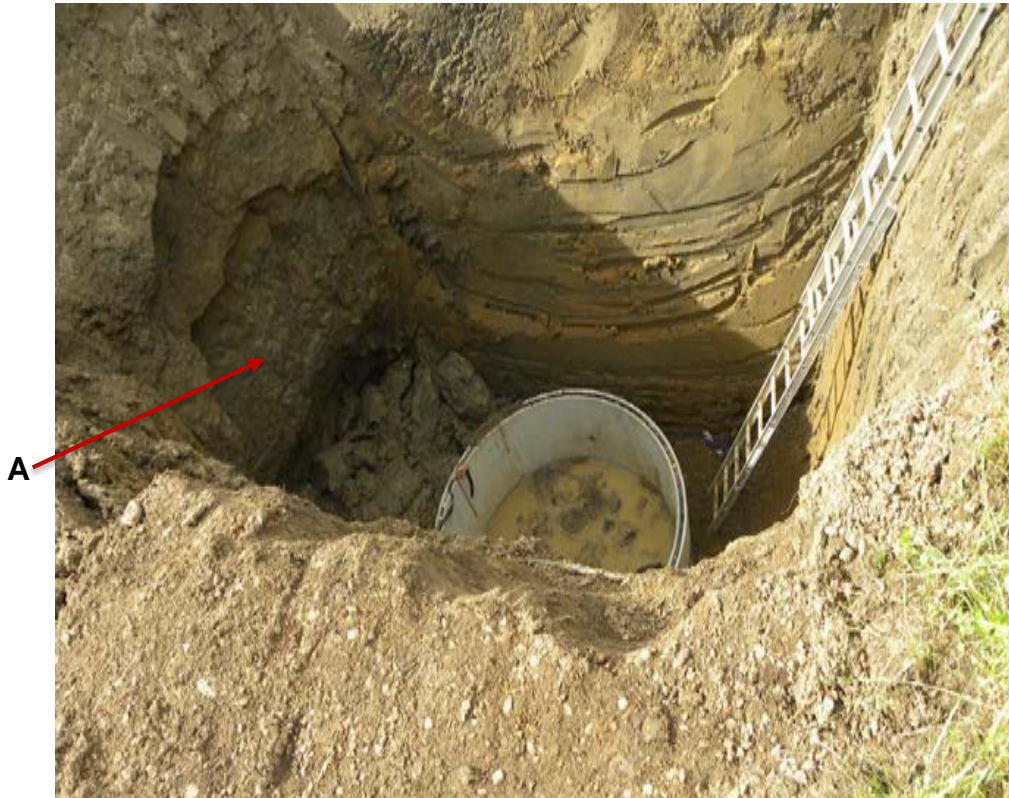
The excavation measured approximately 4.6 m wide from the west to east edge, 7.3 m from south to north edge and 6.7 m deep (Figure 3). The excavation exhibited constant sloughing from the edges throughout the OHS investigation. Initial sloughing of the excavation occurred at the south side of the excavation (Figure 3A).

Figure 3. Looking into the excavation from the east side facing west. The picture was taken by the safety person at Tolko on September 1, 2020.

A. The south side of the excavation where the sloughing occurred.

The Operator dug an excavation that measured approximately 4.6 m wide, 7.3 m long and 6.7 m deep with straight cuts on all four sides, using the excavator. It was cloudy with sporadic rain showers throughout the day. The soil in the excavation was stiff in consistency and compacted. When the excavation was completed, the Operator stated to the Supervisor that there should be cutbacks on the sides of the excavation.

At approximately 11:20 a.m., the Apprentice Plumber was standing on the north side of the septic tank base at the bottom of the excavation. The Plumber bent over the base of the septic tank while installing sealing tape around the rim. The Plumber's back was facing the south side of the excavation. A portion of the south wall of the excavation gave way landing on the Plumber, pinning the worker against the top rim of the septic tank base.

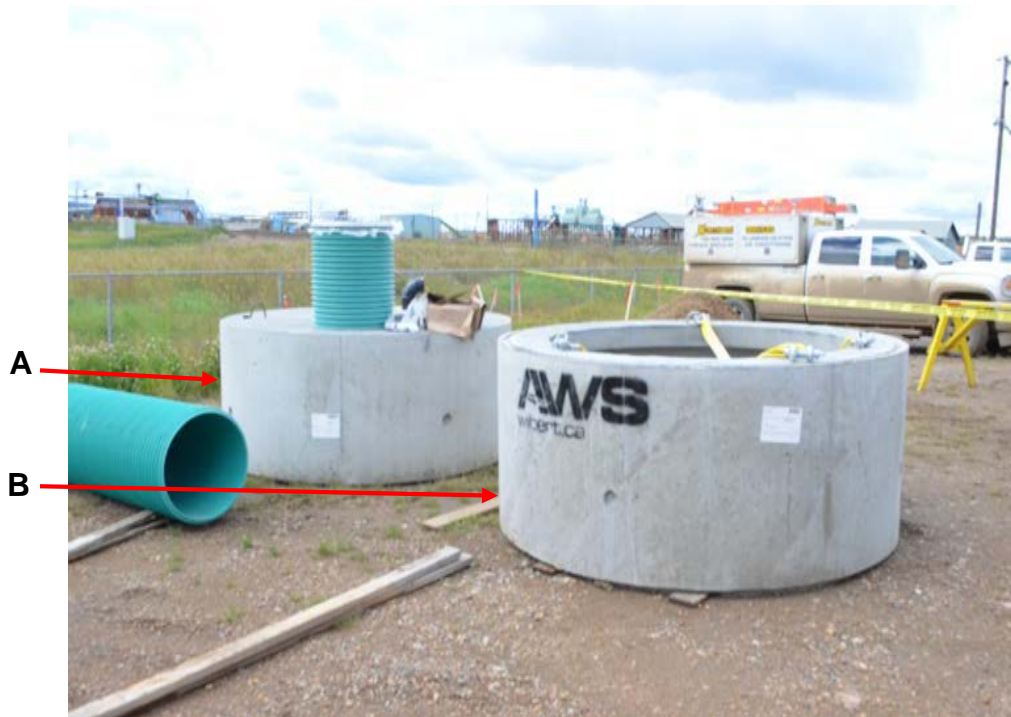
The septic tank (Figure 4), a 2300 gallon 8 foot diameter GMH holding tank, was manufactured by AWS Alberta Wilbert Sales located in Alberta. The septic tank came in three sections. The top section (Figure 4A) measured 91 centimeters (cm) high and 2.4 m wide and weighed 3039 kg. The middle section (Figure 4B) measured 91cm high and 2.4 m wide and weighed 3039 kg. The base section measured 91 cm high and 2.4 m wide.

Figure 4. The top and middle sections of the septic tank were located approximately 7 m from the excavation.

- A. The top section of the septic tank.
- B. The middle section had the slings attached in preparation to attach it to the excavator. It would have been the next section to be placed in the excavation.
