Investigation Report

Fatality - Worker Drowns When Riding Lawnmower Slides Into Pond

August 3, 2017

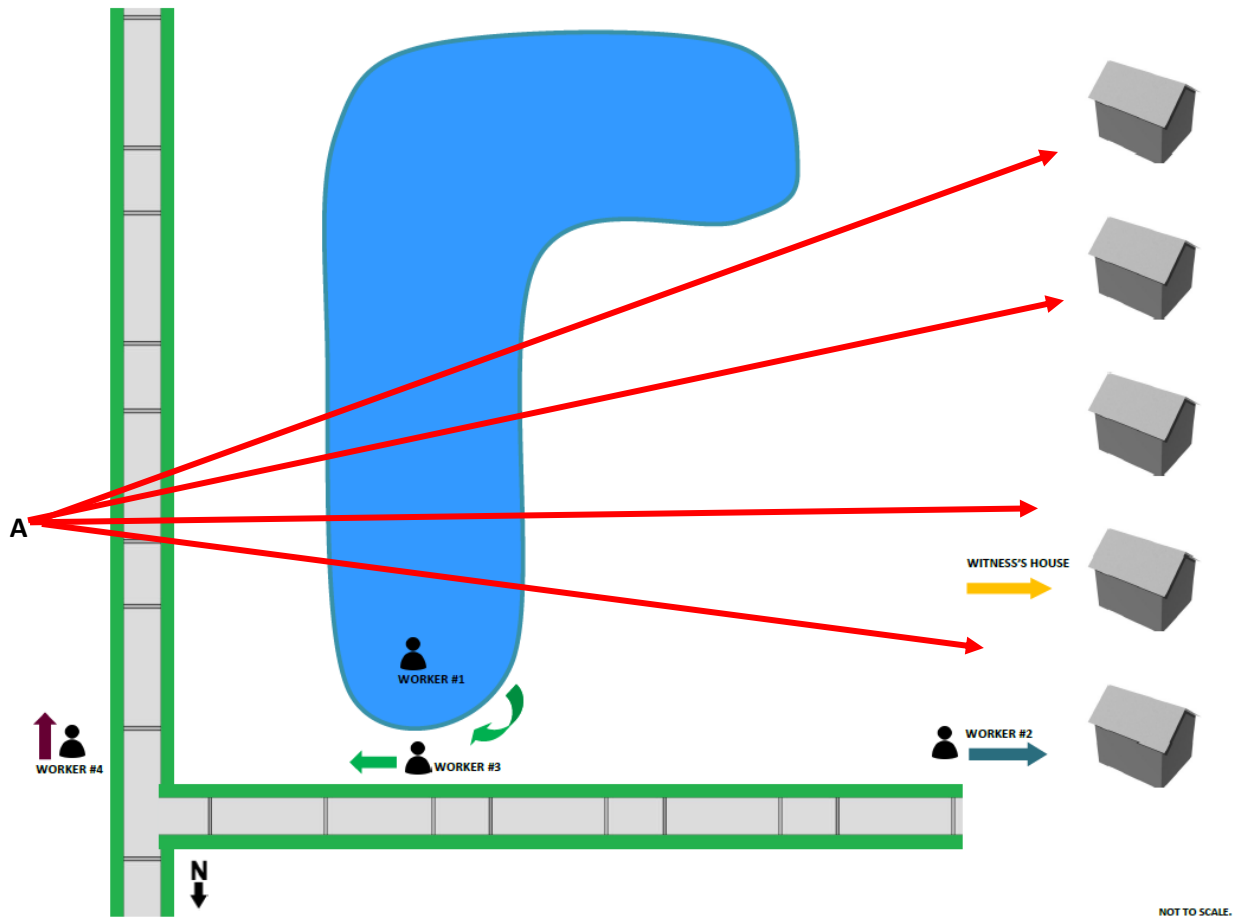
Figure 1. Map of the incident site noting locations of general labourers 1, 2, 3 and 4 in relation to the pond. The arrow on each worker indicates in which direction they were going when the incident occurred.

A. Private residences that backed onto the Town's property; general labourer 2 ran to one residence to ask them to call 911.

When general labourer 2 saw general labourer 3 waving to them, general labourer 2 rode their lawnmower over to the north end of the pond. General labourer 2 then noticed general labourer 1's riding lawnmower upside down in the pond. Together general labourer 2 and 3 attempted to flip general labourer 1's riding lawnmower on to its side. When their attempts to lift the riding lawnmower were unsuccessful, general labourer 2 ran over to a private residence and asked them to call 911. General labourer 2 then returned to the north end of the pond (Figure 1).

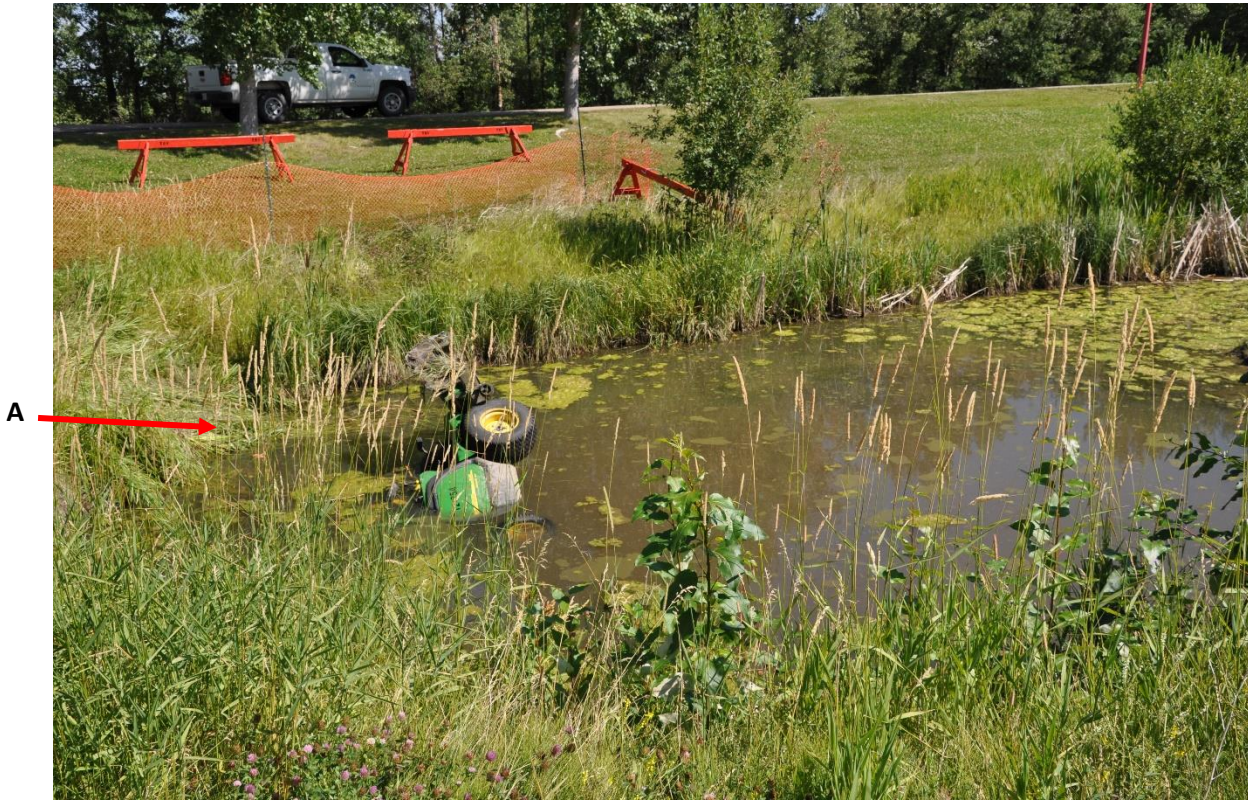
Figure 2. North end of the pond looking west.

A. Where the riding lawnmower operated by general labourer 1 slid into the pond.

General labourer 4 was on the northwest opposite side of the sidewalk from the pond when general labourer 4 noticed that two of the riding lawnmowers were parked on the side of the north sidewalk. General labourer 4 continued to mow when they noticed general labourer 2 was talking to a person in one of the nearby private residences. As general labourer 4 was riding towards general labourers 2 and 3, general labourer 4 noted general labourer 2 was running back to the north side of the pond. General labourer 3 waved to general labourer 4 to come over, and general labourer 4 noticed the riding lawnmower in the pond (Figure 2).

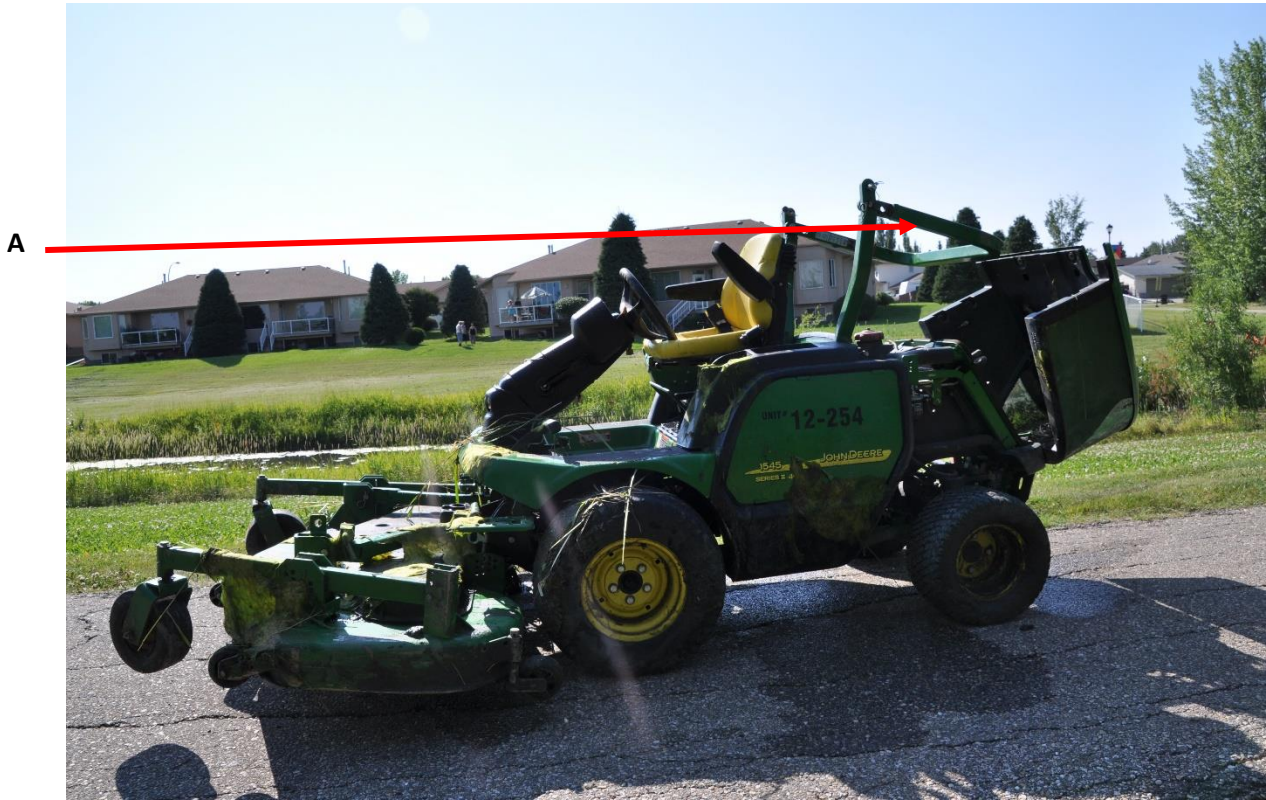
Figure 3. Left side of the riding lawnmower.

A. ROPS in the folded down position.

The riding lawnmower that general labourer 1 was operating was a cabless John Deere 1545 Series II, 4WD, #12-254 with a 72 inch mowing deck (Figure 3). It was purchased new by the Town from MMD Sales Ltd. in 2012. It weighed 570 kilograms (kg) without mower or fuel. The riding lawnmower deck was a 183 centimetres (cm) cutting width commercial side discharge. The riding lawnmower did have a rollover protection system (ROPS) and a seat belt. The operator's manual stated the operator should never operate equipment with the ROPS folded and seat belt on. If the ROPS were folded down, the operator was to ensure the seat belt was off to allow the operator to eject from the equipment during a rollover. The seat belt was required to be secured around the operator when the ROPS were up (Figure 3).

When the riding lawnmower was pulled from the pond, the ROPS were found locked down (Figures 3, 4 and 5).

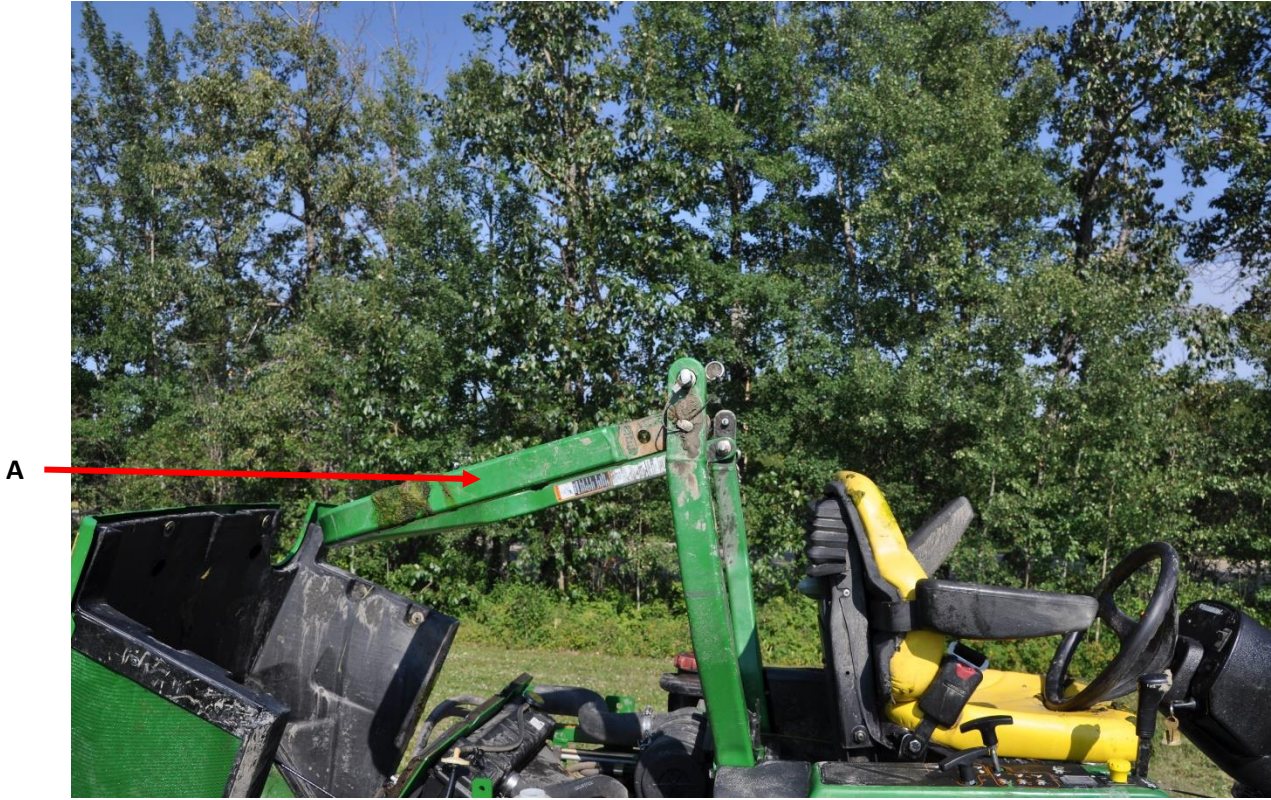
*Figure 4. Right side of the riding lawnmower.*

*A. Closer view of the ROPS in the folded down position.*

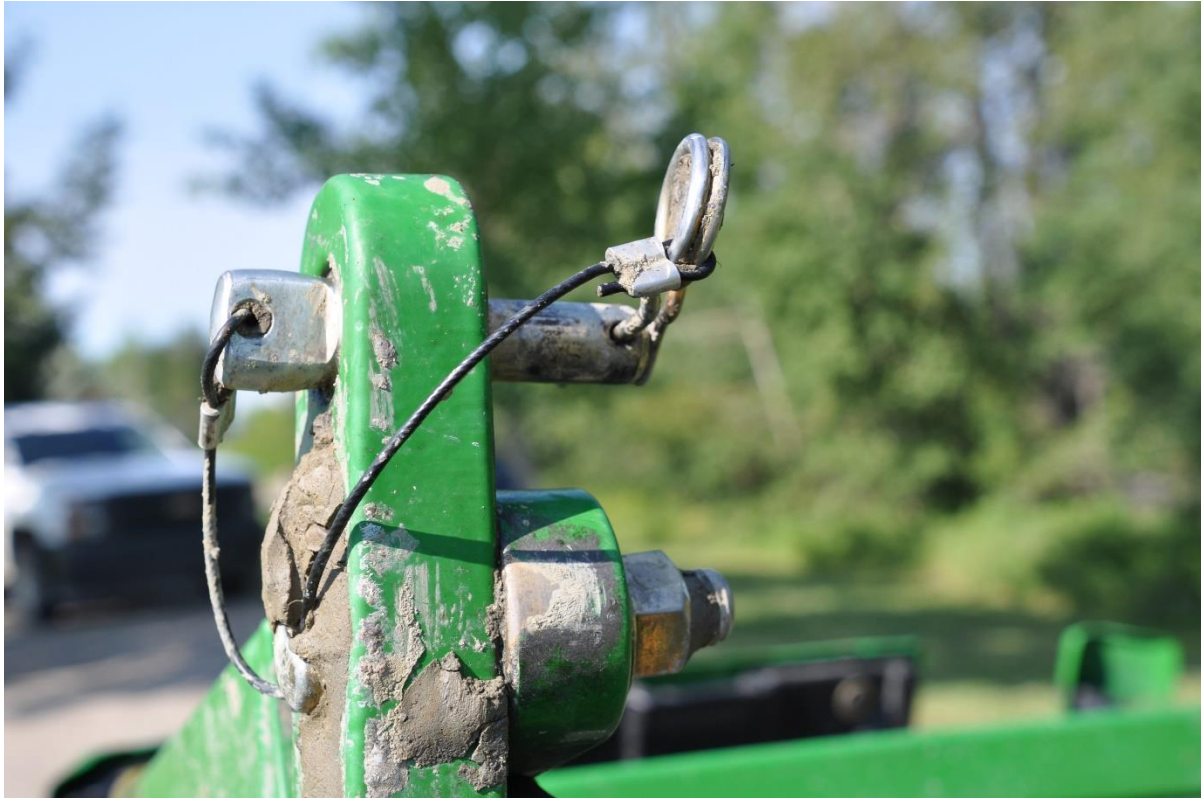
*Figure 5. Close up of the locked pin holding the ROPS in the folded down position.*

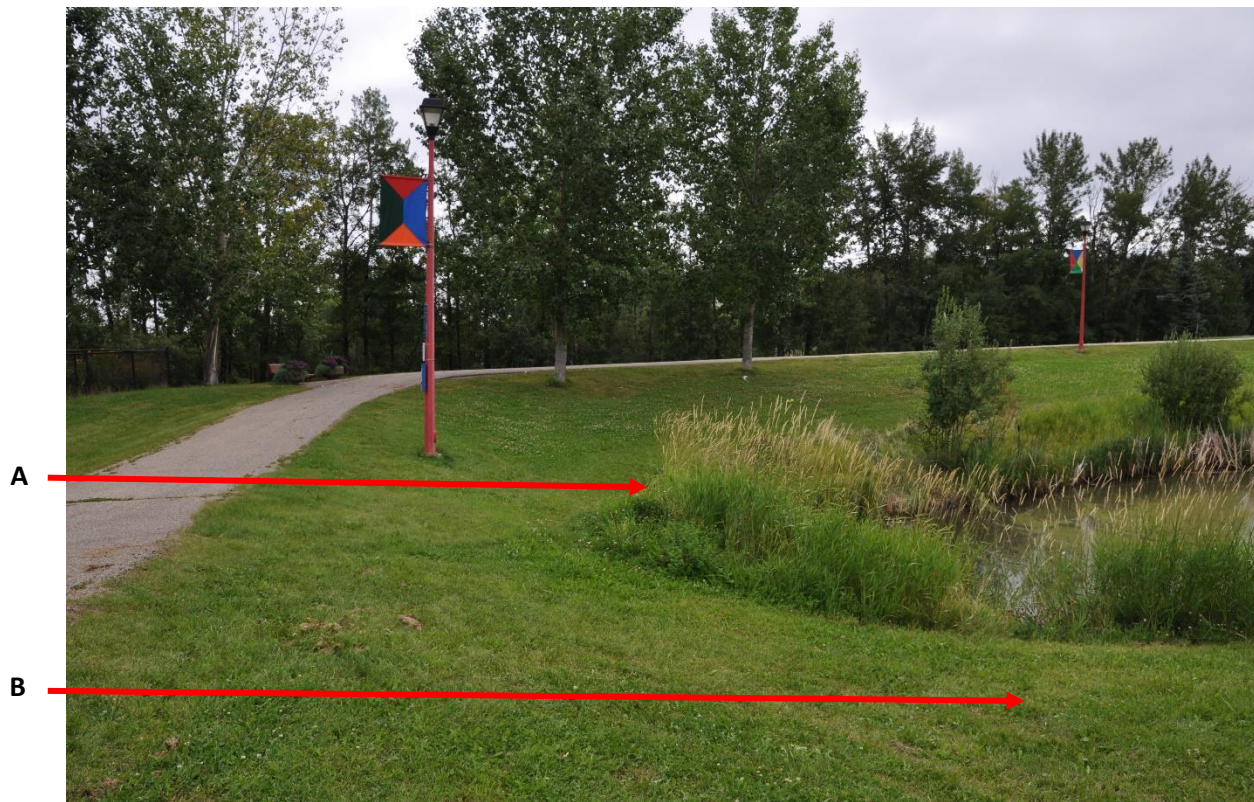
*Figure 6. Investigation photograph of incident location looking west.*

- A. Slope of 23.81% where the riding lawnmower slid into the pond and flipped.*
- B. General labourer 1 was travelling north and rounding the pond going west when it slid and rolled into it.*

The pond, built on February 24, 1984, was 211.28 metres (m) in length with a width of 24.12 m at the centre. The average depth of the pond was 1.5 m and at the point of contact approximately 1.1 m. The slope angles were north 23.81% over 9.67 m, northeast 14.20% over 20.41 m and northwest 18.41 m over 13.6 m. The pond was lined with clay and natural vegetation with a volume of 7 650 449 litres (L).
