Worker Run Over by Tractor Trailer

Type of Incident: Fatality

Date of Incident: 18 August, 2011

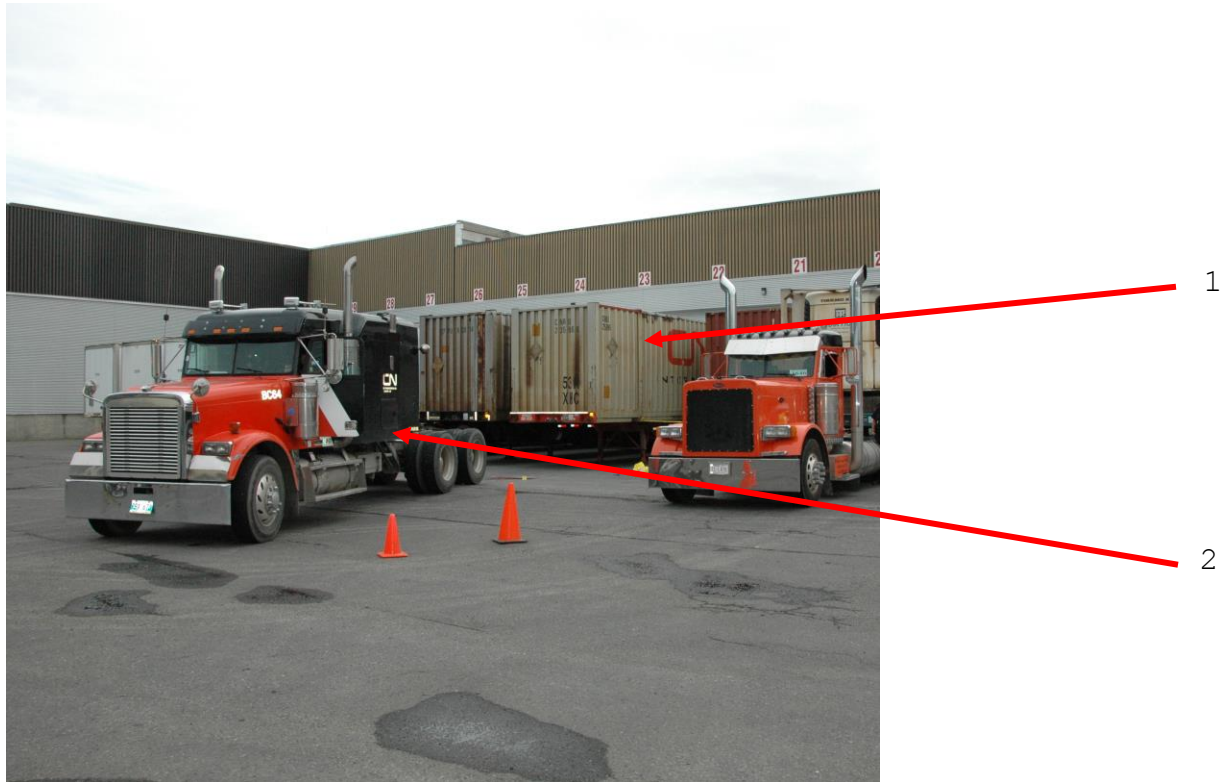
Photograph 1 – Shows the receiving dock where the incident occurred.

1. Shows the trailer involved in the incident
2. Shows the tractor involved in the incident

- 4.1 The incident occurred at the receiving dock (dock) of the Western Grocers Distribution Centre located at 6810 40th St SE. (See Attachment A – Map and Attachment B – Photograph - 1)

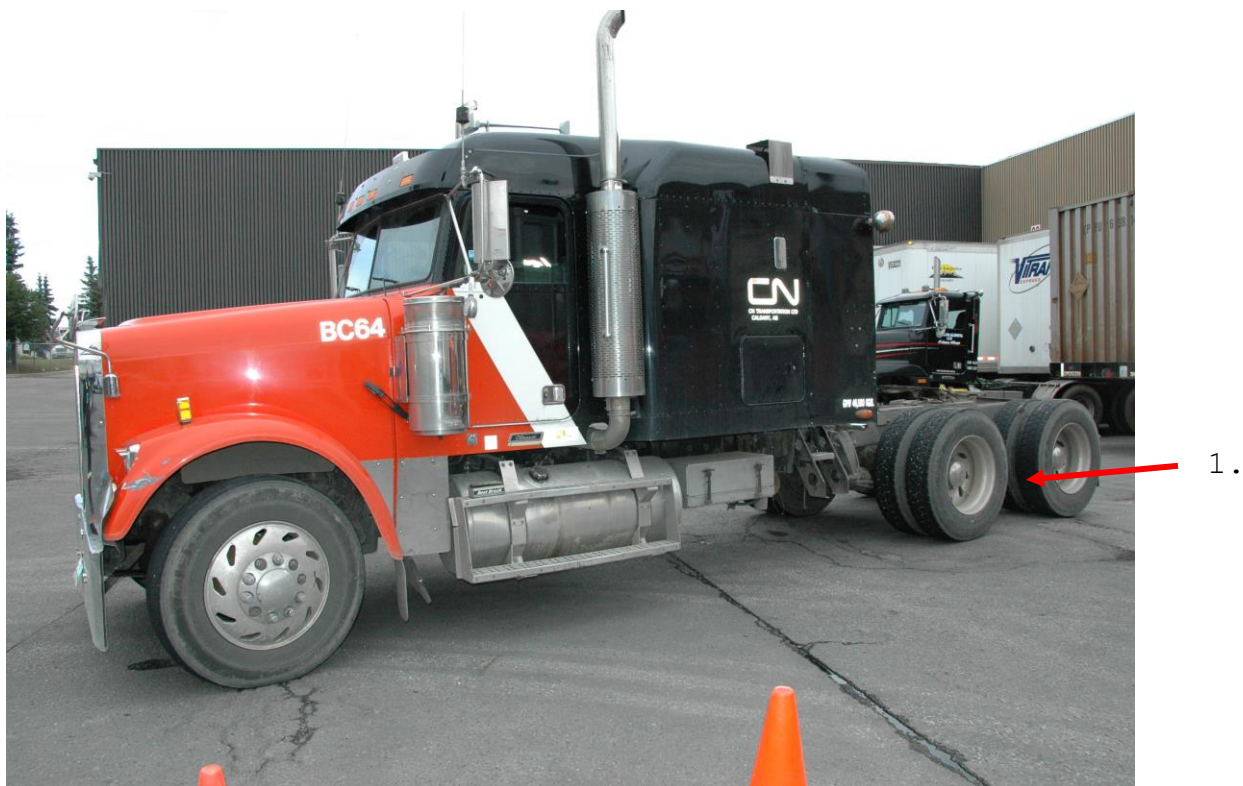
Photograph 2 – Shows the tractor that was involved in the incident.

1. Shows the space between second and third axles.

- 5.1.1 2003 Freightliner “Classic” Tractor, (tractor) Gross Vehicle Weight of 46,500 kg, CN unit number BC64. The tractor has three axles, with approximately 43 cm between the tires of the second and third axles. The tractor is approximately 6.89 meters from the first axle to the third axle. (See Attachment B – Photographs - 2 and 3)
- 5.1.2 Tectran Glad Hand Lock, Model No. 1011LK. Glad hand locks are used to immobilize a trailer by acting as a harness around the air intake valve of the emergency brake system. The glad hand lock must be removed before the air line can be connected to release the trailer emergency brake. (See Attachment B – Photographs – 4 and 5)
- 5.1.3 53 foot Sea-Can type intermodal trailer (trailer) on a Max-Atlas chassis. The air intake valve is located on the front of the chassis. (See Attachment B – Photographs – 1 and 5)

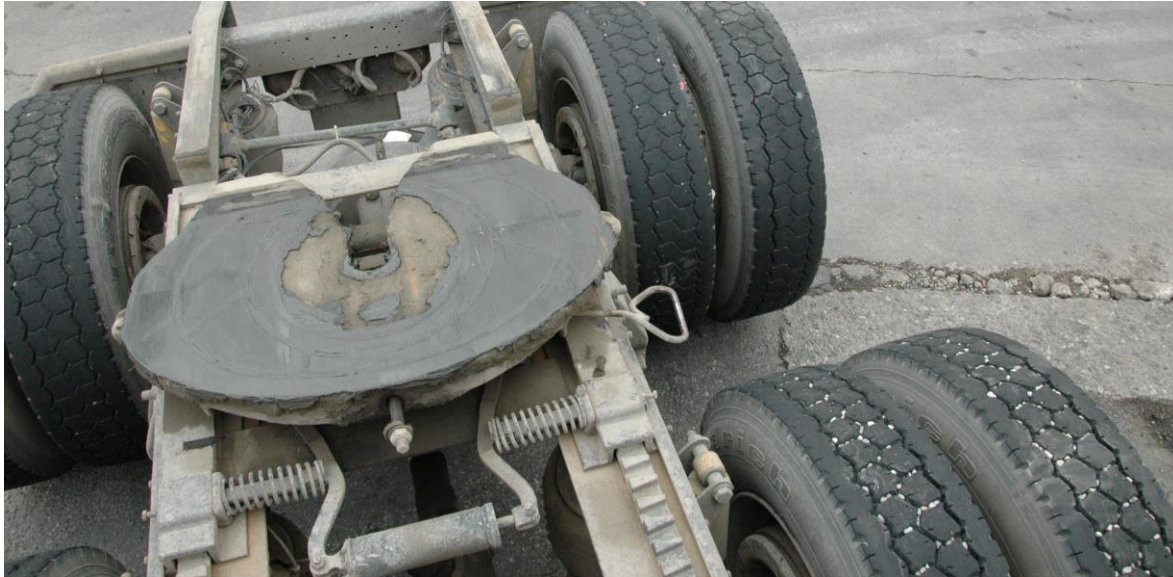
Photograph 3 – Shows the back of the tractor unit and the space between the second and third axles.

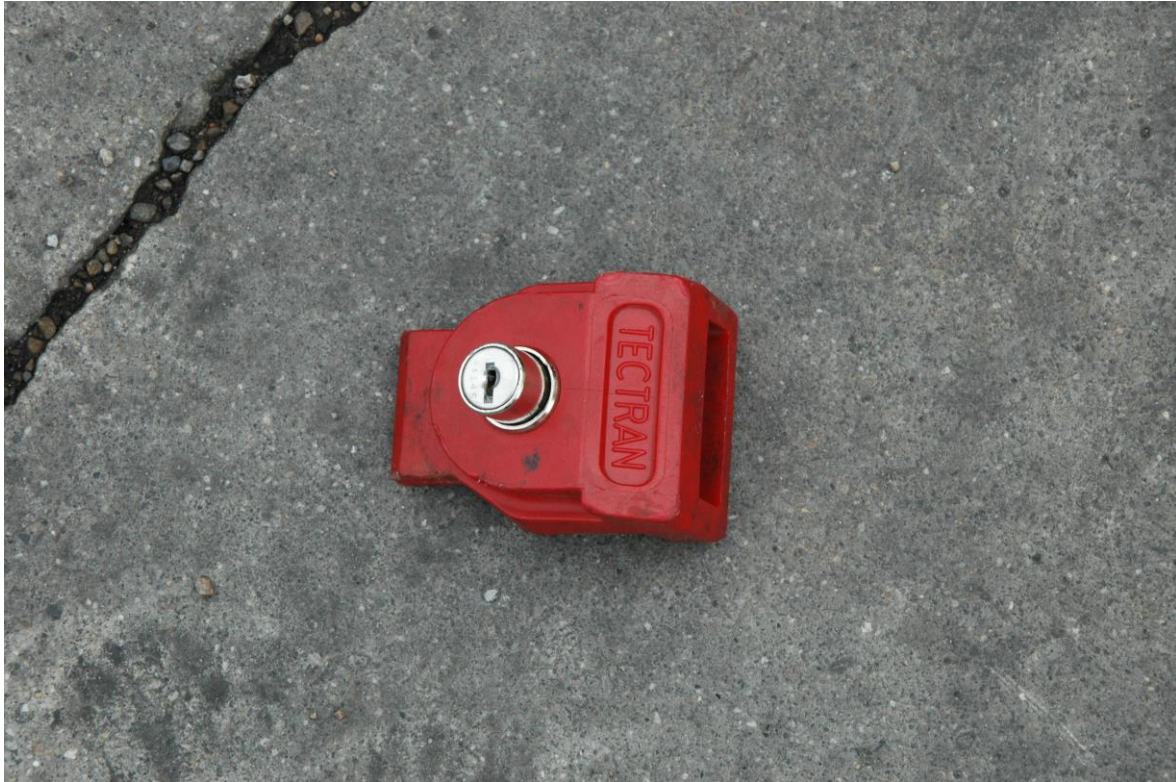
- 5.2.4 A second glad hand lock was found near the workers' (***** ***) right hand.
- 5.2.5 There were 11 lights attached to the dock above the doors.
- 5.2.6 There were 29 overhead doors on the dock; trailers were positioned at 18 of the doors.
- 5.2.7 The asphalt surface of the dock measured approximately 50 X 100 meters.

Photograph 4 – Shows the glad hand lock found near the worker.

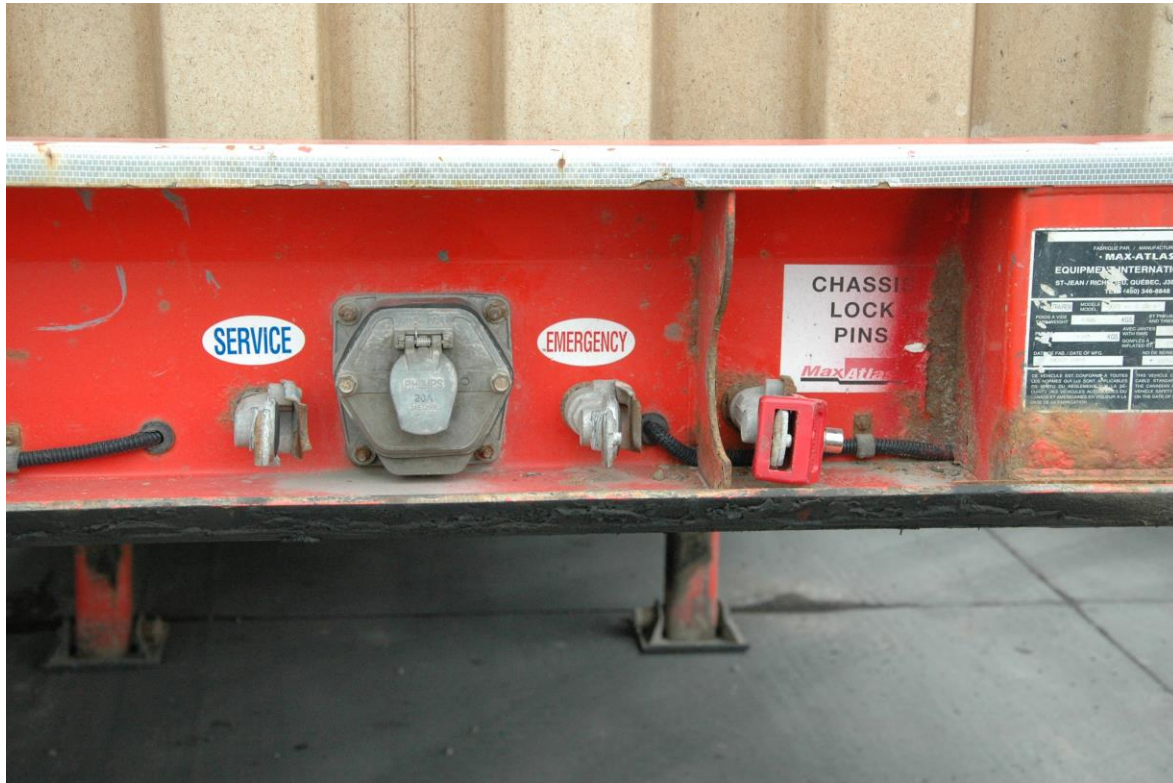
- 5.2.1 The worker (***** ***) was not wearing a reflective vest at the time of the incident.
- 5.2.2 Weather at the time of the incident was overcast with intermittent rain. The temperature was approximately 8.5 C.
- 5.2.3 The glad hand lock on the trailer had been placed on the air line. It was not locked in position.

Photograph 5 – Shows the unlocked glad hand lock on the airline of the trailer involved in the incident.

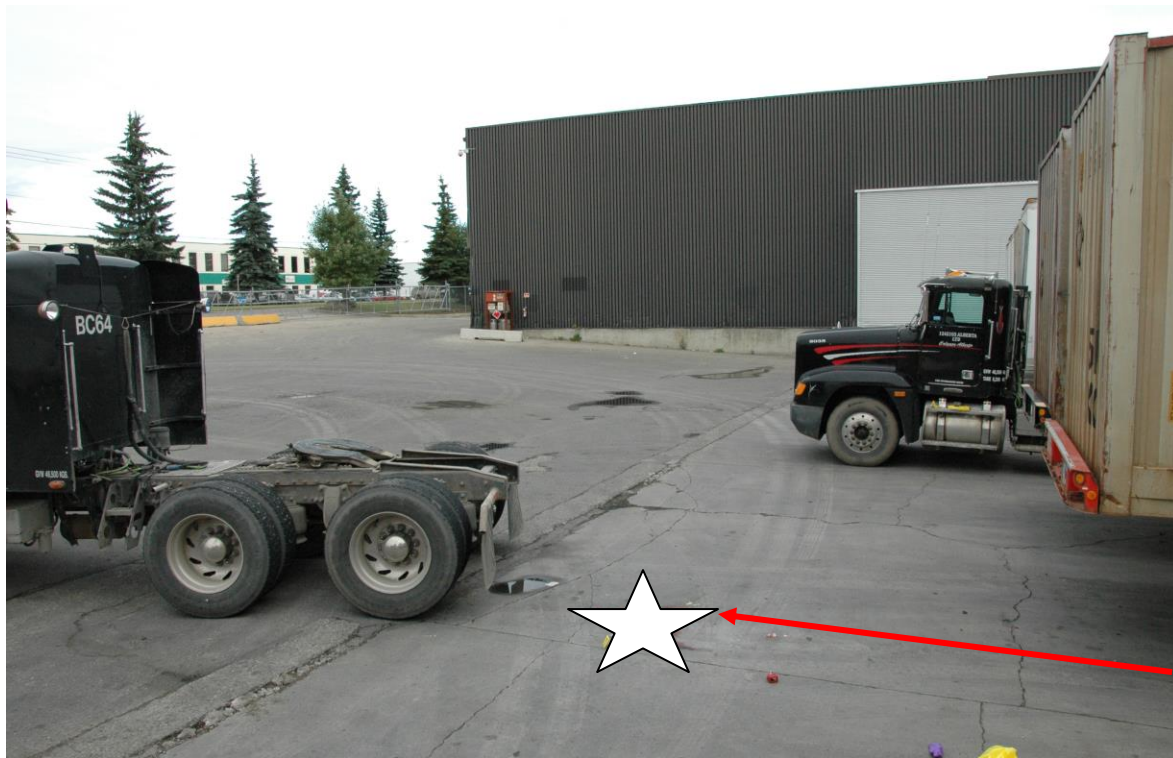
- 6.1.6 The tractor driver (***** ***) heard a scream as he pulled forward, stopped and got out of the tractor. He saw the worker (***** ***) on the ground between the tractor and the trailer. The back end of the tractor was approximately 4.1 meters from the front of the trailer (See Attachment B – Photograph - 6).

Photograph 6 – Shows the location of the tractor after it struck the worker.

1. Shows the approximate location of the worker after he was struck.
