Fatality Investigation Report

Worker Crushed
February 16, 2013

Incident summary

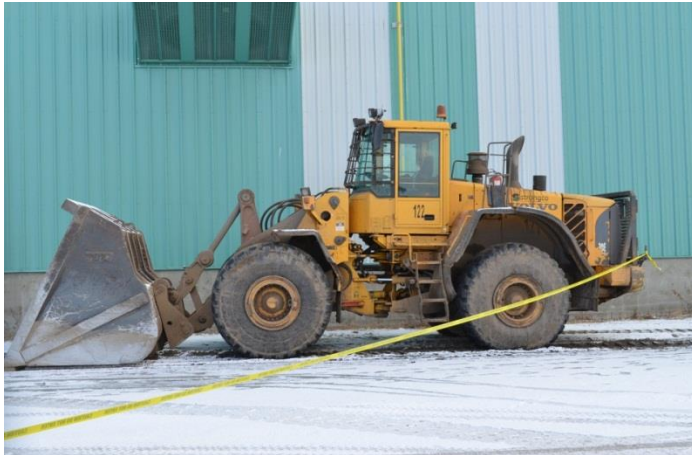
The Loader (loader) was manufactured in 2004 and had 3871 hours on the meter.

Figure 1. Side view of the loader that was involved in the February 16, 2013 incident.

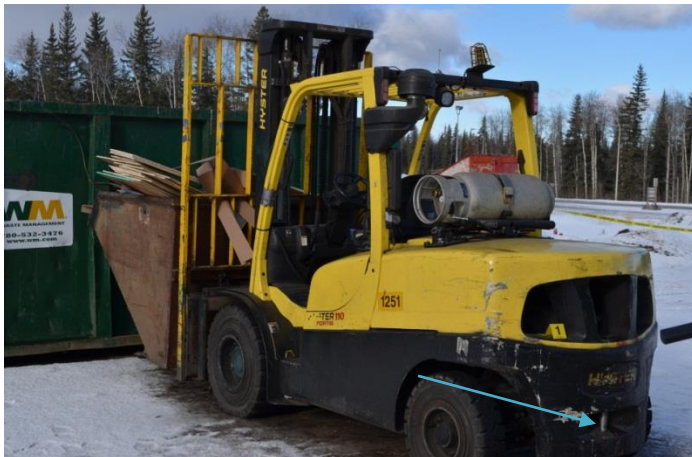
Figure 2. The blue arrow shows the area in which the Loader Operator was hooking the cable to the forklift at the time of the incident.

The forklift operator retrieved the cable from the back of the loader and started to hook the cable to the tow hook on the back of the forklift, but was having trouble securing it properly. The loader operator took the cable from the forklift and proceeded to show him how he hooks the cable to the forklift. The forklift operator stood up and stepped to the side and saw the loader rolling back at them. The loader contacted the loader operator on his left side and pinned him between the loader and the forklift.
