Workplace Health and Safety Fatality Report

WORKER ENTANGLED IN MACHINERY'S ROTATING SHAFT

Date of Incident: October 12, 2007

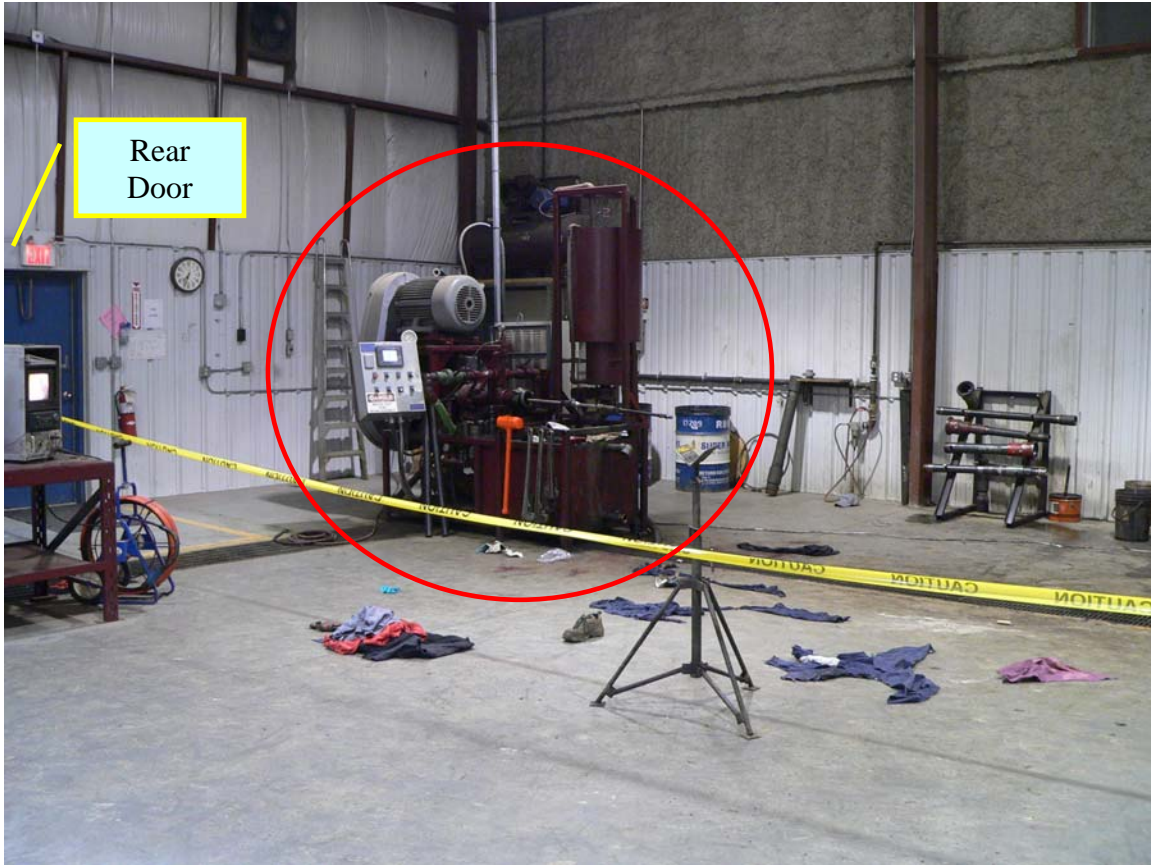
Photograph #1 Shows the progressive cavity pump test bench located in the northeast corner of the pump shop (circled in red).

Test Bench Specifications: Maximum speed 300 revolutions per minute (rpm) maximum pressure 3000 pounds per square inch (psi), maximum torque 1330 ft-lbs. All components are assembled by Corlac Equipment Ltd. The bench consisted of three parts. (Attachment "C" Photographs #1, 2)

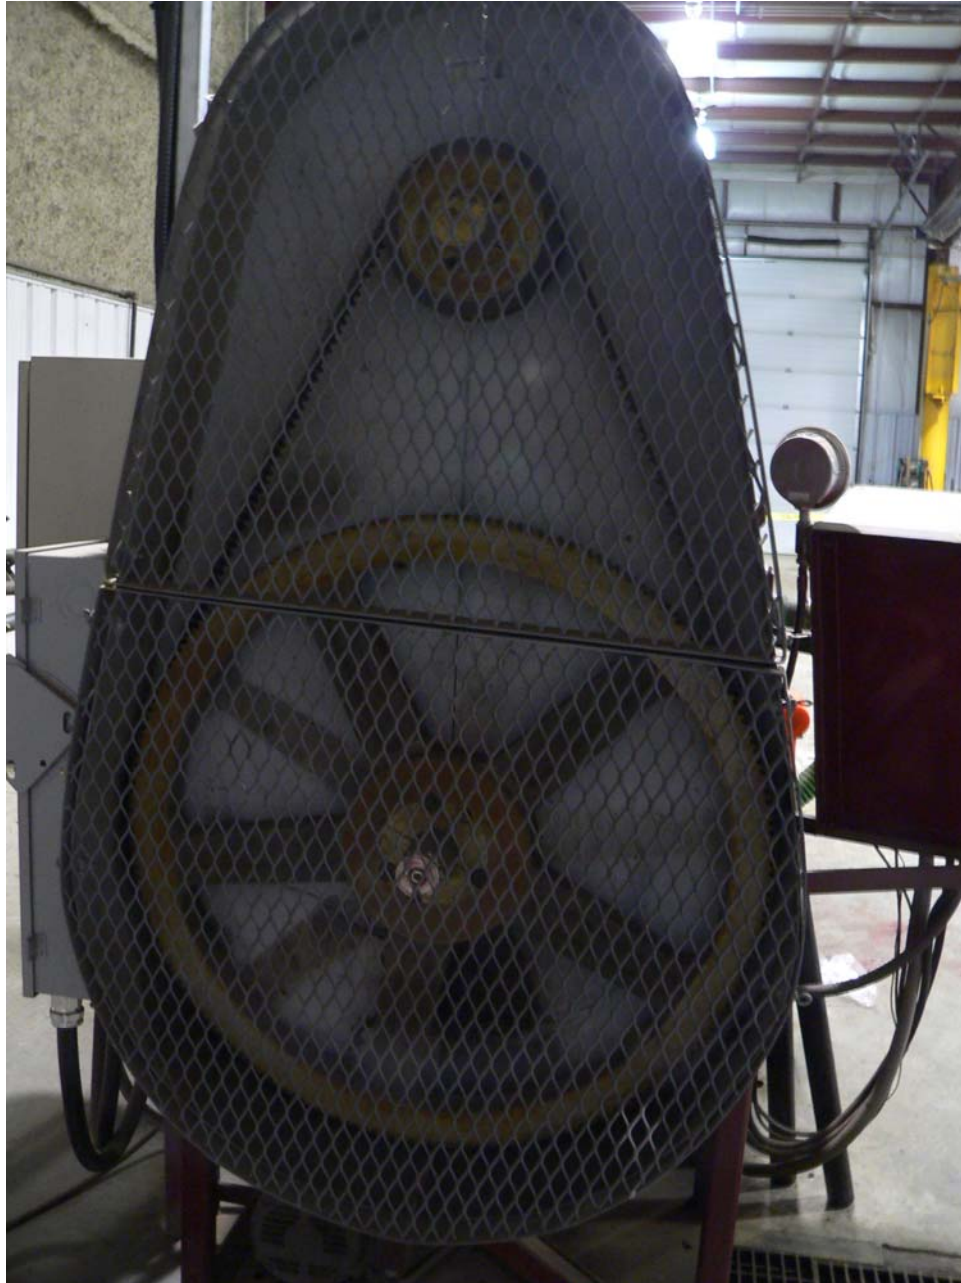
Photograph #5 Shows the right side of the progressive cavity test bench. The flywheel enables the polish rod to rotate at the maximum 300 revolutions per minute (rpm) and 1330 ft-lbs of torque.

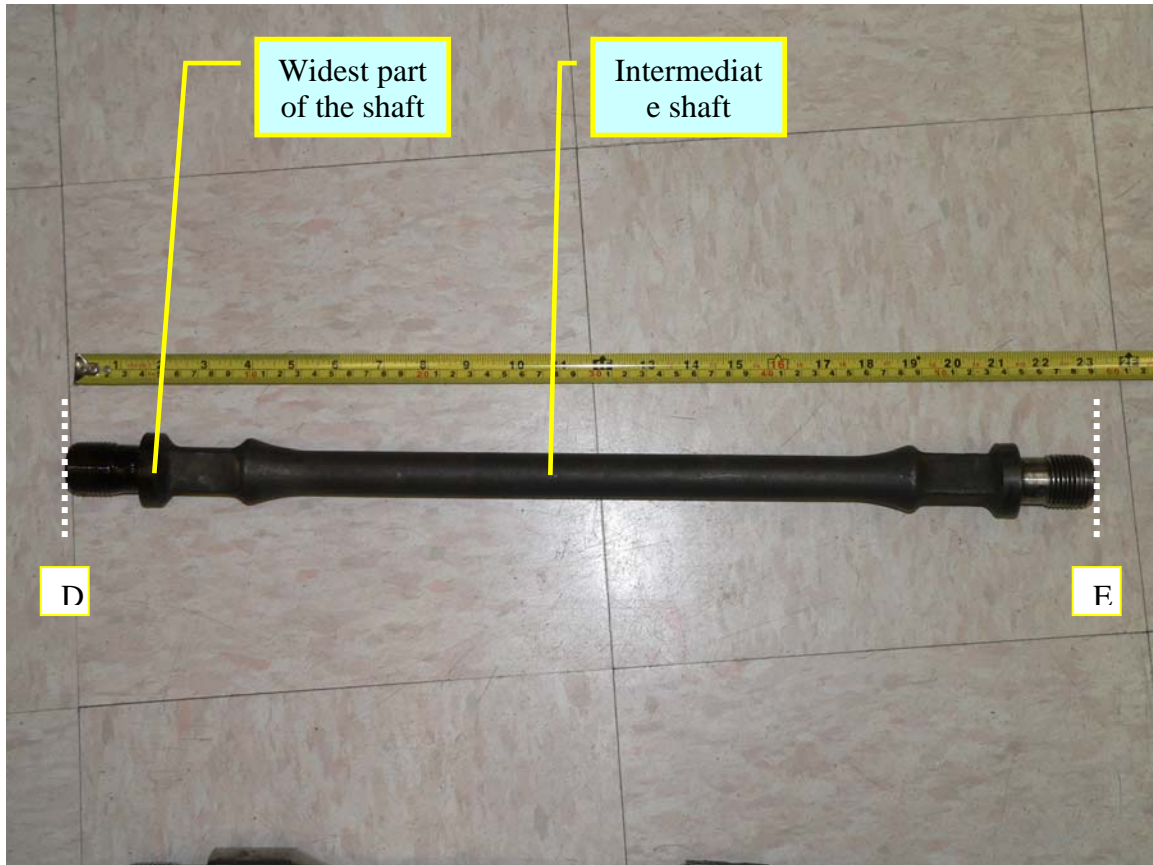
Photograph #8 Shows the second pony rod that attached to the rotor of the progressive cavity pump. It measured 580 mm in length from D to E. This measurement includes the thread length hidden inside the adapter. The threaded end at the widest part measured 40 mm. The ends were also designed to fit a 23 mm wrench. The intermediate or middle shaft measured 25 mm in diameter and was made of steel material.

5.1.3.3 The second pony rod measured 580 mm in length from D to E. This measurement includes the thread length hidden inside the adapter. The threaded end at the widest part measured 40 mm. The ends were also designed to fit a 23 mm wrench. The intermediate or middle shaft measured 25 mm in diameter and was made of steel material. (Attachment "C" Photograph # 8)

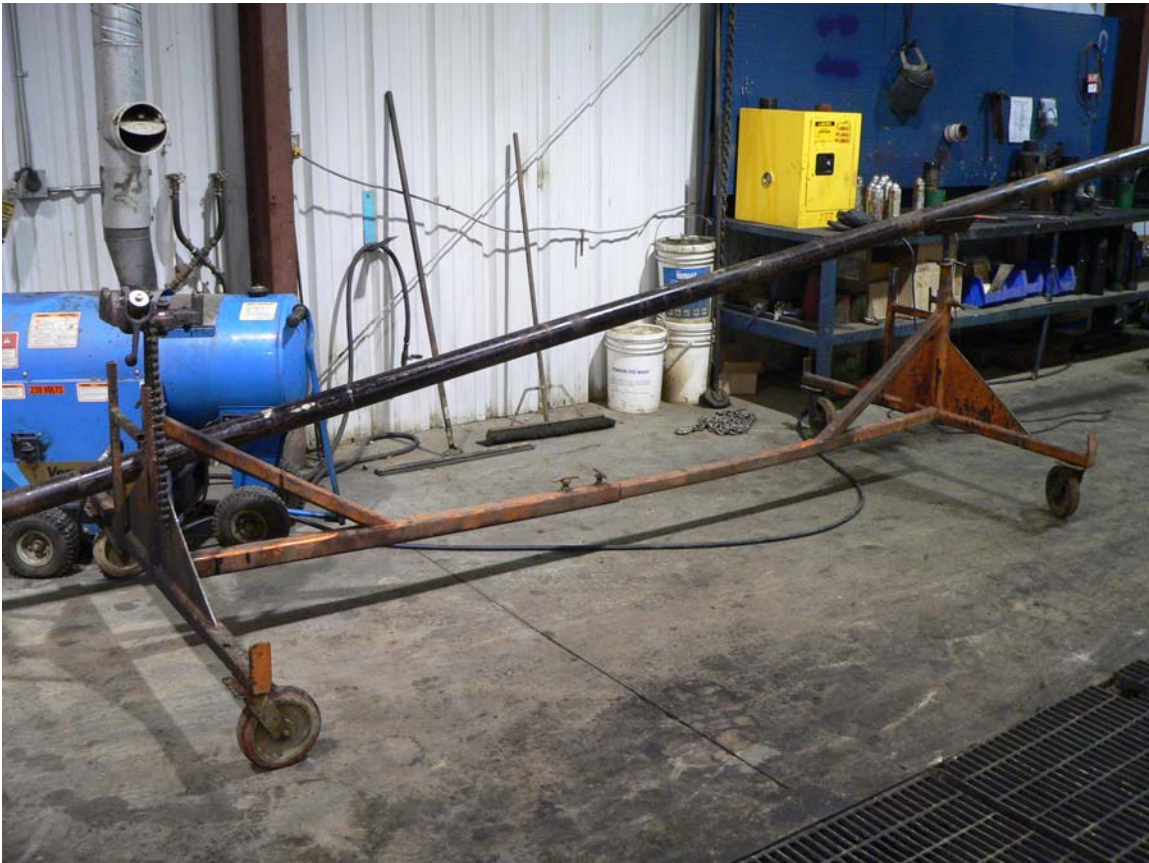
Photograph #9 Shows the progressive cavity pump and the progressive cavity pump stand. A progressive cavity pump is also referred to as an eccentric screw pump, cavity pump or single screw pump.

5.1.4 **Progressive Cavity Pump Stand** (Attachment "C" Photograph # 9)

5.1.4.1 The stand measured approximately 3300 mm long, 1560 mm wide and 1100 mm tall. It was made of steel material and was equipped with a chain vise to secure progressive cavity pumps being serviced.

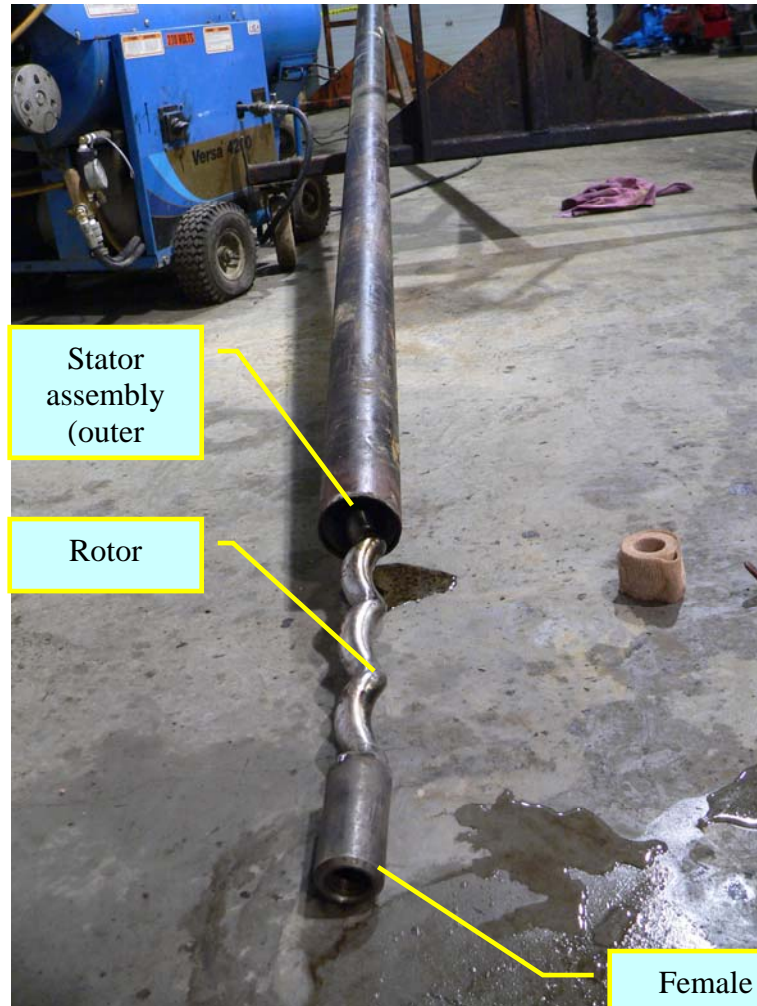
Photograph #10

Shows the progressive cavity pump assembly. It is made up of two parts: A rotor and a stator. The rotor, when spun by electric motor, causes the well fluids to progress in an upwards direction. The stator, which is made up of a synthetic elastomer liner has a double internal helix permanently bonded to the inside of a steel housing. (See Photograph #11 and Attachment "B" Diagram)

The female coupler was welded onto the rotor by the worker. The coupler attaches to a pony rod extending from the progressive cavity test bench.

The worker welded the coupler onto the rotor in anticipation of attaching the rotor to the pony rod to extract the rotor from the stator.

5.1.5 **Progressive Cavity Pump** (Attachment "C" Photograph # 10, 11)

5.1.5.1 It measured approximately 6740 mm in length and 100 mm in diameter. The assembly is made up of a stator and rotor components. The stator is the exterior casing made of steel with a double internal helix made of synthetic elastomer liner which is bonded to the inside of the steel casing. The rotor is a chrome-plated steel external helix, which rotates inside of the liner and casing.

- 6.1 On October 12, 2007 at approximately 9:45 a.m, the Pump Tech was welding a coupler onto the rotor of a Progressive Cavity (PC) Pump. The Pump Tech was telling the Service Foreman he was having difficulty lining up the coupling and welding it on straight.
(Attachment “C” Photograph #10)
