Riparian Assessment for North Saskatchewan Region Lakes

FINAL REPORT

Prepared for:
Alberta Environment and Parks
Policy and Planning Division, Planning Branch

Project 179910

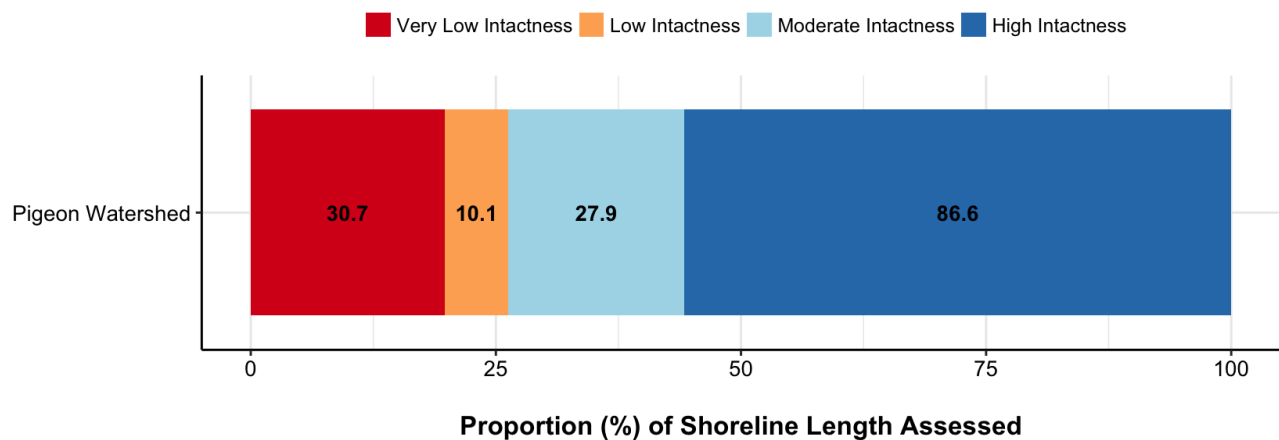
Figure 2. The proportion of shoreline within the Pigeon Lake watershed assigned to each riparian intactness category. The totals include the shorelines of Pigeon Lake as well as 32 unnamed creeks that flow into Pigeon Lake. Numbers within the bars indicate the total length (km) of shoreline associated with each category.

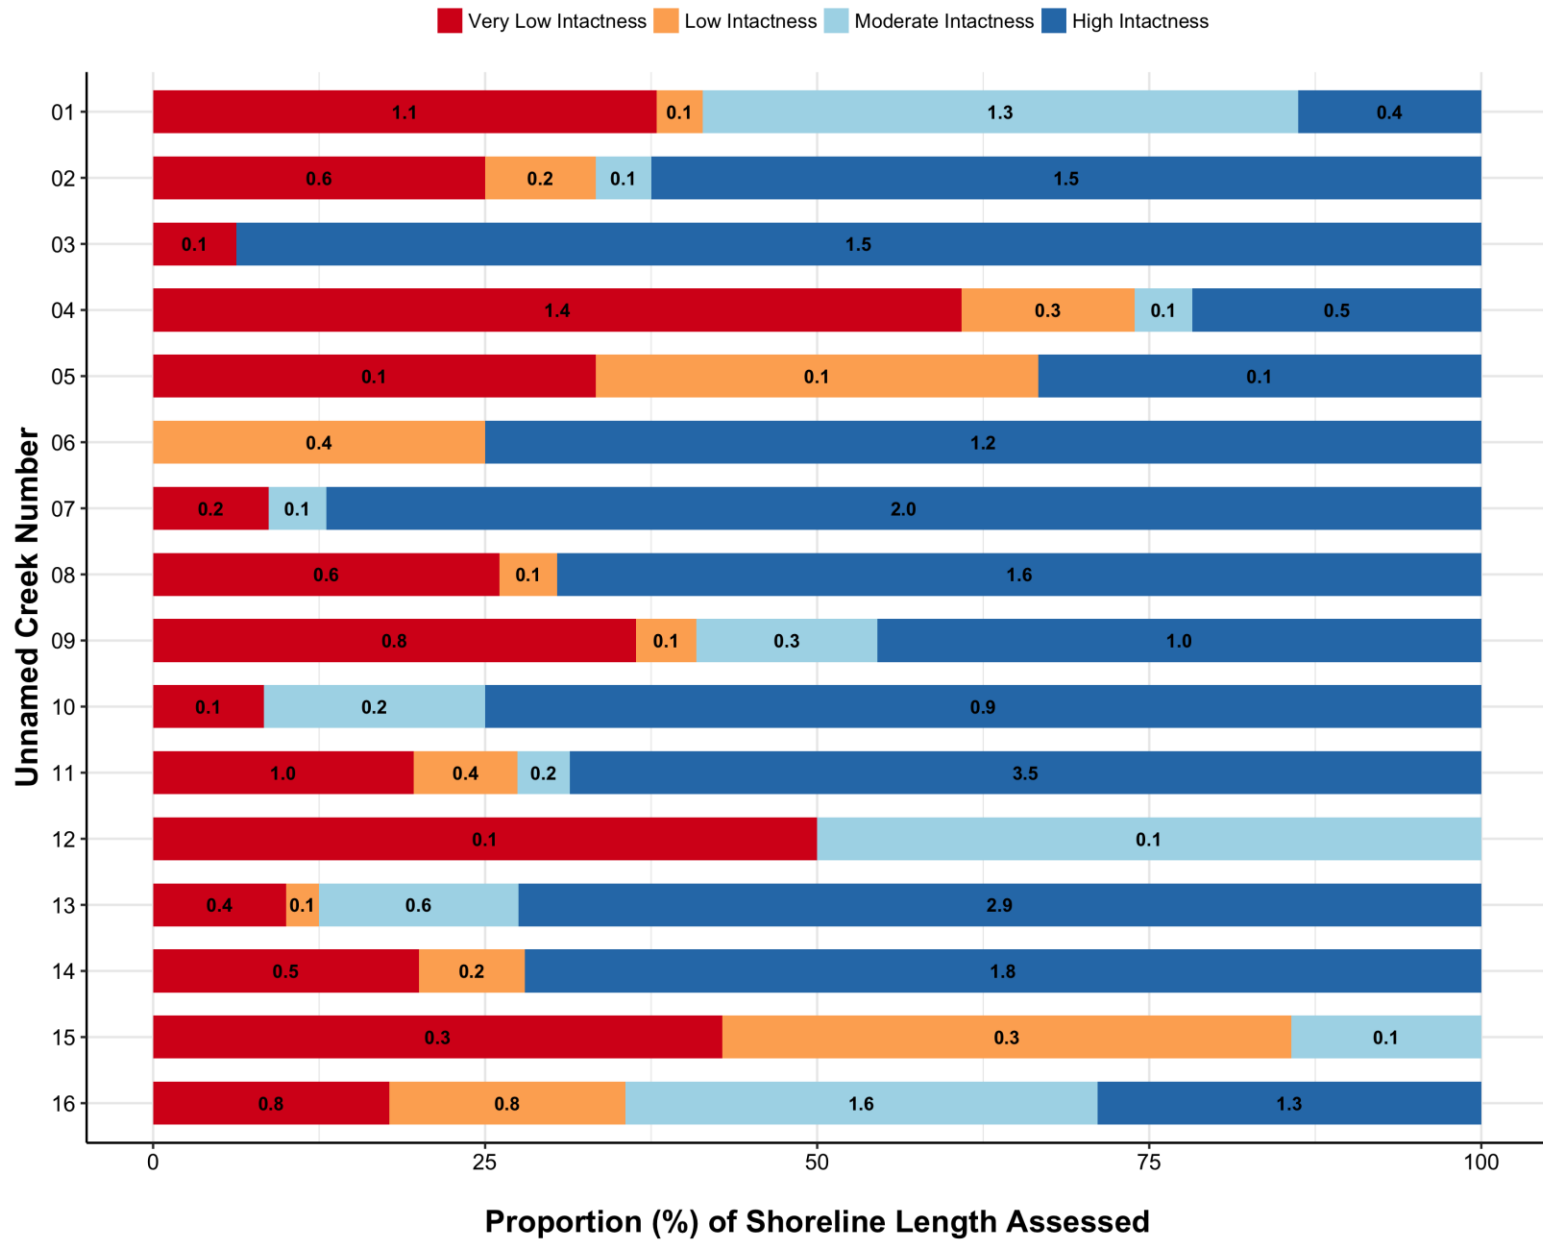
Figure 4. The proportion of shoreline assigned to each riparian intactness category for unnamed creeks 1 through 16 located in the Pigeon Lake watershed. Numbers within the bars indicate the total length (km) of shoreline associated with each category.

Generally, the tributaries that flow into the lake along the northern shoreline (unnamed creeks 01 to 11) have a higher proportion of their shorelines classified as Very Low or Low Intactness (Figure 4), with creeks in the north west portion of the watershed having a higher proportion of their shorelines classified as either Moderate or High Intactness (Figure 5; Map 3; Map 4).

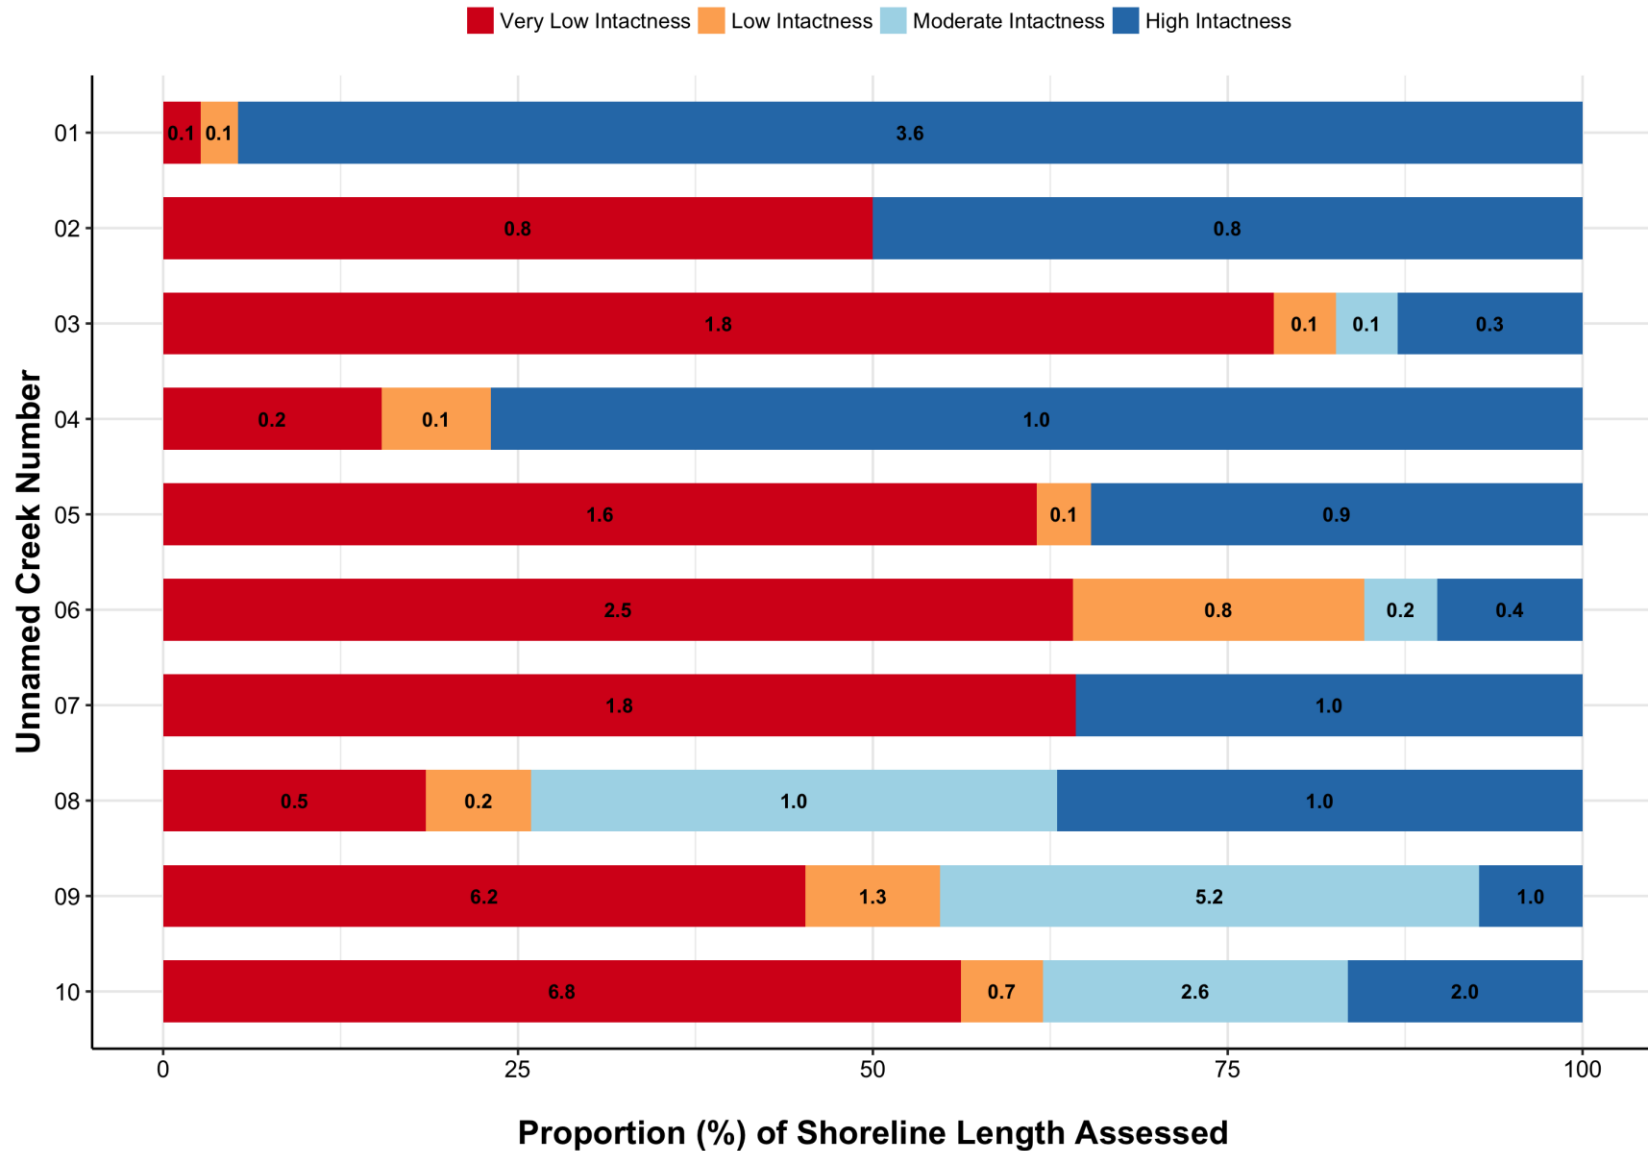
Figure 8. The proportion of shoreline assigned to each riparian intactness category for unnamed creeks 1 through 10 located in the Gull Lake watershed. Numbers within the bars indicate the total length (km) of shoreline associated with each category.

The shoreline of the tributaries that flow into Gull Lake can be generally characterized as being in poor condition, with 15 out of 20 having >25% of their shorelines assessed as Very Low Intactness, and 11 out of 20 having ≥50% of the shoreline classified as Very Low Intactness (Figure 8; Figure 9; Map 7). The shorelines of the unnamed lakes/wetlands in the watershed (one located at the north end of Gull Lake and three associated with unnamed creek 9) are generally in good condition, with >75% of their shorelines assessed as either Moderate or High Intactness (Figure 10).

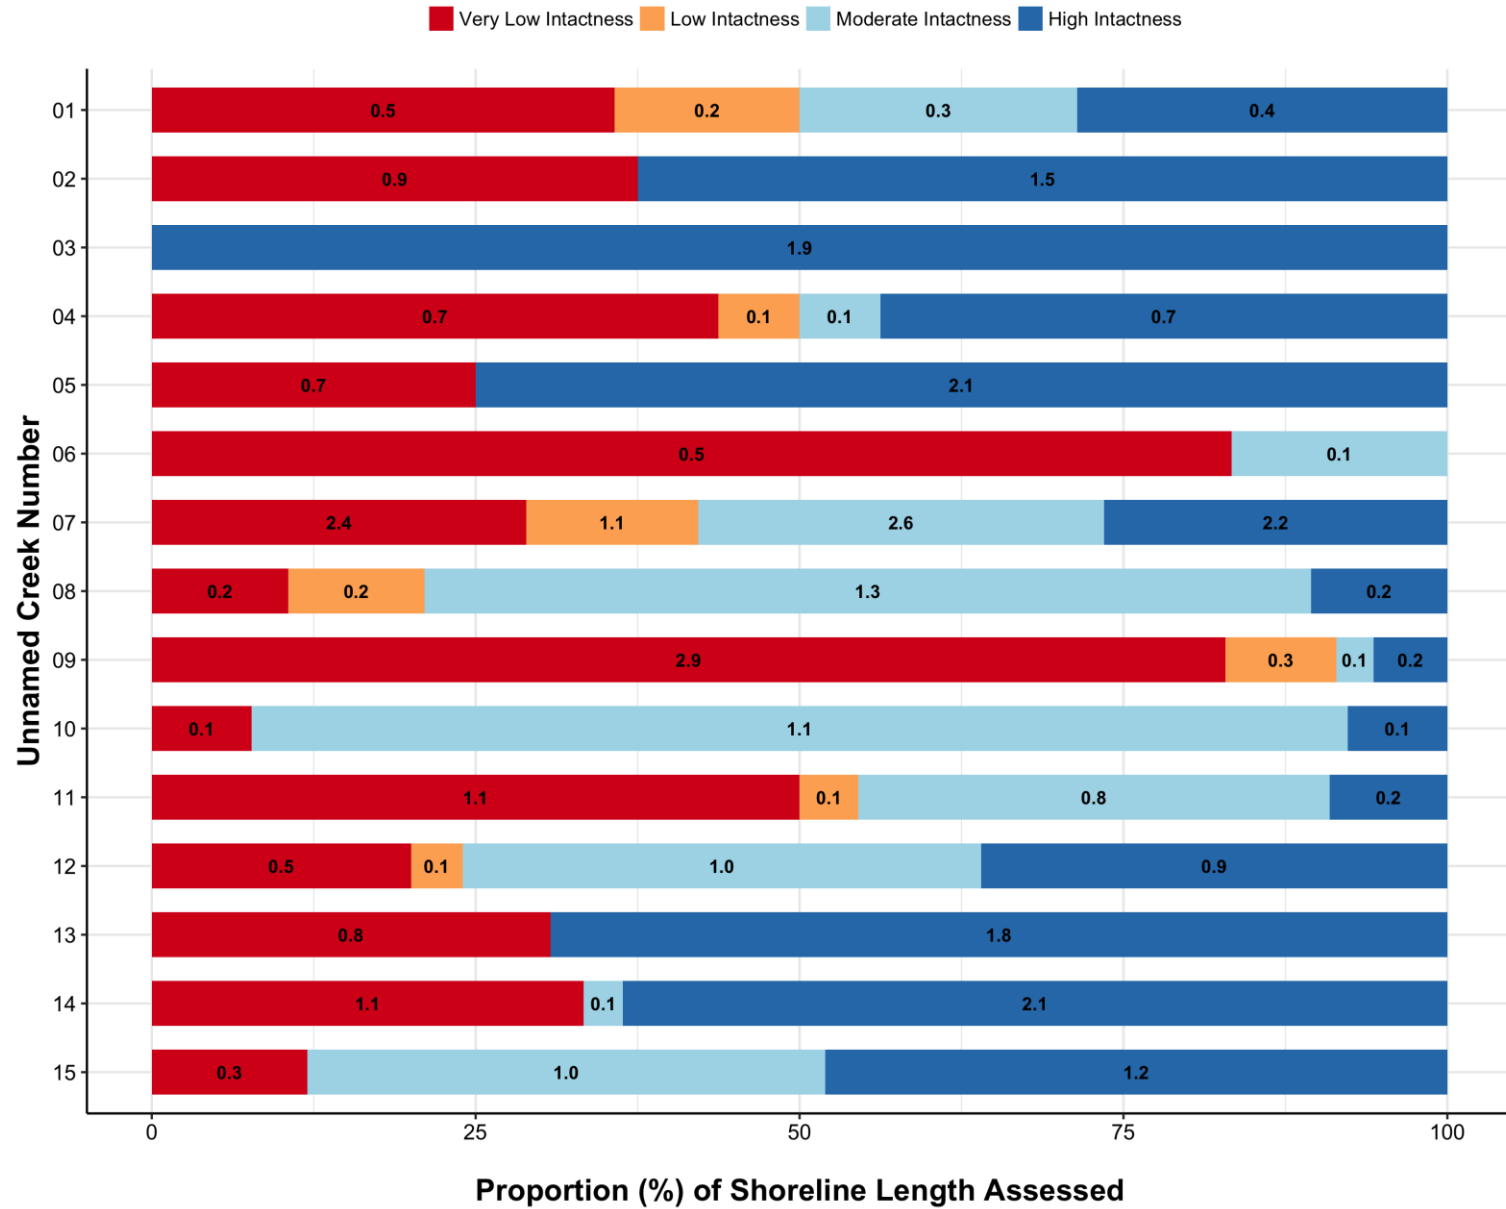
Figure 13. The proportion of shoreline assigned to each riparian intactness category for unnamed creeks located in the Sylvan Lake watershed. Numbers indicate the total length (km) of shoreline associated with each category.

The shorelines of the tributaries flowing into Sylvan Lake vary in condition, with 9 out of 15 having >25% of their shorelines assessed as Very Low condition, and 10 out of 15 having >25% of their shorelines classified as High Intactness (Figure 13). Unnamed creek 09, located along the south shore, has the largest proportion and the greatest length of its shoreline assessed as Very Low Intactness (Figure 13; Map 9 and Map 10).

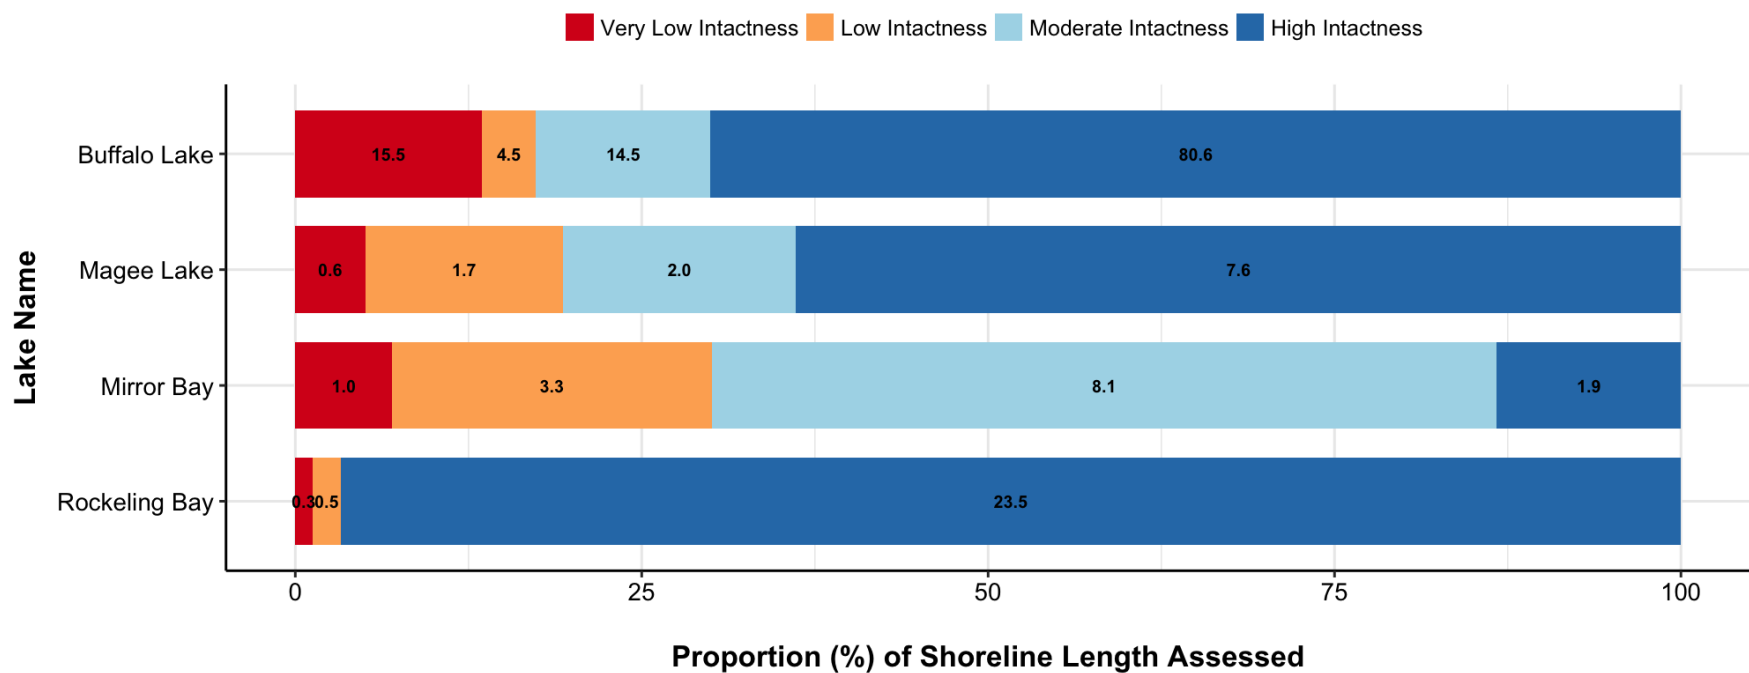
Figure 16. The proportion of shoreline assigned to each riparian intactness category for all named lakes in the Buffalo Lake watershed. Numbers within the bars indicate the total length (km) of shoreline associated with each category.

Three other named lakes/wetlands were included in this assessment: Magee Lake at the headwaters of Parlby Creek, Mirror Bay at the west end of Buffalo Lake, and Rockeling Bay at the north east end of Buffalo Lake (Map 11). Generally, these lakes are in relatively good condition, with only Mirror Bay having >25% of its shoreline assessed as either Very Low or Low Intactness (Figure 16). Three unnamed lakes/wetlands were also assessed, all of which were located along the north shore of Buffalo Lake (Map 11). Two out of the three waterbodies had >25% of their shorelines classified as Very Low Intactness, with one of the three (01) having nearly 100% of its shoreline classified as High Intactness (Figure 17).

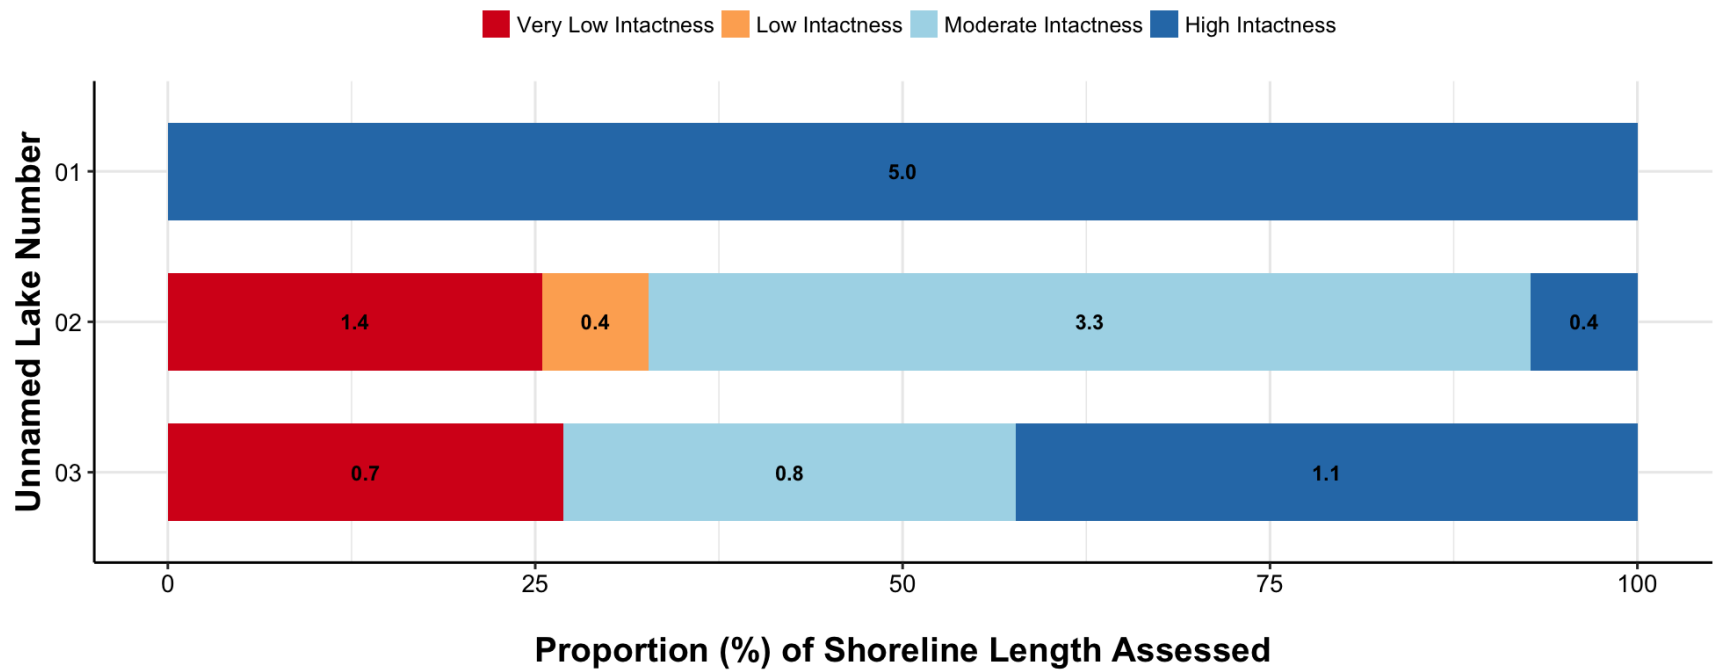
Figure 17. The proportion of shoreline assigned to each riparian intactness category for unnamed lakes in the Buffalo Lake watershed. Numbers within the bars indicate the total length (km) of shoreline associated with each category.
