**IN THE MATTER OF A FATAL COLLISION INVOLVING CALGARY POLICE
SERVICE ON FEBRUARY 10, 2020**

**DECISION OF THE ASSISTANT EXECUTIVE DIRECTOR OF THE ALBERTA
SERIOUS INCIDENT RESPONSE TEAM**

2020-0010(S)

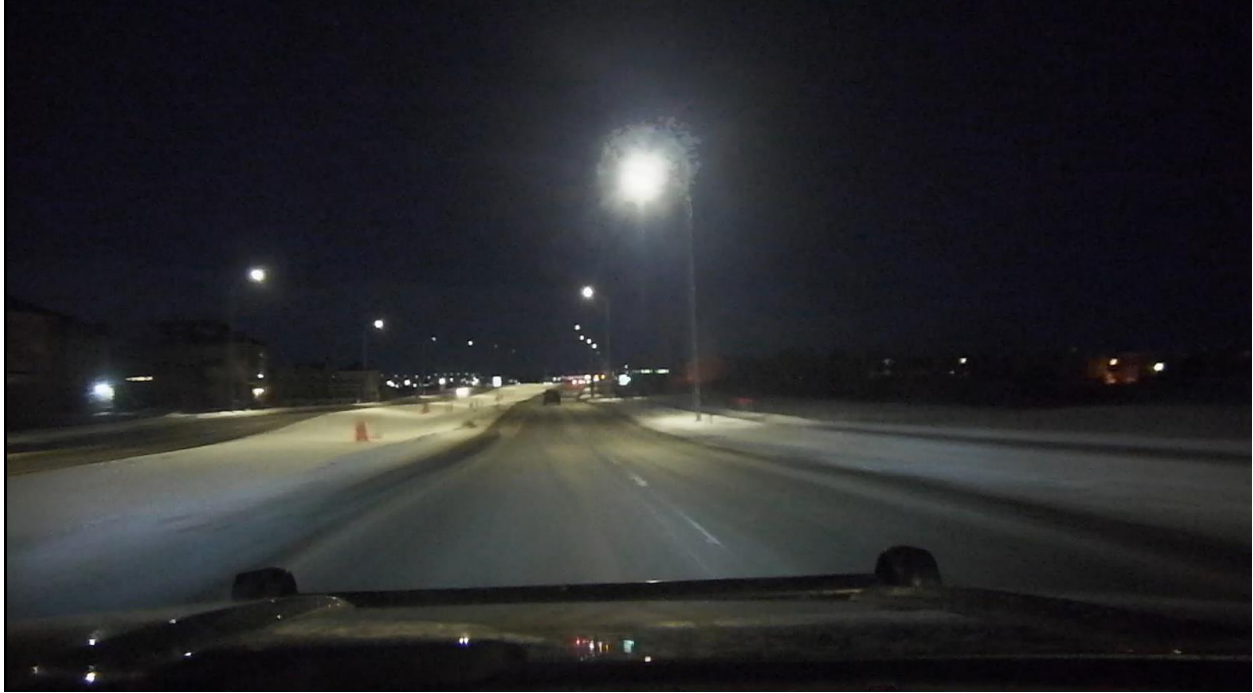
While driving on Country Hills Boulevard, the camera in the police vehicle started recording. When first activated, it showed AP1 in front of the subject officers (Figure 1).

Figure 1 – AP1 driving ahead of the subject officers.

GPS showed that, while on Country Hills Boulevard, SO1 drove as fast as 152 km/h. According to the police vehicle video, AP1 is driving a similar speed at first and then faster than the police vehicle. This section had a speed limit of 70 km/h.

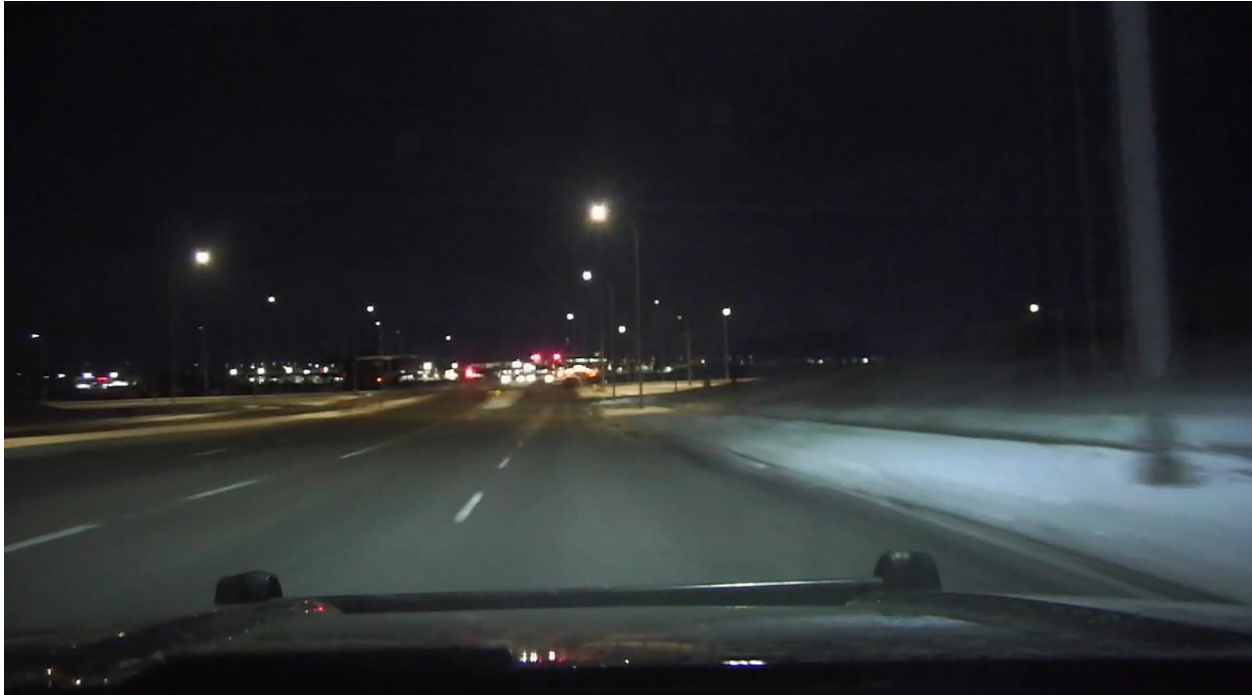
AP1 drove toward that same intersection which, for him, was displaying a red light. Just before entering the intersection, AP1's brake lights illuminated for approximately one second. AP1 struck AP2 in the intersection. At the time of collision, AP2 was going 47 km/h according to the vehicle recorder. AP1 was going at least 126 km/h, since the Toyota's recorder was not capable of recording a speed above 126 km/h. The subject officers advised dispatch that there had been a collision 49 seconds after their initial query of the license plate. The collision was visible on the police vehicle video 14 seconds after it started (Figure 2).

Figure 2 – Collision at the intersection ahead of the subject officers.

SO1 pursued AP1 for approximately one minute or less with no emergency equipment activated. This was a short pursuit where AP1 was pulling away from them and the short pursuit did not cause the collision. The collision was caused by the driving of AP1. AP1 drove through a red light into an intersection with other vehicles. The responsibility for the collision and the resulting injuries rests with AP1.
