Occupational Health and Safety

Fatality Report

**WORKER CRUSHED BY PUMPJACK
COUNTERWEIGHT**

Date of Incident: November 9, 2009

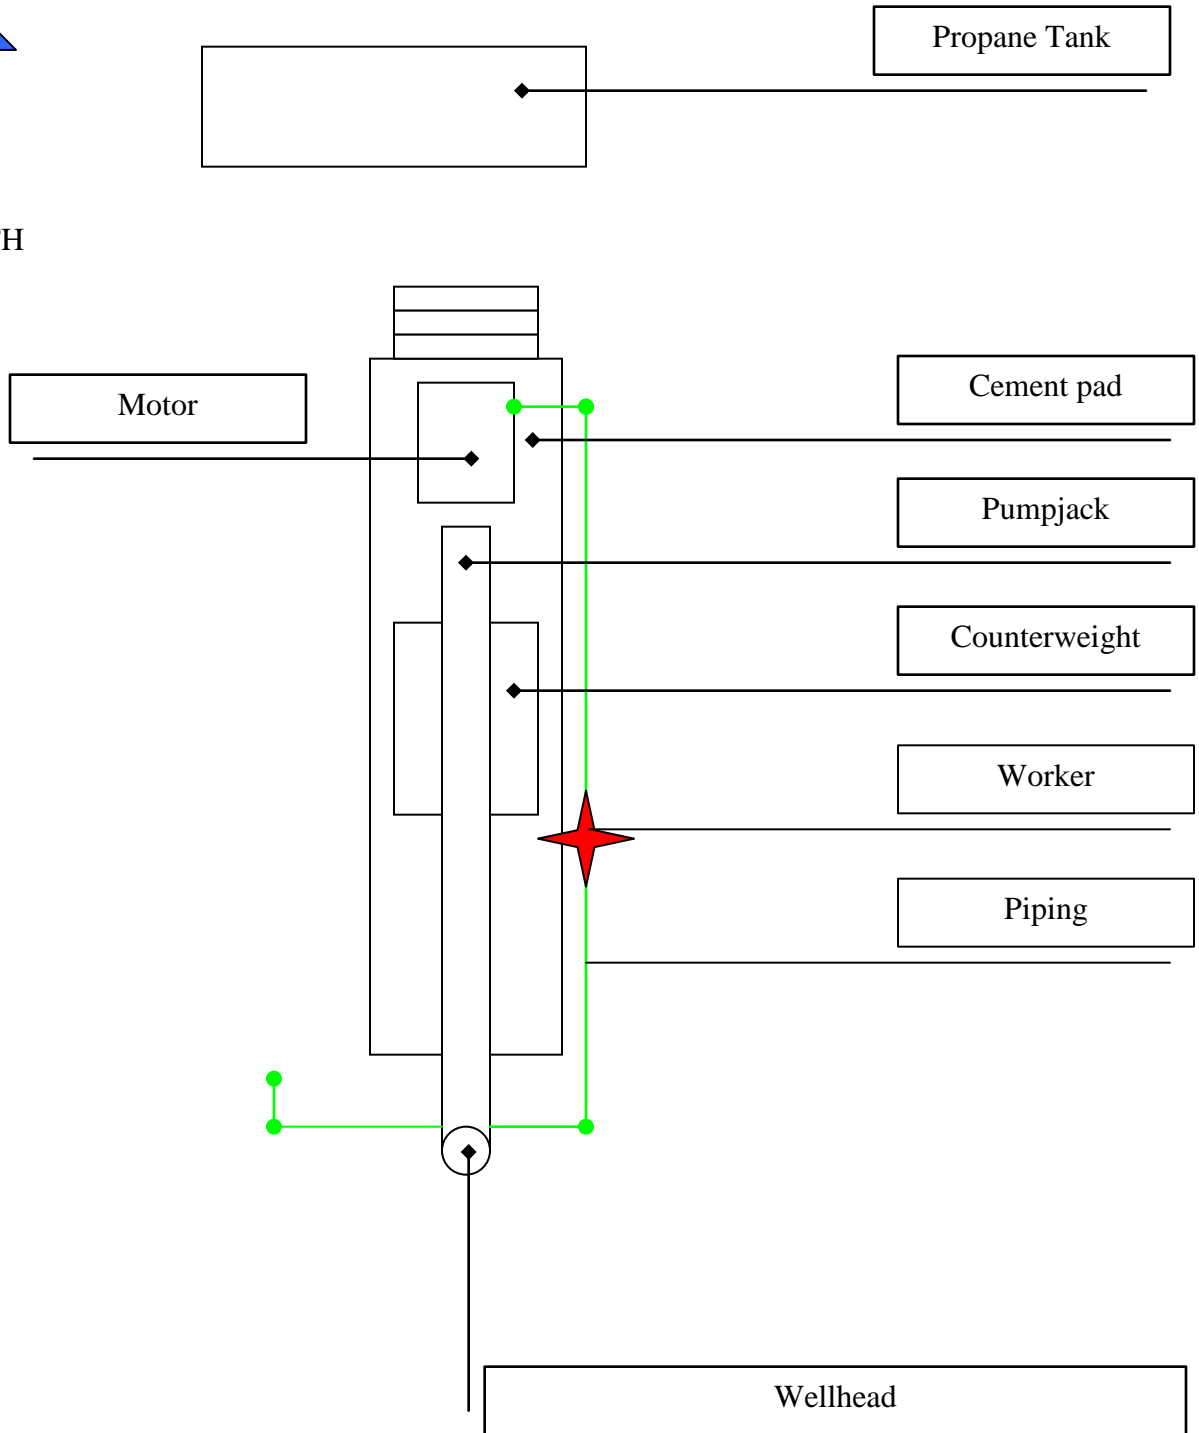
Photograph #1

5.1.1.1 Model # CW 228-213-100, Pumpjack specifications 7.5 m X 2.22 m X 7.06 m. The pump was commissioned on October 2009 and produced an average of 32 m³ per day. (Attachment C – Photographs # 1).
