# **Workplace Health and Safety Fatality Report**

**Worker Fatally Injured in Vehicle Incident**

**Date of Incident: March 7, 2007**

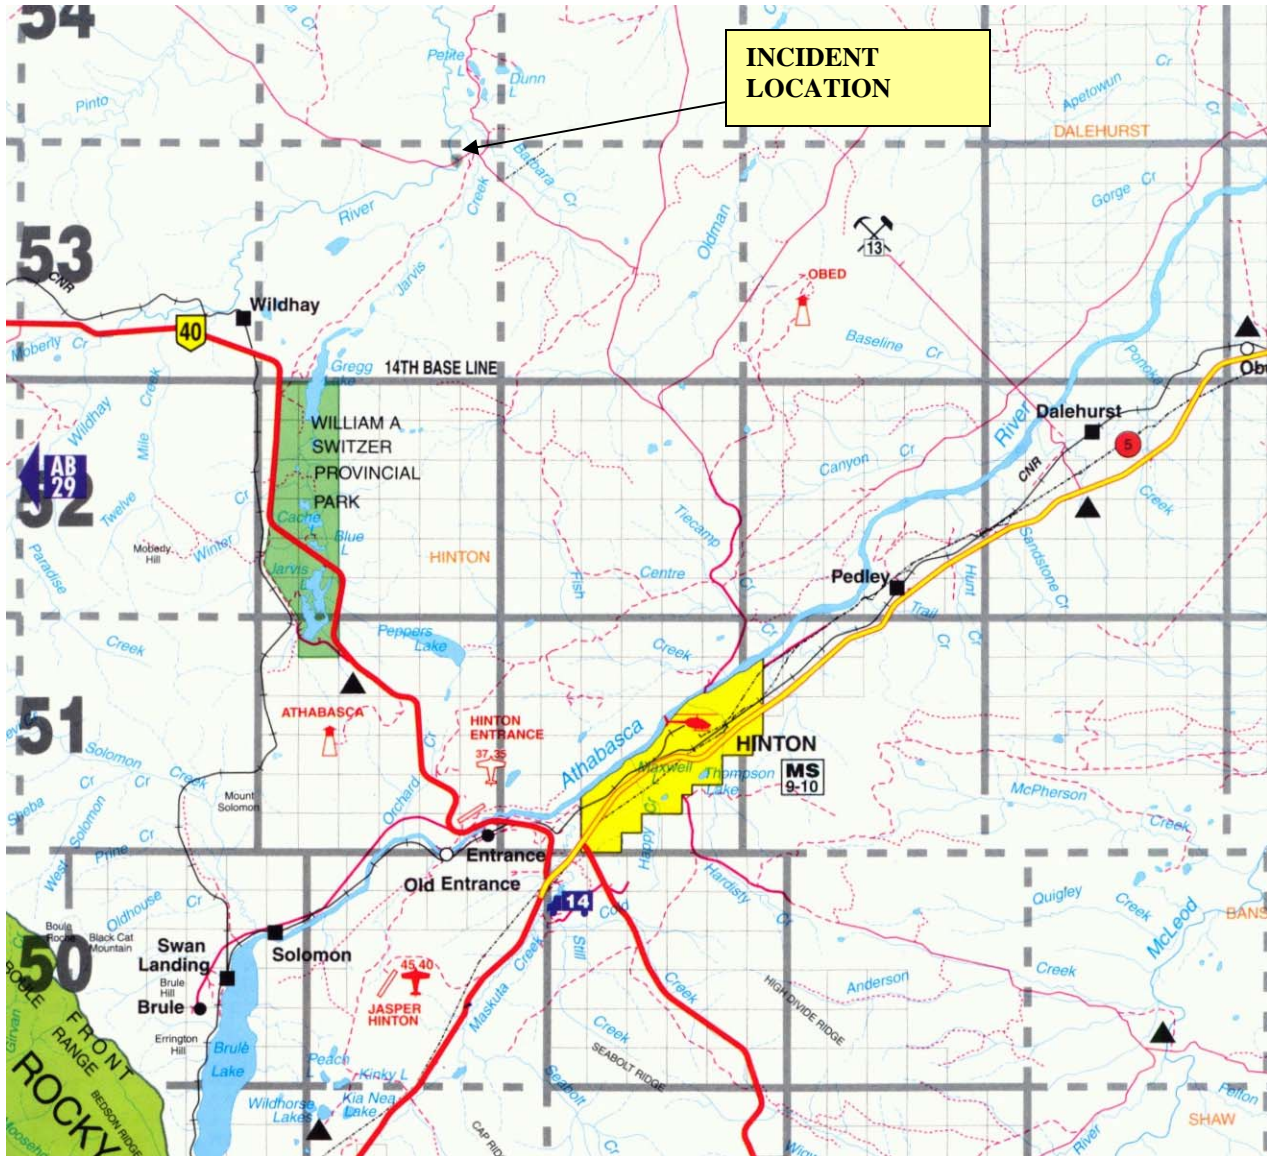
- 6.7 Tracks left in the snow bank showed that the Foreman had attempted to correct his direction and return his vehicle onto the road. However, his vehicle struck the south side wall of the bridge deck and the vehicle flipped. The cab roof was crushed and collapsed onto the cab by impact with rocks on the river bank. The vehicle came to rest on its wheels in the river. The Foreman's head and upper body were hanging out of the driver's side door window. Blood and bone fragments were found on rocks 10 m east of where the vehicle had struck the bridge and 7 m below the deck level of the bridge on the west bank of the river. This indicated that the Foreman had struck his head on the rocks as the truck flipped and fell into the river, suffering fatal injuries. The river was only a few centimetres deep at the location where the truck came to rest. (Attachment "A", Photographs #2, #3, #4, #5)

Photograph #5 Shows the Foreman's truck where it came to rest in the river. Arrow indicates rocks on the west bank of the river that the vehicle impacted before it came to rest. Photograph reproduced courtesy of RCMP Hinton Detachment.
