# **Worker fatally injured after fall from building**

December 12, 2020

## **Incident summary**

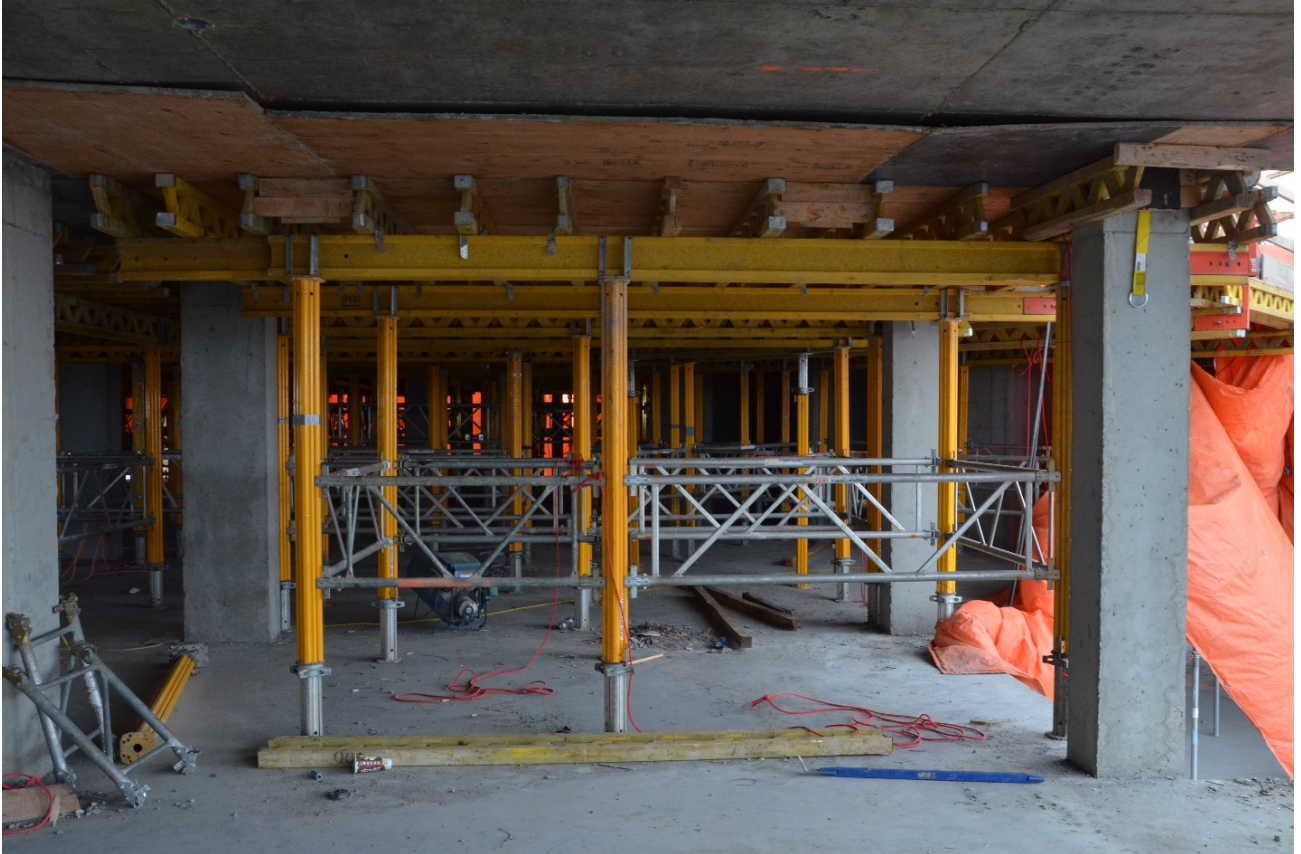
The PERI Multiflex formwork table (table) was an adjustable system of girders, cross beams, plywood, and adjustable legs that was used to create a stable and level platform. The platform became the form for concrete to be poured onto, to create a slab for the floor or ceiling (Figure 2).

*Figure 2. PERI Multiflex formwork table installed on the sixth floor.*
