# **RECAPP Facility Evaluation Report**

## **Aspen Regional Health Authority**

### **Bonnyville Health Centre**

**Evaluation Company:** Koliger Schmidt architect engineer  
**Evaluation Date:** June 26 2009  
**Evaluator Name:** Steve Horvath

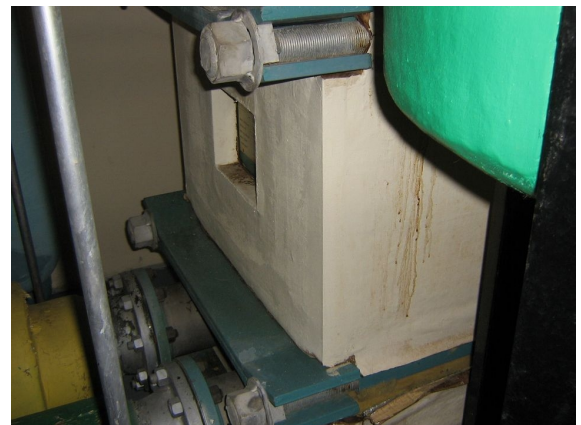
Domestic hot water heat exchanger.

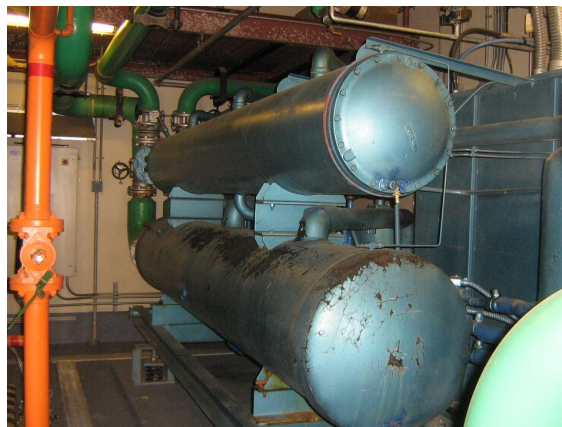
Existing chiller.

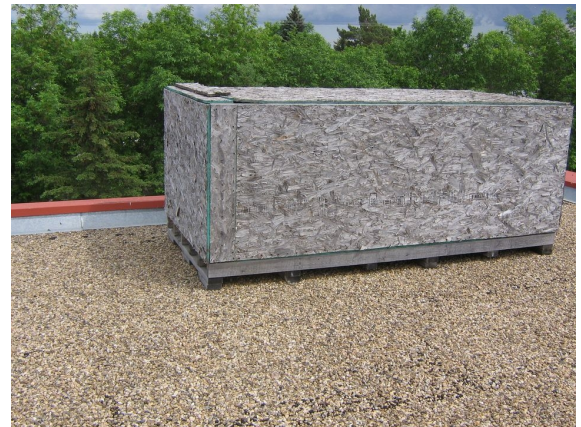
Negative pressure unit.

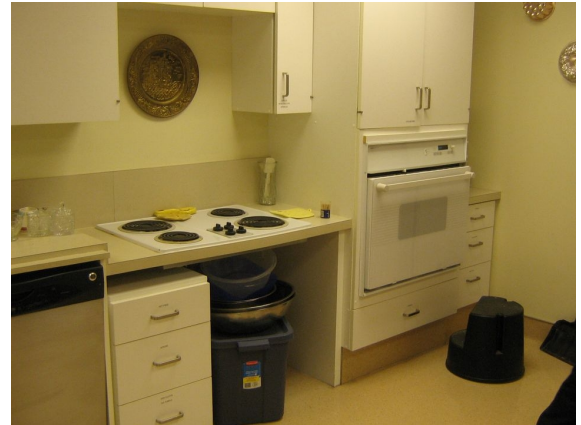
Kitchen area.

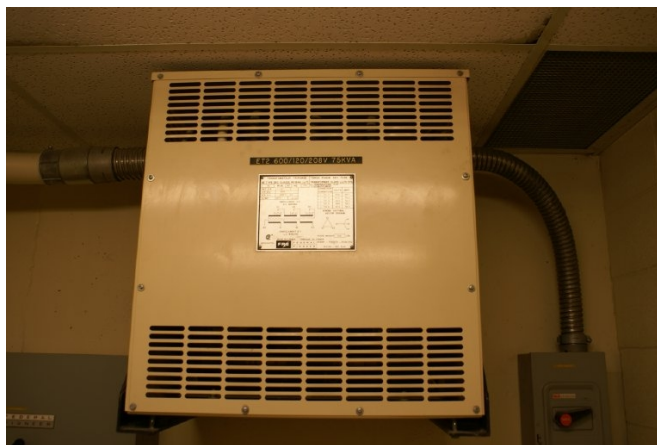
- Transformer T1 450KVA 600V 120/208V 3ph 4w (located in the main electrical room)
- Transformer T2 225KVA 600V 120/208V 3ph 4w (located in room B-37)
- Transformer T3 75KVA 600V 120/208V 3ph 4w (located in room B-42)
- Transformer T4 75KVA 600V 120/208V 3ph 4w (located in the ambulance garage)
- Transformer ET1 225KVA 600V 120/208V 3ph 4w (located in the main electrical room)
- Transformer ET2 75KVA 600V 120/208V 3ph 4w (located in room B-37)
- Xray transformer 150KVA 600V 220/300V 3ph 4w (located in room 1404)

Typical federal pioneer transformer

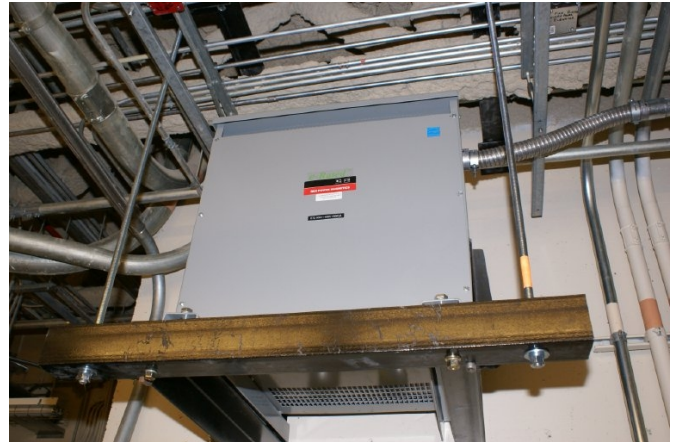
One (1) Rex power manufacturing Transformer ET2 150KVA 600 277/408V 3ph 4w is installed in the main electrical room. The transformer feeds the lab emergency power panel.

75KVA transformer ET2

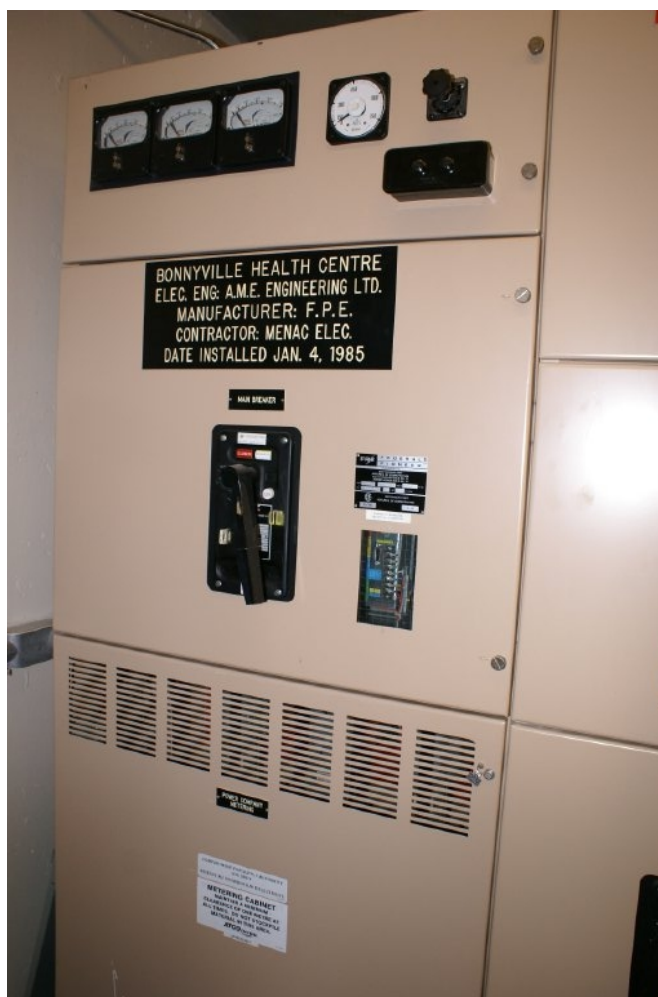
- MDP - 2000A 347/600V 3ph 4w (3 Spaces for future) (located in the main electrical room B-11)
- CDP E6D1 - 347/600V 3ph 4w (3 spaces for future) (located in the main electrical room B-11)
- CDP E2D1 - 120/208V 3ph 4w (4 spaces for future) (located in the main electrical room B-11)
- CDP 6D1 - 347/600V 3ph 4w (3 spaces for future) (located in the main electrical room B-11)
- CDP 6D2 - 347/600V 3ph 4w (8 spaces for future) (located in room B-19)
- CDP 2D1 - 1600A 120/208V 3ph 4w (5 spaces for future) (located in the main electrical room B-11)
- CDP 2D2 - 400A 120/208V 3ph 4w (2 spaces for future) (located in room B-37)
- CDP 2D3 - 400A 120/208V 3ph 4w (6 spaces for future) (located in room B-42)
- CDP 2D4 - 400A 120/208V 3ph 4w (7 spaces for future) (located in the ambulance garage)
- CDP E2D2 - 120/208V 3ph 4w (located in room B-37)

Main distribution switchgear

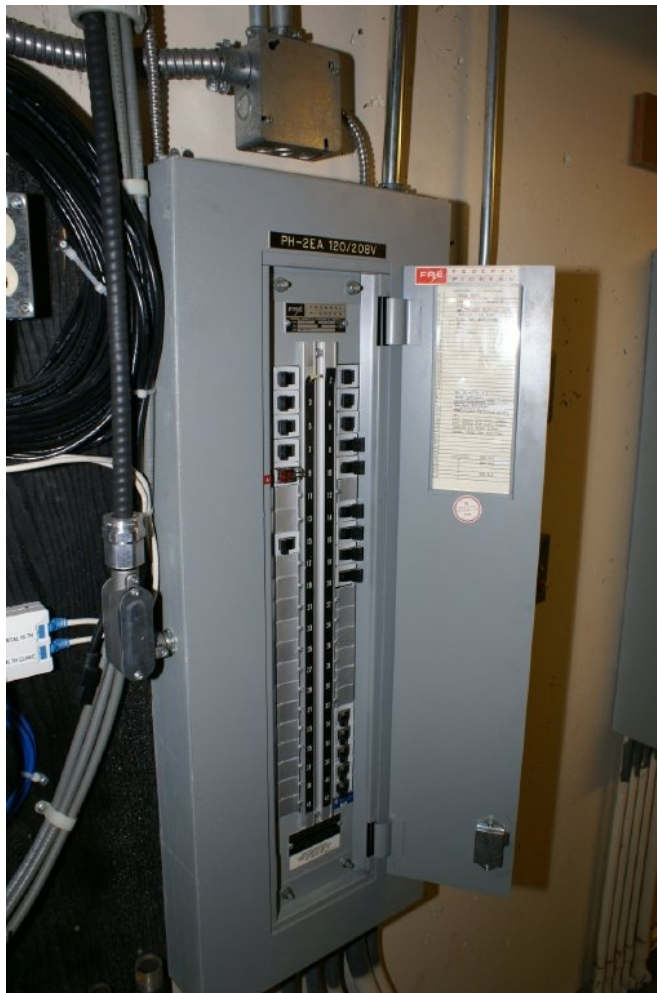
All branch circuit panels are manufactured by federal pioneer. There are approximately 59 branch circuit panels are located throughout the building. Where panels are located in regularly occupied areas, they are flush mounted, and surface mounted were located in utility/service areas. The panels have lockable doors and are color coded according to the voltage, 347/600V panels are beige, and 120/208V panels are gray. The building personnel report that there is approximately 25% spare capacity in the panels for future. There are approximately 7 federal pioneer isolated power panels installed in the O.R., Trauma, and I.C.U. areas.

Typical 120/208V 3ph 4w branch circuit panel

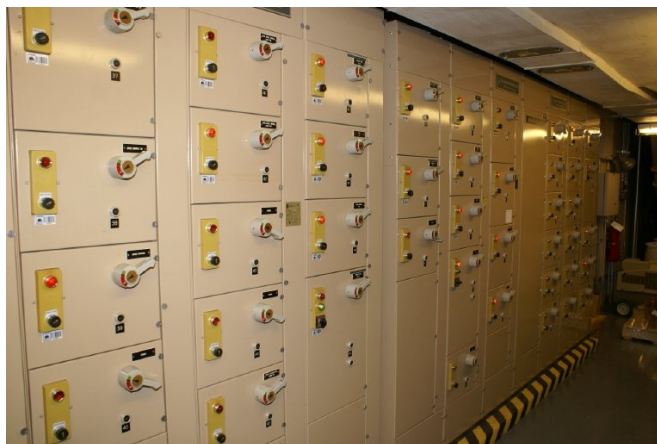
- MCC#1 4 sections 600A 600V 3ph (6 spare, 1 space) (located in room B-51)
- MCC#2 - 6 sections 600A 600V 3ph (6 spare, 5 spaces) (located in the mechanical penthouse)
- MCC#E2 - 6 sections 600A 600V 3ph (12 spare, 3 spaces) (located in the mechanical penthouse)

MCC #2 and MCC #E2

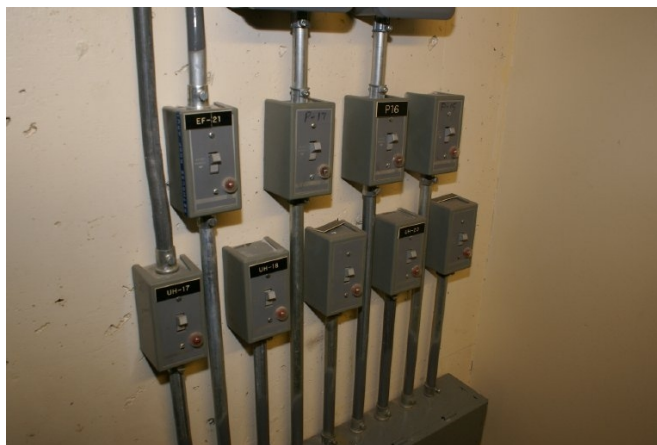
Small motor loads in public areas are controlled via keyed manual motor starters. Toggle manual motor starters are used in other areas. Approximately half of the starters have pilot lights. All of the manual starters are manufactured by Square D. Local disconnects located to adjacent to larger motor loads are manufactured by federal pioneer.

Typical manual motor starters

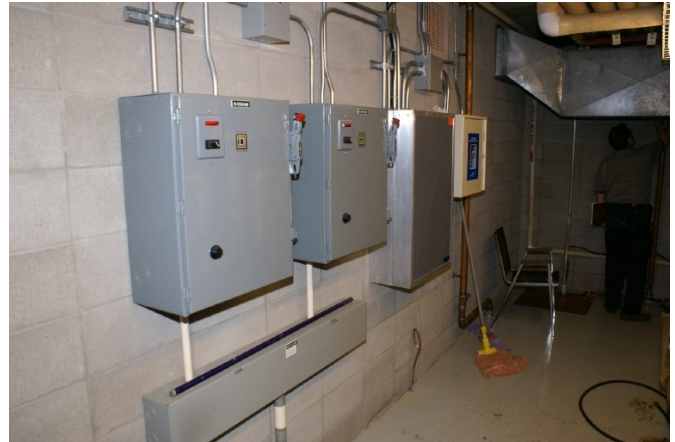
There are two (2) square D magnetic motor starters c/w HOA switches installed in the basement portion of the Lab to control the air handling system supply and return fans.

Square D magnetic motor starters

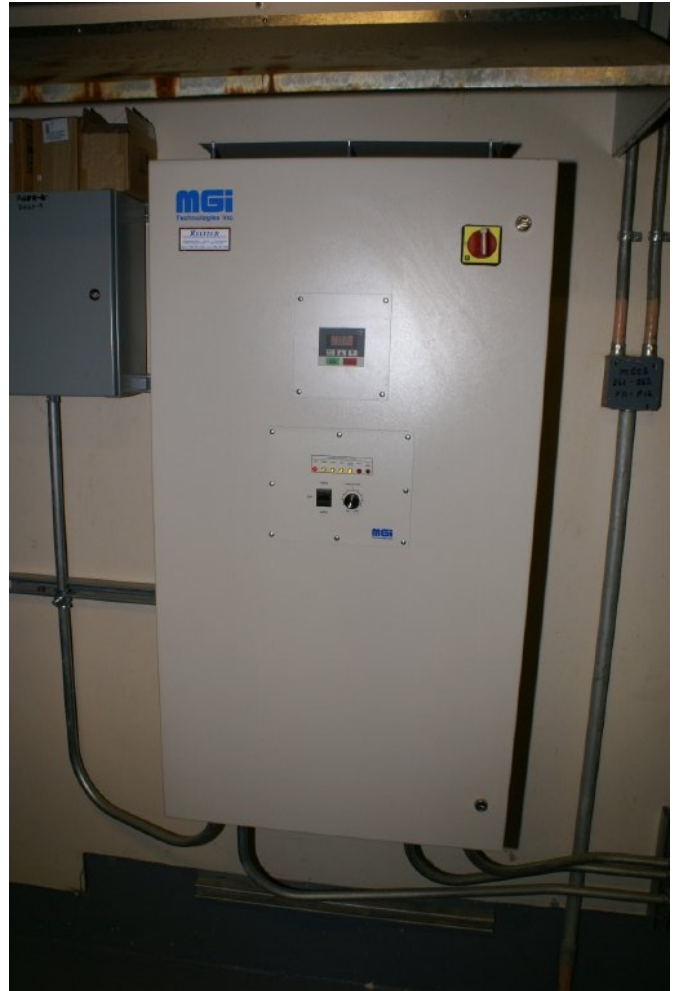
One (1) MGI Technologies VFD is connected to the cooling tower motor load. The VFD is located in the mechanical penthouse. The installation dates within the last 10 years.

MGI Technologies VFD panel

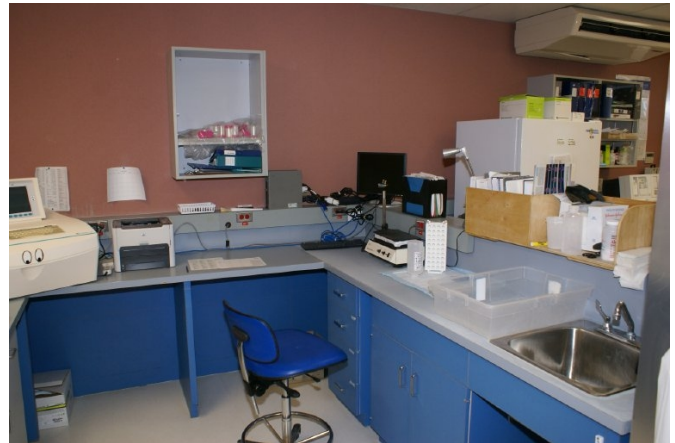
The majority of the lab areas is wired via conductors in conduit. Armoured BX cable is used for lighting drops. Receptacles are standard style, hospital grade with stainless steel coverplates. The receptacles are colored according to the source of the power or type (Regular Power, Emergency, UPS, Isolated Ground, etc.). A steel dual channel raceway is installed above the counter. Half of the raceway contains power, the other half contains communications.

Dual channel raceway installed above counters.

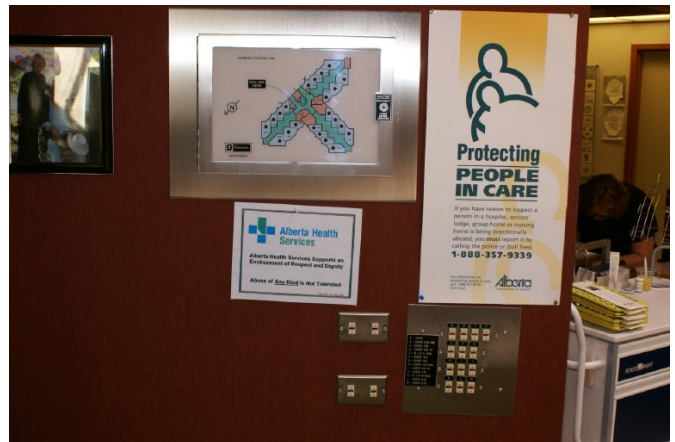
The primary method of switching is via rocker style L.V. switches. Public areas are controlled from switch locations at staff areas (i.e. Nurse Stations, Front Desk, etc.) Non-public areas have local L.V. switches located at main entries/exits of the room. The majority of the building utilizes two-level switching of fixtures. Low voltage relay cabinets are located throughout the building adjacent to branch circuit panels feeding lighting. Relays and panels are manufactured by canadian general electric. Line voltage toggle switches are located in various utility and mechanical areas to switch local lighting.

Typical rocker style L.V. Switches in the main corridors.

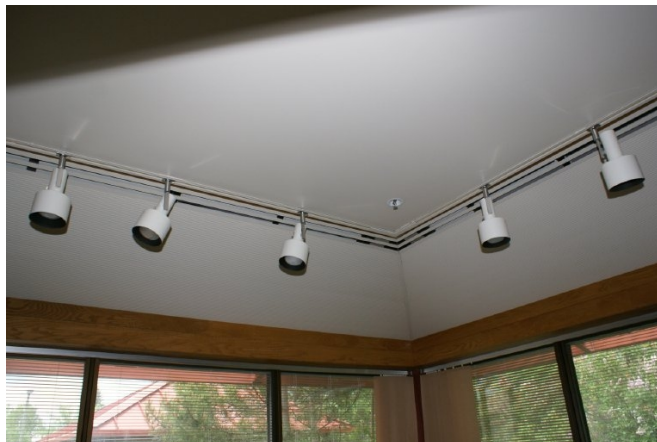
Incandescent downlights c/w black baffles are installed throughout the building. The downlights have been retrofitted with fluorescent lamps. Incandescent track lighting is installed in the elevator lobbies, and mounted on mullions where skylights/atriums are located as well as other various locations throughout. Incandescent night lights are installed in patient rooms at walkways to the bathroom, the night lights are tied into the building management system. Recessed incandescent fixtures are installed in the patient washrooms. Square recessed halogen exam fixtures are located above patient beds. Tiffany style pendant fixtures are located in the cafeteria, library and in the long term care common area. The fixtures have been retrofitted with fluorescent lamps. Hazardous location incandescent lighting is located in the paintshop.

Typical incandescent track lighting

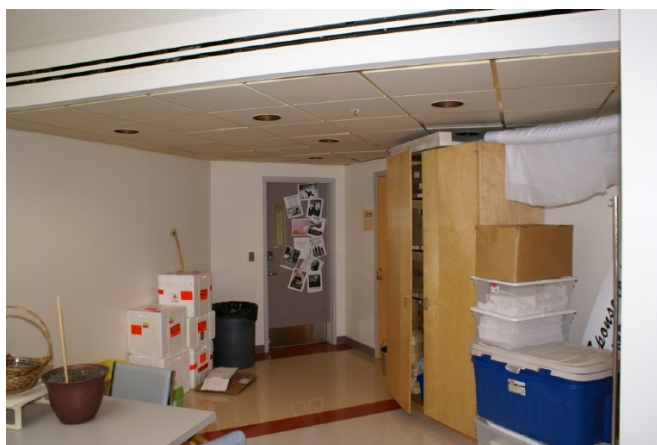
Incandescent downlights c/w clear reflectors/black baffles are installed in the 1998 renovation area.

Incandescent downlighting in the 1998 reno area.

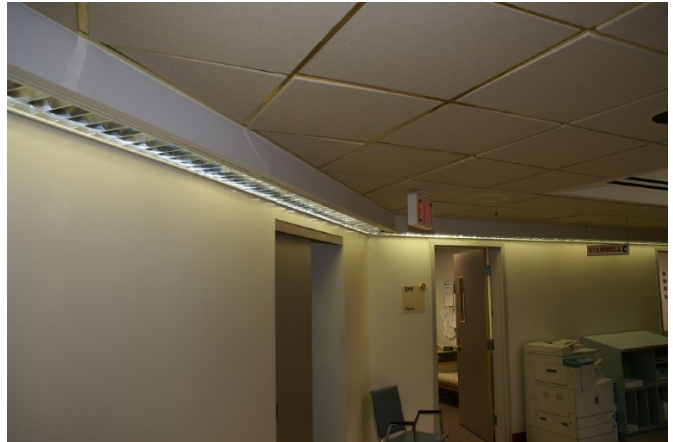
Fluorescent (imperial) fluorescent valance lighting (w/ T12 lamps and ballasts) are installed in the corridor. Recessed 2x4 4-lamp fixtures are installed in the offices and supplies room.

Typical fluorescent valance lighting

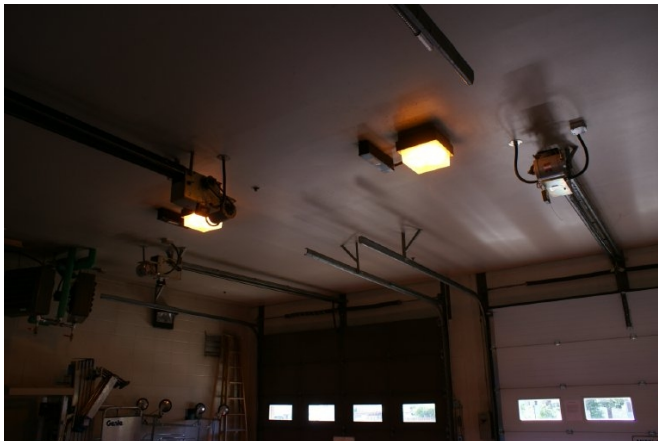
H.P.S. Lighting is used in the ambulance garage. There are two (2) H.P.S. surface mounted fixtures w/ remote mounted instant re-strike ballasts. Four (4) wall pack fixtures are located on the walls of the garage.

HID fixtures in the ambulance garage

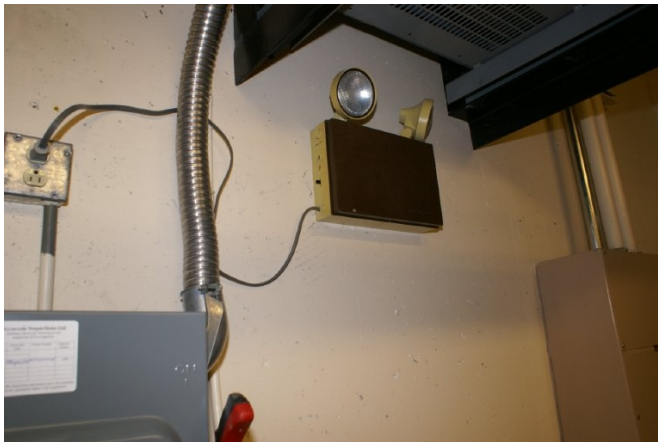
Emergency lighting throughout the hospital is provided by fluorescent fixtures connected to the backup generator. However there are two (2) emergi-lite battery packs installed. One (1) is located in the main electrical room and one (1) is located in the emergency generator room.

Emergi-Lite battery pack located in the main electrical room.

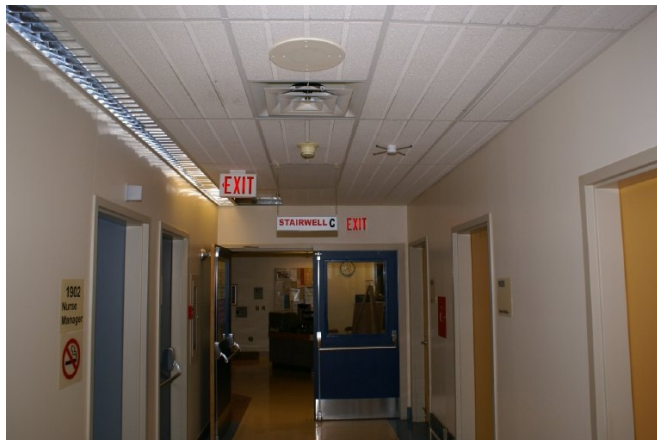
All exit signs are fluorescent PL type. Approximately 90% of the exit signs have been retrofitted with LED lamps. The coverage of signs is adequate and the exit signs are in good working order. The signs are circuited to an emergency circuit.

Typical exit signs in corridor

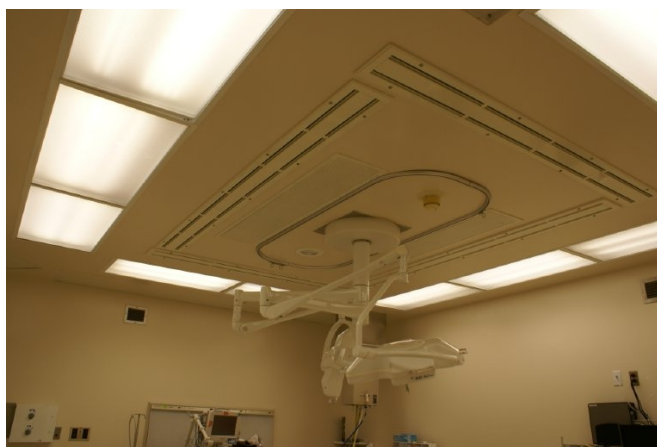
Typical O.R. lighting

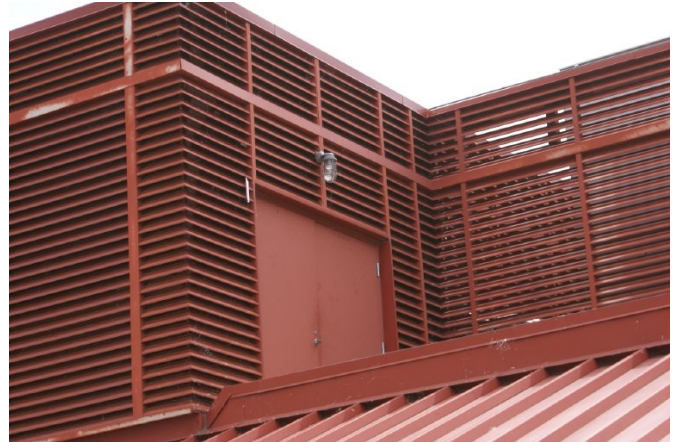
Incandescent wall fixtures are mounted at the exterior generator room entrance and the at the access door from the mechanical penthouse to the roof. Incandescent wall sconces are located in the exterior gas storage area.

Exterior incandescent wall mount fixture.

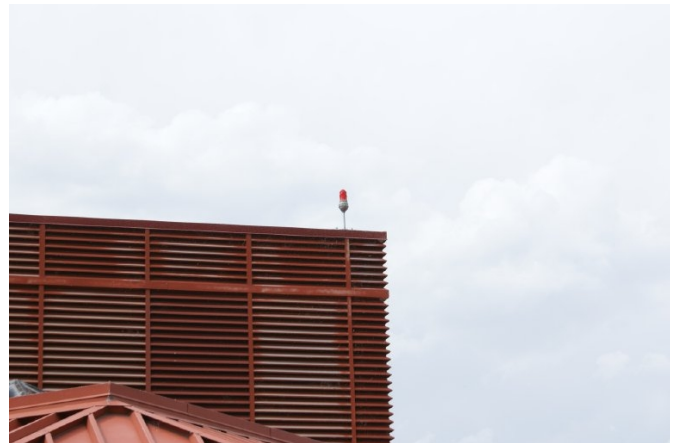
Incandescent aircraft clearance lamps are installed on the top of the building.

Aircraft clearance fixture on the top of the mechanical penthouse.

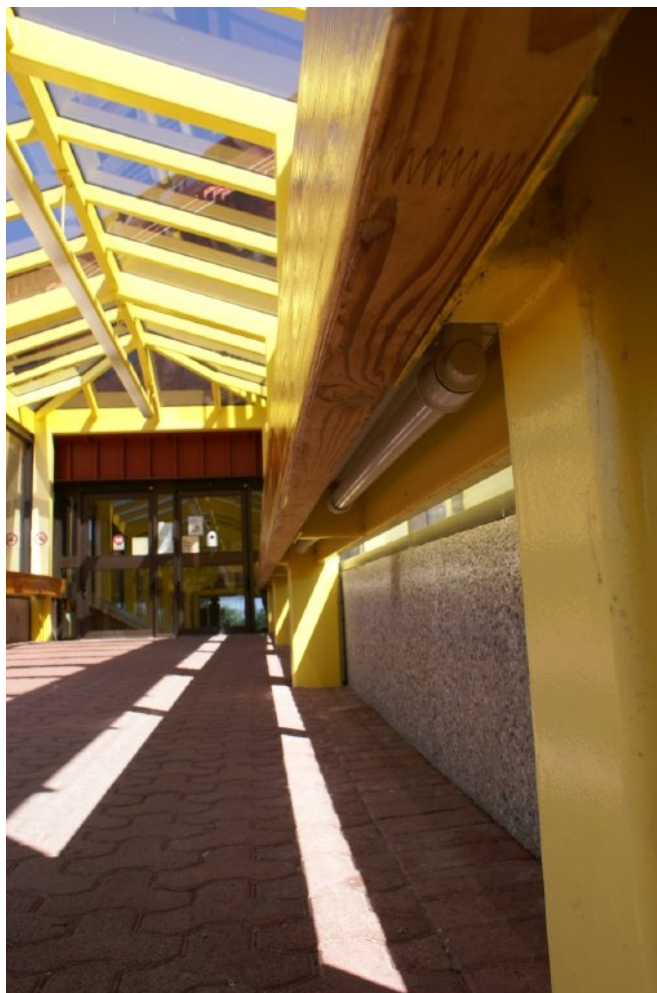
Exterior pendant linear fluorescent lighting is installed at the main entry and rear entry canopies. Florescent fixtures are installed under the handrails leading up the rear entrance ramp.

Exterior fluorescent fixtures mounted under handrails

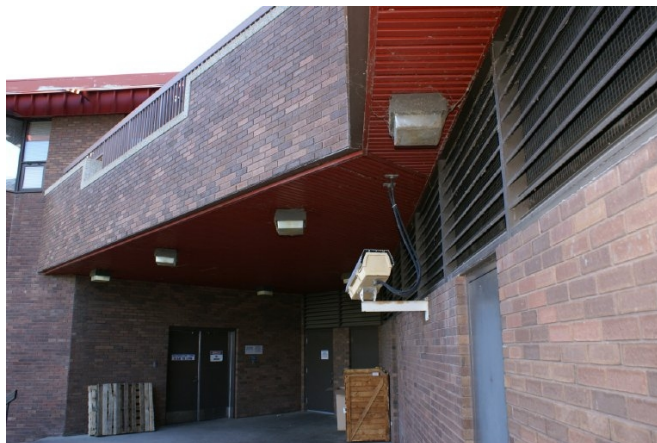
Various types of H.P.S. Lighting is installed around the exterior of the building. All of the exterior H.P.S. Lighting is 347V. There are 7 canopy fixtures located at the loading dock, and 3 canopy fixtures outside of the cafeteria. Pendant cylinder downlights are located at the three (3) exterior patio canopies. Wall mounted cylinder downlights are mounted at secondary exits. Seven (7) wall pack fixtures are located at the ambulance parking garage.

H.P.S. Canopy fixtures located at the loading dock

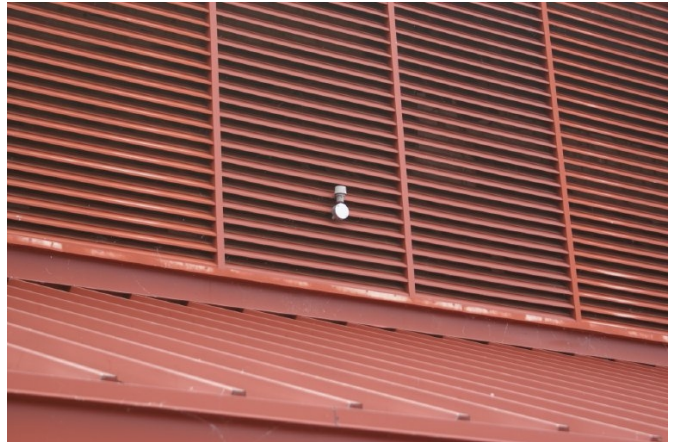
Exterior lighting is controlled via photocell w/ manual override switch. The photocell is mounted on the exterior wall of the penthouse and the manual override switch is located in the basement storage room #B-14.

Exterior photocell on mechanical penthouse wall.

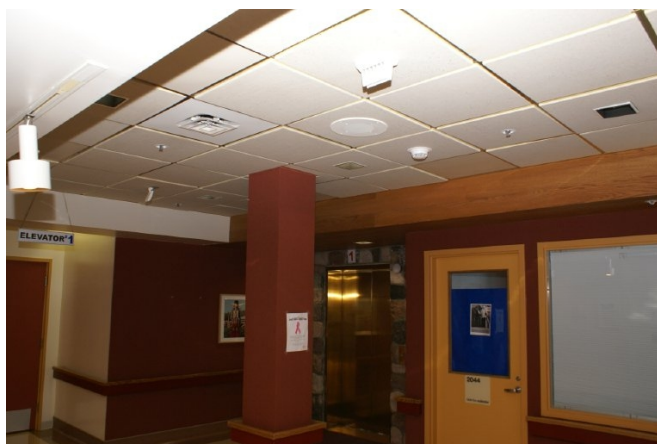
The second floor fire alarm system has been replaced with new simplex fire alarm components using the existing infrastructure. The new components are manufactured by simplex and are tied into the existing simplex fire alarm system.

New fire alarm smoke detector in the elevator lobby.

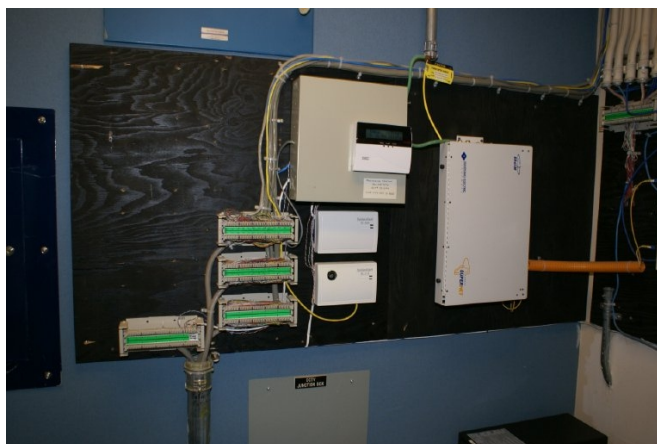
A DSC power series intrusion detection system is installed. The main control panel is located in the utility room behind the main desk in the lobby. Motion sensors monitor corridors adjacent the elevators and at major intersections. The system dates within the last 10 years.

The main intrusion detection control panel

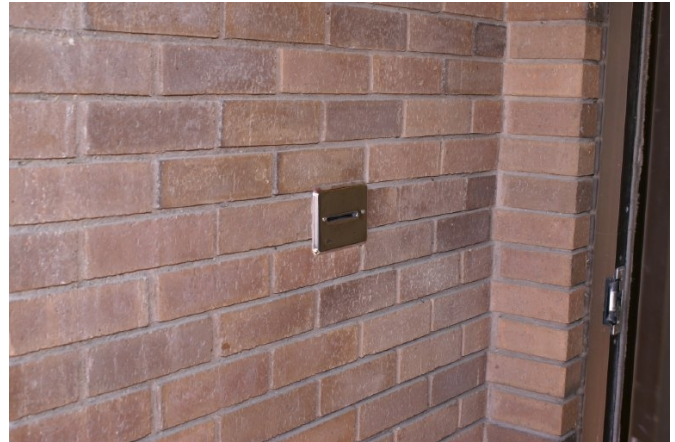
A card access system is installed. Card readers are located at the main entry, the rear entry and at the east staff entry. The card access system is no longer used.

Typical card reader

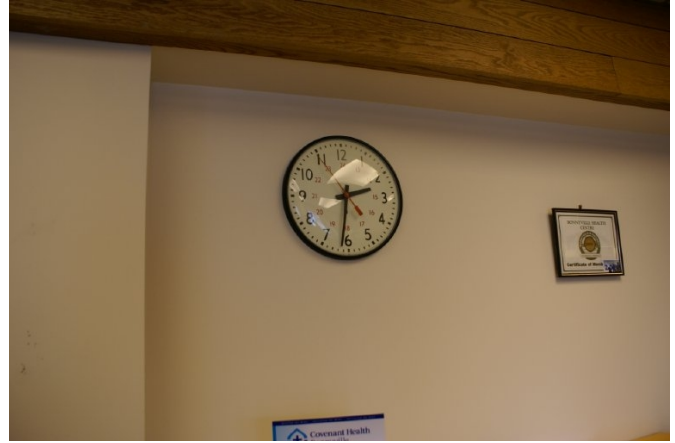
The synchronous clock system is manufactured by simplex and is tied into the multiplex fire alarm system. Clocks are round analog 12/24hr. The clocks are located throughout in corridors, staff rooms, nursing stations, Operation Rooms, Building personnel reports that the clock system is in working order. There are plenty of spare parts and clocks in the maintenance shop.

Typical analog clock

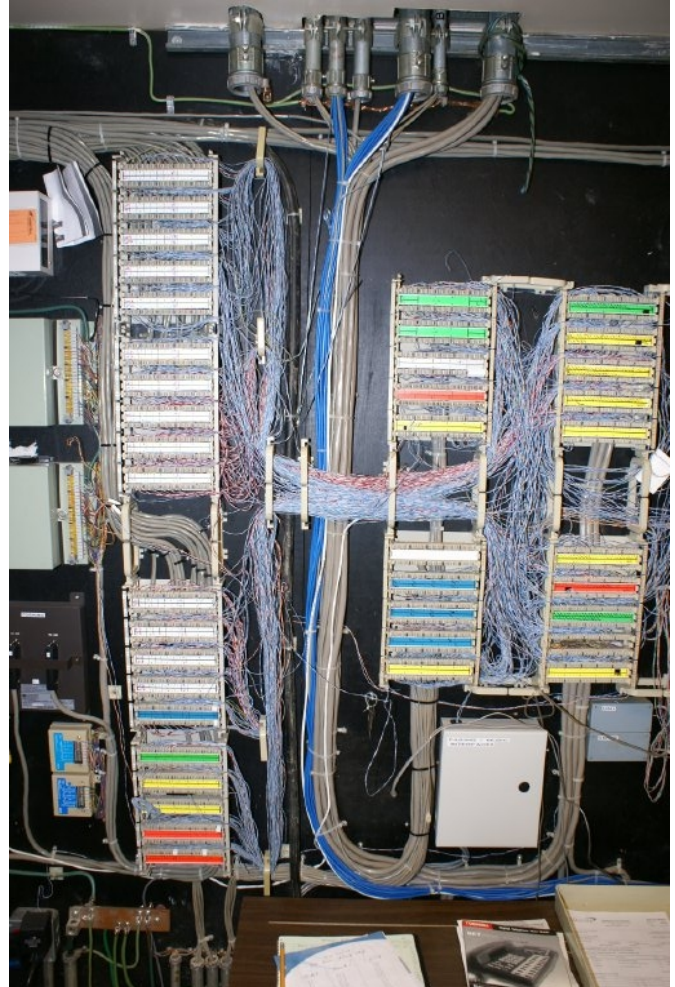
The main telephone demarcation is located in the main telephone room B-07. The PBX equipment is Toshiba Strata. Telephone tie cables run from the main telephone room to zone boxes located in various locations. From the zone boxes cat.3 cables are run to patient rooms and staff areas. The building personnel have noted that the telephone system is in good working order.

The main telephone demarcation

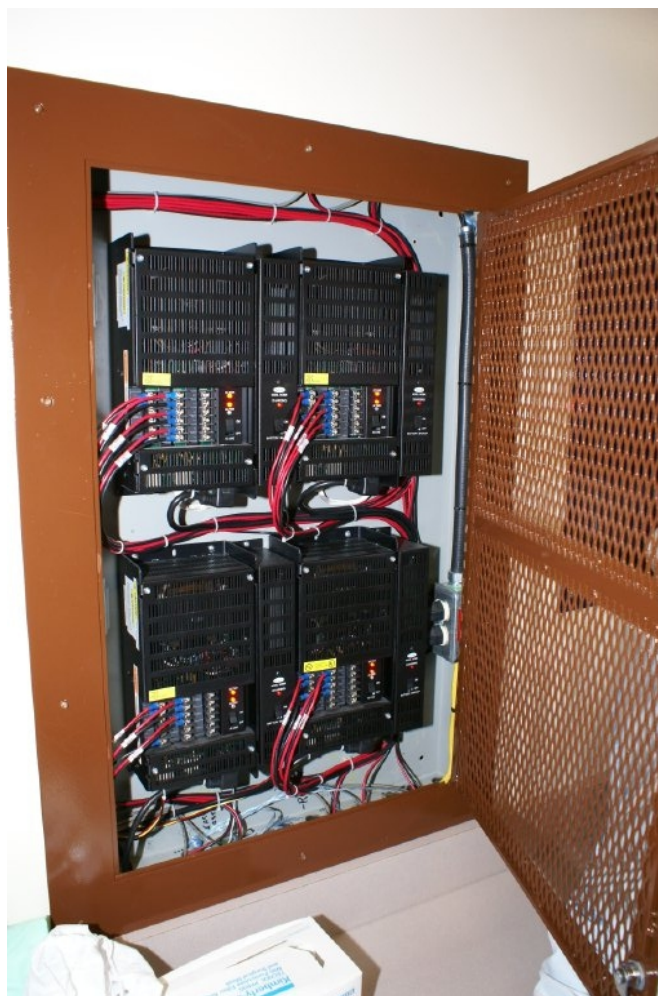
The nurse call system on the second floor has been replaced with new in 2008. The system was completely replaced with a Rauland Responder IV system. The nurse call stations in each patient room have been replaced with new stations. Nurse call response handsets are located in corridors and at the main nursing desk. Dome lamps located in corridors outside of patient rooms have been replaced with new. The existing nurse call system panels have been utilized to house new power supplies and main system electronics.

New power supplies installed in existing panels.

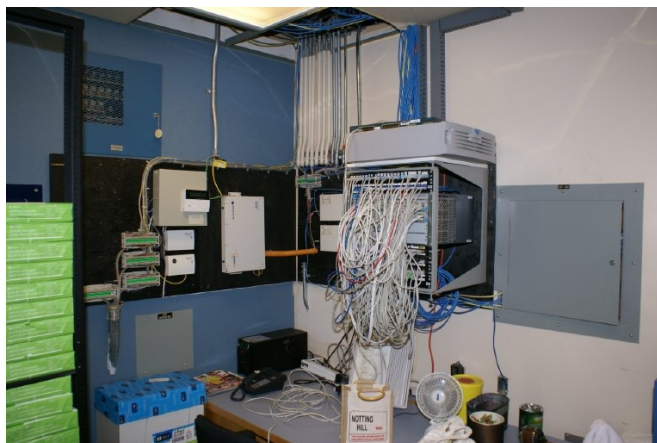
The main server is located on the second floor. Data racks are located throughout the hospital in various service rooms. Data cables are run from local outlets to the respective data rack/hub. Data cabling from the racks to outlets are of mixed types and mixed installation as cabling was added over the course of 10 years. The majority of cables are run free-air. Approximately 50% of the cables are Cat. 5, 45% are Cat. 5e, and 5% are Cat. 6.

Data rack/patch panel located behind the main desk.

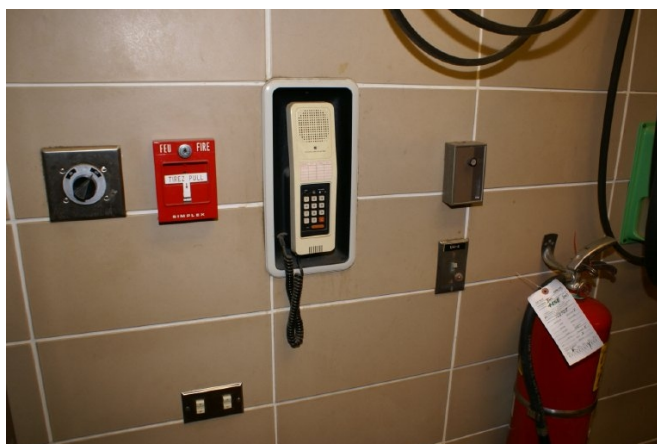
TOA intercom handsets are located throughout the building. Handsets are located at maintenance areas, staff rooms, and nursing stations. The main TOA intercom rack is located in the main electrical room. Building personnel report that the system is still operational and there are many spare parts and handsets located in the maintenance room.

Typical TOA intercom handsets

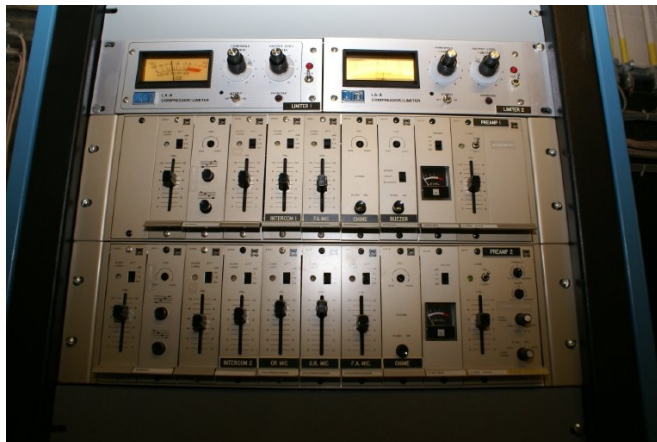
P.A. Speakers are located throughout the hospital in main corridors, public areas, utility rooms, and staff areas. The speakers are connected to the main telephone system, and paging functions are performed through the telephone handsets. The main P.A. system rack is located in the main electrical room. There are two (2) UREI LA-4 compression limiters, two (2) TOA pre-amps amplifiers, and four (4) TOA P-906 amplifiers. Adjacent the P.A. System rack is the Music System Rack. The music system rack is tied to the telephone system. There is one (1) Rauland MPX1100A Audio control panel, two (2) Rauland SRX145 AM/FM tuners, one (1) JVC XL-F215 CD player, and one (1) 4 cassette changer.

P.A. system pre-amps

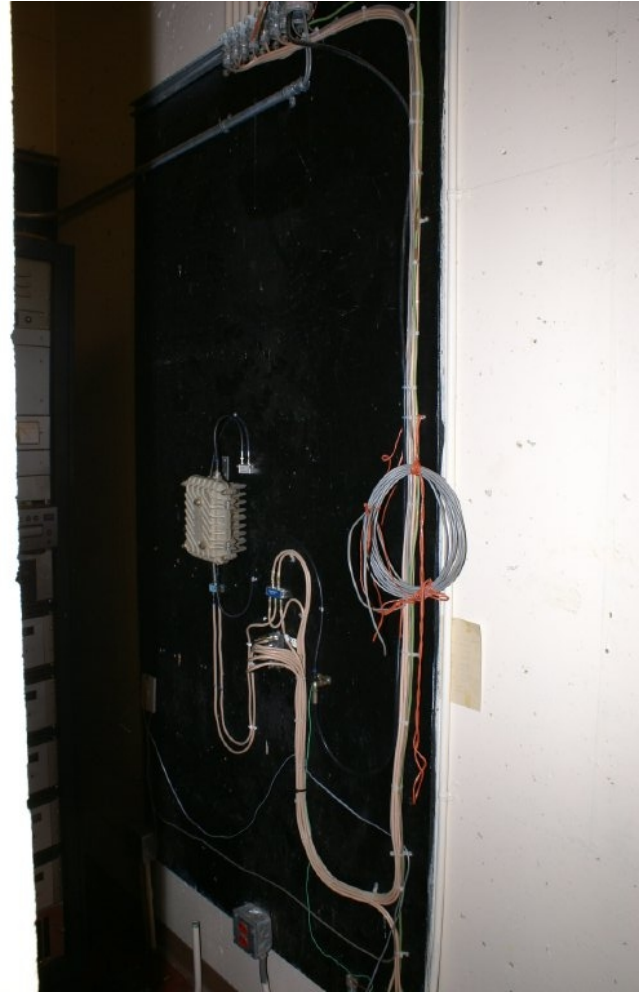
The main CATV demarcation is located in the main electrical room B-11. COAX cables run from the demarcation to various CATV zone boxes located in local electrical rooms throughout the hospital. COAX cables run from the local zone boxes to outlets located in patient rooms, waiting rooms and staff areas.

The main CATV demarcation

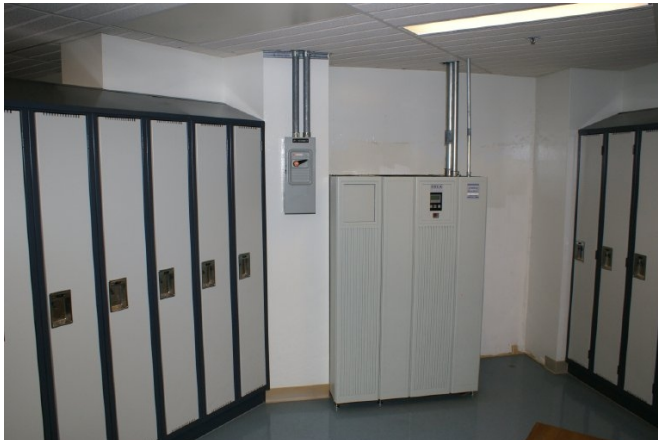
The UPS system is a Sola 6000 6KVA 120/208V 3ph 4w system. The UPS is located in the basement locker room B-09 and serves the UPS panel located in the main floor Laboratory. Building personnel have indicated that the batteries need to be replaced in the next couple of years.

Sola 6000 UPS

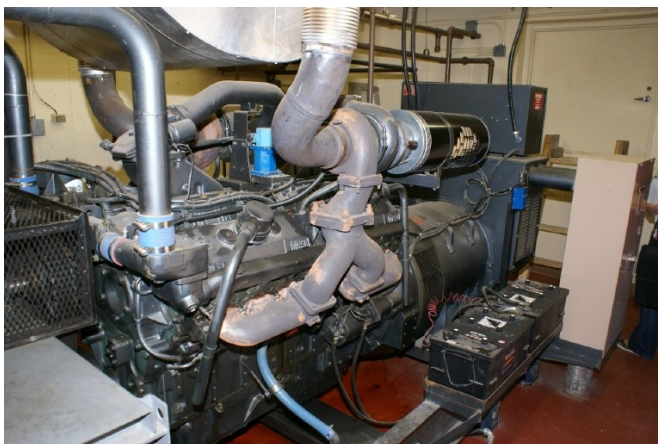
dsc00671.jpg

A diesel 625KVA 347/600V 3ph 4w Waterous/Leroy Sommer generator is located in the basement generator room. A diesel tank is located on the exterior of the room. A 120V Vulcan electric battery charger is located adjacent the generator. The Automatic transfer switch # 1 and 2 is manufactured by Asco. The transfer switches are located in the main electrical room. Automatic transfer switch #2 was originally designed for Peak shaving to the manual transfer switch located in the CSR (room B-19) however the transfer switch is manually set to bypass the peak shave system.
