WORKER CRUSHED BY FORKLIFT

Type of Incident: Fatality

Date of Incident: October 17, 2012

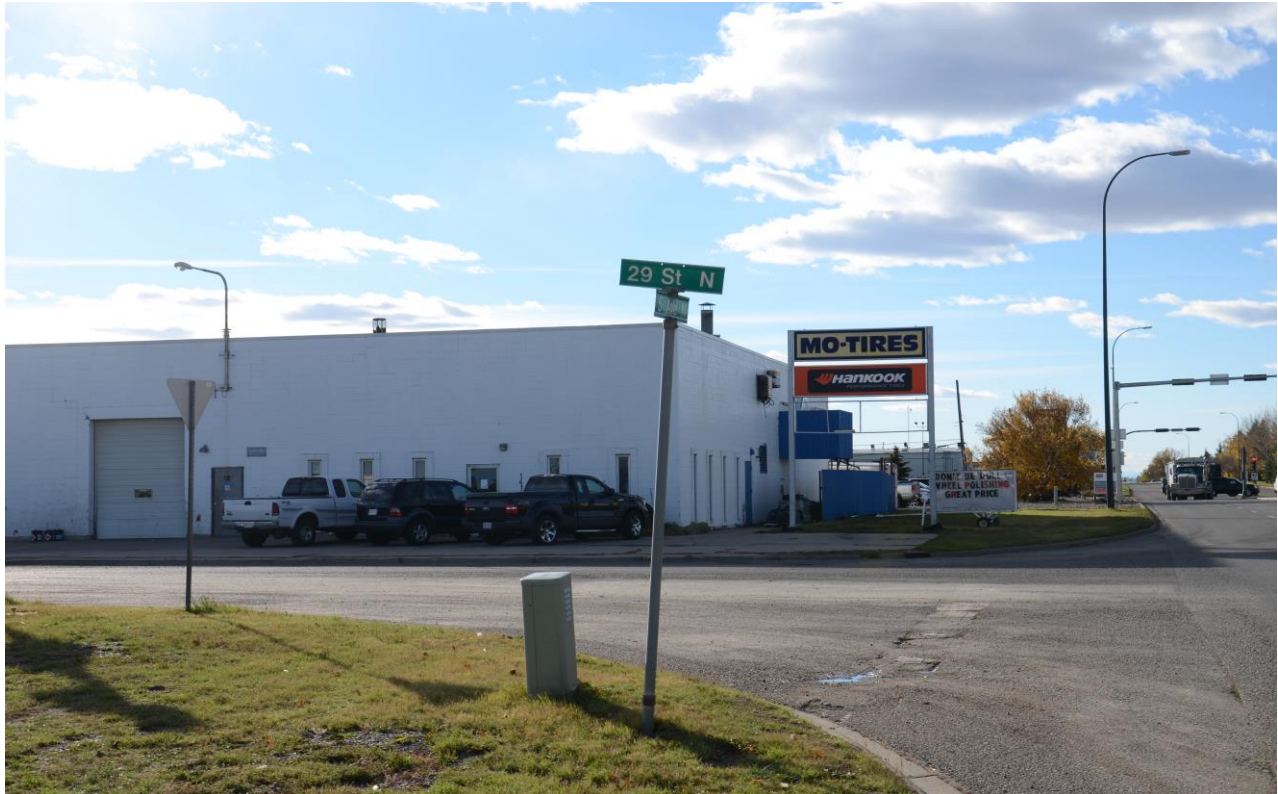
**File: F-16739
ATTACHMENT B
PHOTOGRAPH 1 of 5**

Photograph 1 - Picture shows the Mo-Tires Ltd. truck center office and shop located at 2830 – 5 Avenue North, Lethbridge, Alberta.
