WORKER CRUSHED IN CONVEYOR

Type of Incident: Fatality

Date of Incident: December 6, 2012

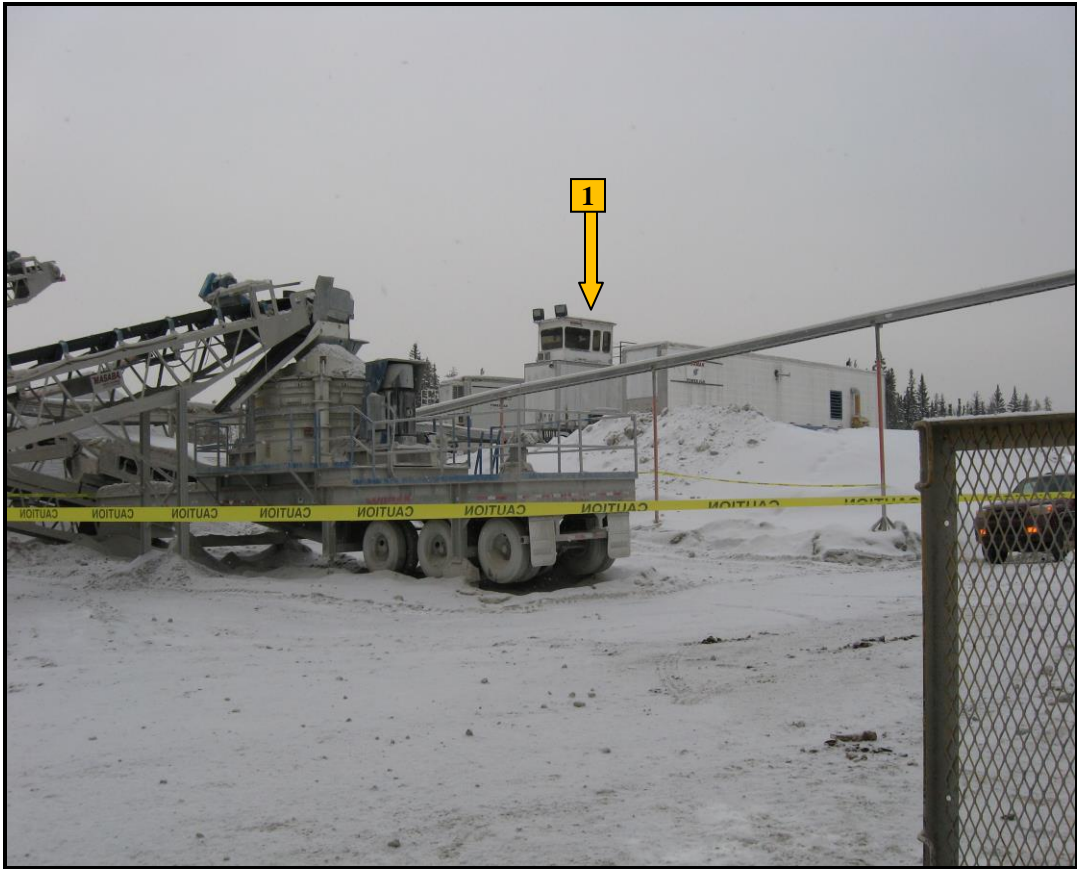
Photograph #1

This is a photograph facing northeast of the Andreas Crushing System’s control tower. Note: this photo was taken from the belt gravity take up on conveyor 88 where the incident happened.

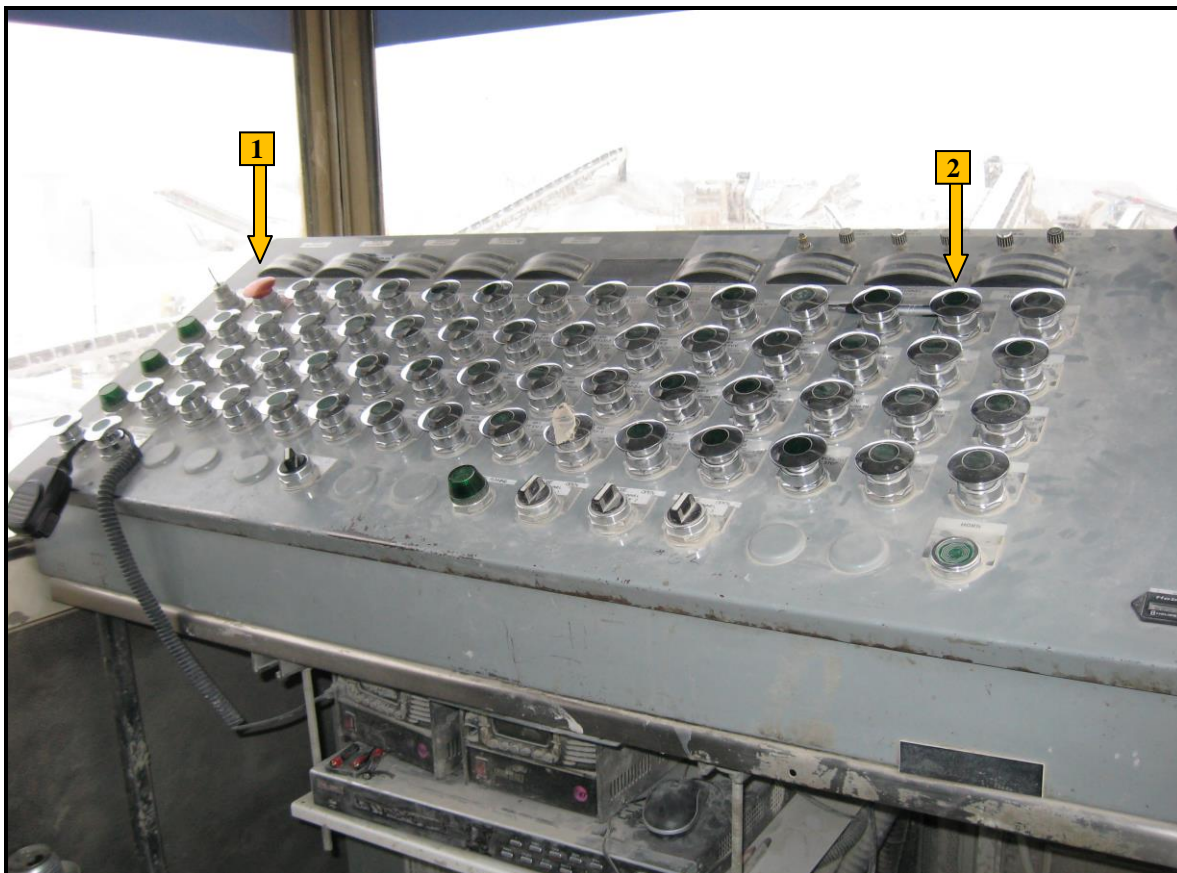
Photograph #2

This is a photograph of the control panel located in the Andreas control tower with stop buttons for the various pieces of equipment contained within the Andreas Crushing Spread.

1. Emergency stop button
2. Conveyor 88 stop button

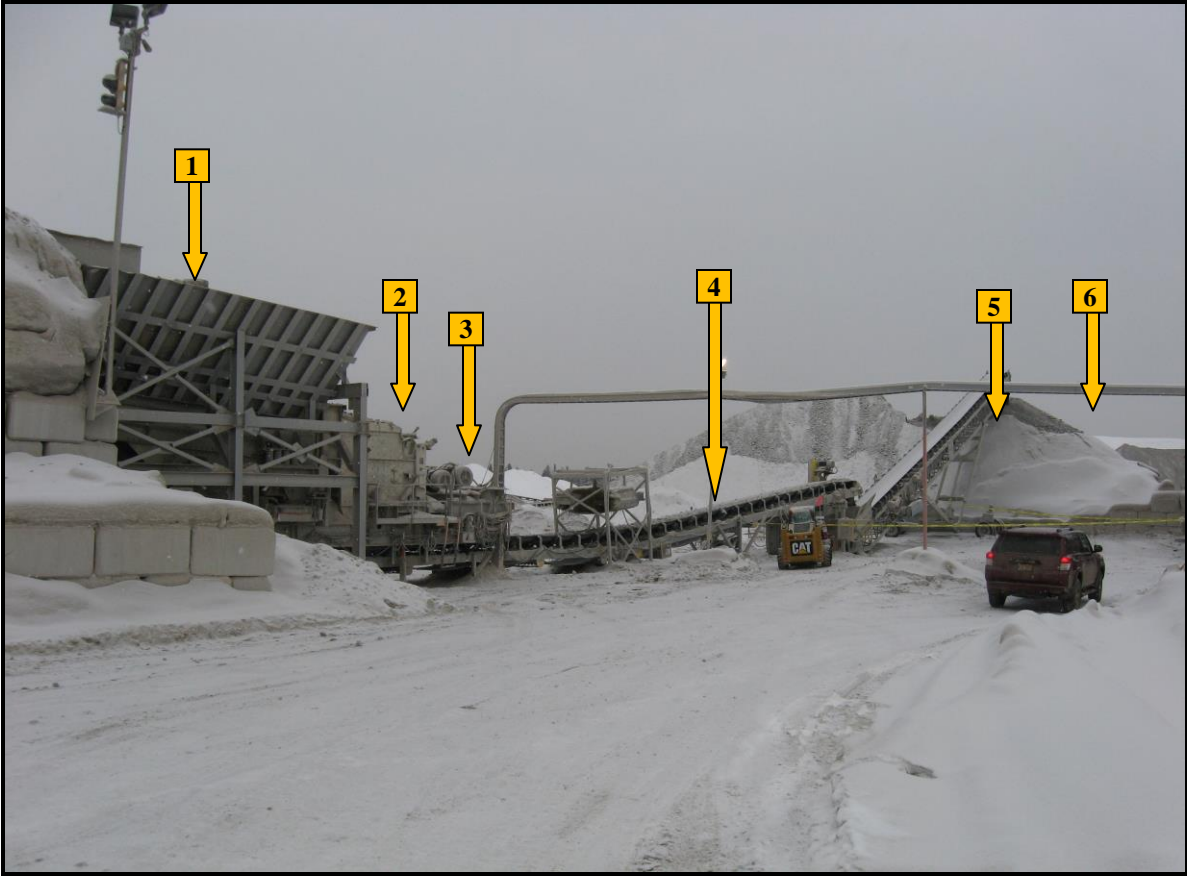
Photograph #3

5.1.2.3 Limestone is blasted in the mine area and transported to the Andreas system where it is dumped into the receiving hopper. At the bottom of the hopper, a vibrating grizzly feeder (VGF) facilitates delivery of the product into the horizontal shaft impactor (primary crusher) which is located immediately adjacent to the VGF. Limestone is crushed to 15-25 cm diameter and then falls onto the Andreas discharge conveyor below (conveyor 88) which, in turn, feeds onto the adjacent stacker conveyor (conveyor 25/26). The stacker conveyor builds a conical mound of crushed limestone known as a surge pile (Attachment C, Photograph #3).

5.1.2.4 Limestone from the surge pile is removed through the reclaim tunnel system which is located underneath the pile itself. The tower operator monitors and controls the rate at which the limestone is reclaimed. The reclaimed limestone is fed onto a series of screen boxes (screeners) which distribute the crushed limestone according to size. Coarse product is directed to the surge bin by way of the secondary crusher, optimally sized product is transported directly to the surge bin and fine product is sent to a waste stockpile (Attachment C, Photographs #3 and #4).

This is a photograph facing southwest of the primary Andreas Crushing Spread.
