**CARPENTER WORKER SUFFERS FATAL
HEAD INJURIES IN FALL FROM HEIGHT**

Type of Incident: Fatal Incident

Date of Incident: February 11, 2011

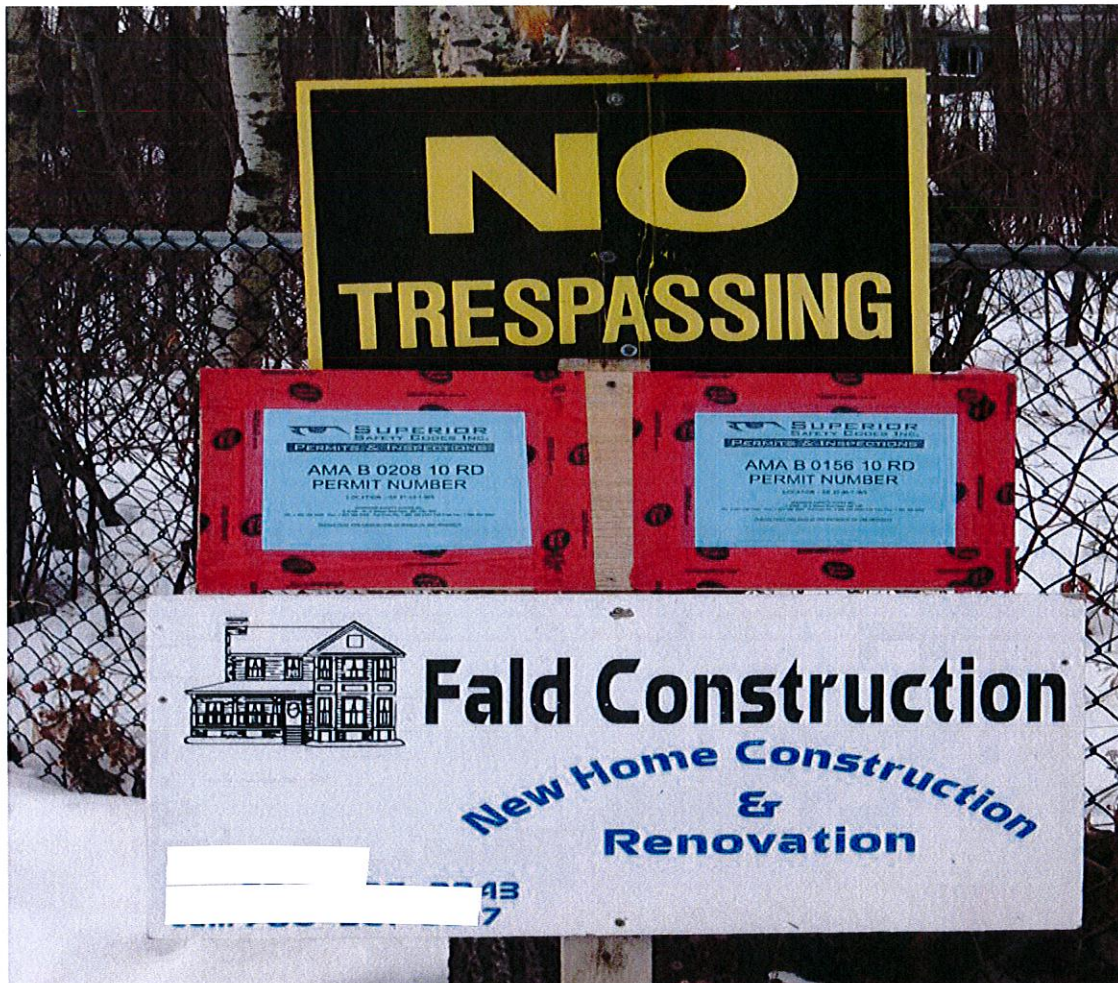
Photograph #1 Shows the signage posted at the entrance to the property with the company information for Fald Construction

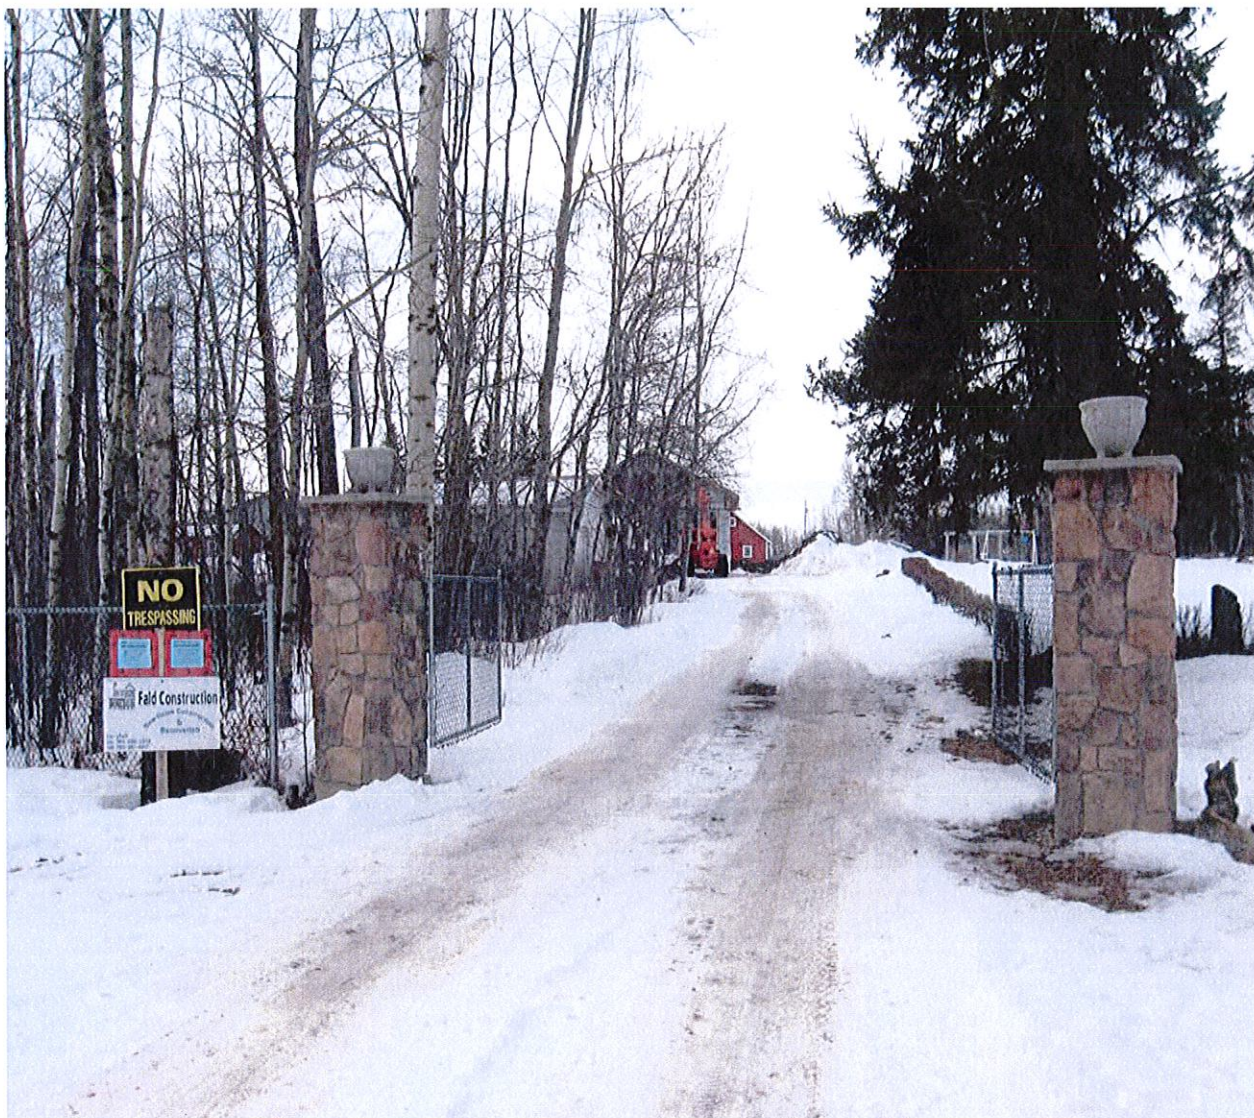
Photograph #2 Shows the entrance to the property looking to the west
