RECAPP Facility Evaluation Report

Aspen Regional Health Authority

Hinton General Hospital

Evaluation Company: KOLIGER SCHMIDT architect-engineer
Evaluation Date: November 27 2008
Evaluator Name: Steve Horvath

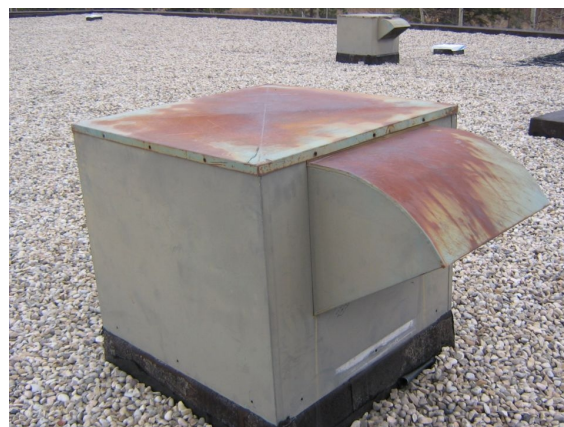
Roof mounted exhaust fan.

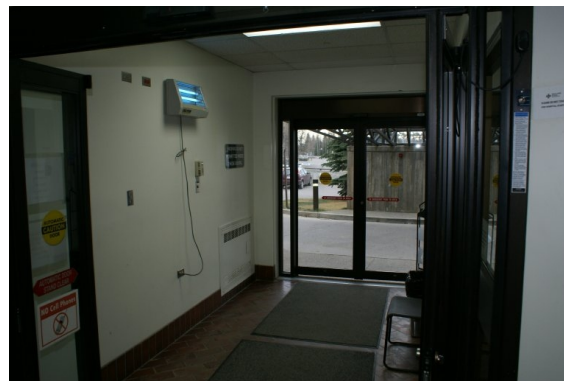
Fan coil unit and electric heater.

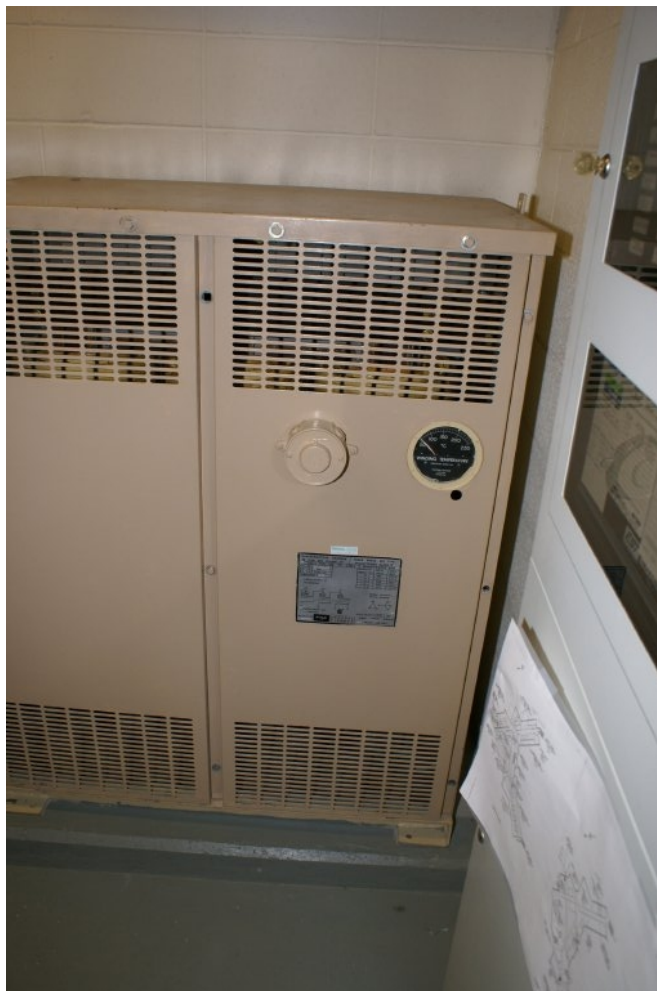
Federal Pioneer Transformer

Event: Replace Secondary Electrical Transformers (Interior)

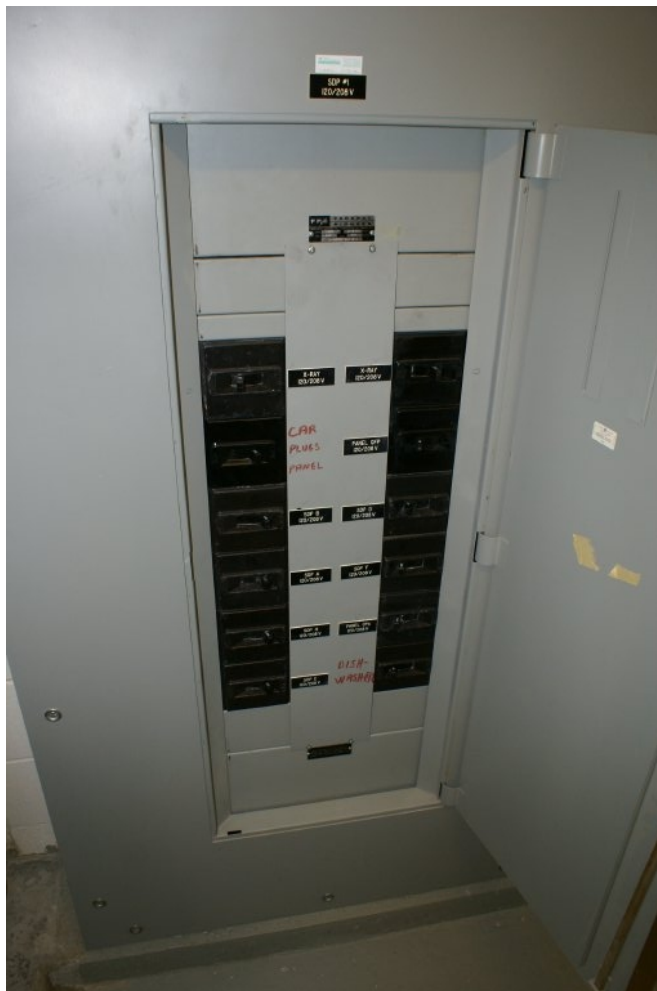
The majority of branch circuit panels are manufactured by Federal Pioneer. 120/208V panels are painted 'gray' and 347/600V panels are painted 'sand'. There are Four (4) secondary distribution panels, one (1) is 600A 347/600V 3ph 4w (6 spaces for future) and three (3) are 120/208V 3ph 4w (various amperages) There is approx 15% spare capacity. There are a total of eight (8) 225A 347/600V 3ph 4w branch circuit panels with approx 60% spare capacity. There is a total of eighteen (18) 225A 120/208V 3ph 4w pranch circuit panels with approx 10% spare capacity (About 8 panels are full). There one (1) 600A 120/208V 84cct panel in the kitchen (16 spaces for future). There is a total of eight (8) 120V 1ph 2w panels (various amperages), and two (2) 208V 1ph 2w panels. There is one (1) 120/240V 1ph 3w G.F.C.I. panel (12 spaces for future).

Typical CDP panel

Event: Replace Electrical Branch Circuit Panelboards (Secondary Distribution)

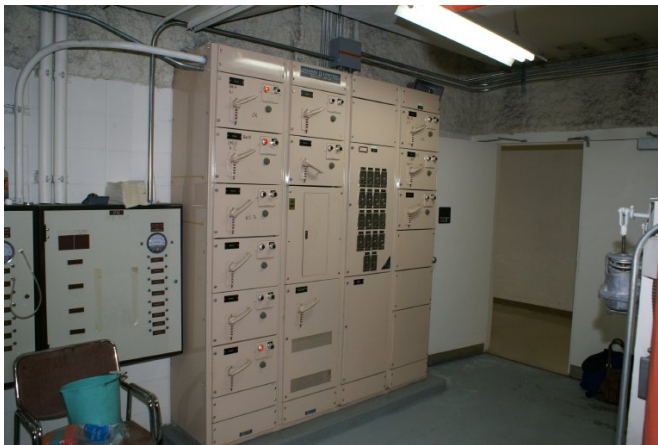
Motor Control Centre #MCC2

There are three (3) Motor control centers. All MCC's are manufactured by Square 'D'. MCC's consist of a Regular 600V section and an Emergency 600V section in each. MCC #1 and MCC #EM1 is 600A 600V 3ph 3w and consists of three (3) mag starter sections and one (1) control section w/ 12 circuit panel (1 space and 4 breaker spaces) for MCC #1 and two (2) mag starter sections and one (1) control sections w/ 12cct panel (1 spare and 8 breaker spaces) for MCC #EM1. MCC #2 and MCC #EM2 is 600A 600V 3ph 3w and consists of two (2) mag starter sections and one (1) control section w/ 30cct panel (12 breaker spaces) for MCC #2 and one (1) mag starter section (3 spaces) for MCC #EM2. MCC #3 and MCC #EM3 is 600A 600V 3ph 3w and consists of two (2) mag starter sections and one (1) control section w/ 12cct panel (2 breaker spaces) for MCC #3 and one (1) mag starter section (3 spaces) for MCC #EM3. There is one (1) 50A 600V Sylvania fire pump booster panel.

Event: Replace Switchboards, Panelboards, and (Motor) Control Centers

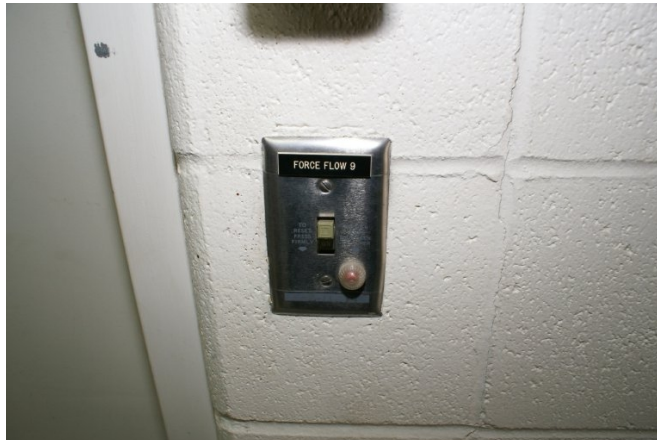
The majority of Motor Starters are located in the MCC units. There are some Fractional H.P. motor starters located throughout the building to control local motor loads (such as small exhaust fans and force flow heaters) The motor starters are manufactured by Square 'D'.

Manual motor starter c/w pilot light

Event: Replace Motor Starters and Accessories

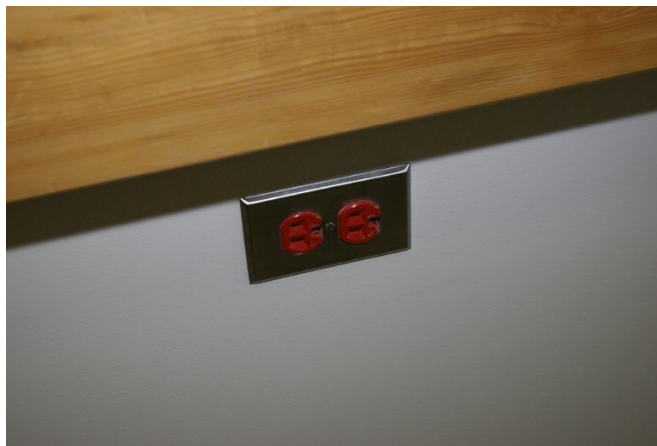
The majority of the building wiring is conductors in conduit. Armored BX cable is used for lighting drops in t-bar ceilings. In some of the recent electrical renovations/additions Teck cable has been utilized for the feeders the newer equipment such as the car plug panel, sterilizer, and autoclave unit. Some of the junction box coverplates containing 347V circuits are painted gold. Receptacles on normal power are standard ivory w/ stainless steel coverplates. Receptacles on emergency power are red with stainless steel coverplates. Patient rooms consist of two (2) normal power receptacles and one (1) emergency receptacle opposite from the bed. Building users report that there are not enough receptacles/circuits for some areas.

Typical Patient Room emergency receptacle

Event: Install 6 receptacles

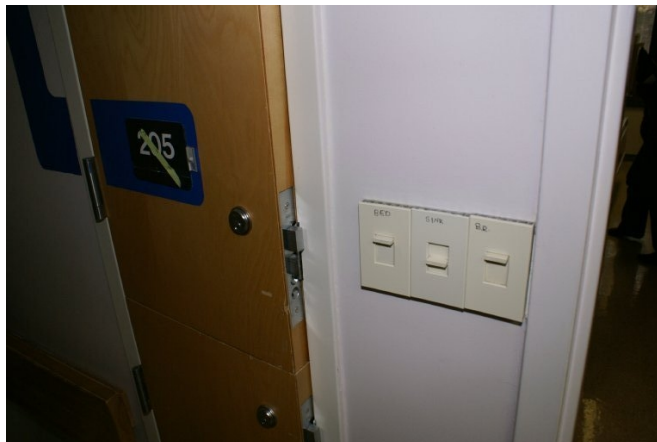
Typical patient room switches.

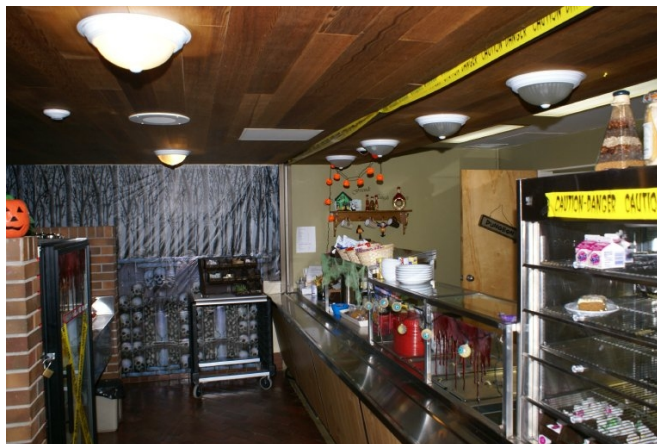
Incandescent lighting is used in various locations in the hospital and some of the incandescent fixtures are retro-fitted with fluorescent bulbs. Downlights are used in the lower floor doctors lounge and upper floor main waiting area. Keyless incandescent lamps holders are used in some utility areas on the lower floor. Incandescent dome lights are used in various utility rooms throughout the hospital but some are missing the glass lenses. Repairs are required. Incandescent dome lights are used throughout the Dining Area and the lower floor rotunda bulkheads. There is approximately 15 fixtures in Dining and 6 in the rotunda. Lighting levels in the Dining Area is poor 7-10FC. Incandescent wall sconces are used in the main stairwell. Building users comment the lighting levels in the main stairwell at night are very poor. Lighting needs to be upgraded. Patient rooms have incandescent vanity lights in bathrooms and Incandescent downlights above the beds.

Incandescent dome lights in the Dining Area

Event: Replace Interior Incandescent Fixtures

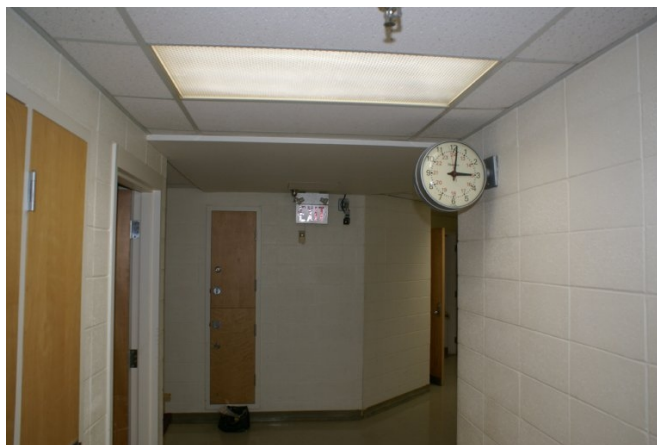
T12 lamps and ballasts will not longer be available for purchase after 2010. Fixtures will need to be retro-fitted or replaced with T8 lamps and ballasts after 2010. Maintenance personnel can retrofit fixtures as T12 lamps or ballasts burn out.

Typical corridor fluorescent light

Event: Install additional Interior Fluorescent Fixtures

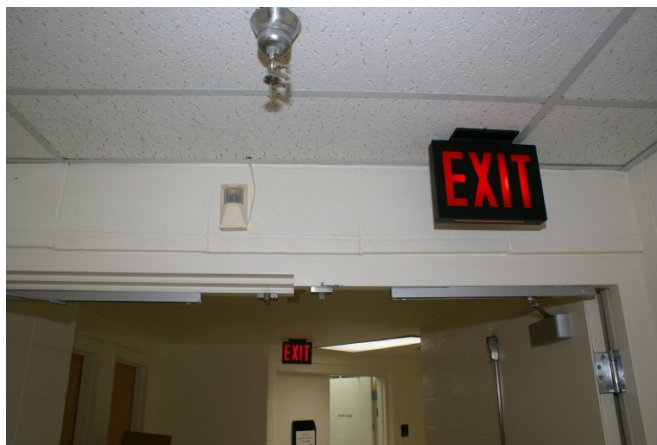
The majority of the exit signs in the building are from the 1979 construction and are in good working order. The exit signs are black incandescent style and have been retro-fitted with LED lamps. Some exit signs (w/ emergency heads) have been added in the lower floor corridor within the last 10 years. Some of the bulbs in the exit signs are burnt out and need to be replaced. General maintenance is required. The exit sign located at the mechanical room exit is concealed and needs to be relocated.

Typical incandescent exit sign.

Event: Relocate Exit Sign

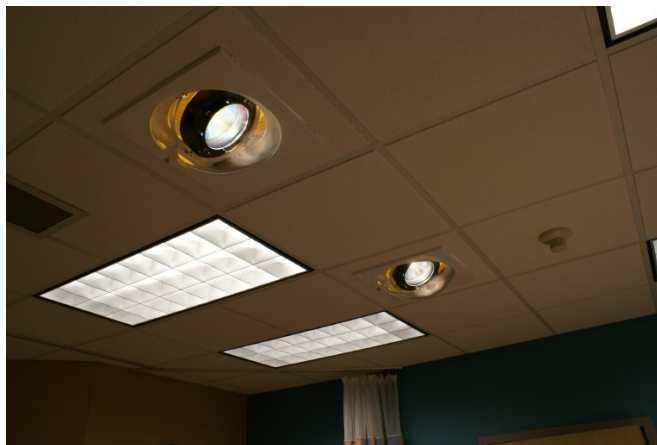
Examination lighting in the delivery room

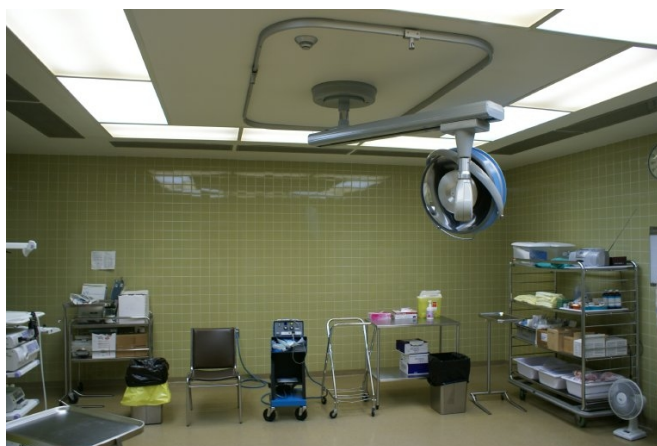
Endoscopy Operating Room

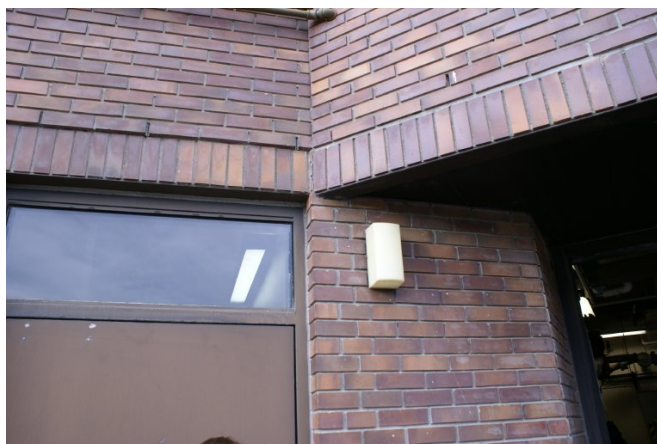
Incandescent wall mounted fixture.

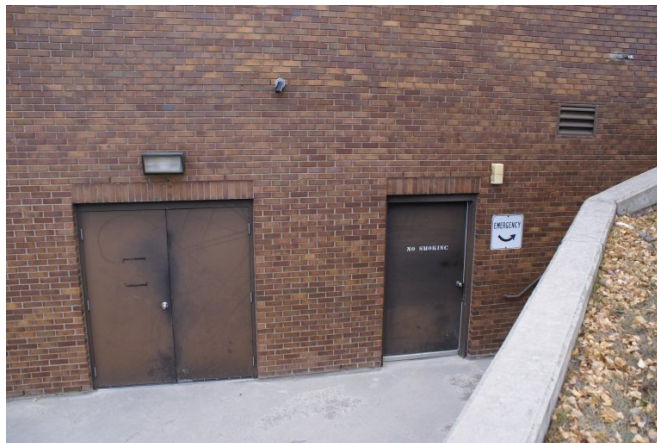
There are nine (9) flush wall mounted HPS fixtures located at the emergency entrance. There are two (2) HPS wall pack fixtures at the south stairwell exit and at shipping & receiving. HPS flood lights (installed within the last 15 years) are located on the top of the parapet. Fixtures were removed at time of inspection to accommodate installation of new flashing, damaging the conduit installation. Repairs are required for the conduit feeding roof mounted flood lights.

HPS wall pack fixture at Shipping & Receiving

Event: Repair Exterior H.P. Sodium Fixtures

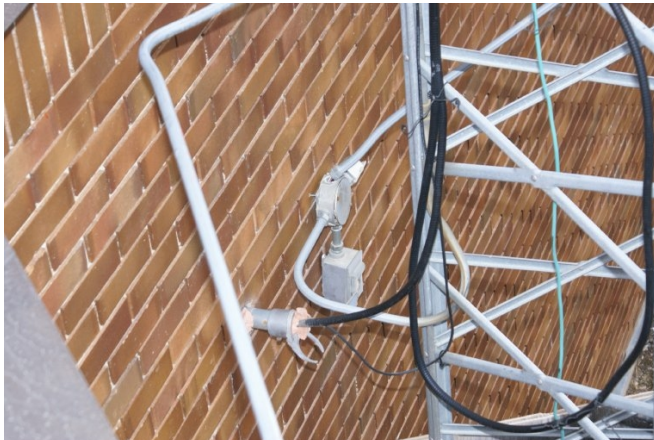
The exterior lighting original to the 1979 construction is controlled via photocell mounted on the roof and a timeclock override. HPS flood lights located on the roof are controlled via wall mounted photocell at the east side of the building. Conduits from photocells are damaged and require repair.

Photocell controlling roof mounted flood lights.

Event: Repair/Replace damaged conduits.

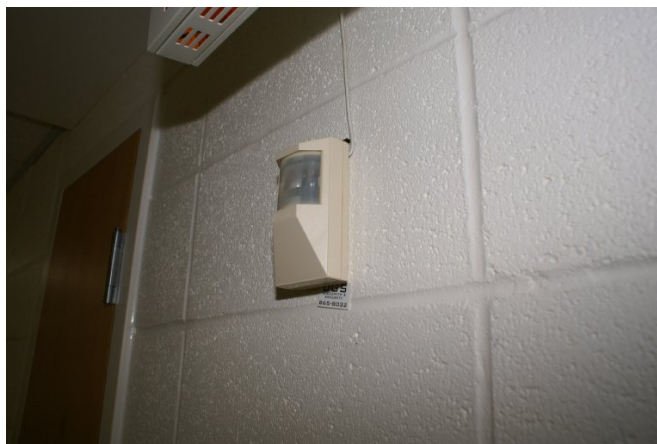
Typical security motion sensors

Event: Replace Intrusion Detection System

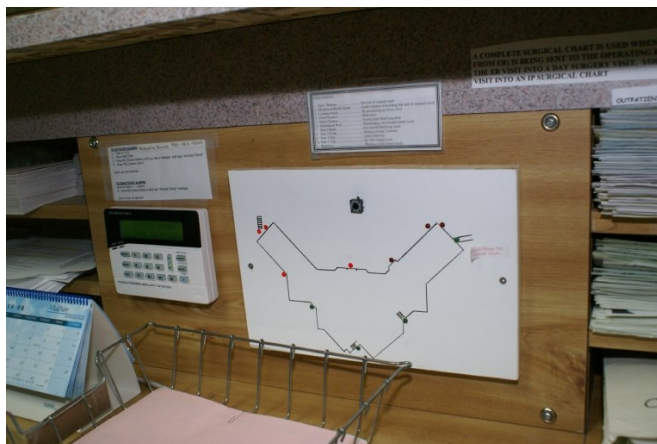
There is no security access system in the hospital, however all exterior exit doors are monitored and alarmed. The main monitoring station is located at the main admitting desk. The system appears to be from the original 1978 construction and is operational

Exit door security and alarm system

Event: Replace Security Access System

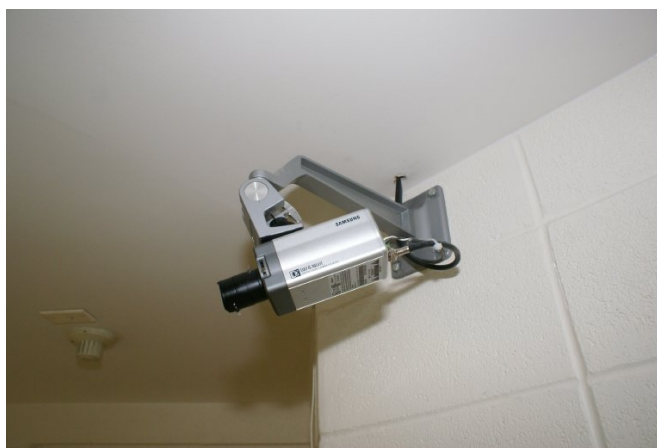
Samsung CCTV security camera

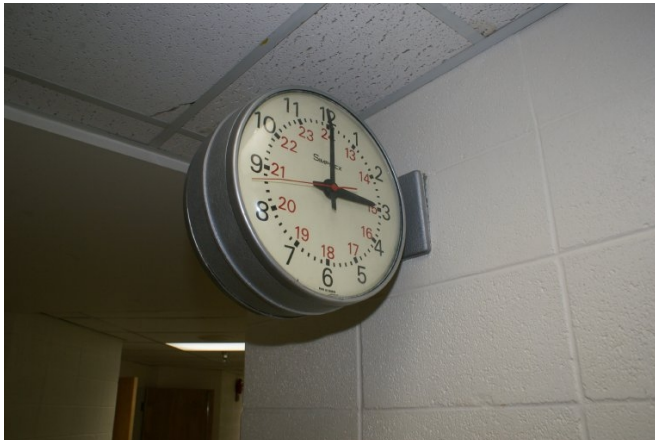
The clock system in the hospital is a Simplex 120V analog clock system with no central control. The clocks are operational, however building maintenance reports that setting the built-in clocks is very time consuming and since they are manually set individually they all display different times.

Simplex wall mounted clock

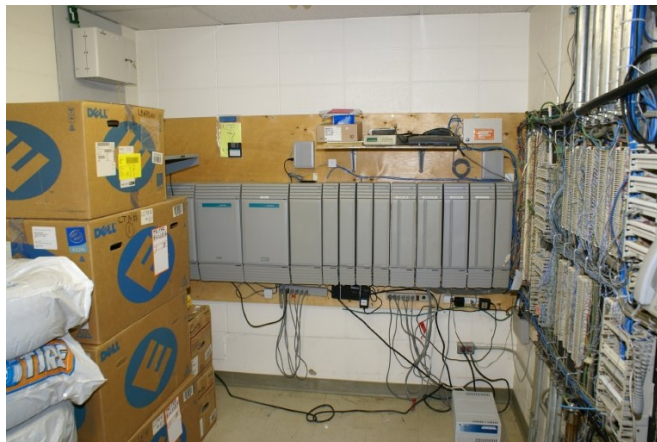
The telephone system and handsets are a Nortel Meridian system . The main telephone demarcation is located in the telephone room on the south east side of the lower floor. The service entrance conduit shows signs of water ingress and repairs are needed.

Main telephone demarcation and the Nortel Meridian PBX system

Event: Repair Telephone Systems

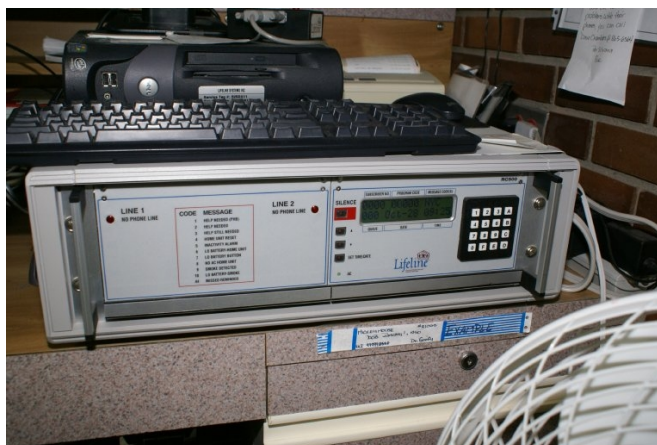
Lifeline PC500 system

Event: Replace Call Systems (~9300m²)

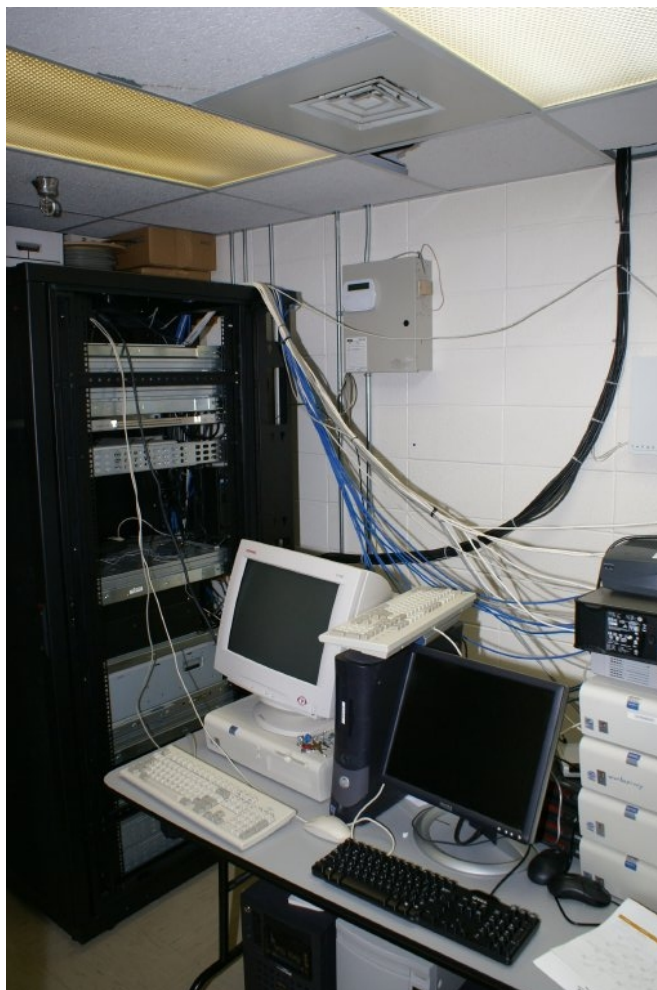
The local area network consists of cat 5e cabling run free air in the ceiling space from various wall outlets located throughout the hospital to the main data room located on the lower floor. The laboratory has a local area network of data outlets connected to a local hub. The local hub is connected to the main data room. Laboratory users note that there are not enough data outlets for the functionality of the laboratory.

Main data rack and server room.

Event: Provide additional data outlets (~400m²)

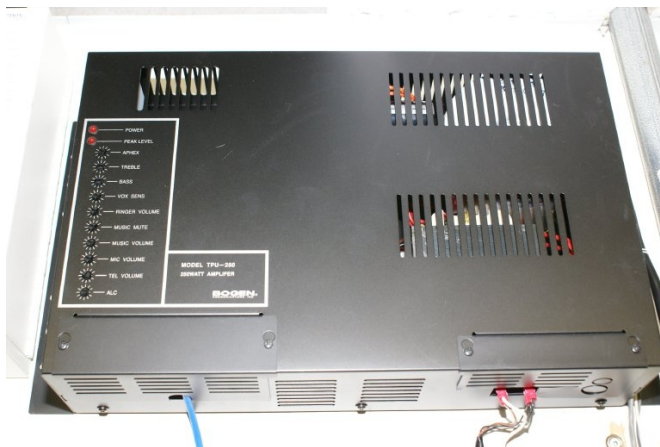
Bogen TPU-250 P.A. amplifier

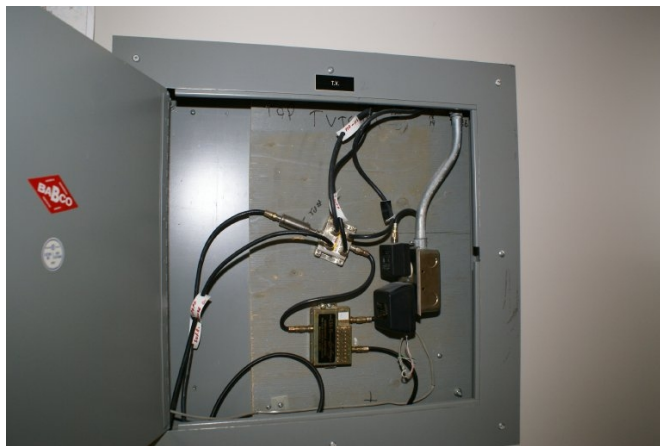
Sub-catv cabinet located on the upper floor.

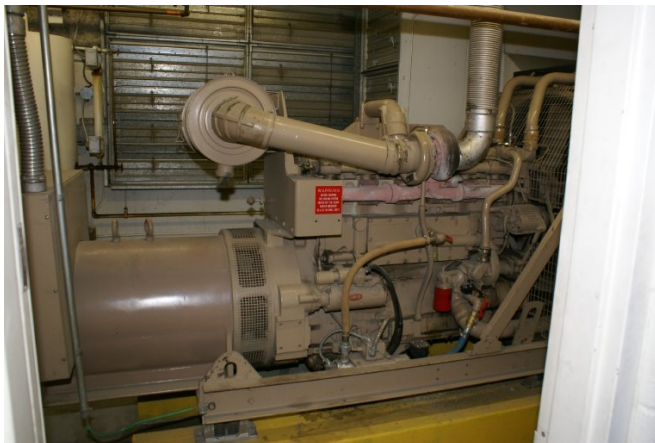
The diesel emergency generator

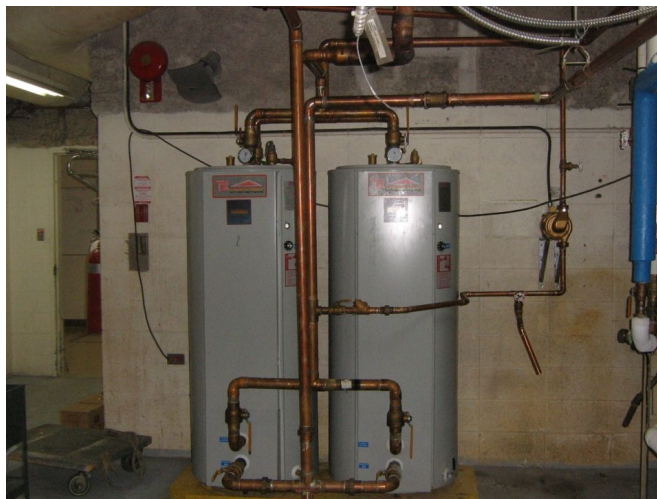
IMG_2593.JPG

Sprayed on material to ceilings and walls in boiler rooms - Refer to B1010.09 Floor Construction Fireproofing*

<u>Rating</u>	<u>Installed</u>	<u>Design Life</u>	<u>Updated</u>
4 - Acceptable	1979	0	MAR-10
