# Worker fatally injured when crushed by falling pipe

October 30, 2021

# Summary of investigation and outcomes

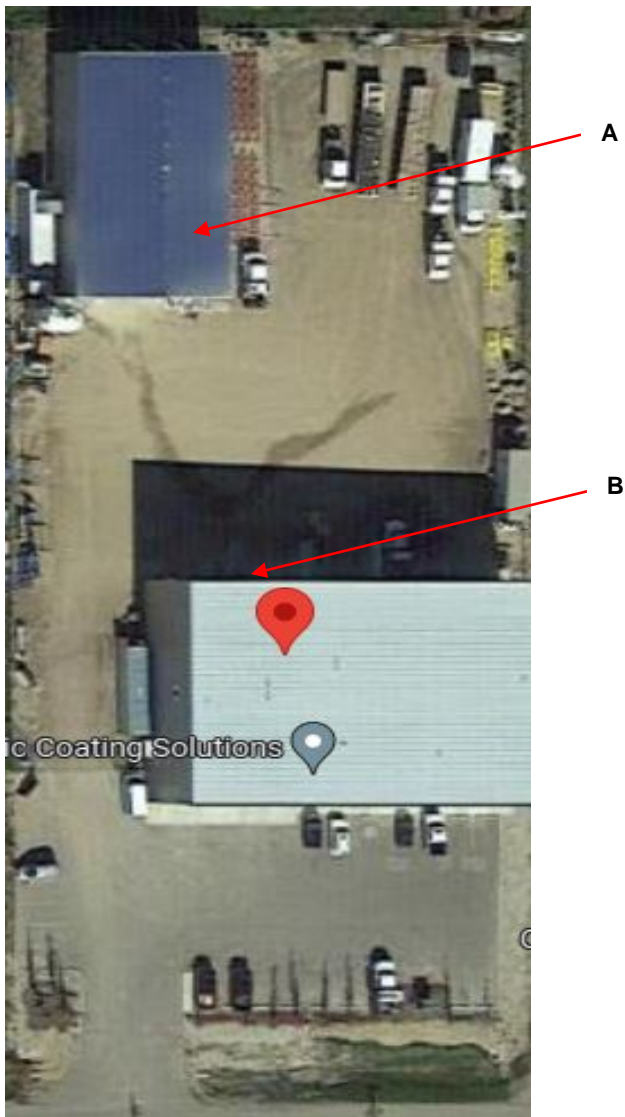
*Figure 1. Post incident Google map view of the work site.*

- A. Abrasive blasting building.
- B. Paint bay entrance in main building where incident occurred.

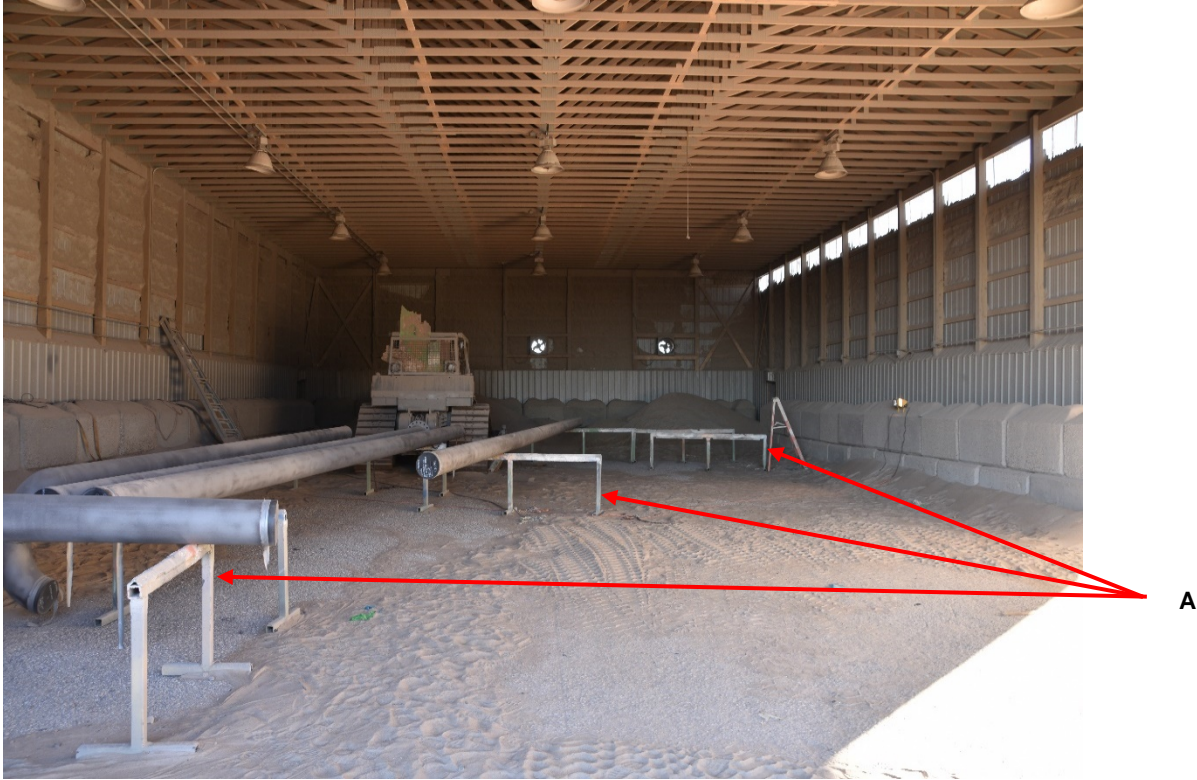
**Figure 2.** Post incident view of the bunks in the abrasive blasting building for pipe sections.

A. Bunks for loads.

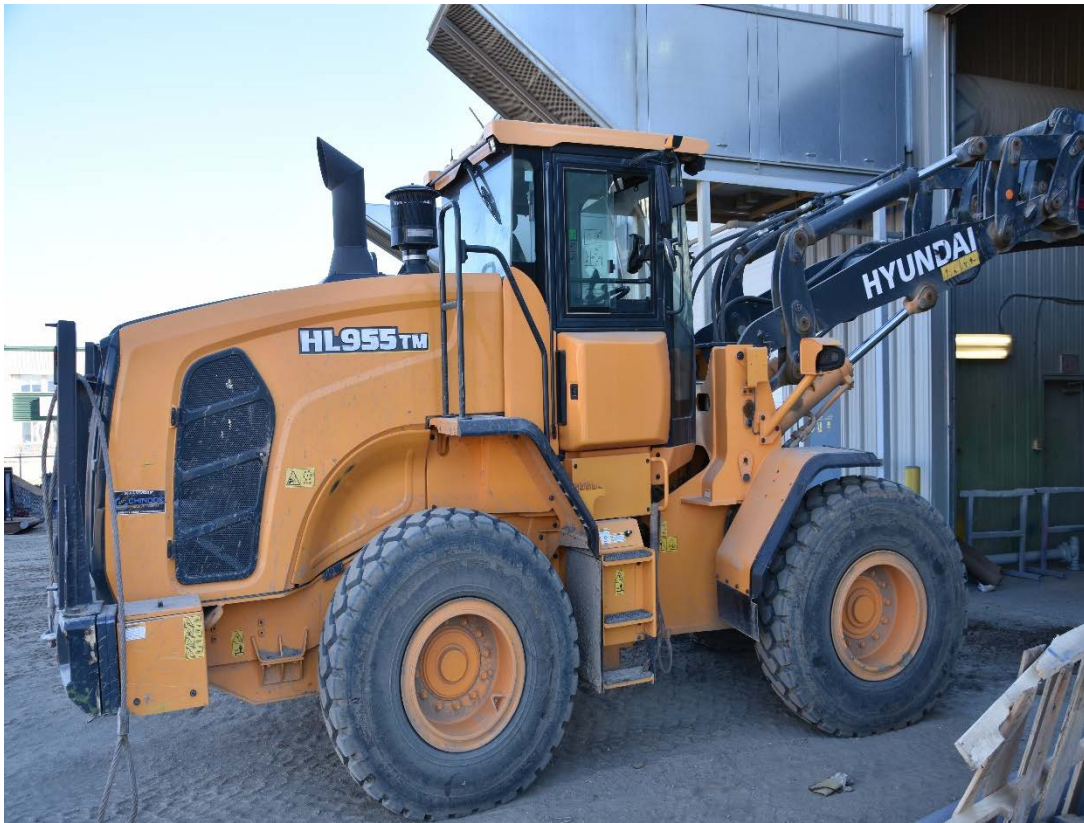
*Figure 5. Hyundai HL 955TM wheeled loader.*

- The abrasive blaster was positioned in an area of significant restricted visibility on the right side of the loader when struck by the pipe.
- The jib boom control joystick was not equipped with a 'deadman' switch, which would have prevented accidental activation.
- The movement of the loader operator caused them to strike the jib boom control joystick, which caused the load to drop.

The loader operator inadvertently contacted the jib boom controls. This caused the pipe to drop and strike the worker.
