Investigation Report
Worker Fatally Injured When Pinned by Workpiece
November 17, 2018

This document reports Occupational Health and Safety's investigation of a workplace fatality in November 2018. It begins with a short summary of what happened. The rest of the report covers this same information in greater detail.

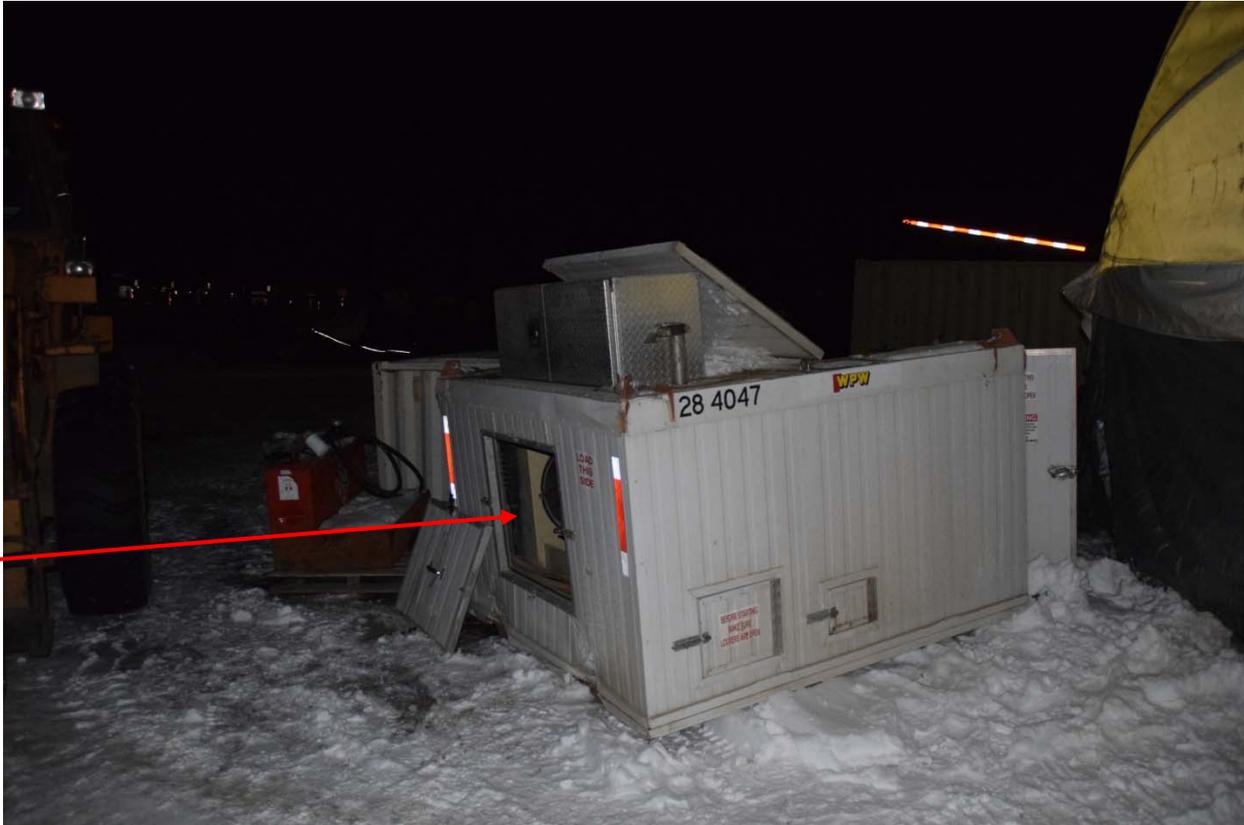
Figure 1. Abrasive blasting unit assembly (compressor, abrasive blasting unit and breathing air filter) located outside the sandblasting area. The compressor is indicated by the arrow.

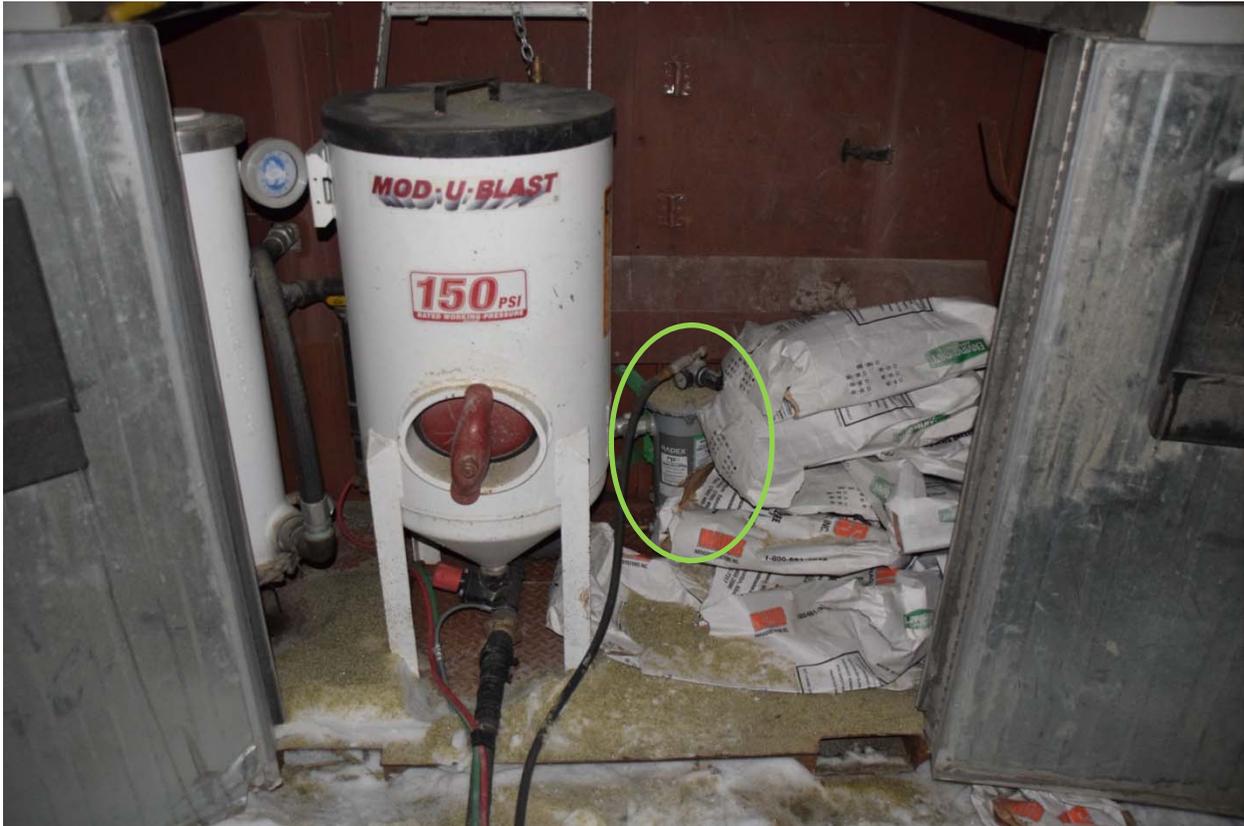
Figure 2. Mod-U-Blast Abrasive Blasting Machine and RADEX breathing air filter (indicated by green circle).
