RECAPP Facility Evaluation Report

Aspen Regional Health Authority

Elk Point Health Centre

B1044A

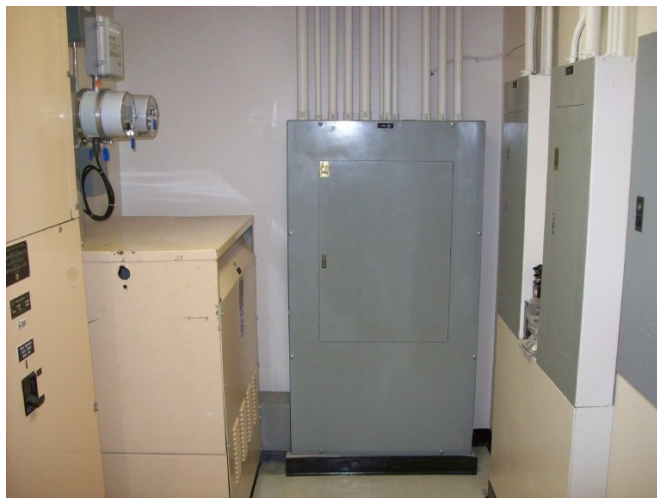
Transformer ? 50KVA 600V 120/240V 1ph 3w (located in the mechanical penthouse)

Typical floor mounted transformer

Event: Replace 5 Transformers

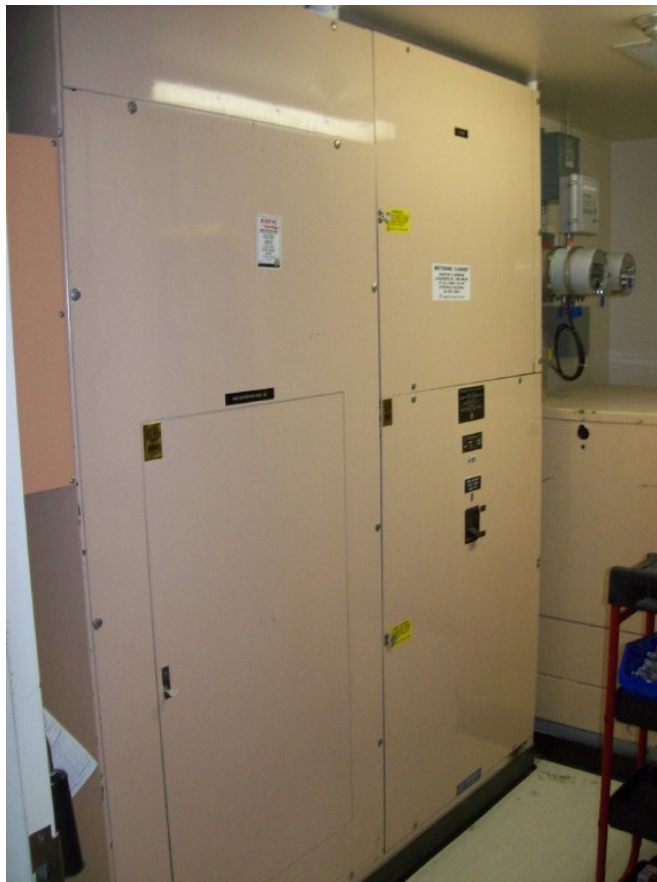
The main distribution panel is a Westinghouse 1200A-347/600V 3ph 4w w/ an 800A main breaker. The distribution panel consists of 2 cells. The main cell contains the main breaker and c/t compartment the second cell contains the distribution breakers. There are 2 spare breakers and 8 spaces for future. The main power service experiences frequent power surges - an upgrade to add a TVSS is identified under K3010.

The Westinghouse 1200A 120/208V 3ph 4w main distribution

Event: Replace Main Distribution Panel

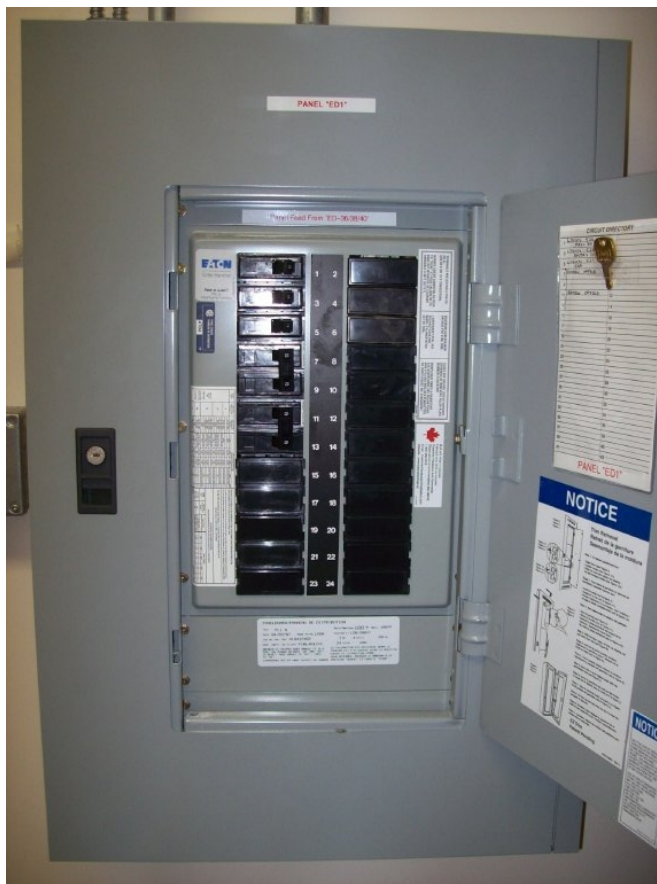
There is one 24cct 120/208V 3ph 4w Cutler Hammer panel installed in the main electrical room.

Cutler hammer panelboard

Event: Replace 1 Branch Circuit Panelboard

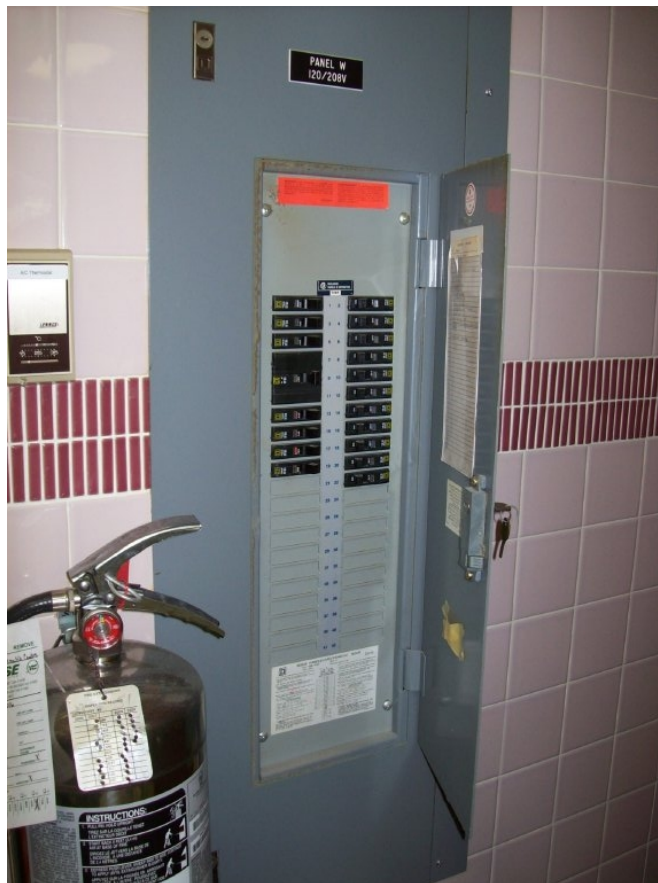
- Panel F - 8 spaces
- Panel W - 21 spaces
- Panel V - 15 Spaces

Typical Square D panelboard

Event: Replace 3 Branch Circuit Panelboards

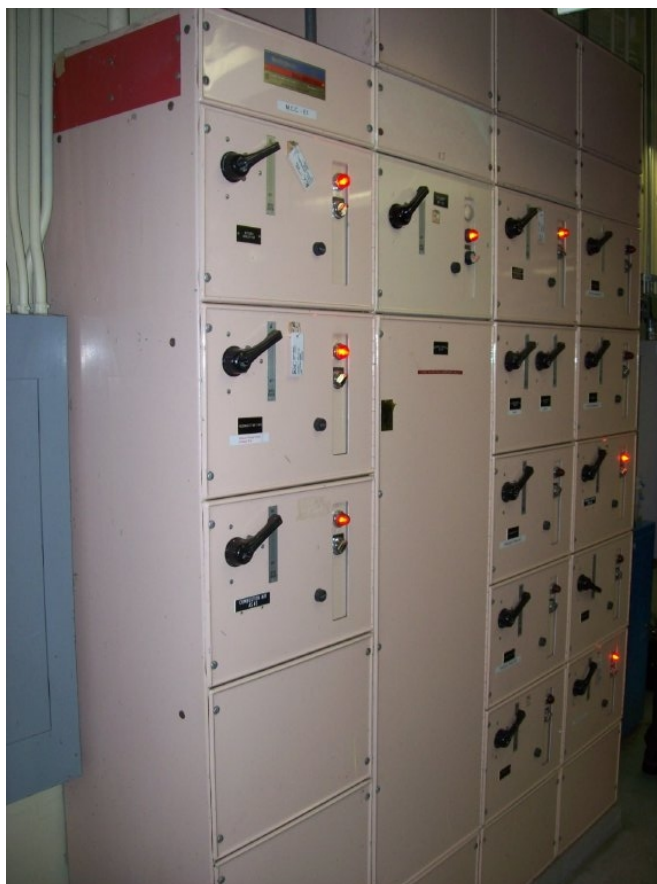
MCC E1 - Westinghouse 600A 600V 3ph 3w (4 sections) Located in the mechanical room. 2 spaces for future.
 MCC 2/E2 - Westinghouse 600A 600V 3ph 3w (3 sections. 1 section on normal power, 2 sections on EM power) Located in the mechanical penthouse. 2 spaces for future.

Westinghouse 4 section MCC

Event: Replace 2 MCC panels

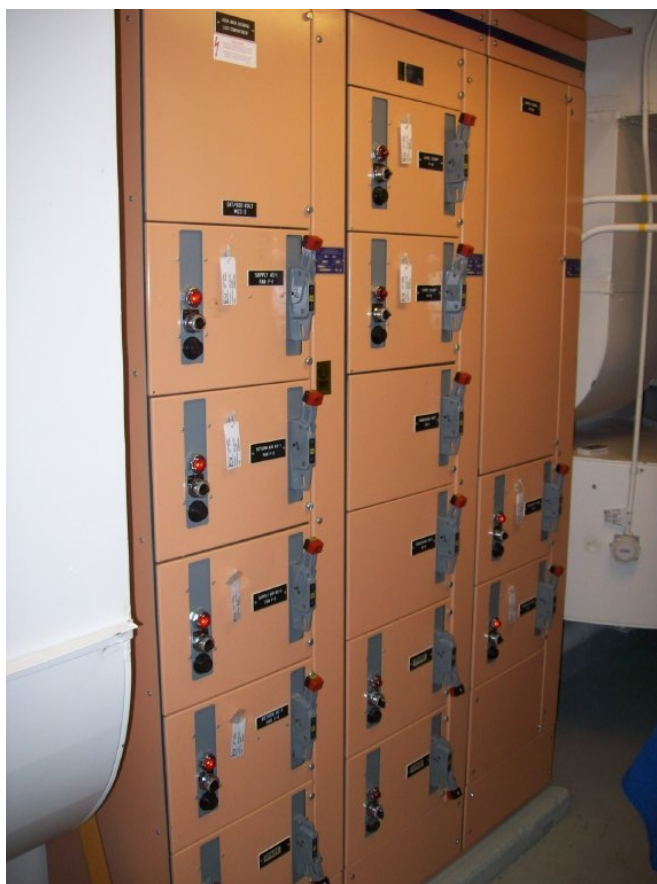
There is 1 MCC panel located in the Parkview L.T.C. Area. The MCC panel is manufactured by Square D. The MCC details are as follows;
 MCC 3 - 600A 600V 3ph 3w (3 sections). Located in the mechanical penthouse. 3 spare, 1 space for future.

Square D 3 section MCC

Event: Replace 1 MCC panel

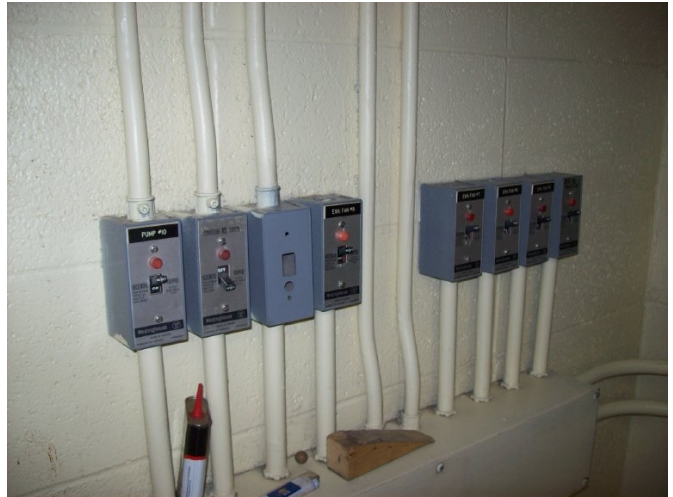
Small motor loads in are controlled by Westinghouse manual motor starters c/w pilot lights. Westinghouse magnetic motor starters are used for larger motors not controlled by MCC's.

Typical Westinghouse manual motor starters

Event: Replace 4 Mag starters and 20 Manual starters

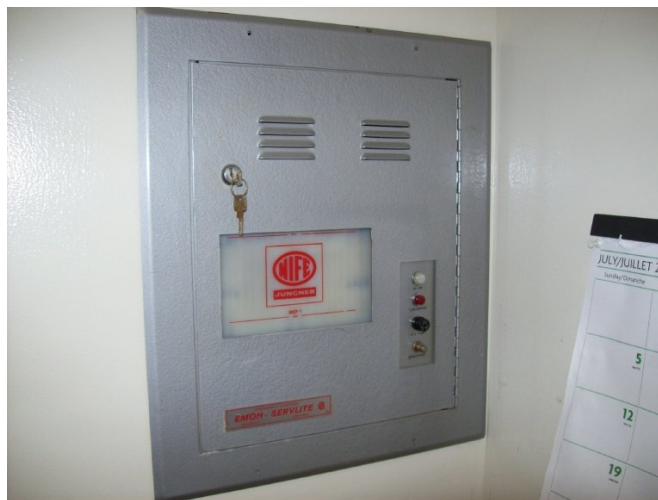
There is 1 EMOH Servelite emergency backup panel located in the Janitor Room #605.

O.R. Area emergency lighting backup panel

Event: Replace 1 emergency lighting battery pack

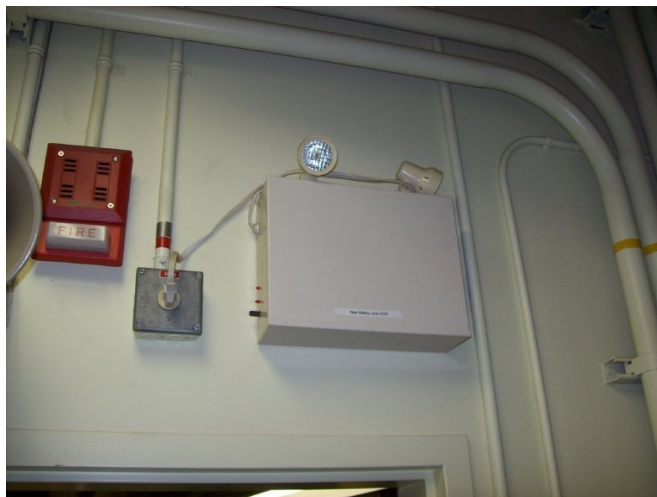
There is one dual head emergency battery pack located in the generator room. The batteries have been replaced in 2007.

Emergency battery pack in generator room

Event: Replace 1 Emergency lighting battery pack

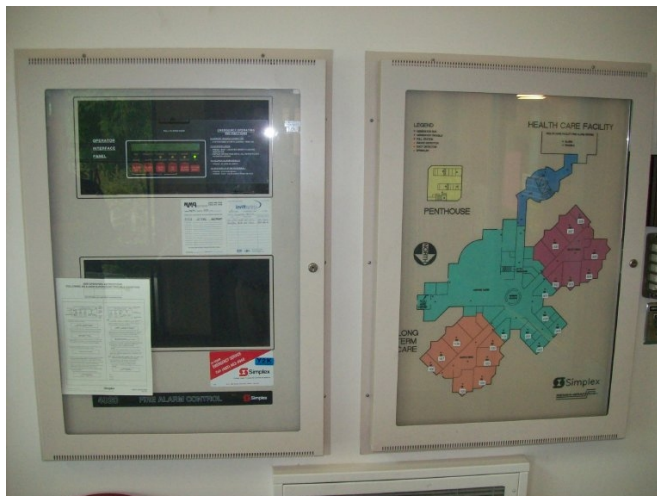
The fire alarm control panel for the Parkview L.T.C. Building is located in the main entry of the building. The fire alarm control panel is a Simplex 4020 system. A fire alarm graphic is installed adjacent to the panel to annunciate zone locations. The system is tied into the Health Care centre as a zone. A simplex 4602 annunciator panel is located adjacent the main nursing desk. Audio/Visual devices are combination gong/strobes and provide good coverage throughout. Breakglass stations are located at each exit. Tamper and flow devices monitor the sprinkler tree for the Parkview building, and sprinkler heads are located throughout however various smoke and heat detectors are located throughout the building in high profile areas.

The Simplex 4120 FACP

Event: Replace Fire alarm system (1856sq m)

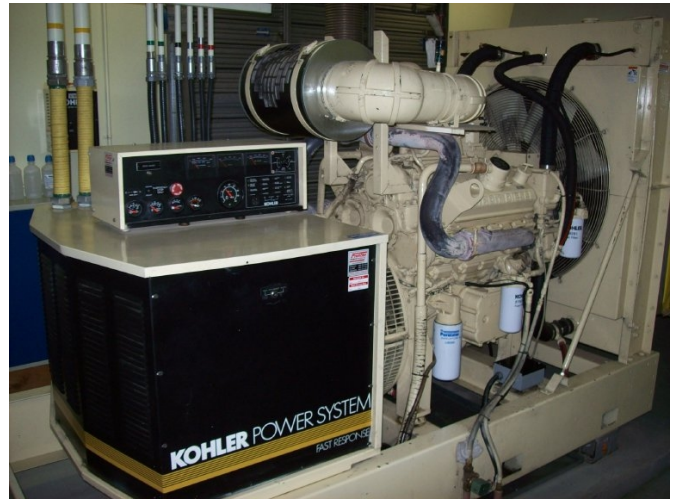
A diesel 250KVA 347/600V 3ph 4w Detroit Diesel/Kohler generator is located in the generator room of the Health Care Centre. A 120V Kohler electric battery charger is located adjacent the generator. The Automatic transfer/Bypass switch is an Asco 962 transfer station. The transfer switch is located in the main electrical room. Critical loads for the entire building are connected to the generator system. Emergency lighting, emergency plugs, critical loads in CSR and the Administration Office, and Critical Mechanical Loads (MCC E1, E2 and E3)

250KW Kohler/Detroit Diesel Genset.

Event: Replace 250KW Generator System
