Investigation Report
Worker fatally injured by a steer while loading cattle
August 17, 2017

This document reports Occupational Health and Safety's (OHS) investigation of an incident when a worker was fatally injured by a steer while loading cattle into a cattle liner in August 2017. It begins with a short summary of what happened. The rest of the report covers this same information in greater detail.

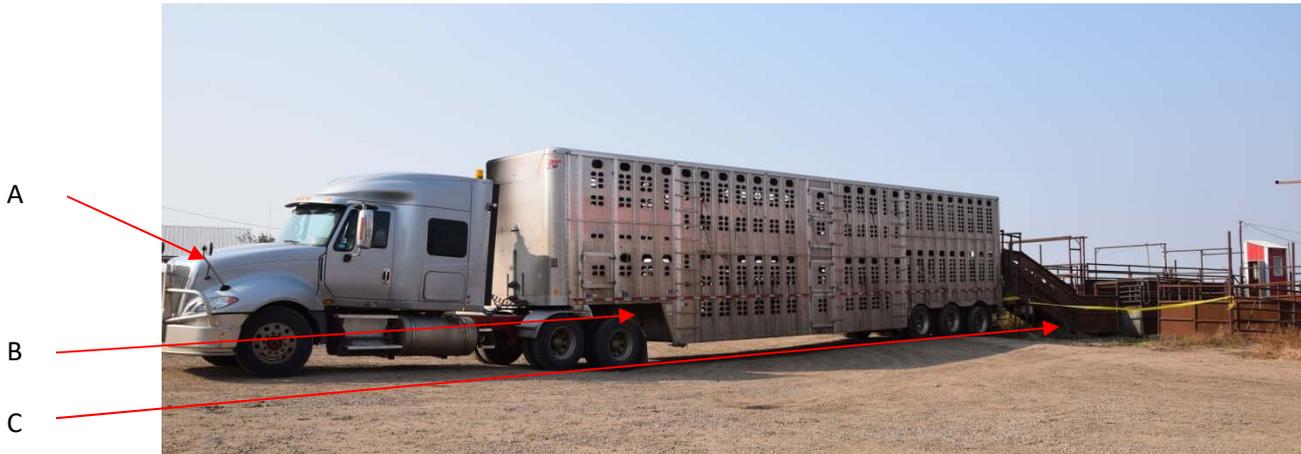
Figure 1. Coro View Farms' semi-tractor and Wilson cattle liner parked at the feedlot loading area.

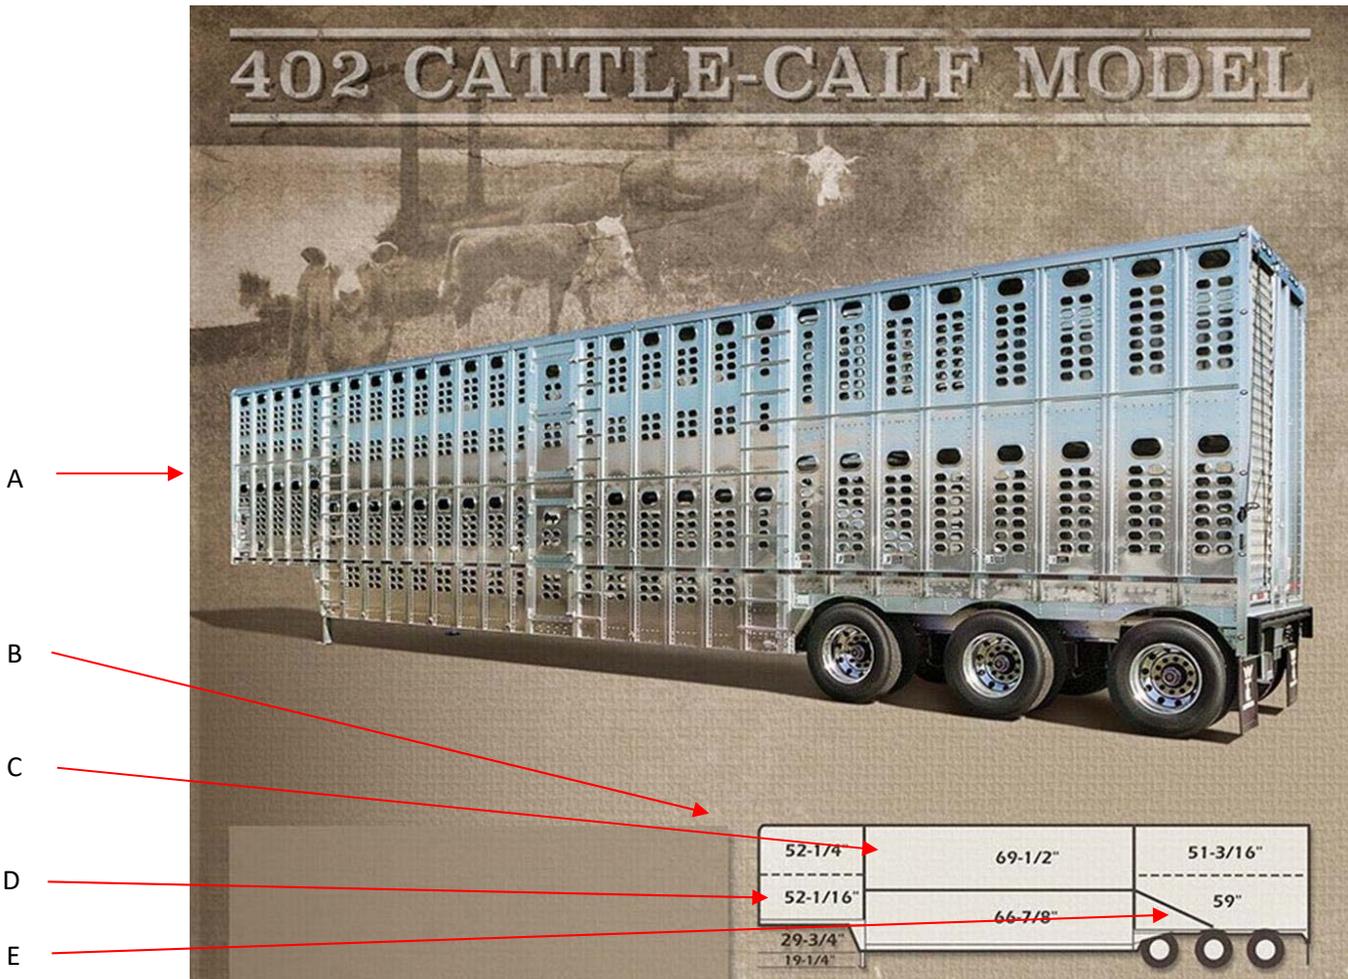
The cattle liner was 16.2 metres (m) in length, 2.4 m in width and 4.1 m in height (53 feet in length, 8 feet wide and height of 13.5 feet as per standard industry measurements) (Figure 2A). The cattle liner had three axles and a semi-trailer coupling to a truck tractor unit. The cattle liner had five interior compartments with gates and ramps connecting and controlling the location of cattle loaded inside (Figure 2B). Placement of the cattle inside a cattle liner was based on size and weight in order to balance the load. Cattle were loaded into the nose compartment first (Figure 2D) and then the remaining compartments. Cattle loading into the nose compartment had to pass through the top deck where gates were in place to swing behind the cattle to prevent them from turning around and leaving the cattle liner.

Figure 2. Copy of photograph from Wilson Livestock Trailers Brochure dated 2016 showing exterior of 402 Cattle-Calf Model cattle liner and drawing of interior compartments of the cattle liner.

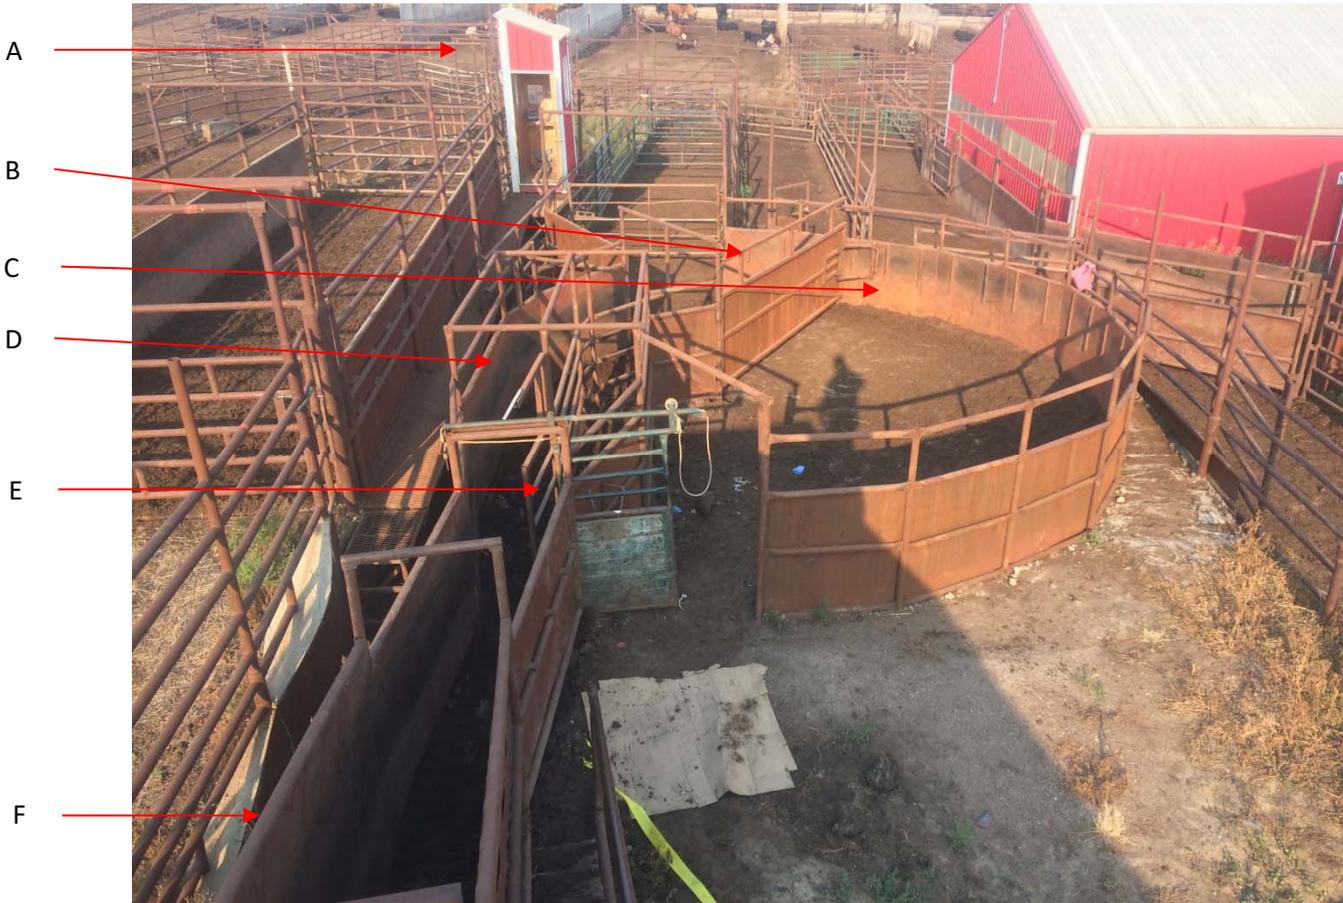
Alleys were travel paths for cattle and workers and had multiple gates along their lengths. A semi-circular solid sided pen called the “tub” (Figure 3C) had an interior solid swing panel (Figure 3B) that directed cattle into a paired set of single file chutes (Figure 3D). The chutes led to a single chute (Figure 3F) which accessed the rear loading door and ramp for the cattle liner. A sliding gate (Figure 3E) blocked the cattle from climbing the single chute until it was pulled out of the way by a worker. Individual cattle or small groups were given access to the ramp by a worker moving the gate as needed. When the cattle reached the top of the loading ramp, the gates and ramps inside the cattle liner were operated by a worker, usually the driver.

Figure 3. Loading area of Coro View Farms feedlot. Photograph provided by Coro View Farms.

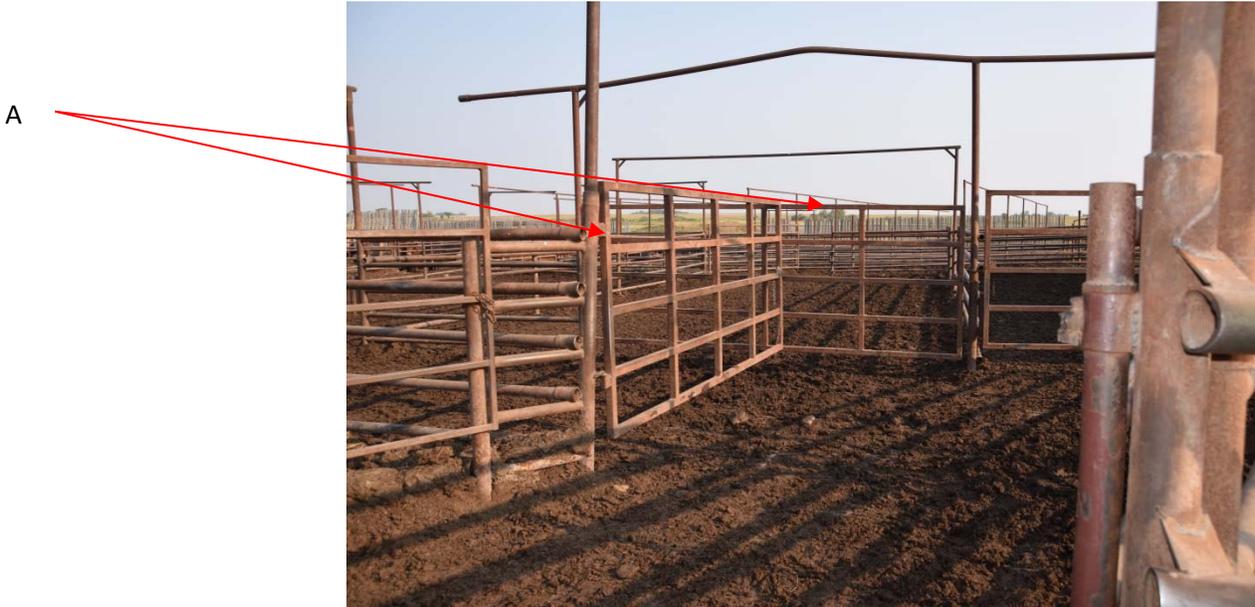
Figure 4. Alley with gates closed to control cattle movement.

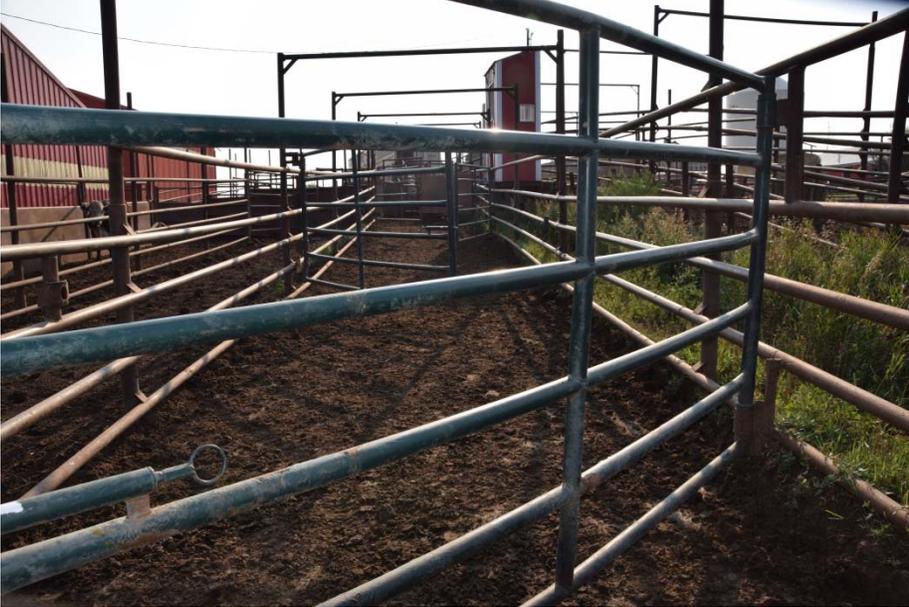
Figure 5. Alley leading to tub with gates partially open to show their location.

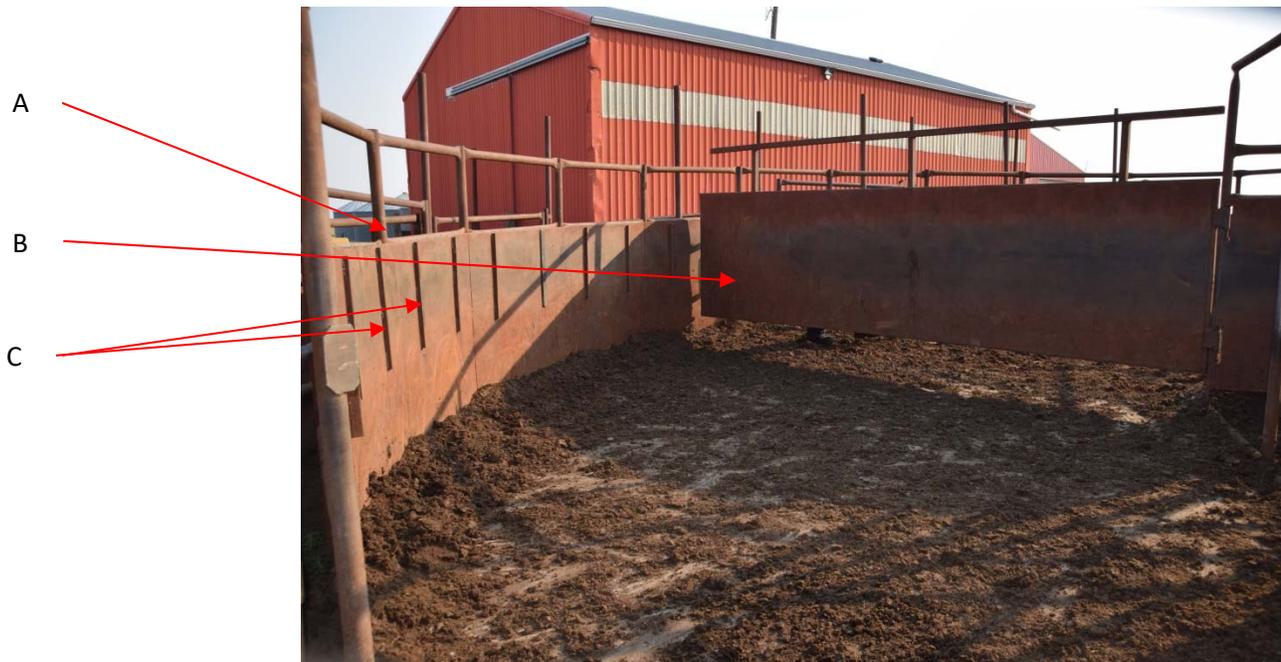
The tub had solid walls (Figure 6A) and the swing gate was also solid (Figure 6B). The tub had raised vertical stops that connected with a latch mechanism (Figure 6C) on the swing gate so workers could allow one-way movement of the swing gate as needed. Cattle entered the tub, and the tub swing gate was moved in a clockwise direction to allow room for the cattle. When all the cattle were in the tub, the last gate on the alley was closed.

Figure 6. Interior view of tub and location of swing gate.

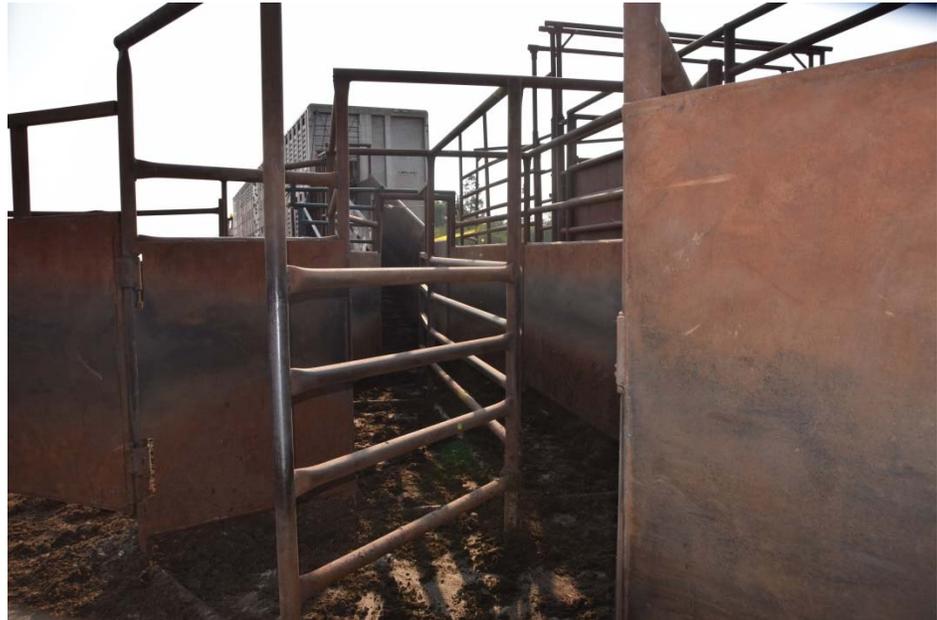
Once in the tub, worker 1 and worker 2 used the solid swing panel in a counterclockwise direction to push all three cattle into a paired set of single file chutes (Figure 7) and towards the chute leading to the cattle liner back door.

Figure 7. Paired single file chutes.

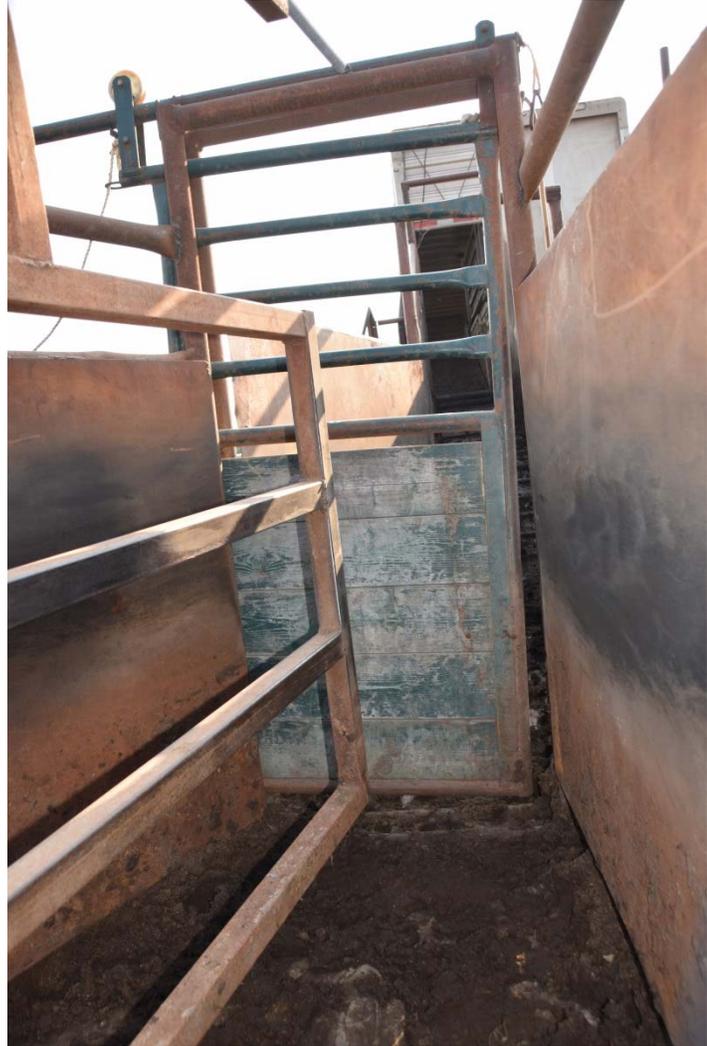
Figure 9. Slide gate in closed position. View from inside paired single file chutes.

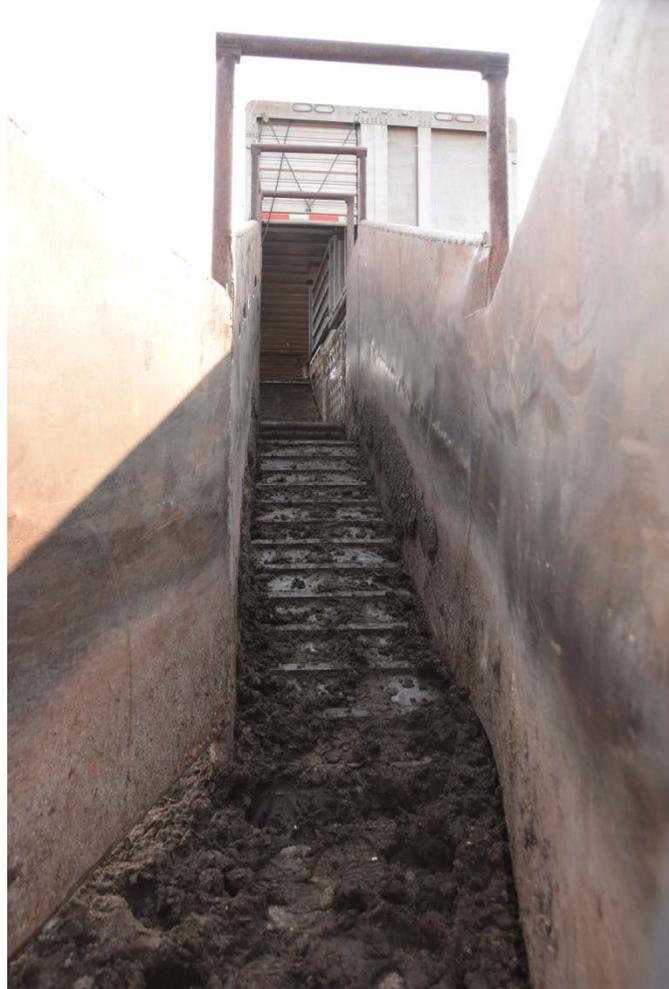
Figure 10. Chute and loading ramp leading to cattle liner. View from interior of chute.

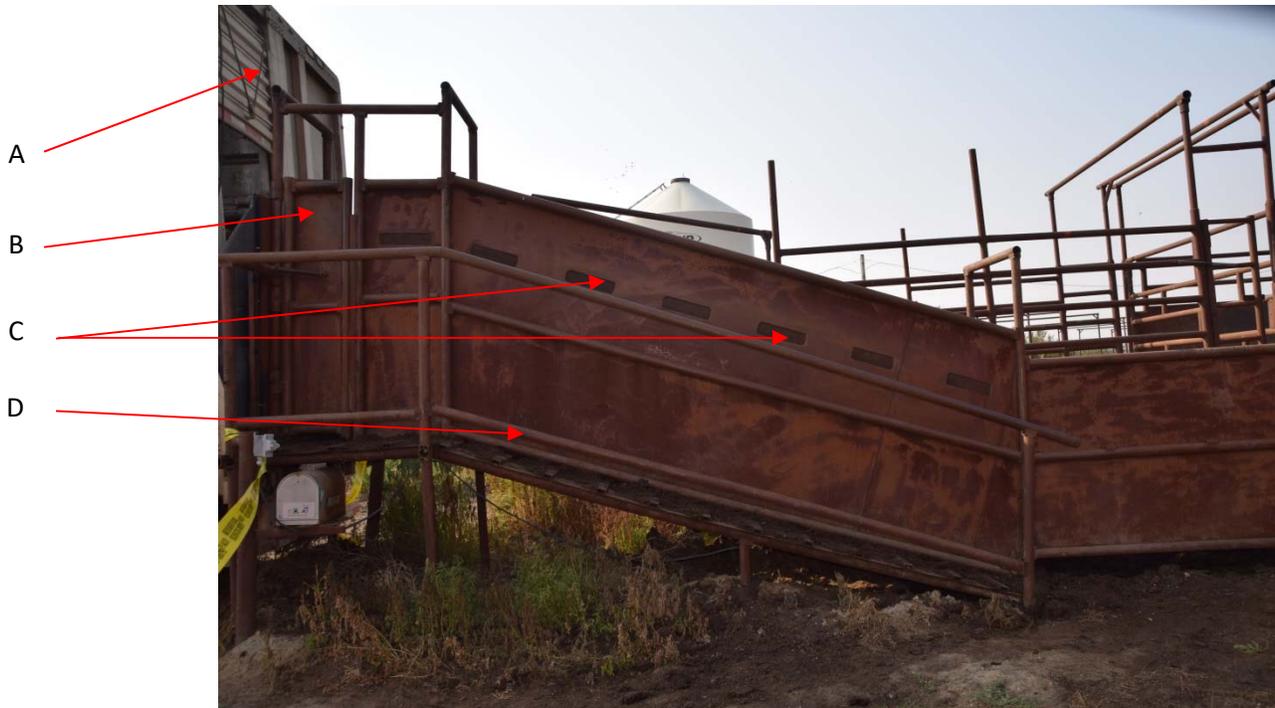
The chute leading to the rear of the cattle liner had solid panels with oval cutouts so cattle were visible from outside the chute (Figure 11C). A ramp with cleats and a railing for workers was on the outside of the cattle loading chute (Figure 11D). A spring loaded door that opened one-way into the cattle chute was in place at the top of the worker access ramp (Figure 11B and Figure 12).

Figure 11. Photograph of exterior of loading chute ramp.

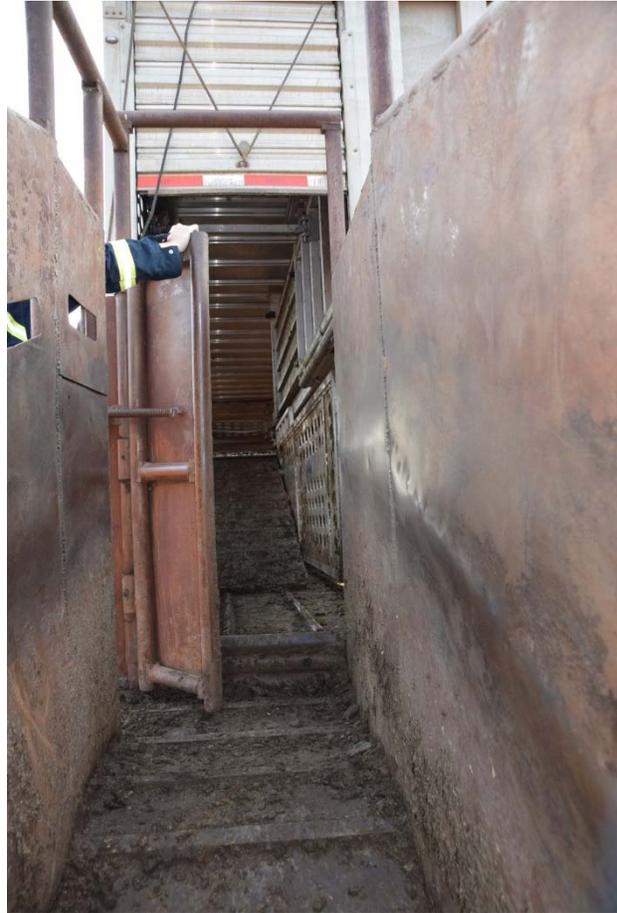
The spring loaded door was also considered an emergency escape route from the cattle liner or chute (Figure 11B and Figure 12).

Figure 12. Spring loaded door at top of loading chute/ramp.

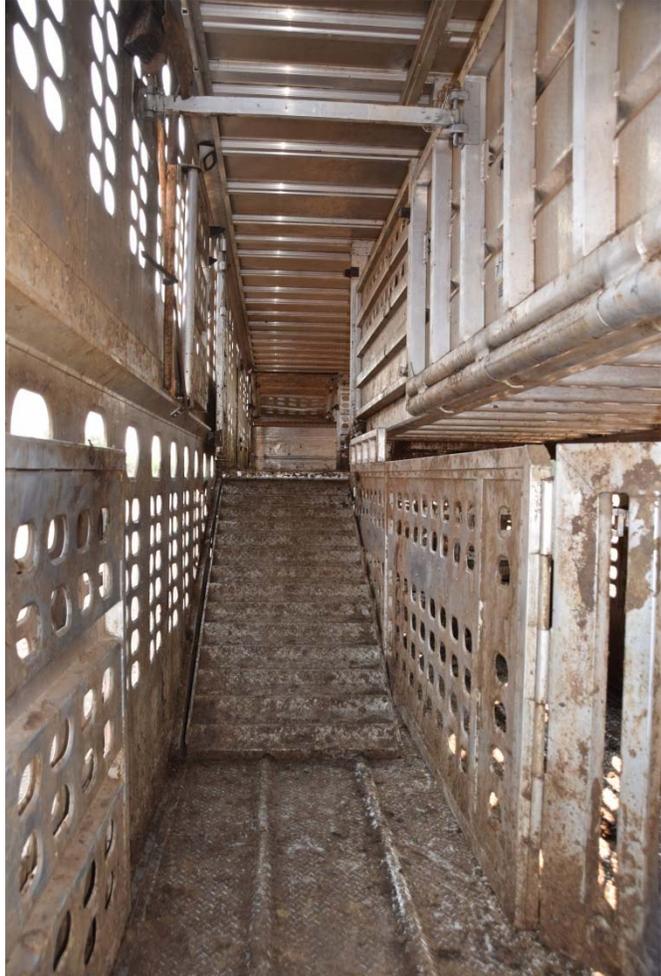
Figure 13. Interior ramp of cattle liner.

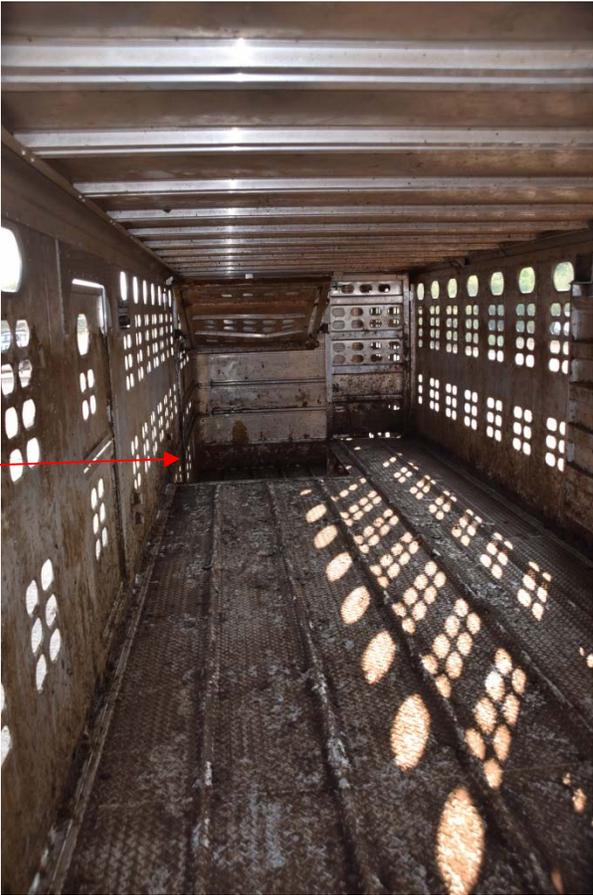
Figure 14. Top deck of cattle liner

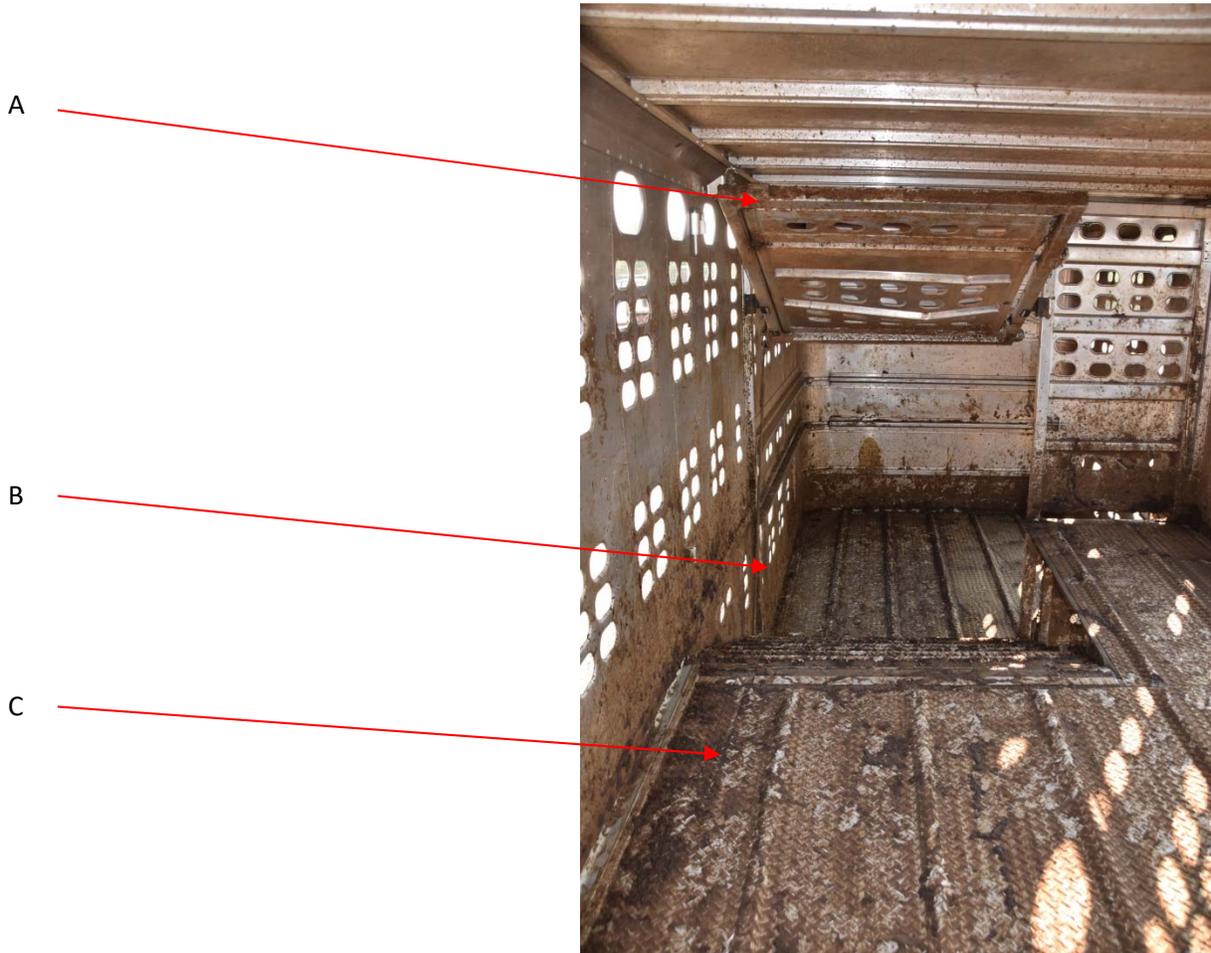
The nose compartment gate was in the elevated position (Figure 15A) and the nose compartment ramp (Figure 15B) was in the lowered position to move the cattle into the nose compartment. The nose ramp and a gate across the nose ramp were counterweighted so that opening the gate lowered the ramp and shutting the gate raised the ramp.

Figure 15. Nose compartment with gate open and ramp lowered.

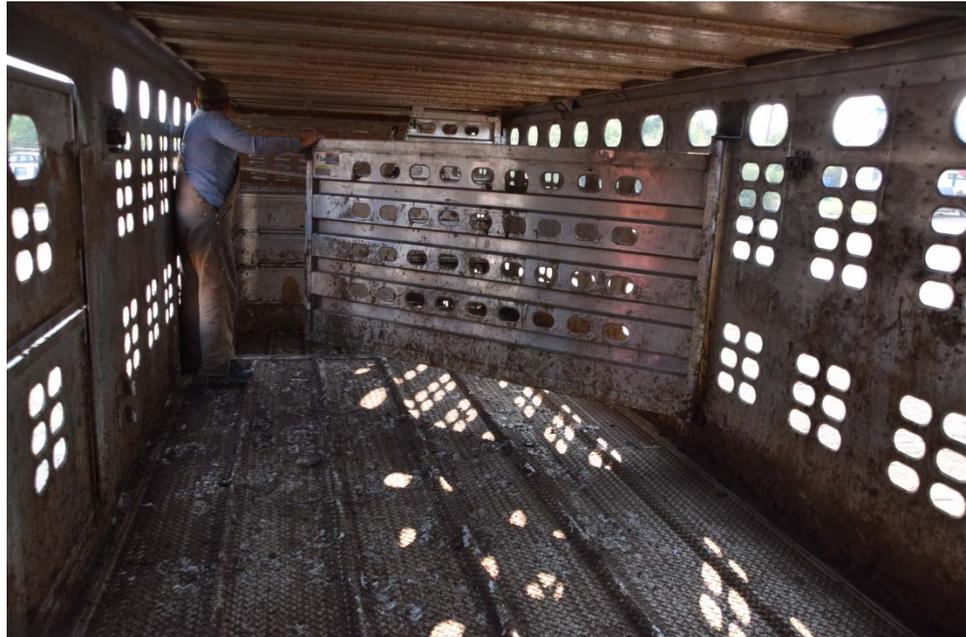
The midgate was used to swing behind the cattle and keep them from turning back (Figure 17). Immediately following the incident, the midgate was found locked in place to the passenger side of the cattle liner's wall and pinned in place (Figure 16A)

Figure 17. Midgate on top deck in position when used to push cattle towards nose compartment.

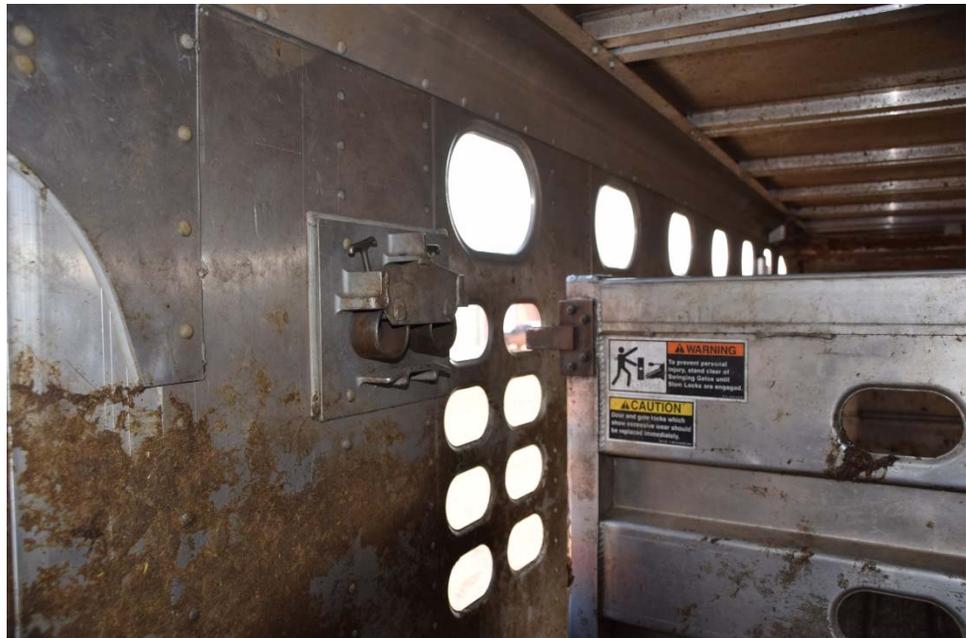
The latch on the driver's sidewall operated automatically and would latch the midgate in either direction (Figure 18).

Figure 18. Latch for midgate on driver's side of cattle liner wall.

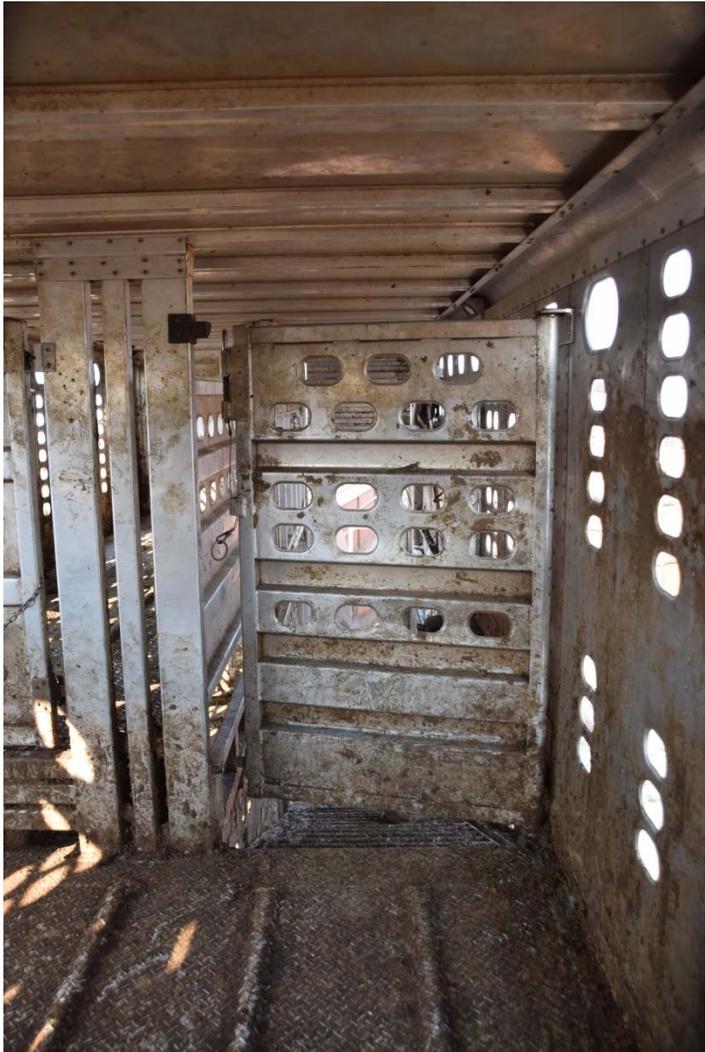
The gate located at the top of the cattle liner entry ramp would swing rearward only. It was found locked in place to the driver's side of the cattle liner wall (Figure 19 and Figure 20).

Figure 20. Gate at top of interior ramp deck.
