Inspection of Small Dams

Publication No. T/434
Revised October 1998
ISBN: 0-7785-0633-9

Alberta
ENVIRONMENT

INSPECTION OF SMALL DAMS

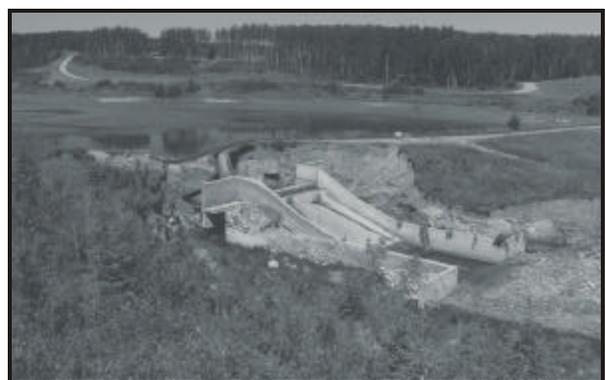
Photo No. 2 (DSB 9051-18)
Mound Red Park Reservoir July, 1990

An overtopping failure as a result of storm runoff larger the spillway capacity.

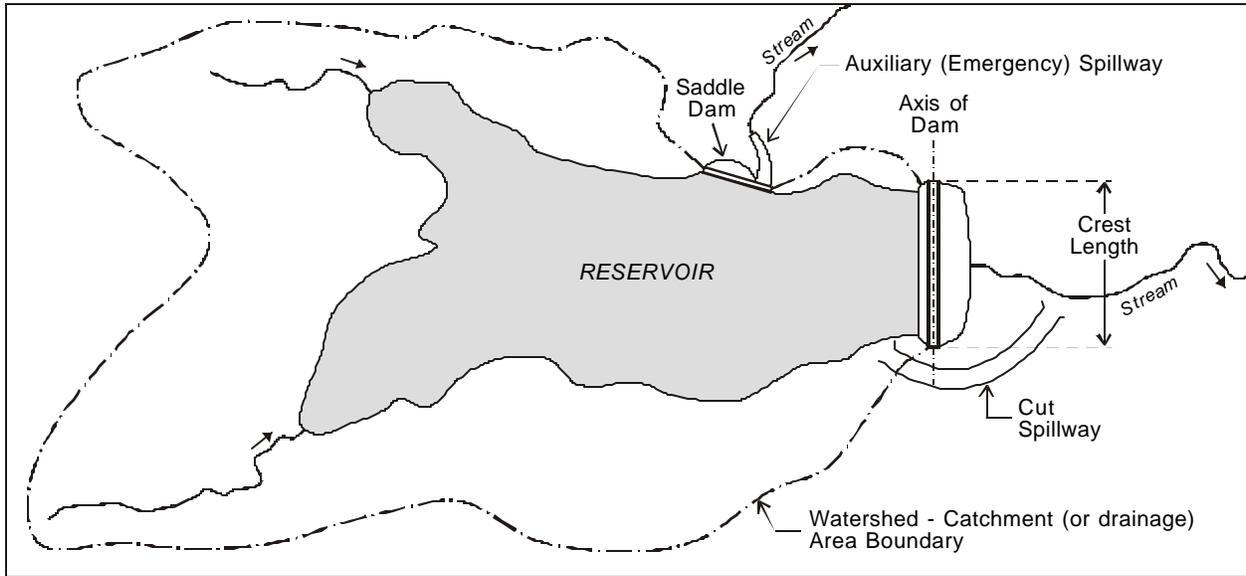
TYPICAL PLAN VIEW

Drawing No. 1 – Typical Plan, Profile and Section

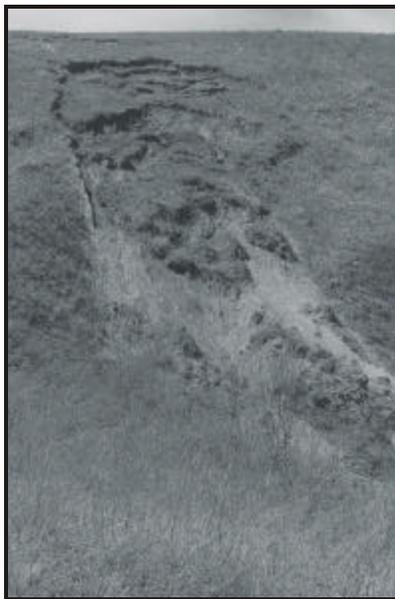
Photo No. 8 (DSB 18A-13)

A downstream slope failure (slide)

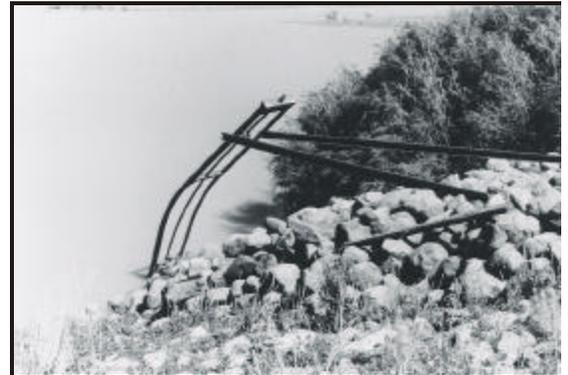
Photo No. 9 (DSB 9200-41)

Slide gate control for a low level outlet damaged by ice action

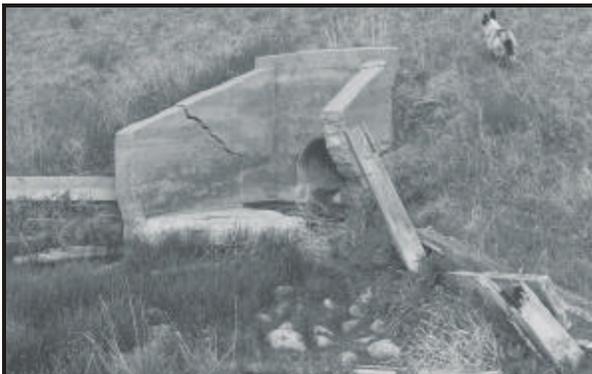
Photo No. 12 (DSB 7763-09)

A low level outlet structure in very poor condition

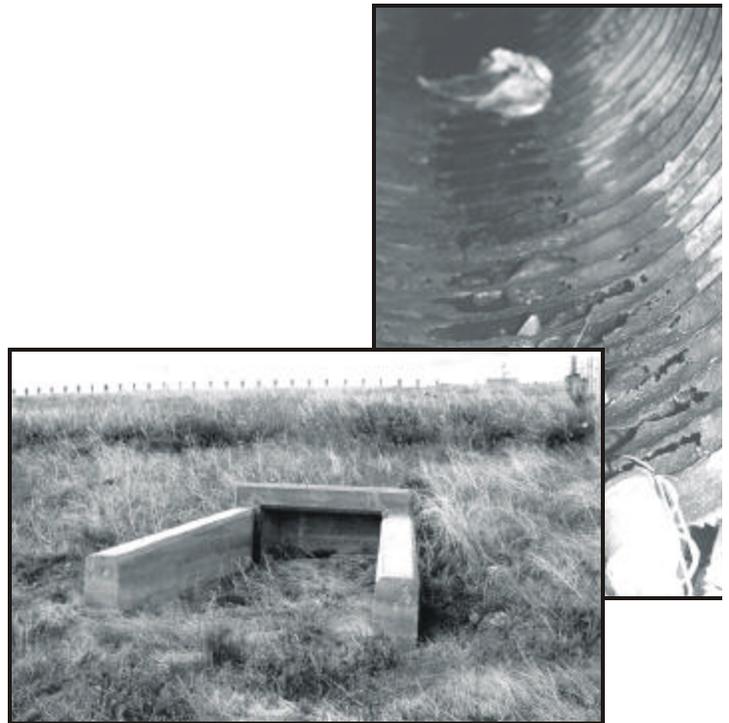
Photo No. 12 (DSB 8644-6)

A badly corroded conduit in a low level outlet. Note the erosion occurring under the conduit. This erosion has created a large cavity around the conduit extending upwards through the embankment to the crest.

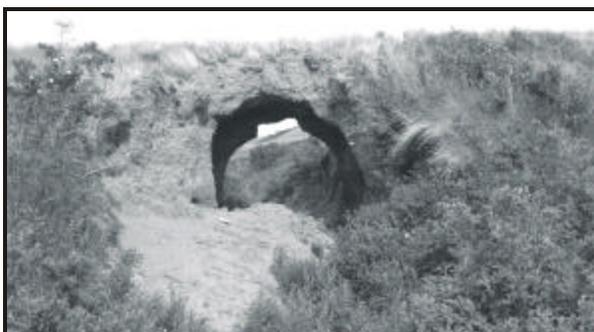
Photo No. 13 (DSB 7745-11)

A hole which developed through an embankment as a result of a piping failure.

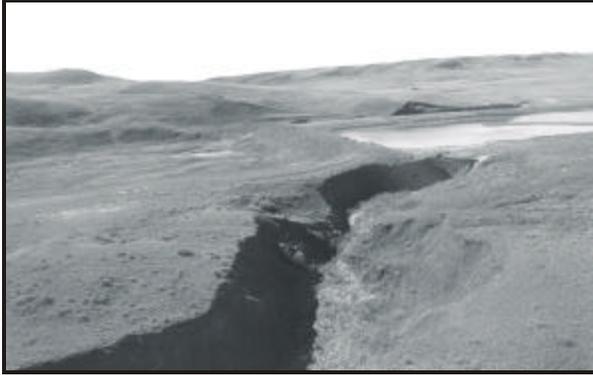
Photo No. 14 (DSB E7824-21)

A badly eroded spillway channel. As the erosion progresses upstream, the threat of the reservoir draining through this channel increases.

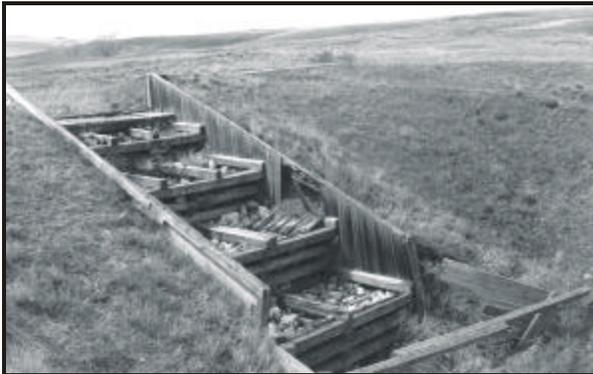
Photo No. 15 (DSB 8402-1)

A timber chute spillway in very poor condition.

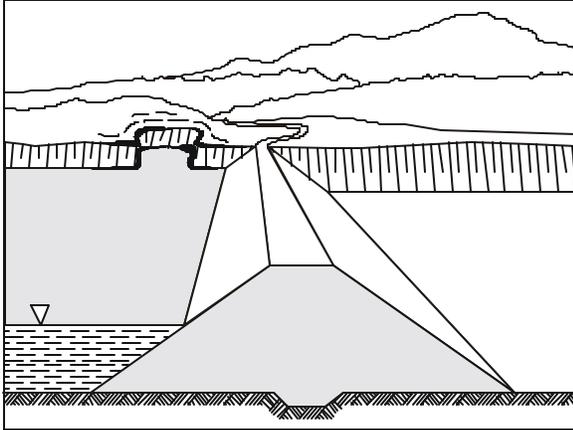
SLIDES AND SLOUGHS

Causes:

1. Ice action and wave erosion creates steep slopes.
2. Toe of the slope becomes saturated by the reservoir.

1. The slide or slough could block the spillway or outlet.
2. Waves caused by a slide may overtop the embankment.

1. Monitor the area and contact an engineer if the embankment is threatened.

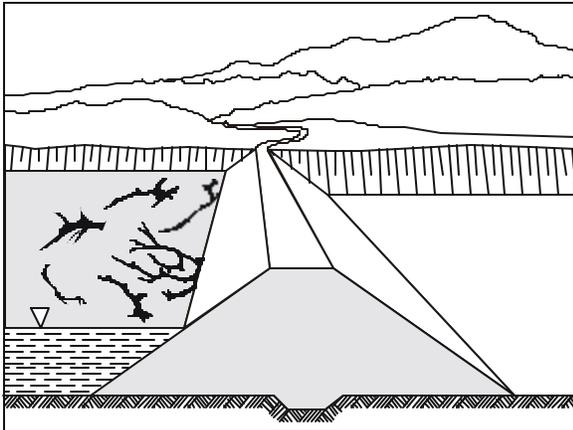
FLOATING DEBRIS

1. Beaver activity in the drainage basin.
2. Tree cutting.
3. Heavy runoff.

1. Install trash racks where necessary and clean them as required.

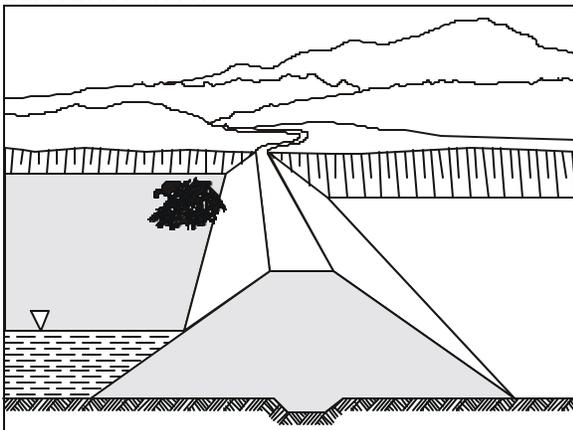
BEAVER ACTIVITY

1. Beaver activity around the dam.

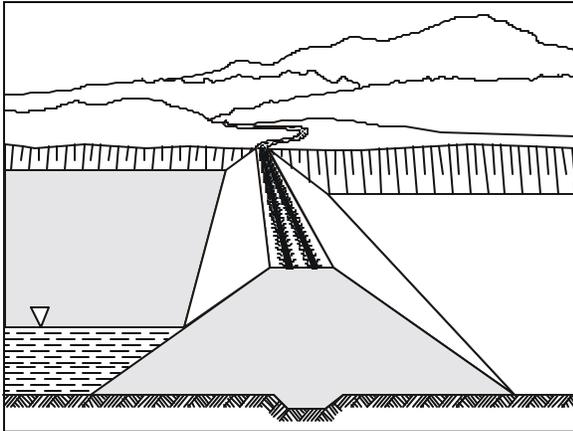
RUTS ALONG CREST

1. The main cause is inadequate drainage of the crest allowing water to stand.
2. Vehicle crossing when surface is soft or wet.

1. Allows standing water to collect and saturate the crest.
2. Vehicles crossing the crest can get stuck causing further damage.

1. Re-grade and re-compact crest to original elevation with a slope toward the upstream slope.
2. Provide surface resistance to rutting by adding gravel.

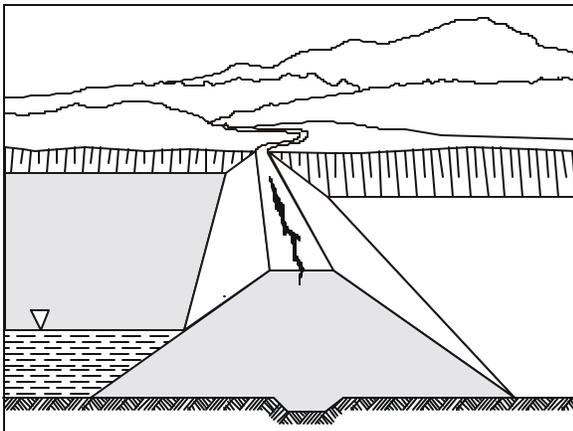
LONGITUDINAL CRACKS

1. Uneven settlement within the embankment or foundation.
2. Slope instability.

1. An engineer should determine the cause of the crack and recommend a course of action.
2. The crack(s) should be excavated and backfilled with compacted material to prevent seepage.
3. Area should be closely monitored for future movement.

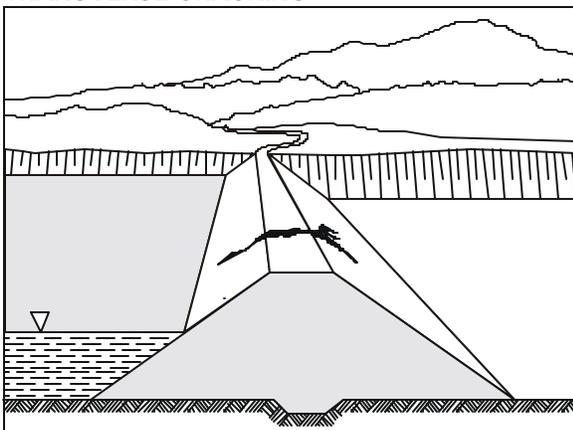
TRANSVERSE CRACKING

1. Uneven movement between two adjacent segments of the embankment.
2. Instability of the embankment or foundation.

1. Provides an entry point for surface water.
2. May create a seepage path from the reservoir and a potential piping failure.

1. An engineer should determine the cause of the crack and recommend a course of action.
2. The crack(s) should be excavated and backfilled with compacted material to prevent seepage.
3. Area should be closely monitored for future movement.

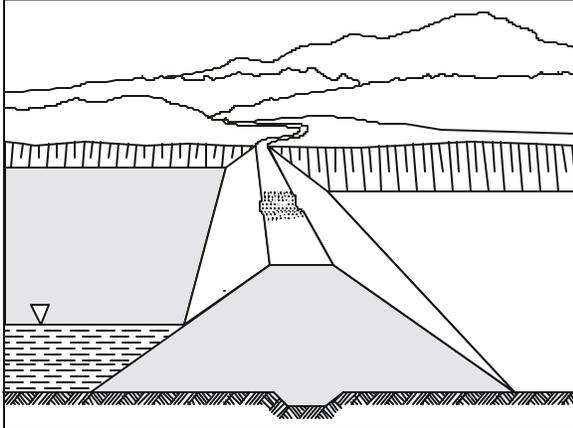
LOW AREA ON THE CREST

1. Excessive settlement of the embankment material or the foundation (area of deepest fill usually settles the most).
2. Internal erosion of the embankment material.
3. Prolonged erosion from wind or water
4. Poor construction practices.

1. An engineer should determine the cause of the low area and recommend method to repair and prevent reoccurrence.
2. Re-grade the crest to original design elevation.

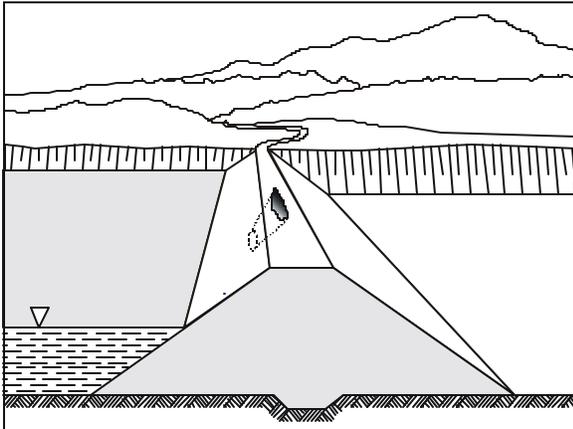
SINKHOLE ON THE CREST

1. Internal erosion from seepage, for example, piping into a hole in the conduit.
2. A breakdown of dispersive clays by seepage (this is a concern in some areas of Southern Alberta).

1. Sloughing / caving can occur in the sinkhole leading to embankment instability and development of a low area.
2. Provides an entrance point for surface water.
3. Depending on size and depth, may lead to a failure.

An engineer should determine the cause of the sinkhole and recommend a method of repair.

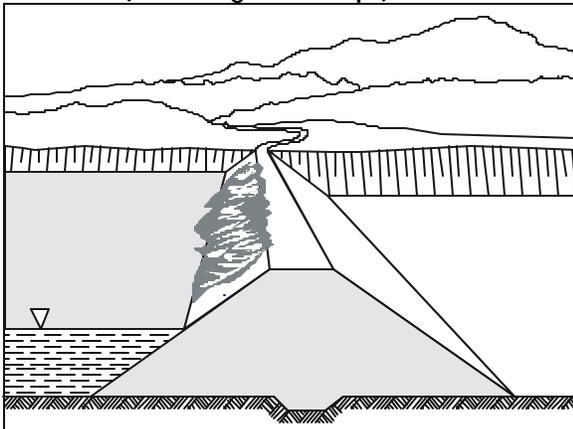
EROSION (Breaching and Scarps)

1. Wave or ice action.
2. Local settlement.
3. Inadequate erosion protection.

1. Continued erosion can reduce crest width and elevation leading to a possible overtopping.
2. May cause increased seepage.

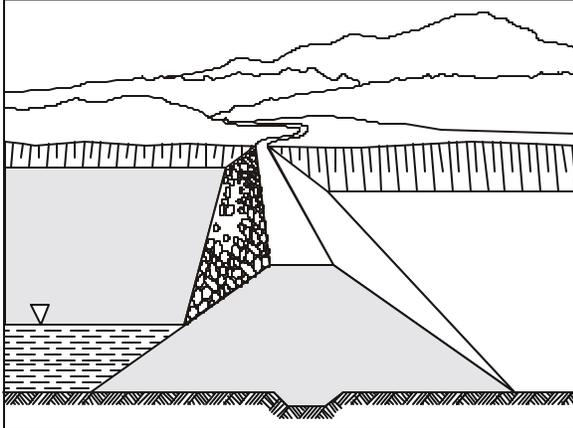
DISPLACED OR WEATHERED RIPRAP

1. Wave or ice action.
2. Poor quality riprap.
3. Same size rock, leaving gaps which allow waves to erode underlying material.

1. Repair erosion damage.
2. Re-establish adequate slope protection with underlying filter bed.

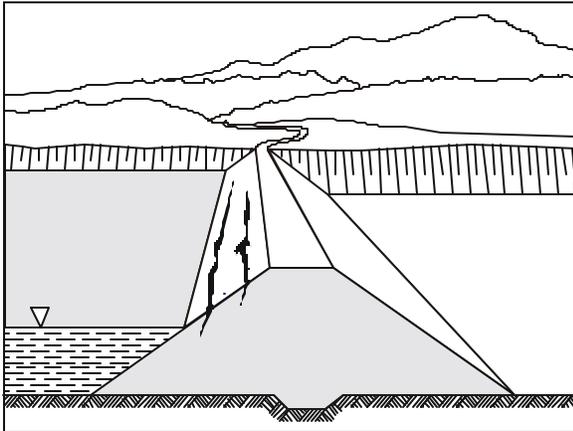
LARGE CRACKS

1. Slope instability.
2. Differential settlement.

1. Almost always precedes a slope failure or large scale settlement.

1. The reservoir should be drawn down.
2. The engineer should determine the cause and recommend a course of action.

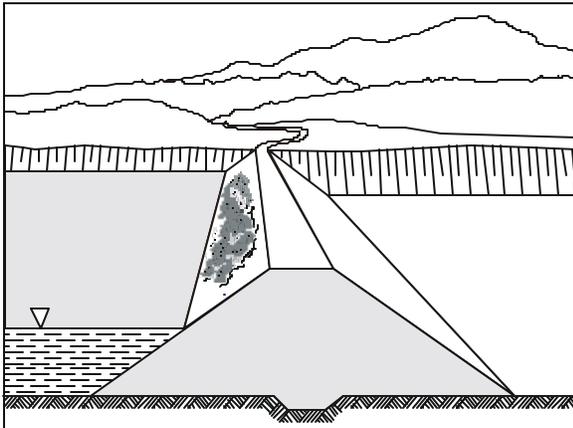
SLIDE OR SLUMP

1. A foundation failure.
2. Too steep a slope.
3. A rapid draw down of the reservoir.

1. Can lead to a failure of the dam.
2. Slide debris can block low level outlets.

1. Draw the reservoir down. Should advise affected downstream owners who would be affected by releases.
2. The engineer should determine the cause and recommend a course of action.

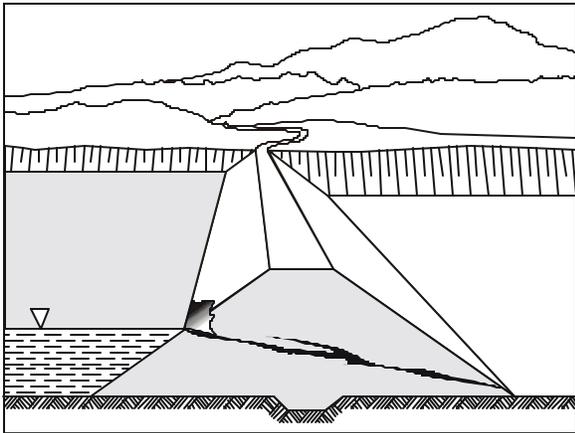
SINKHOLE

1. Concentrated seepage begins to erode embankment material through the dam. This loss of material causes the inlet of the "pipe" to collapse forming a sinkhole.

1. Usually results in a piping failure.

1. Draw the reservoir down.
2. Look for other sinkholes and their exits.
3. Examine outflow for dirty water.
2. An engineer should evaluate the situation and recommend a course of action.

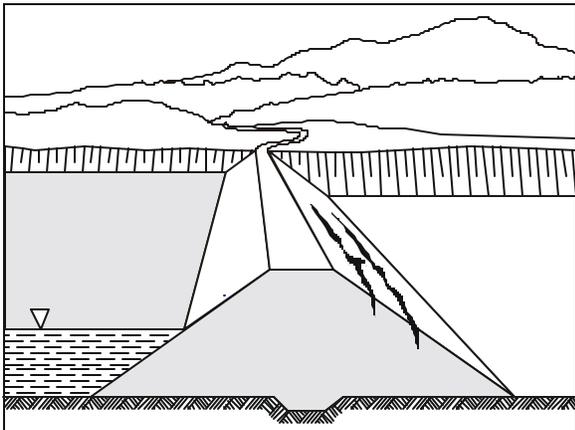
LONGITUDINAL CRACKING

1. Drying and shrinking of embankment material.
2. Settlement of embankment or foundation material.
3. Slope instability.

1. Provides an entry point for surface water.
2. Can be early warning of a slope failure, slide or slump.

1. Drying cracks should be sealed.
2. An engineer should determine the cause of the cracks and recommend a course of action.

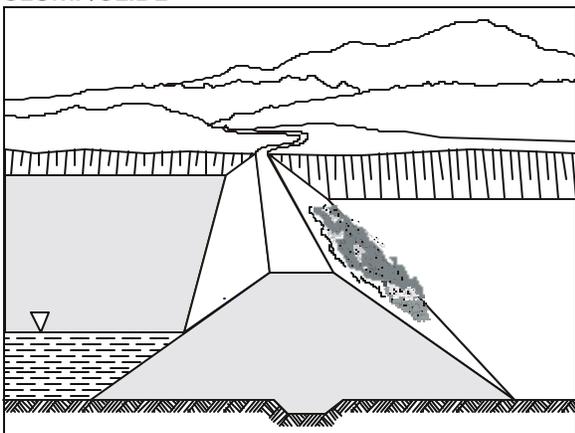
SLUMP/SLIDE

1. Too steep a slope.
2. Loss of embankment material strength from excessive seepage.

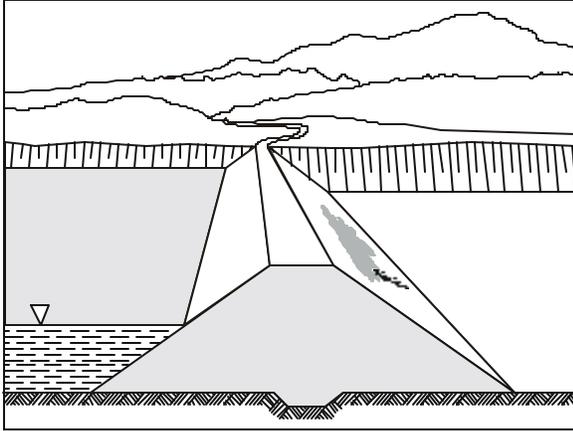
WET AREAS/SEEPAGE

1. Seepage through the embankment or under the foundation.
2. Surface water entering through cracks or animal burrows.

1. The outflow should be examined for dirty water - an indication that piping may be occurring.
2. The area and flow should be monitored and the reservoir drawn down if flows increase.
3. An engineer should assess the situation and recommend a course of action.
4. Consult an Engineer immediately if flow volume increases or dirty water is present.

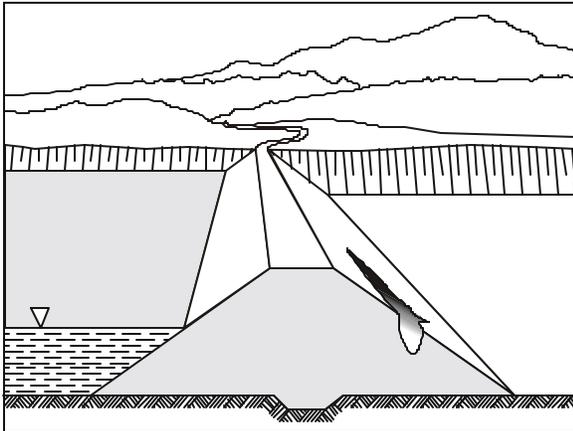
CAVE IN/COLLAPSE

1. Poor compaction during construction.
2. Internal erosion / piping through the embankment or foundation.
3. Animal burrowing.

1. Monitor the area for change.
2. An engineer should determine the cause and recommend a course of action.

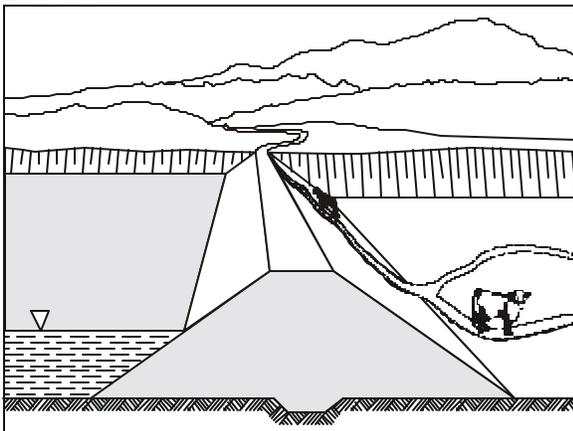
EROSION

1. Livestock traffic.
2. Surface runoff.

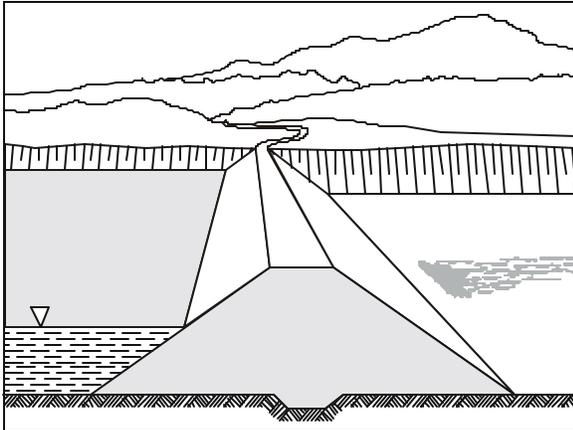
SEEPAGE WATER EXITING FROM A WATER BOIL

1. A concentrated seepage path or "pipe" has developed through the foundation.
2. Seepage from the reservoir through a sand or gravel layer in the foundation.

1. The outflow should be examined for dirty water - an indication that piping may be occurring.
2. The area and flow should be monitored and the reservoir drawn down if flows increase.
3. An engineer should assess the situation and recommend a course of action.
4. Consult an Engineer immediately if flow volume increases or dirty water is present.

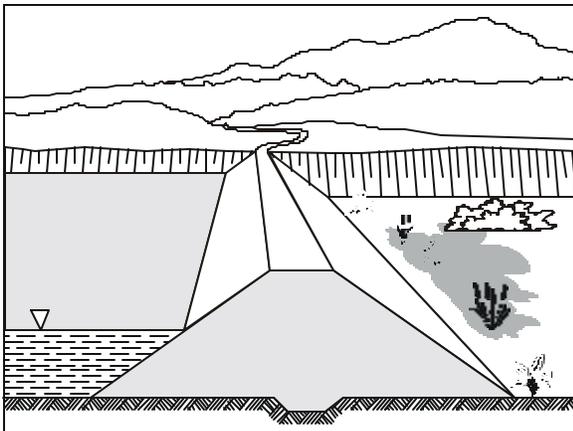
STANDING/PONDED WATER AT THE DOWNSTREAM TOE

1. Heavy seepage.
2. Surface runoff.
3. Poor drainage away from the toe, for example, due to beaver dams.

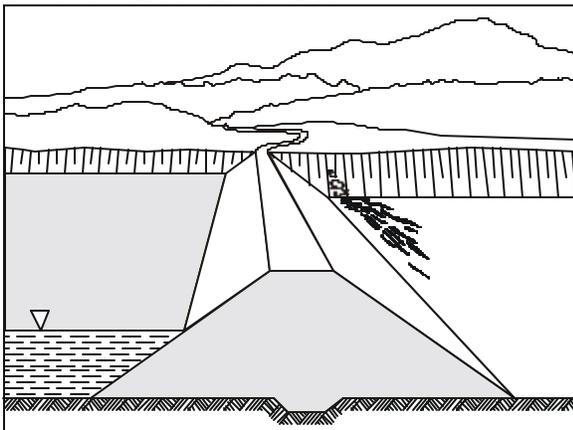
WET AREAS OR WATER EXITING FROM DOWNSTREAM ABUTMENT

1. A seepage path or "pipe" passing around the embankment through the natural abutment material.

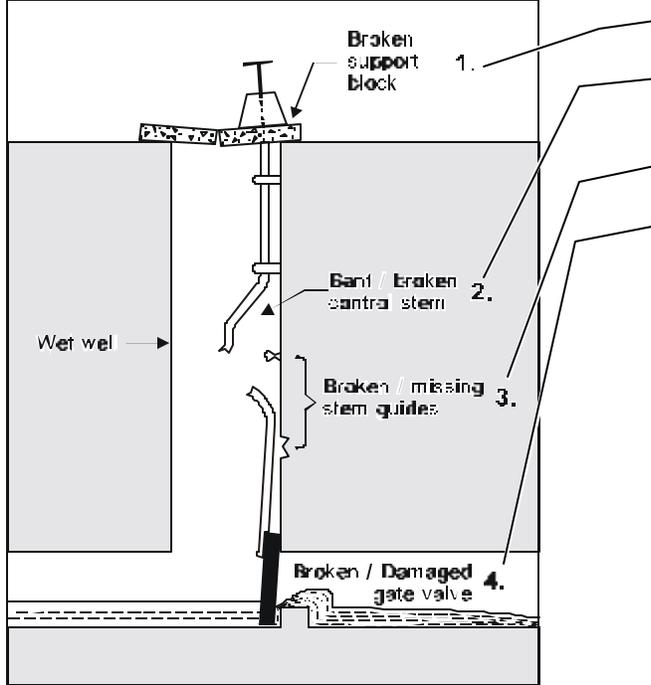
INOPERABLE LOW LEVEL OUTLET CONTROL

1. Deterioration of concrete. Excessive force applied to a jammed control stem.
2. Inadequate or broken stem guides. Lack of maintenance requiring excessive force to operate the gate.
3. Lack of maintenance causing guides to bind to stem and break when gate is jammed.
4. Corrosion, cavitation, impact from waterborne debris.

point where the embankment can fail (see Section 12.7 on page 20). Corrugated steel conduits have a usual service life of 25 to 30 years before rusting through.

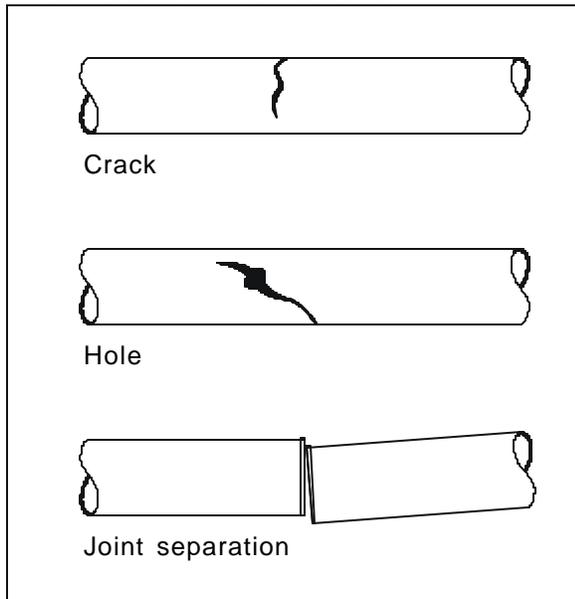
CONDUIT IN POOR CONDITION

Causes:

1. Rust.
2. Joint separation.

1. May lead to serious internal erosion and a possible piping failure

Recommended action:

1. An engineer should determine the cause and recommend a course of action.

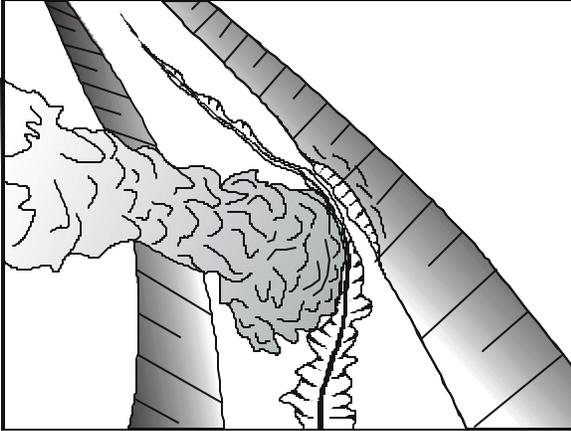
ERODED CHANNEL/SLIDE

Causes:

1. Inadequate erosion protection.
2. Too steep a gradient.

Recommended action:

1. Repair the eroded area with compacted fill.
2. Provide adequate erosion protection.
3. Re-grade the channel if necessary.

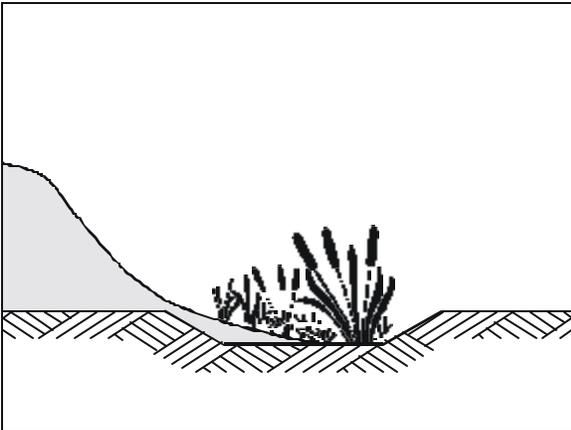
BLOCKED CHANNEL

Causes:

1. Floating debris.
2. Animal activity.
3. Man made.

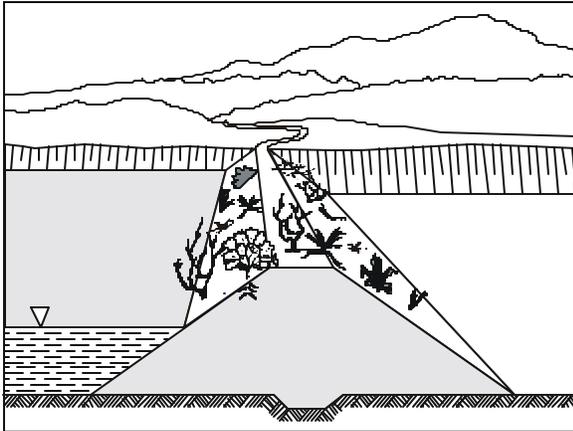
EXCESSIVE VEGETATION

Causes:

1. Lack of maintenance.

Recommended action:

1. Remove excessive vegetation and root systems.

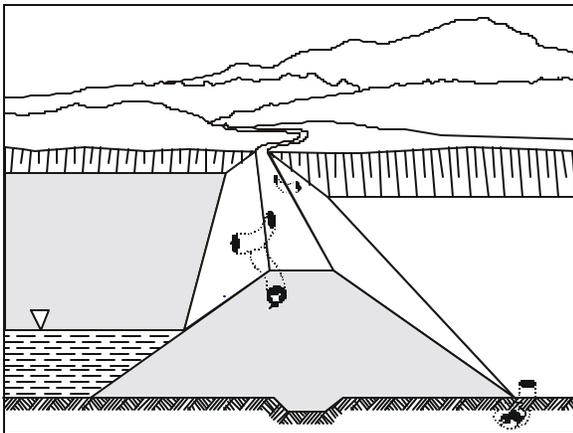
BURROWING ANIMAL ACTIVITY

Cause:

1. Burrowing animals.

1. Can weaken the embankment.
2. Can cause a piping failure.

Recommended action:

1. Control rodents.
2. Remove favorable habitat conditions.
3. Backfill rodent burrows with compacted fill or grout.
