RECAPP Facility Evaluation Report

Capital Care - Norwood - North Pavilion
B0205A
Edmonton

Facility Details

General Summary:

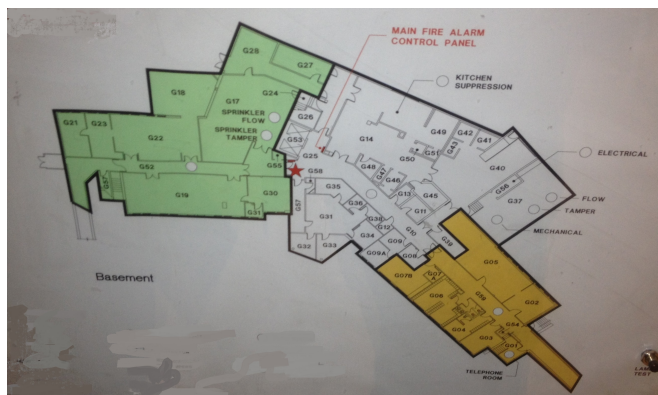
Basement

North Pavilion at the Norwood Extended Care Centre is a 3 storey, concrete construction building.
