**Cold Lake Expansion Project
Fracture Characterization**

COLD LAKE EXPANSION PROJECT FRACTURE CHARACTERIZATION

PREPARED By: DRAGAN ANDJELKOVIC (MSc. GEOLOGIST) &
MUNAZZAH AFZAL (MSc. GEOLOGIST)

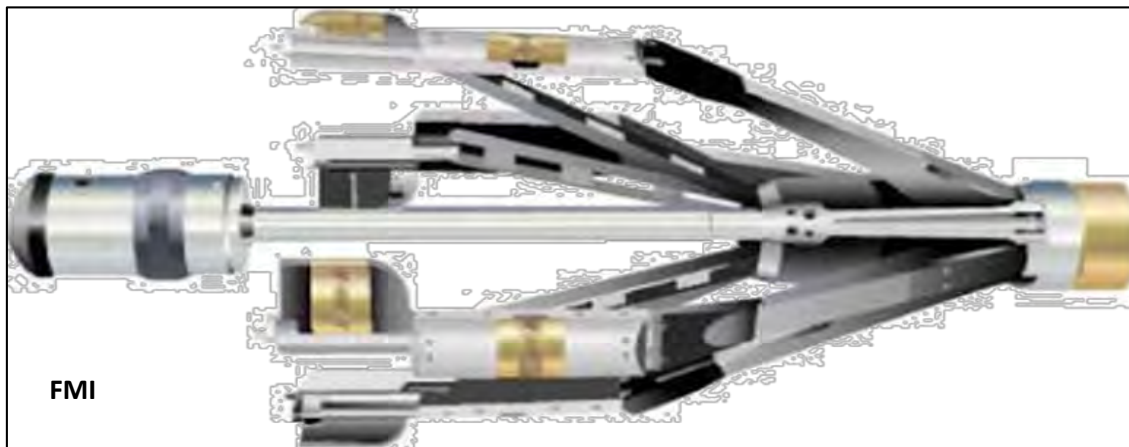
Figure 1. FMI* tool with 4 pad/4Flaps.

The physics of the FMI measurement makes it a highly versatile geological and reservoir characterization tool that produces complete and reliable answer products. The FMI* tool is a 4 arm tool, with each arm comprised of 1 pad and 1 flap, thus creating it a total of 8 pads. Each pad provide 24 electrode measurements which makes a total of 192 micro-resistivity measurements that generate the electrical image of borehole with 0.2in resolution (Figure 1). GPIT (General Purpose Inclinator Tool) check, speed correction, depth alignment, electrode equalization and static and dynamic normalization using a histogram equalization technique were performed on FMI images as standard process before image interpretation (Figure 2).

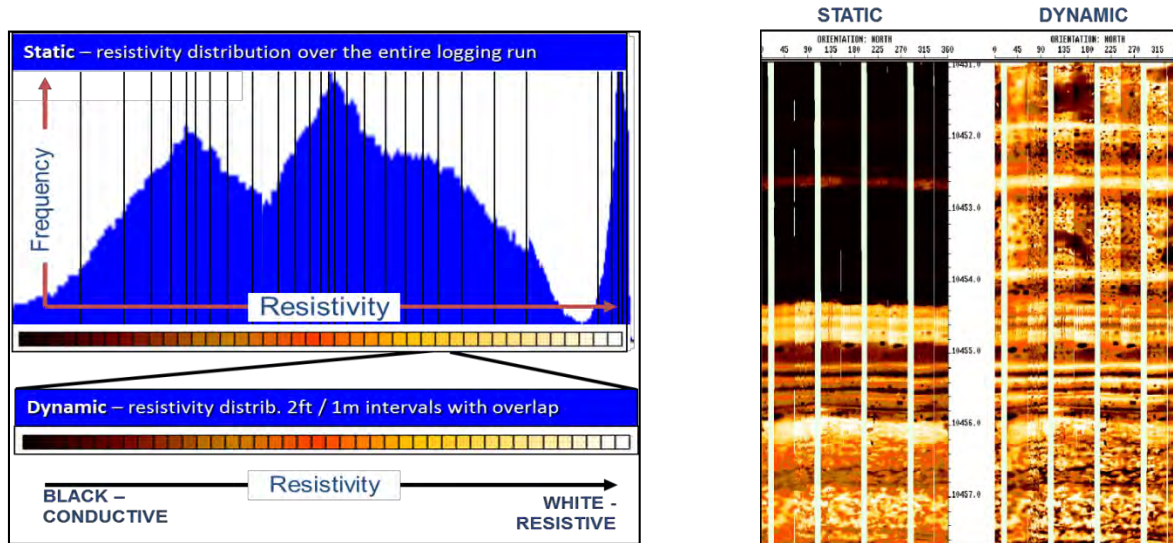
Figure 2. Micro resistivity values recorded by the FMI image tool converted into color images.

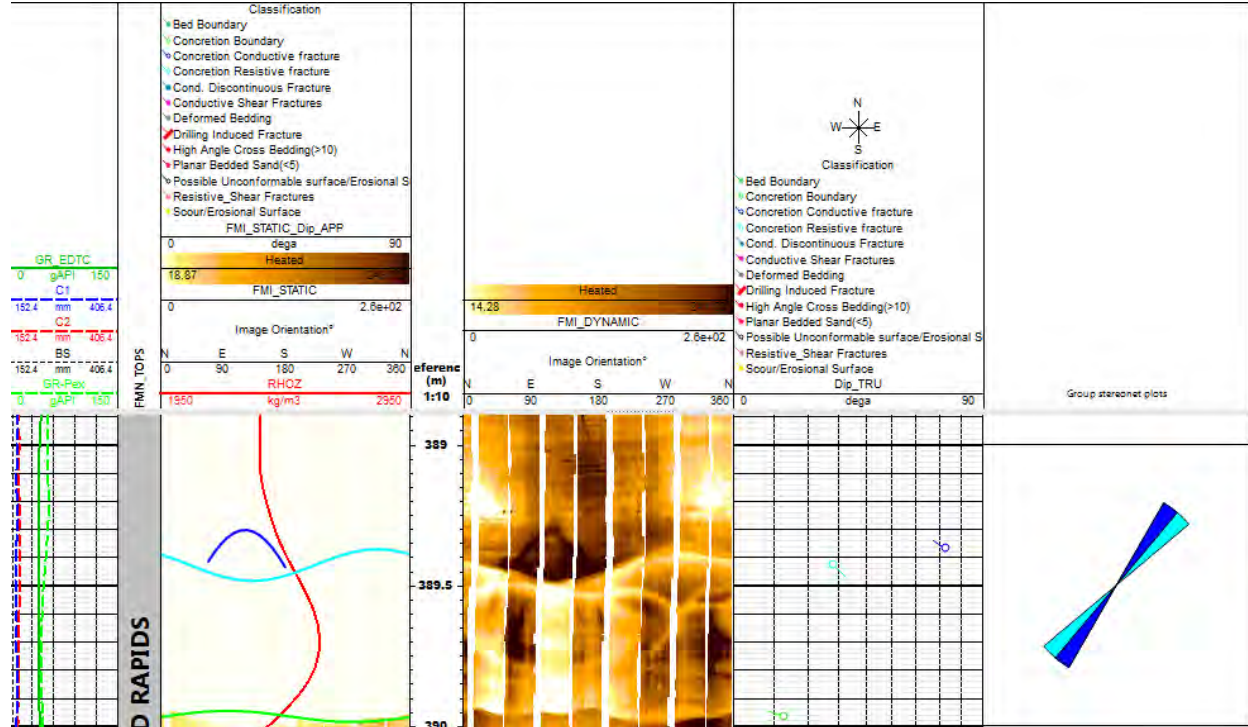
Figure 6 An image example of “NE/SW” trending concretion conductive and resistive fracture visible in high density cemented bed or calcite concretions in Grand Rapids formation from IMP OV-GR2 COLD LK 4-32-65-3 well.

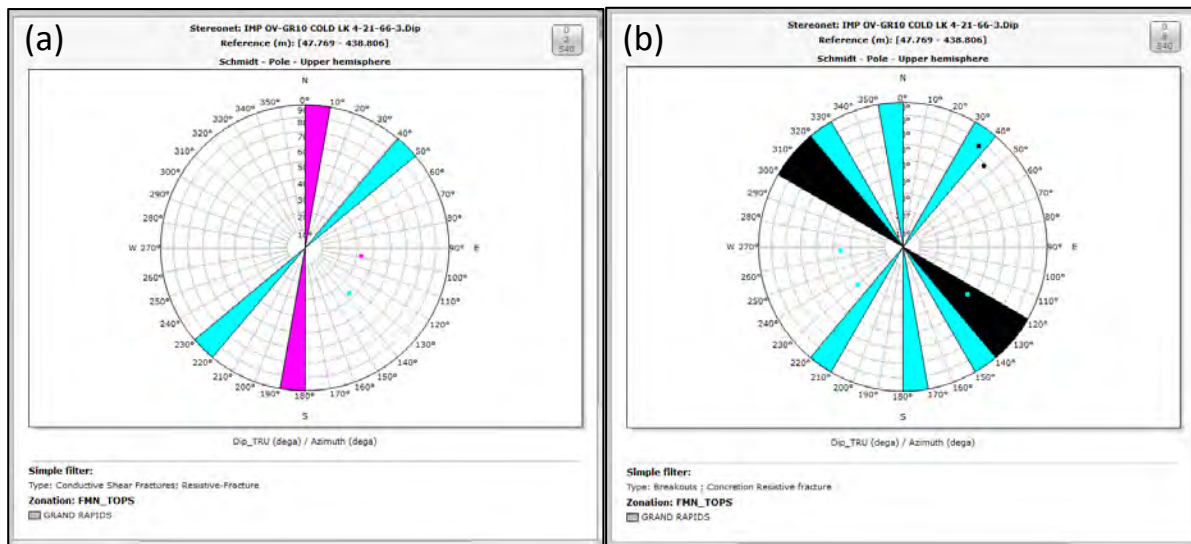
Figure 38 Schmidt diagram of conductive shear fracture (magenta color) and resistive fracture (cyan color) (a), concretion resistive fracture (cyan color) and breakouts (black color) (b) in the Grand Rapids formation for the well 4-21-66-3.

In the Grand Rapids formation, one (1) conductive shear, one (1) resistive and three (3) concretion resistive fractures are interpreted. Conductive shear and resistive fractures show “N-S” and “NE-SW” directions with dip magnitude of 31° and 39° respectively (Figure 38). Concretion fractures show random strike direction in “NS”, “NE-SW” and “NW-SE” with dip magnitude from 34° -46° (Figure 38). Concretion fractures are present in high density calcite concretion at 408.5m (MD). Image example of conductive shear fracture is shown in Figure 39.

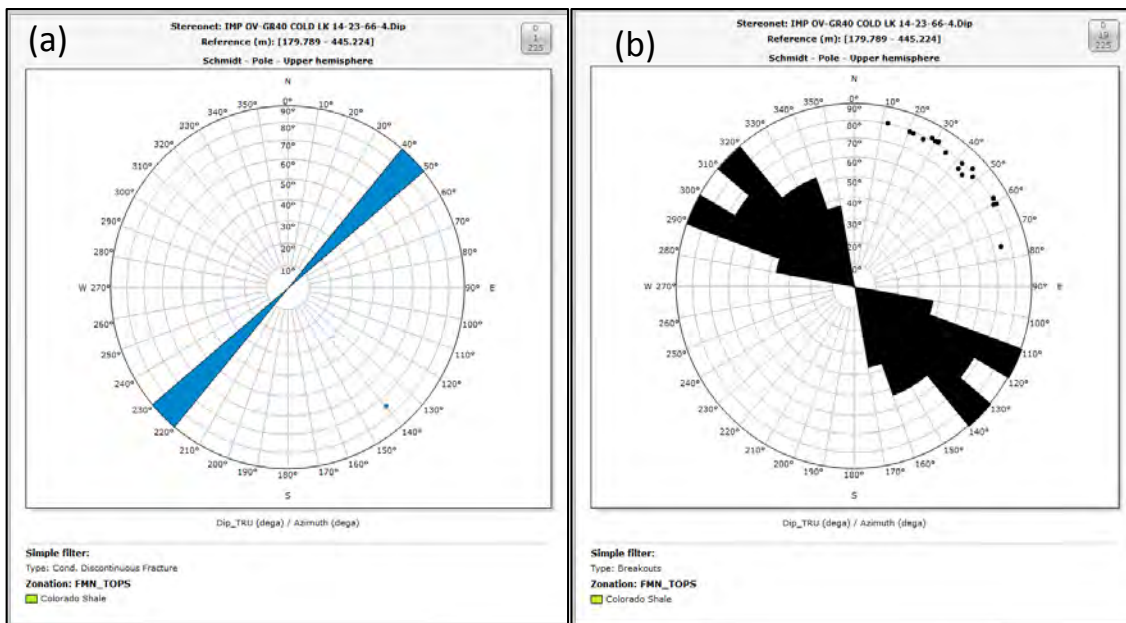
Figure 57 Schmidt diagram of discontinuous conductive fracture (a) and breakouts features (b) in the Colorado Shale formation for the well 14-23-66-4.

In the Colorado Shale formation, one (1) discontinuous conductive fracture is interpreted at 202.28m (MD) with strike in “NE-SW” direction and dip magnitude of 72° (Figure 57). Breakouts are also observed with “NW-SE” strike and dip magnitude of ~80°. Image example of conductive fracture is shown on Figure 58.

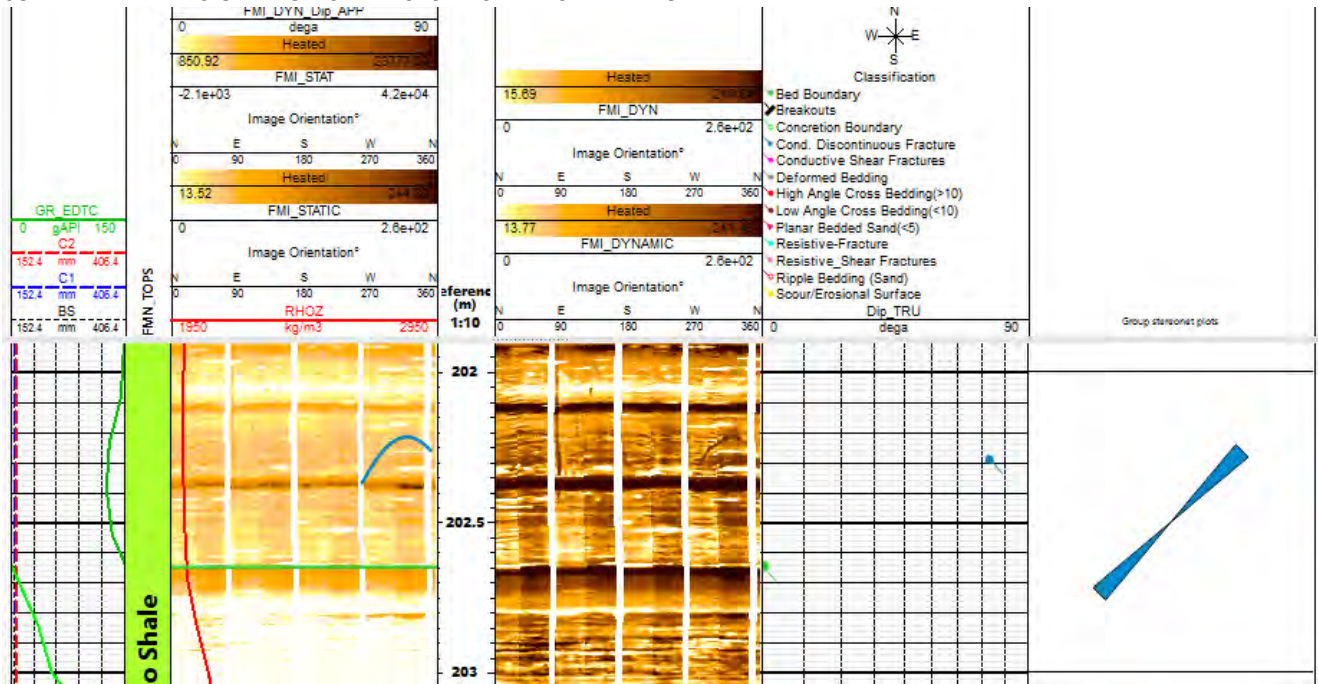
Figure 58 FMI Images showing discontinuous conductive fracture (blue color tadpole) in the Colorado Shale formation for the well 14-23-66-4. Fan plot is showing the fracture strike.
