**ALBERTA TRANSPORTATION SPRINGBANK OFF-STREAM RESERVOIR PROJECT  
RESPONSE TO CEEA INFORMATION REQUEST PACKAGE 3, AUGUST 31, 2018**

**APPENDIX IR13-1 NATIONAL RESEARCH COUNCIL CANADA  
PHYSICAL MODEL STUDY REPORT**

## Physical Model Study of the Springbank Off-stream Storage Project Diversion Structure on the Elbow River

Paul Knox, Andrew Cornett, Mitchel Provan  
Ocean, Coastal and River Engineering  
NRC Technical Report: OCRE-TR-2016-028

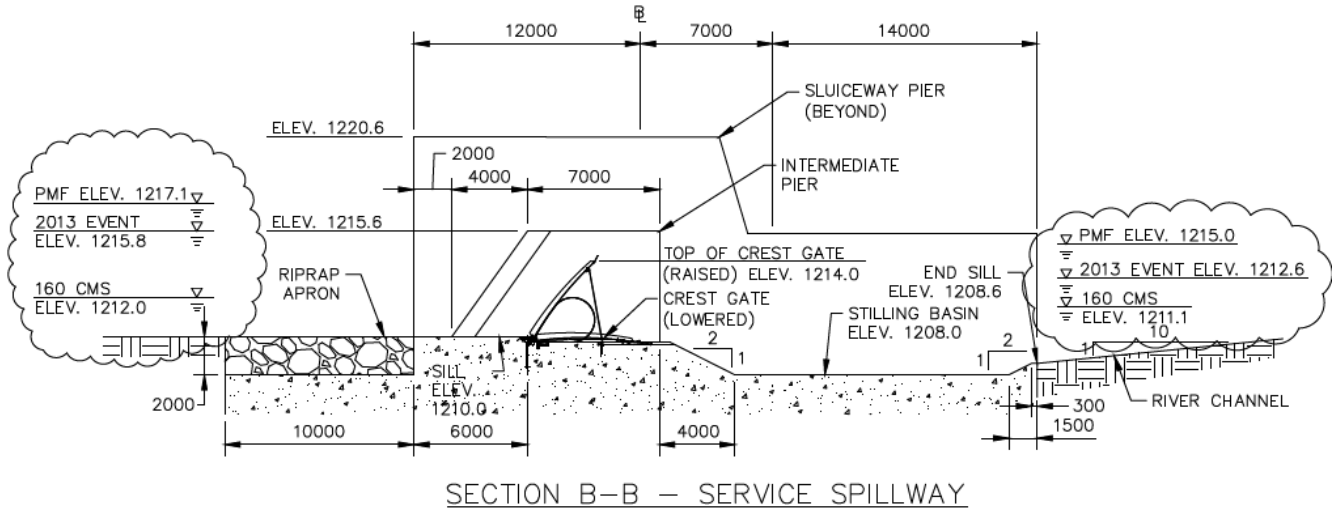
Figure 5. Section view of the initial service spillway design.

The original designs for the diversion inlet and service spillway are shown in Figure 2 to Figure 6. The diversion inlet structure featured four 10m wide bays separated by 2m wide piers, radial gates to control the flow, and energy dissipation chute blocks through the stilling basin. There were two structures to control the flow of the main river channel – a 10m wide sluiceway featuring a radial gate, and a 31m wide service spillway with Obermeyer style crest gates. There were curved retaining walls on the west side of the diversion inlet and also on the east side of the service spillway (fronting

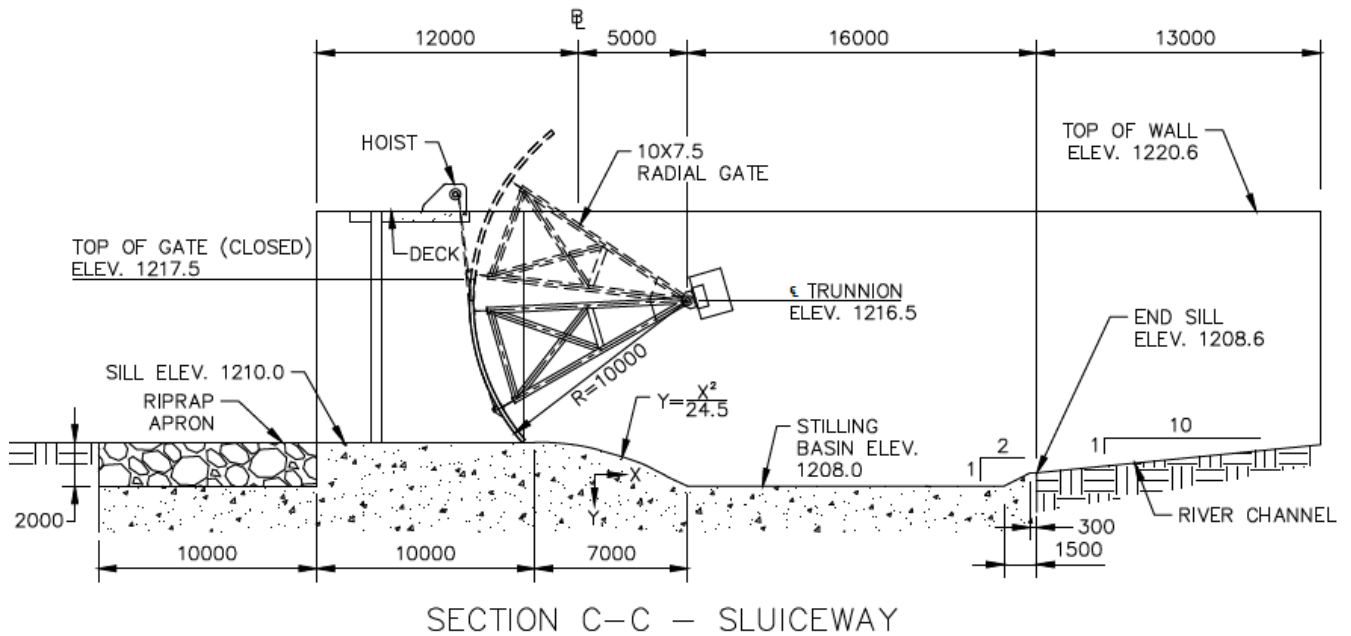
Figure 6. Section view of the initial design sluiceway bay for the service spillway.

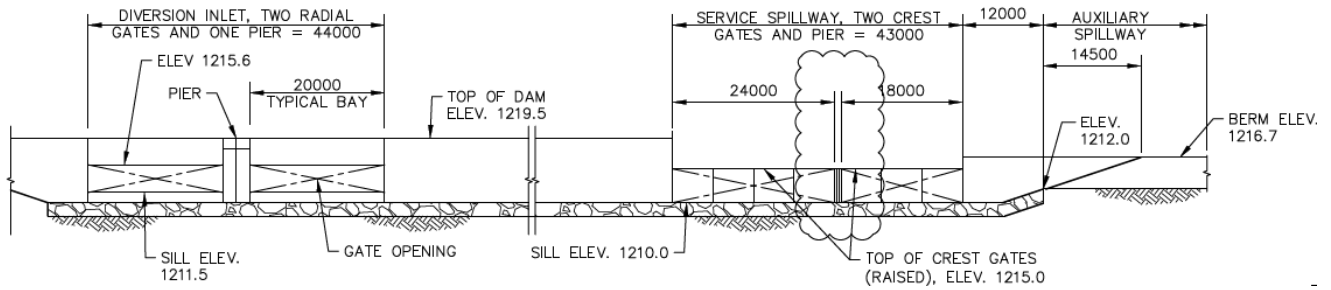
Figure 9. Profile view of the revised diversion inlet structure and service spillway.

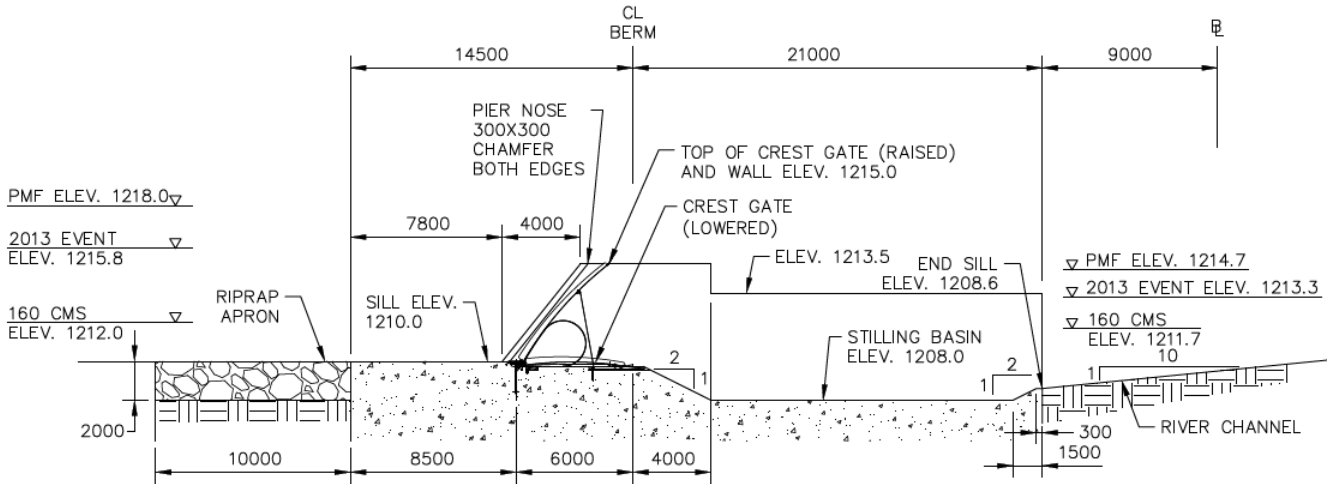
Figure 10. Section view B-B of the service spillway.

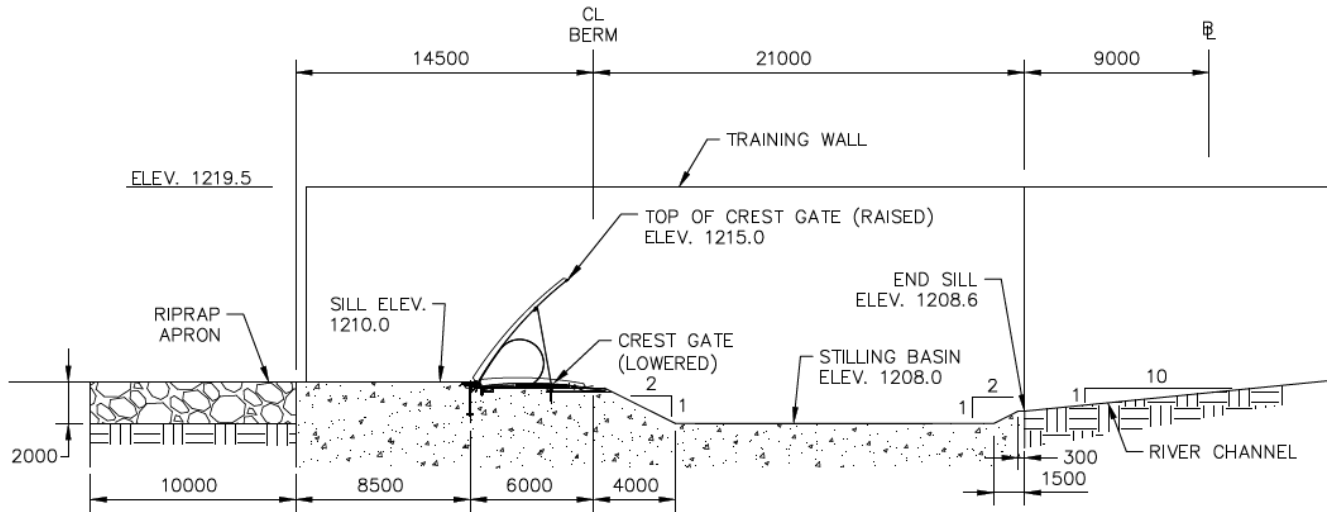
Figure 11. Section view C-C of the service spillway.

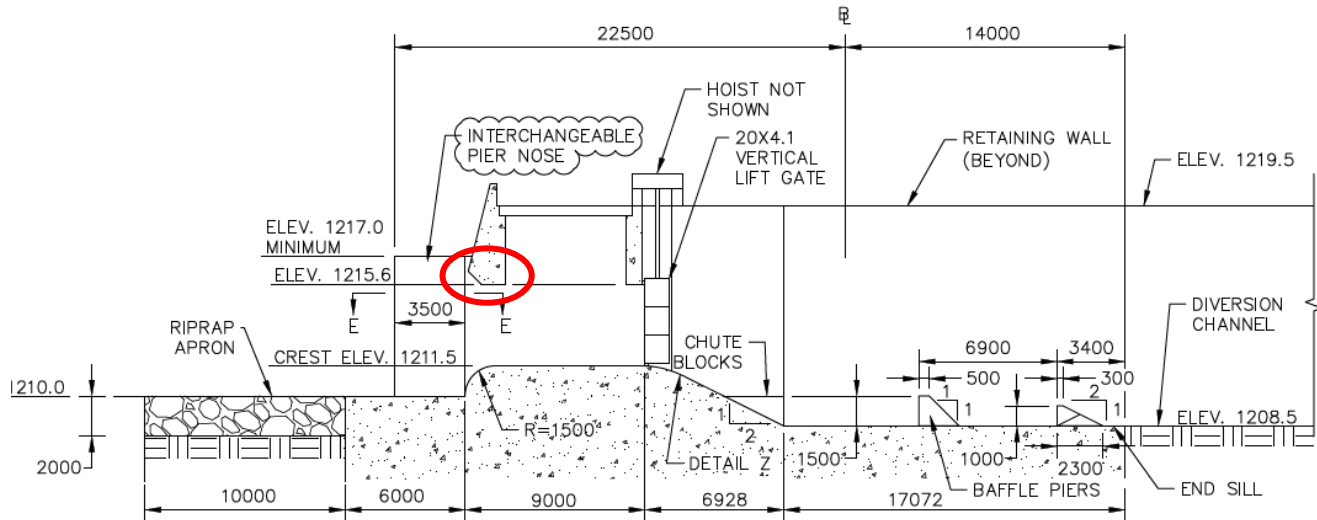
Figure 12. Section view of the diversion inlet structure. Note, the red ellipse highlights the breast wall, which was further modified to a curved profile in the model during the testing.

- The breast walls in the diversion inlet bays were modified during the testing from a flat profile, to a curved profile that could more easily pass debris.

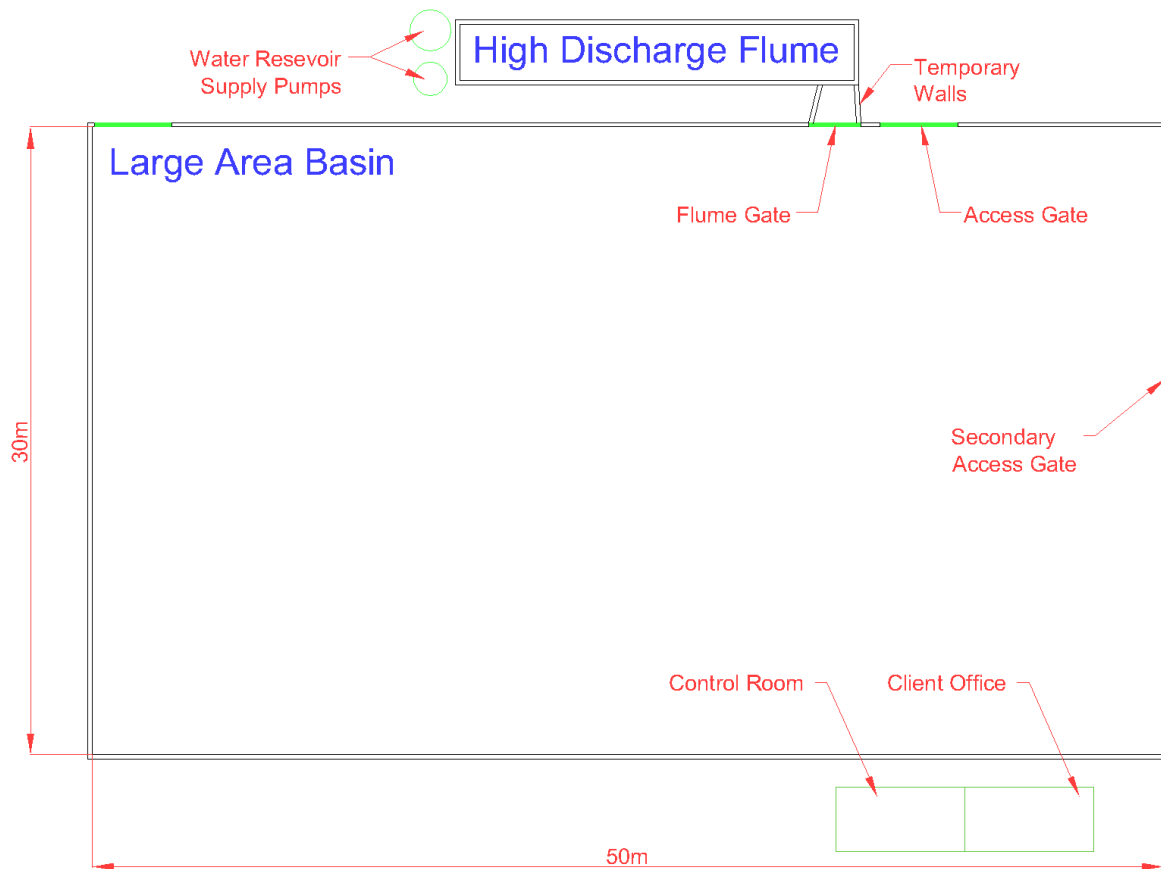
Figure 13. Schematic of NRC-OCRE's Large Area Basin and High Discharge Flume facilities.

A schematic showing the HDF and the LAB in NRC-OCRE's Ottawa laboratory is shown in Figure 13.

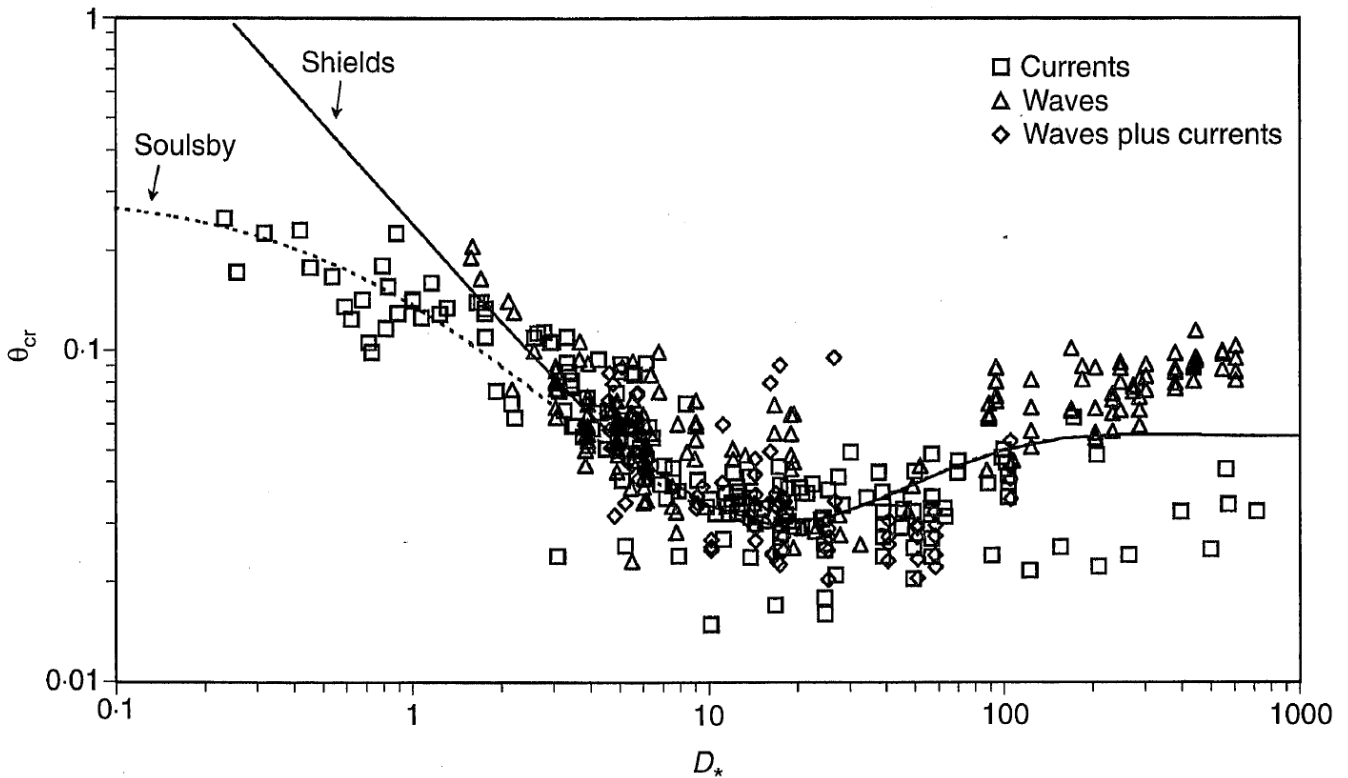
Figure 14. Mobility threshold for sediments (from Soulsby 1997).

This expression for  $\theta_c$  fits well to experimental data and is identical to the Shields curve for  $D_* > 10$  (see Figure 14). Theory, supported by numerous experiments, suggests that sediments will be stable for  $\theta < \theta_c$ , and will be mobile for  $\theta > \theta_c$ . In reality, the transition from a stable condition to a mobile condition occurs over a range of  $\theta$  around  $\theta_c$ . The fact that the experimental data on the threshold of motion of granular materials is moderately scattered supports this view. Within the mobile regime,

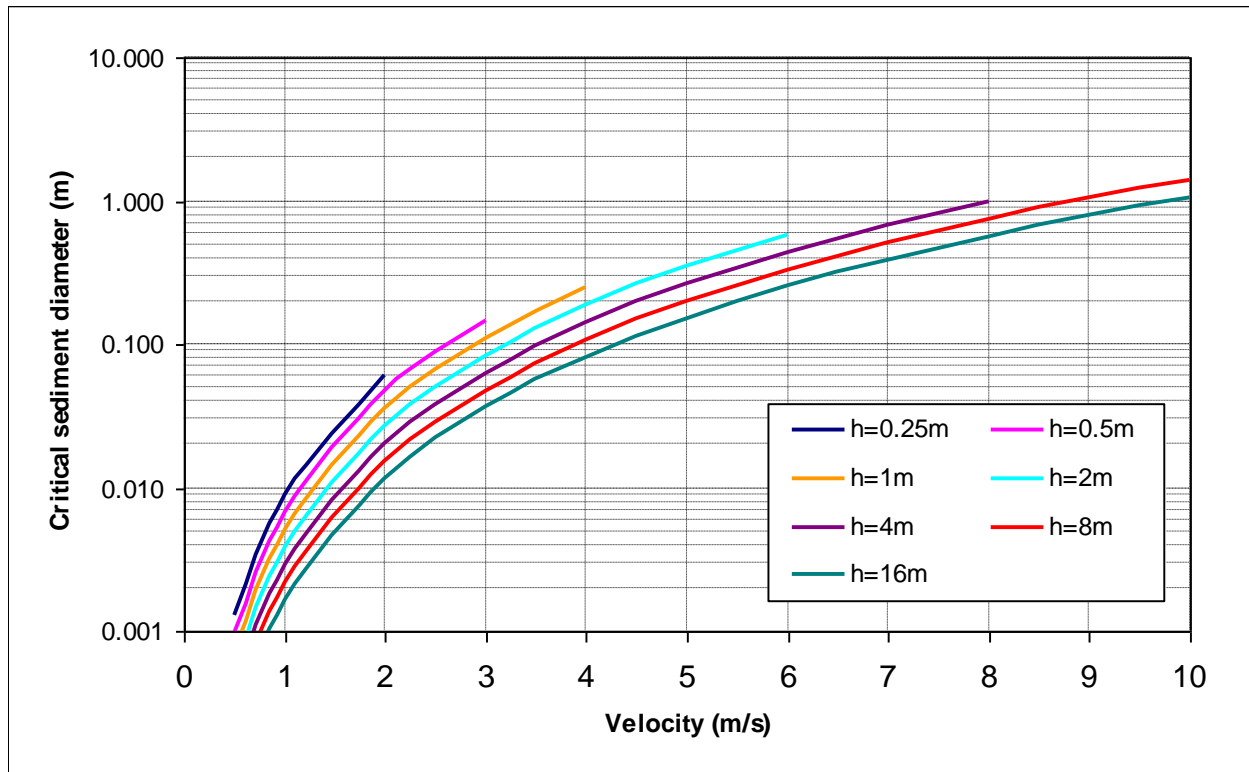
Figure 15. Threshold current speed for mobility of gravels in steady flows.

Figure 15 shows the threshold current speed plotted as a function of sediment size for various water depths. This figure can be used to guide the initial selection of riprap for a horizontal bed, once the depth averaged velocity and water depth are known. However, the reader should note that this figure does not take into account any possible flow disturbance and amplification of bed shear stress around structures such as piers, piles, caissons, sluice gates, etc. Whitehouse (1998) reports shear stress amplification factors around structures on the order of between 2 and 6. In other words, the shear stress on the bed near a structure can be up to 6 times larger than the far field shear stress. In such situations, the initial selection of riprap or armour stone should be verified through physical model tests.

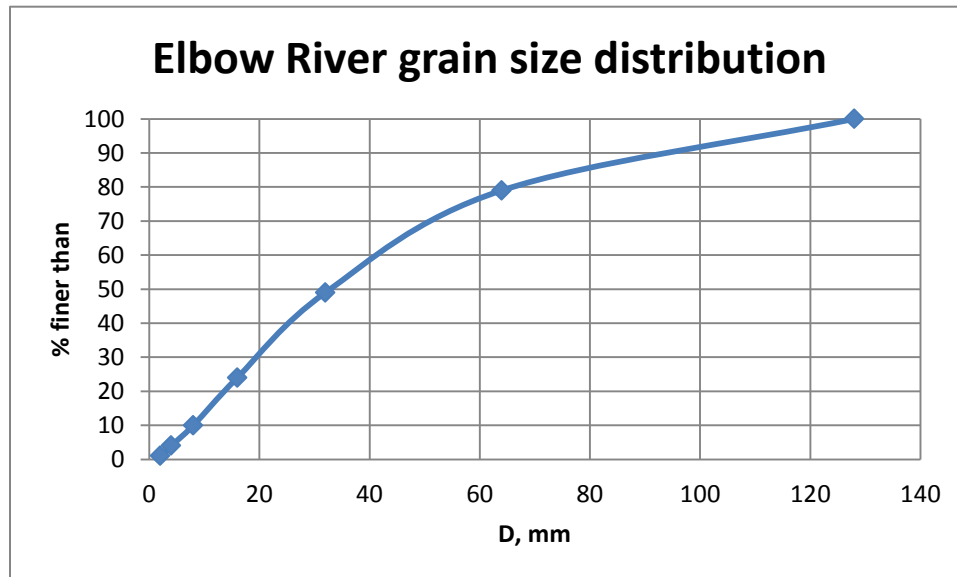
Figure 16. Typical grain size distribution at the Elbow River study site.

Stantec provided measured grain size distributions at the study site. The typical grain size distribution from these data was used as the prototype grain size distribution (Figure 16).

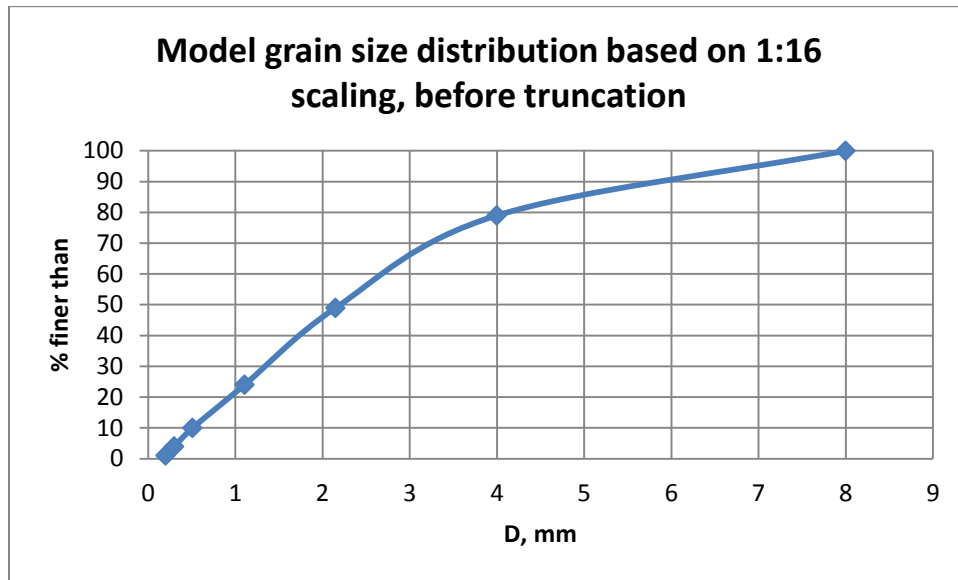
Figure 17. Model scale (1:16) grain size distribution, adjusted slightly to ensure same mobility in model as prototype based on Shields scaling.

The model scale of 1:16 was used for preliminary dimensional scaling of the bed sediments to be used for mobile bed model runs. The mobility of the 1:16 grain size distribution was evaluated based on the non-dimensional Shields criterion in both model and prototype:  $D^*$  was calculated for  $D_{90}$ ,  $D_{50}$ ,  $D_{24}$ , and  $D_{10}$  in both model and prototype, and hence  $\theta_c$  for each fraction was calculated in model and prototype. To calculate  $\theta_c$ , bed shear stress was calculated using the depth slope product ( $\tau = \rho g Y S$ ), with  $S$  the reach average bed slope of 0.0064, and  $Y$  the flow depth during the  $Q=320 \text{ m}^3/\text{s}$  flow stage ( $Y_{\text{prototype}}=2\text{m}$ ,  $Y_{\text{model}}=0.13 \text{ m}$ ). For the finer fractions ( $D \leq D_{50}$ ),  $D_{\text{model}}$  was increased slightly to ensure that  $[\theta_{\text{prototype}} - \theta_{c,\text{prototype}} = \theta_{\text{model}} - \theta_{c,\text{model}}]$ , i.e., to ensure all fractions had the same mobility in model as in the prototype. Due to the relatively coarse bed sediments in the Elbow River, and the relatively large model scale, little adjustment was required. For example,  $D_{50,\text{model}}$  was increased from 0.0020 m to 0.0022 m, and  $D_{10,\text{model}}$  was increased from 0.00050 m to 0.00051 m. The resulting model grain size distribution is shown in Figure 17.

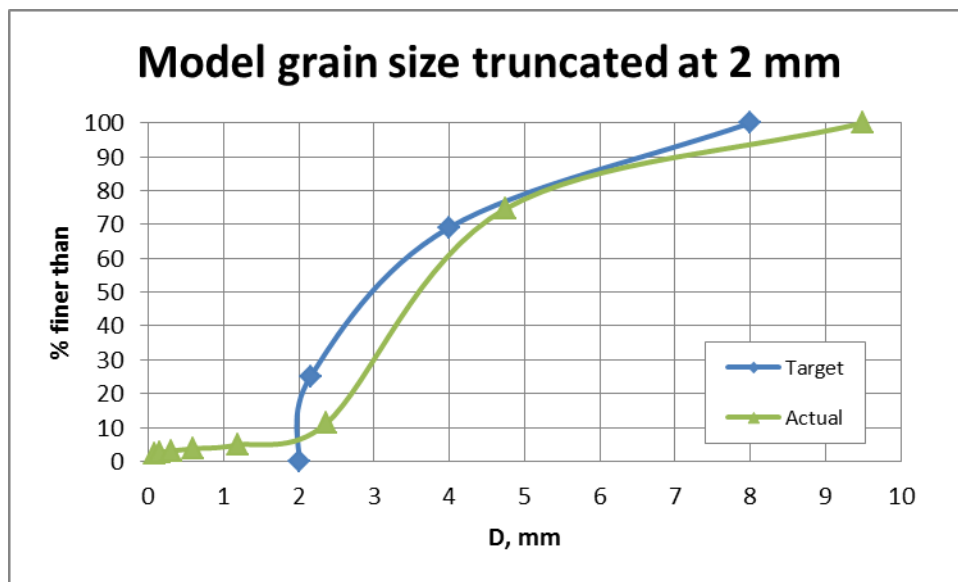
Figure 18. Final model grain size distribution, based on model (1:16) scaled grain size distribution, adjusted slightly to ensure same mobility in model as prototype based on Shields scaling, and truncated at 2 mm.

However, the total bed material load during the larger flow events was deemed to be too large for the physical model. Furthermore, the transport, erosion, and deposition behaviour of the coarser fraction was deemed to be of the greatest interest. Consequently, the model grain size distribution was truncated near the  $D_{50,model}$  at 2mm. The final model grain size distribution is shown in Figure 18. This figure shows the target gradation from theory (blue) as well as the model material selected that reasonably represented the target curve (green).

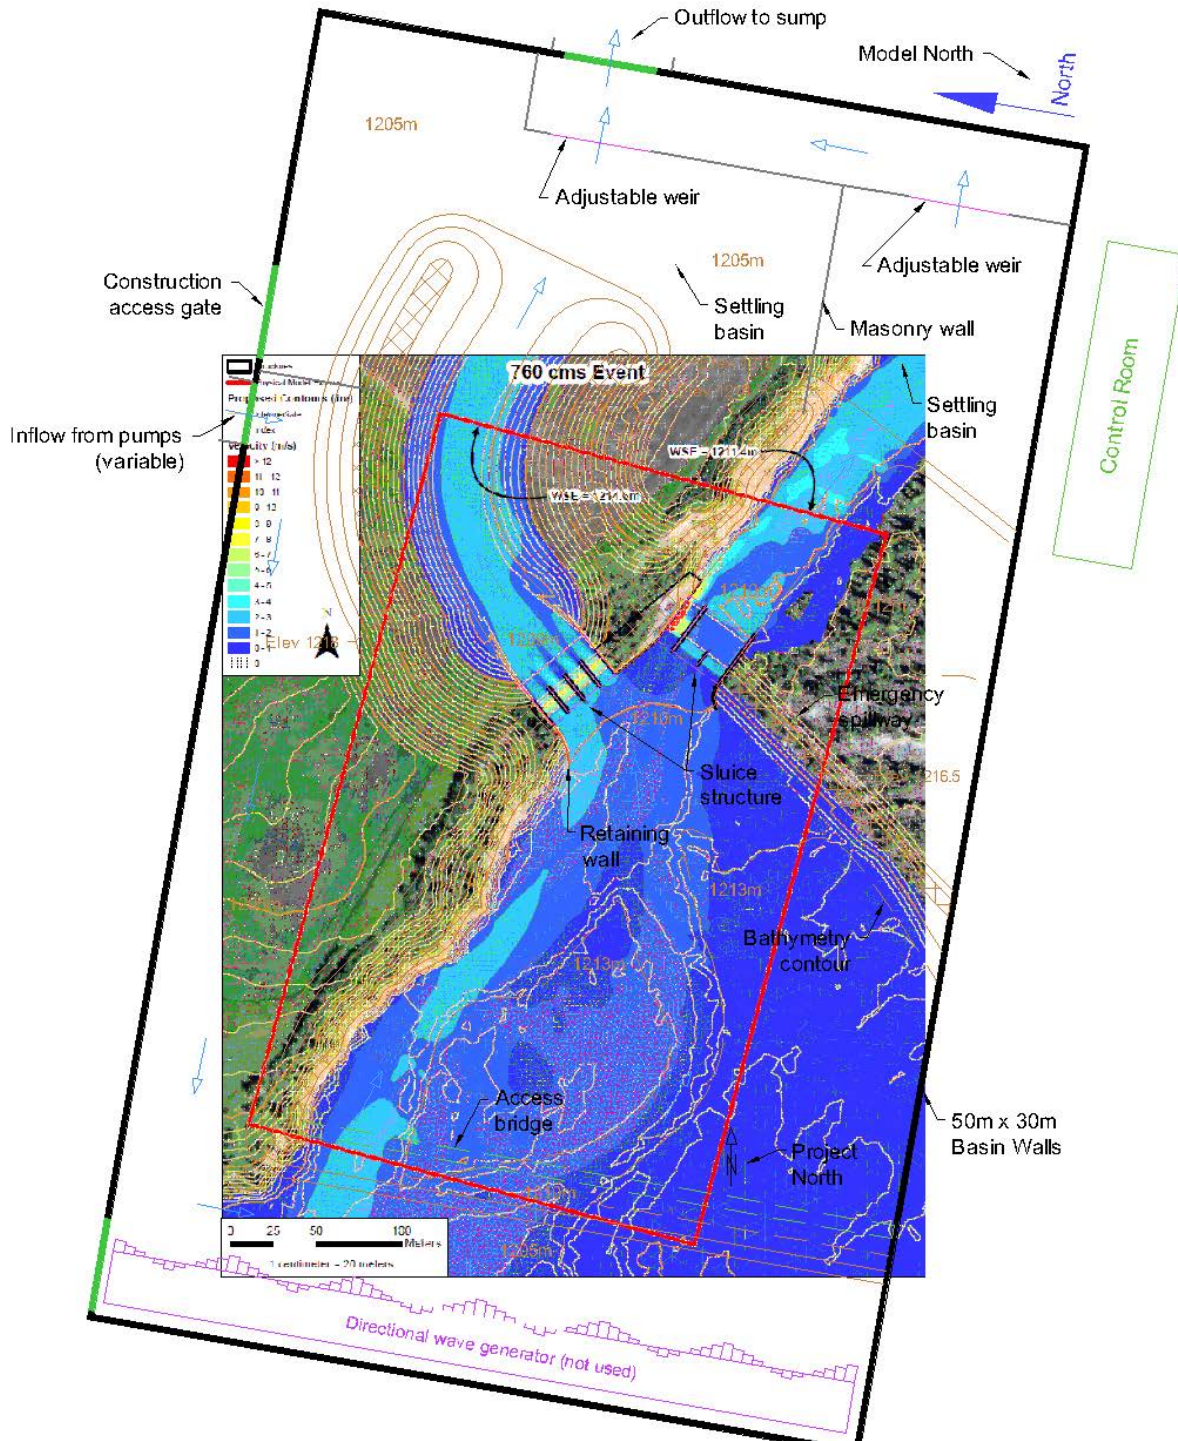
Figure 20. Plan view of the physical model overlain with Stantec numerical modelling results.

manner, and the model provided an excellent means of verifying the performance and optimising the design of the proposed structures, including the risks of sediment deposition and blockage due to floating debris. Scaled replicas of woody debris (logs, trees) were modelled to match debris characterisations and loading estimates provided by Stantec (see Section 3.4.4). The debris was added near the upstream model boundary and allowed to drift downstream, possibly grounding in shallows or snagging in the sluiceway or service spillway. A range of granular sediments were utilized in the model to replicate the mobility of the sediments available in the natural river bed (see Section 3.4.5). These sediments were either pre-loaded on the river bottom, or added to the flow using mechanical spreaders. The layout of the physical model is shown in Figure 20 and Figure 21 as well as the photographs of Figure 22 to Figure 26.

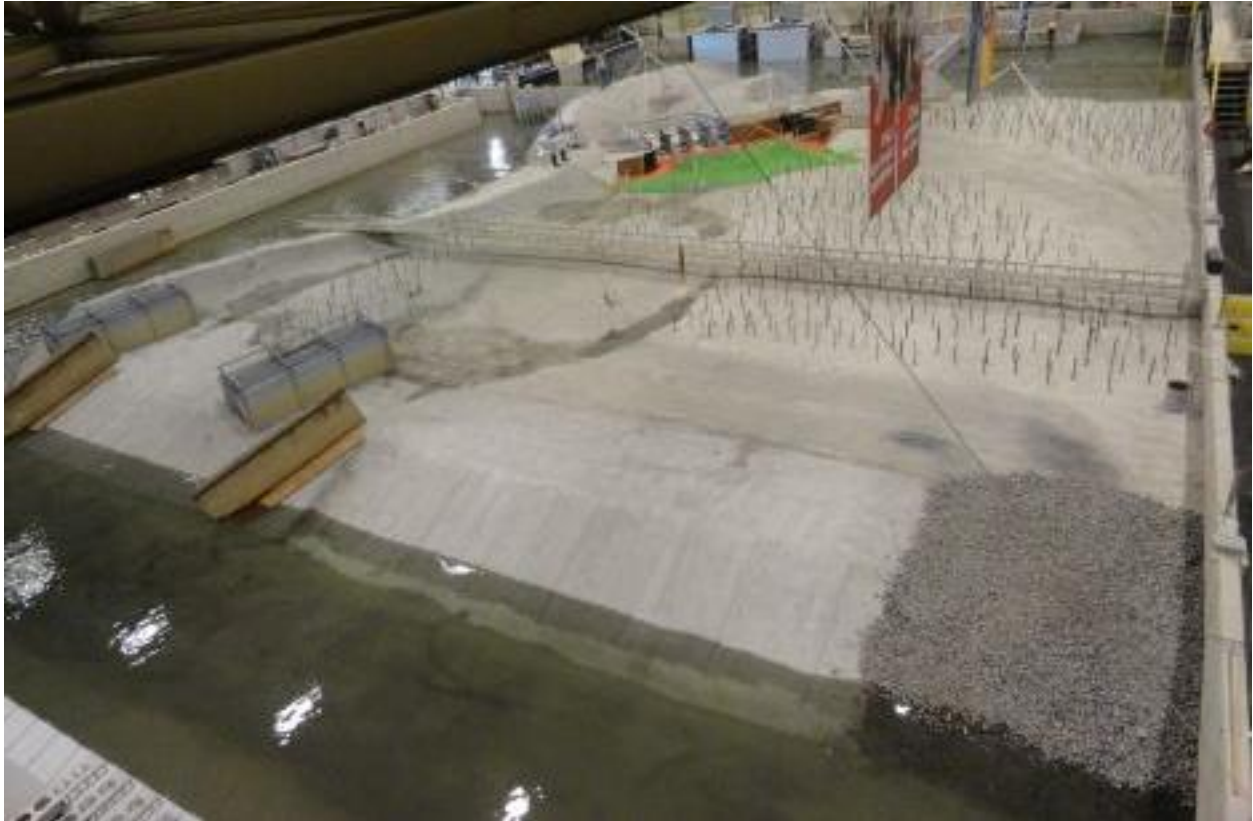
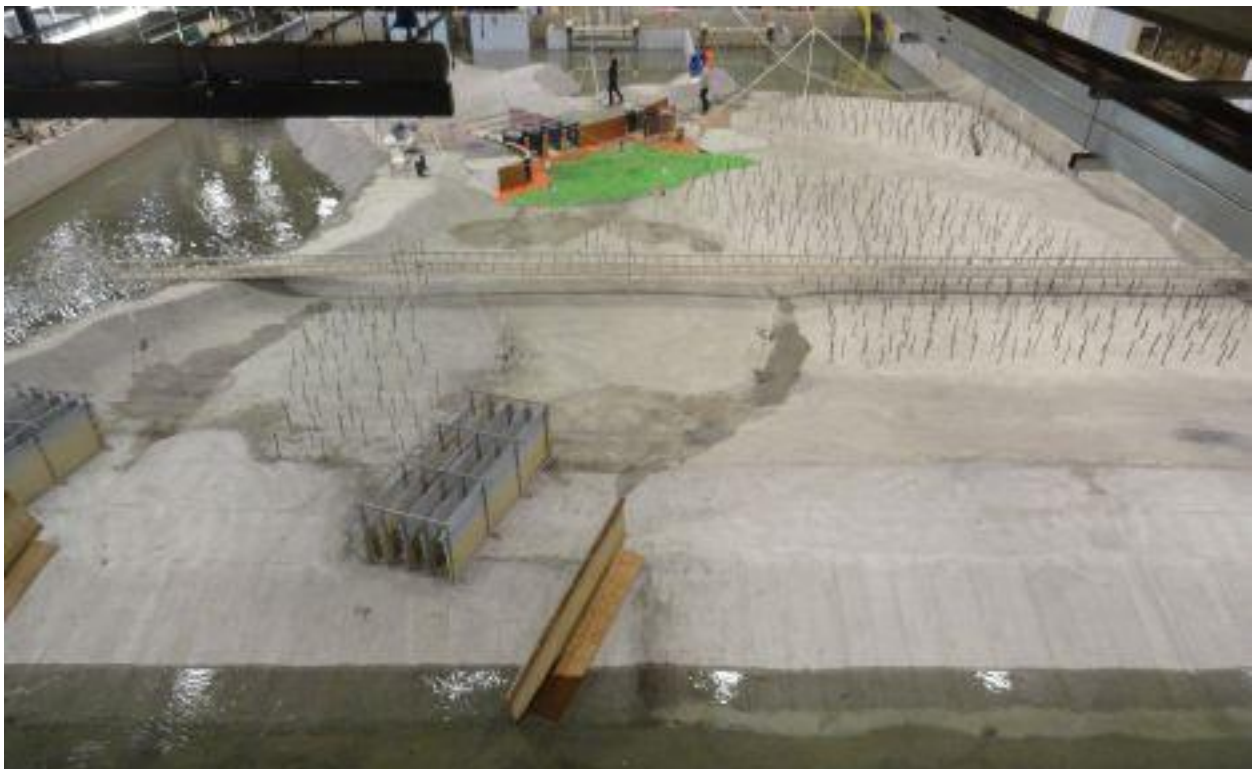
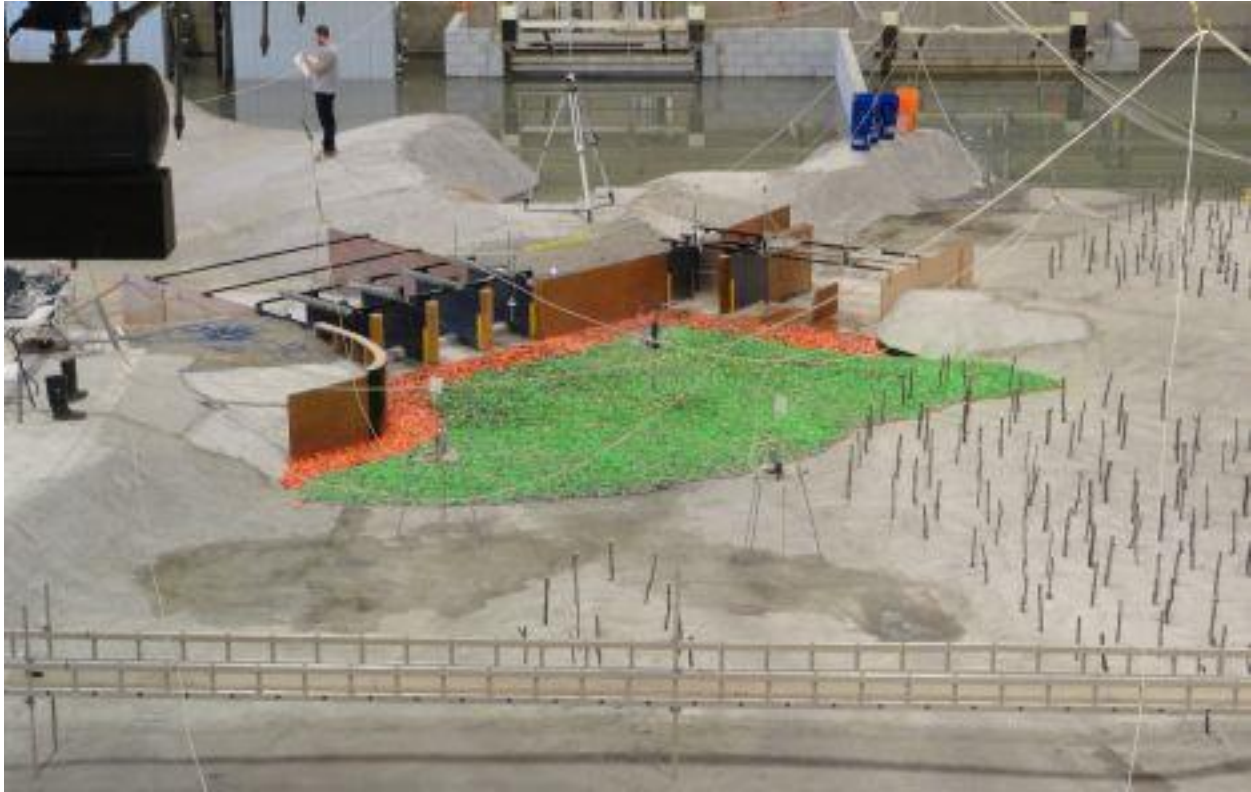
Figure 22. Photograph of the physical model after construction – looking downstream.

Figure 23. Photograph of the physical model after construction – looking downstream.

Figure 24. Photograph of the physical model after construction – looking downstream.

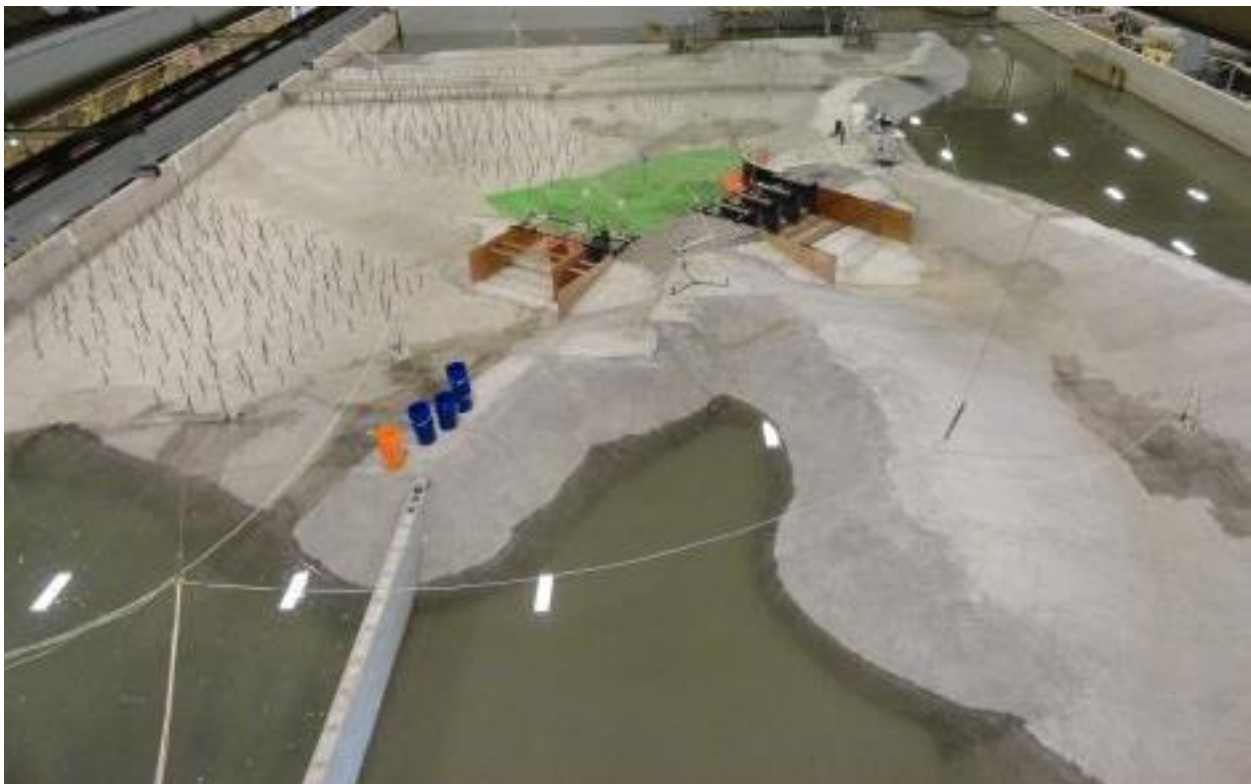
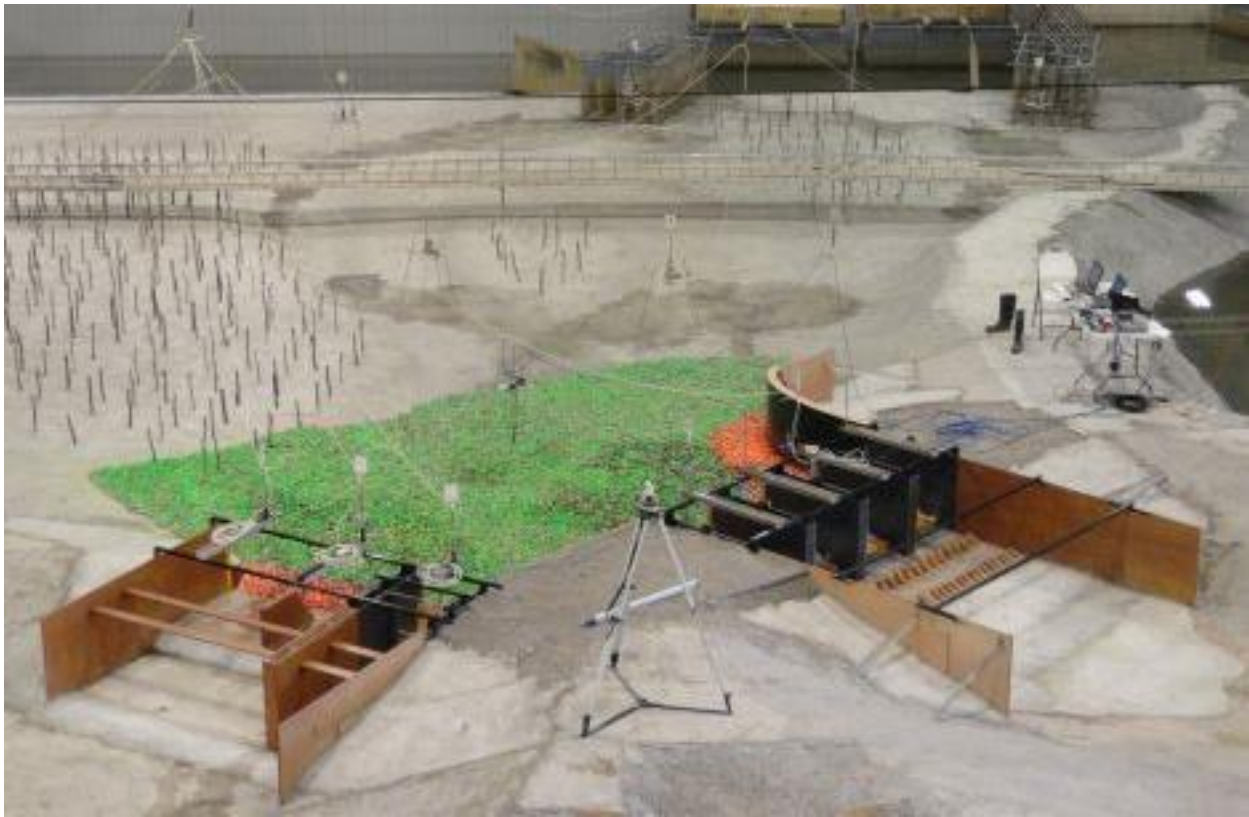
Figure 25. Photograph of the physical model after construction – looking upstream.

Figure 26. Photograph of the physical model after construction – looking upstream.

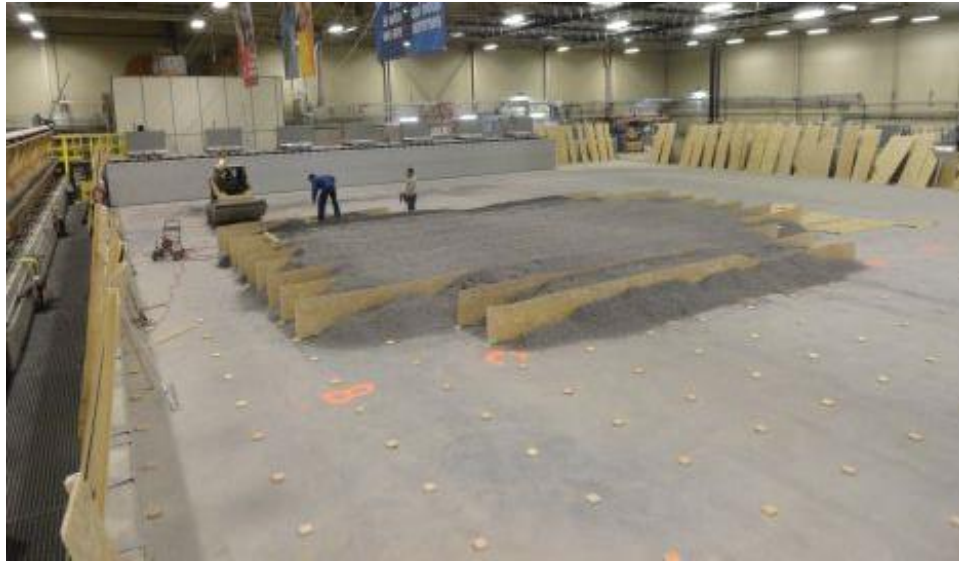
Figure 27. Fibreboard templates were erected and backfilled with fine gravel.

The concrete bathymetry was constructed using a series of fibreboard templates erected at 1m intervals (model scale, or MS) throughout the model domain. The templates, used to represent cross-sections of the riverbed, were cut to an accuracy of  $\pm 2\text{mm MS}$  and were supported on the basin floor by a grid of pads leveled to within  $\pm 1\text{mm MS}$ . Heavy construction equipment was used to fill the templates with clear gravel once secured on top of the leveled pads. The clear gravel was then compacted with a plate tamper such that the final surface rested approximately 5cm MS below the top edge of the templates. Fine aggregate concrete was then placed on top of the gravel base and power screeded to match the elevations of the templates. Once cured, a smooth finish was achieved using a combination of hand- and mechanical-trowelling, and a roughened finish (where applicable) was achieved using a stiff broom finish on the curing concrete. Photographs showing some of the stages of the bathymetry construction are shown in Figure 27 to Figure 32.

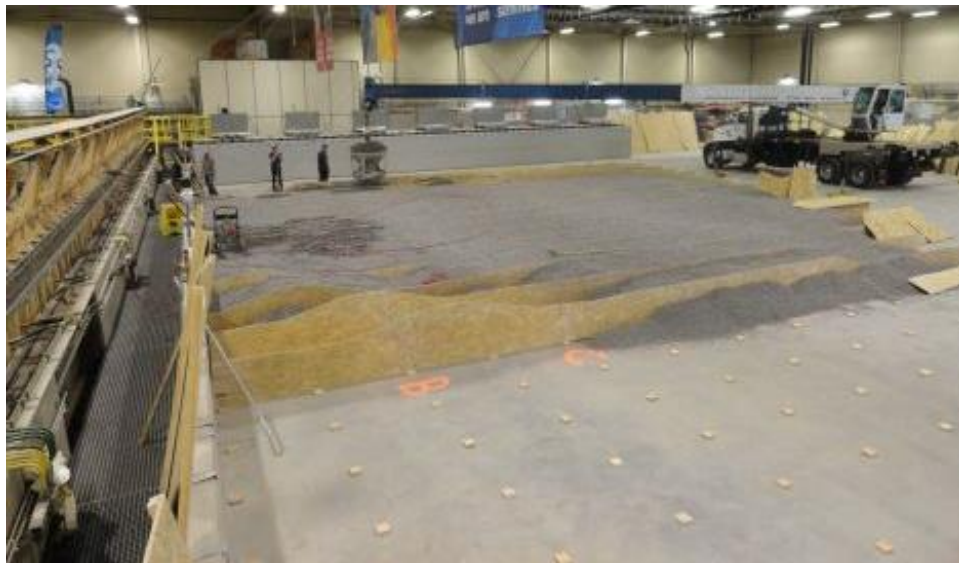
Figure 28. Heavy construction equipment was used to fill templates.

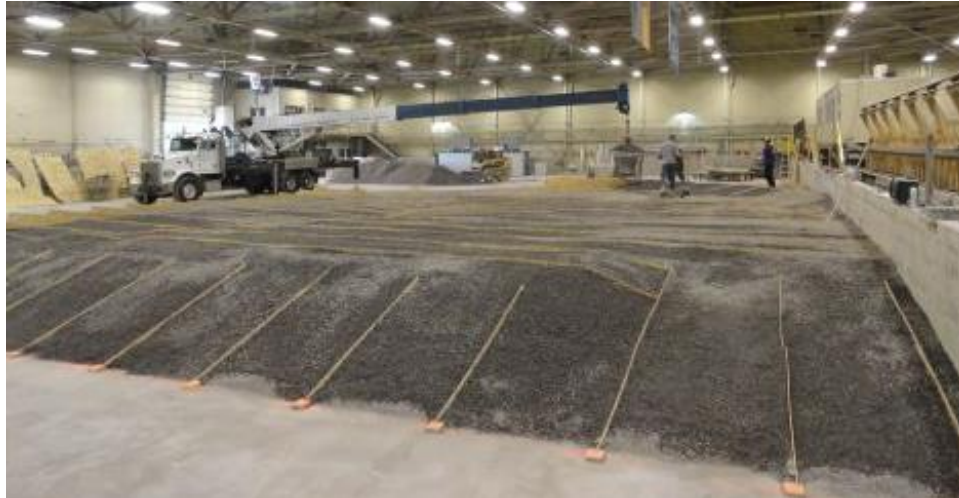
Figure 29. Heavy construction equipment was used to pour concrete.

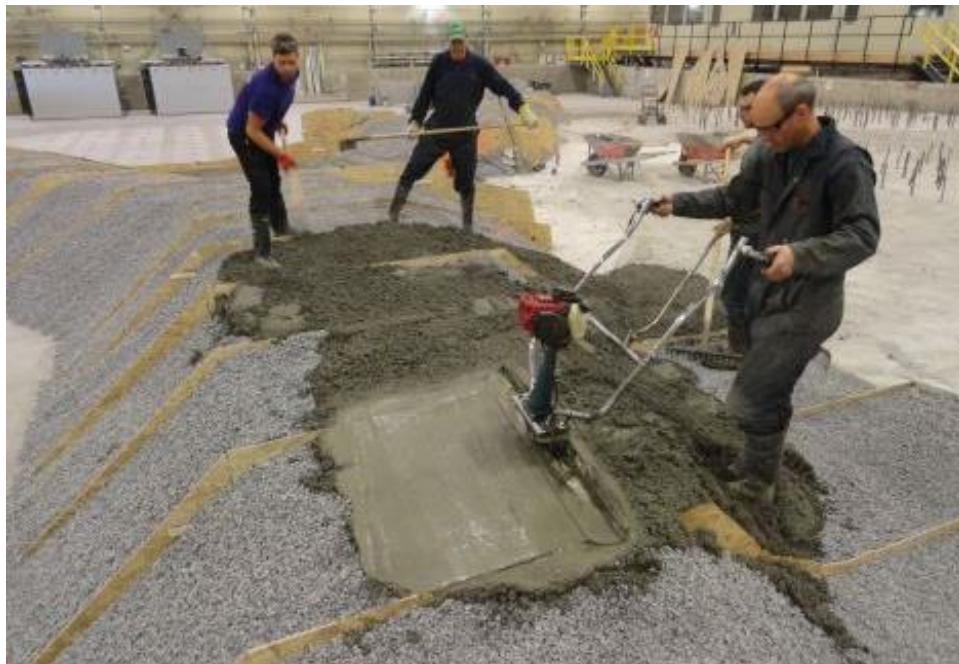
Figure 30. The concrete was screeded to match the template surfaces.

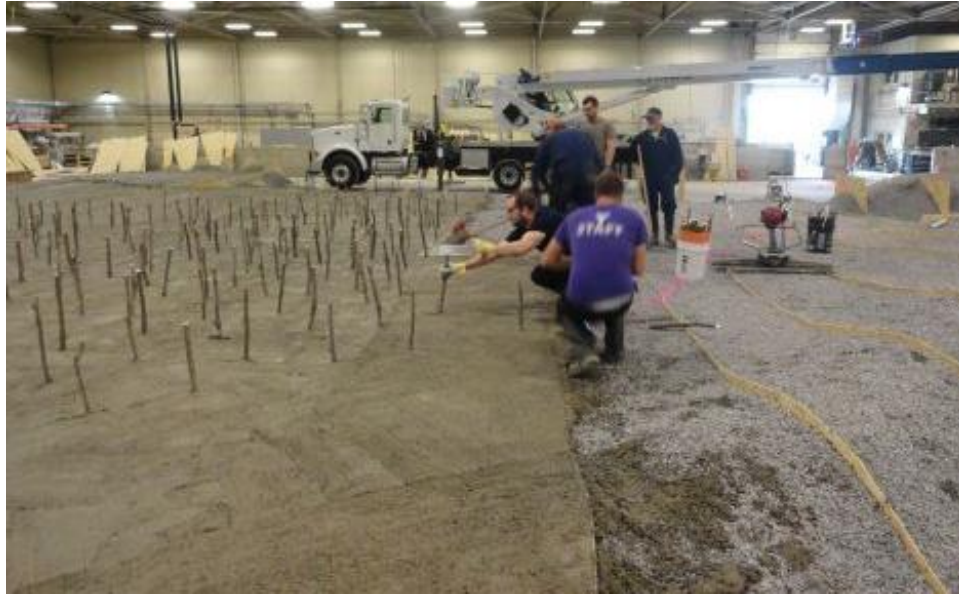
Figure 31. The concrete was broom finished to roughen the surface, and model trees were inserted into the wet concrete to model forested regions of the floodplain.

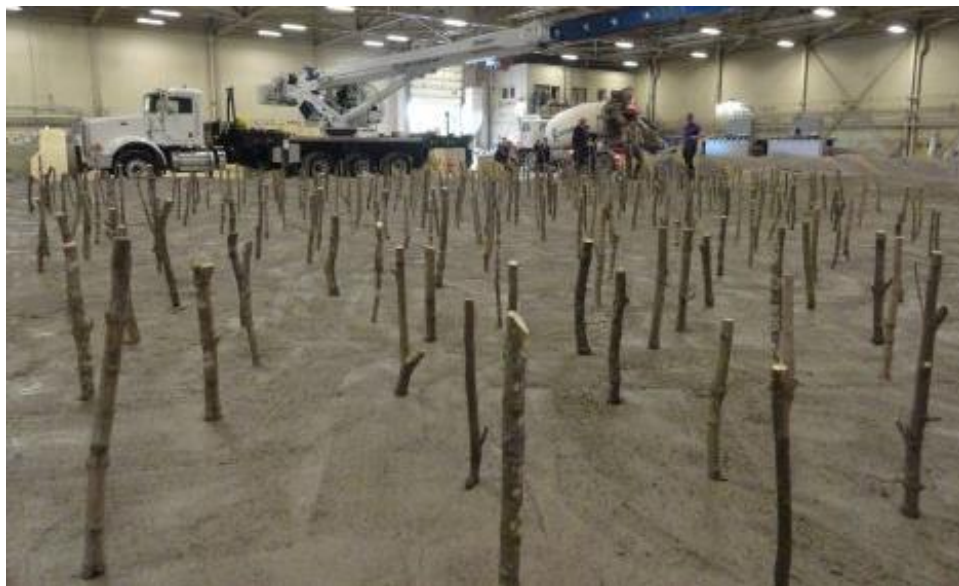
Figure 32. Model trees in the curing concrete.

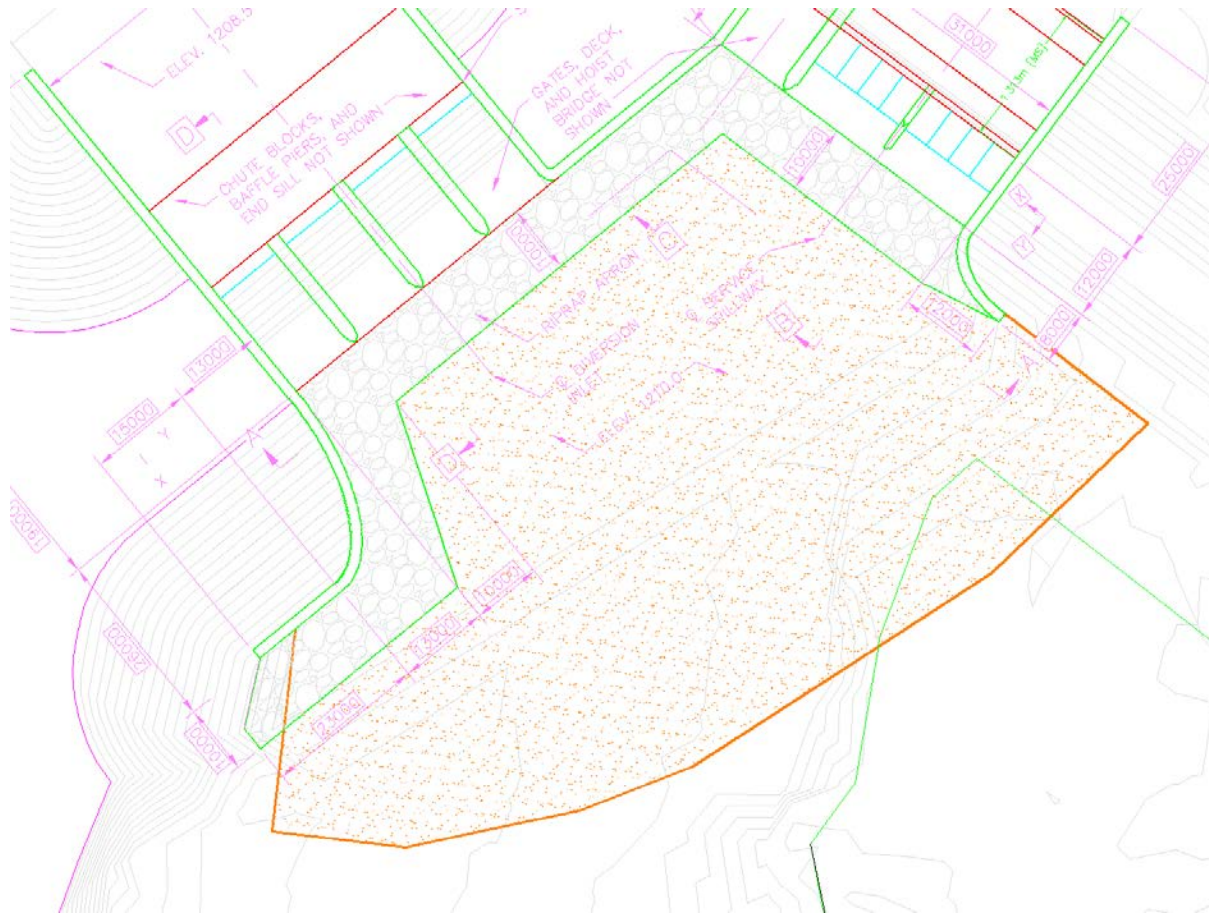
Figure 33. Drawing showing the extents of the lowered concrete where mobile bed material was used (orange hatching).

The concrete bathymetry for an area close to the diversion inlet and service spillway/sluiceway was lowered to 0.5m below the actual surface level. In this area, scaled mobile river sediments were placed to investigate their mobility and the potential for erosion, scour, and accretion in the model. This mobile-bed area is shown below in Figure 33 and Figure 34. During test series where investigating sediment transport was not desired, the mobile bed area was filled with 210kg riprap stone.
