**ALBERTA TRANSPORTATION SPRINGBANK OFF-STREAM RESERVOIR PROJECT  
RESPONSE TO CEEA INFORMATION REQUEST PACKAGE 3, AUGUST 31, 2018**

**APPENDIX IR13-1 NATIONAL RESEARCH COUNCIL CANADA  
PHYSICAL MODEL STUDY REPORT**

## Physical Model Study of the Springbank Off-stream Storage Project Diversion Structure on the Elbow River

Paul Knox, Andrew Cornett, Mitchel Provan  
Ocean, Coastal and River Engineering  
NRC Technical Report: OCRE-TR-2016-028

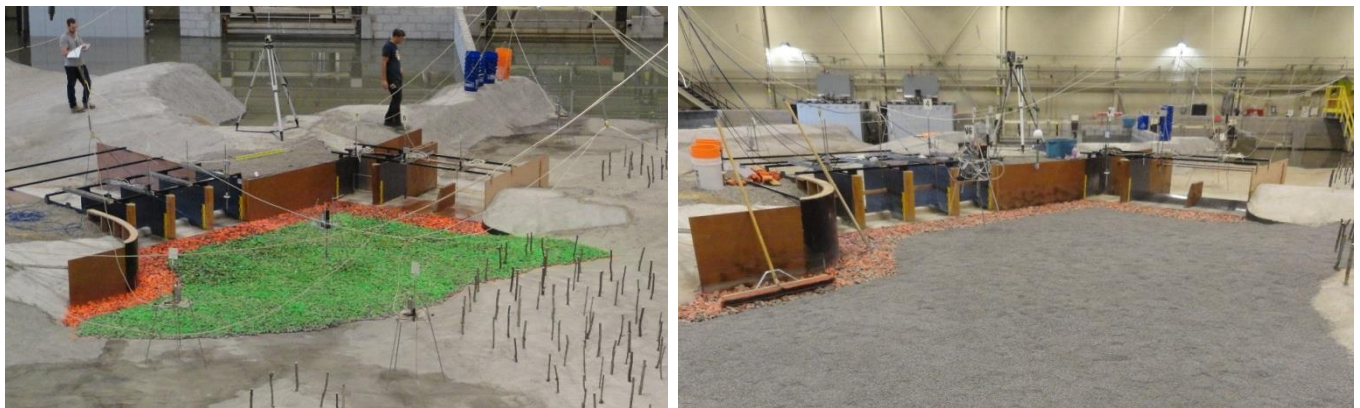
Figure 34. Left – mobile bed area of the model was filled with 210kg (green) riprap stone during clear water or debris tests. Right – model river sediments placed in the mobile bed area.

The concrete bathymetry for an area close to the diversion inlet and service spillway/sluiceway was lowered to 0.5m below the actual surface level. In this area, scaled mobile river sediments were placed to investigate their mobility and the potential for erosion, scour, and accretion in the model. This mobile-bed area is shown below in Figure 33 and Figure 34. During test series where investigating sediment transport was not desired, the mobile bed area was filled with 210kg riprap stone.

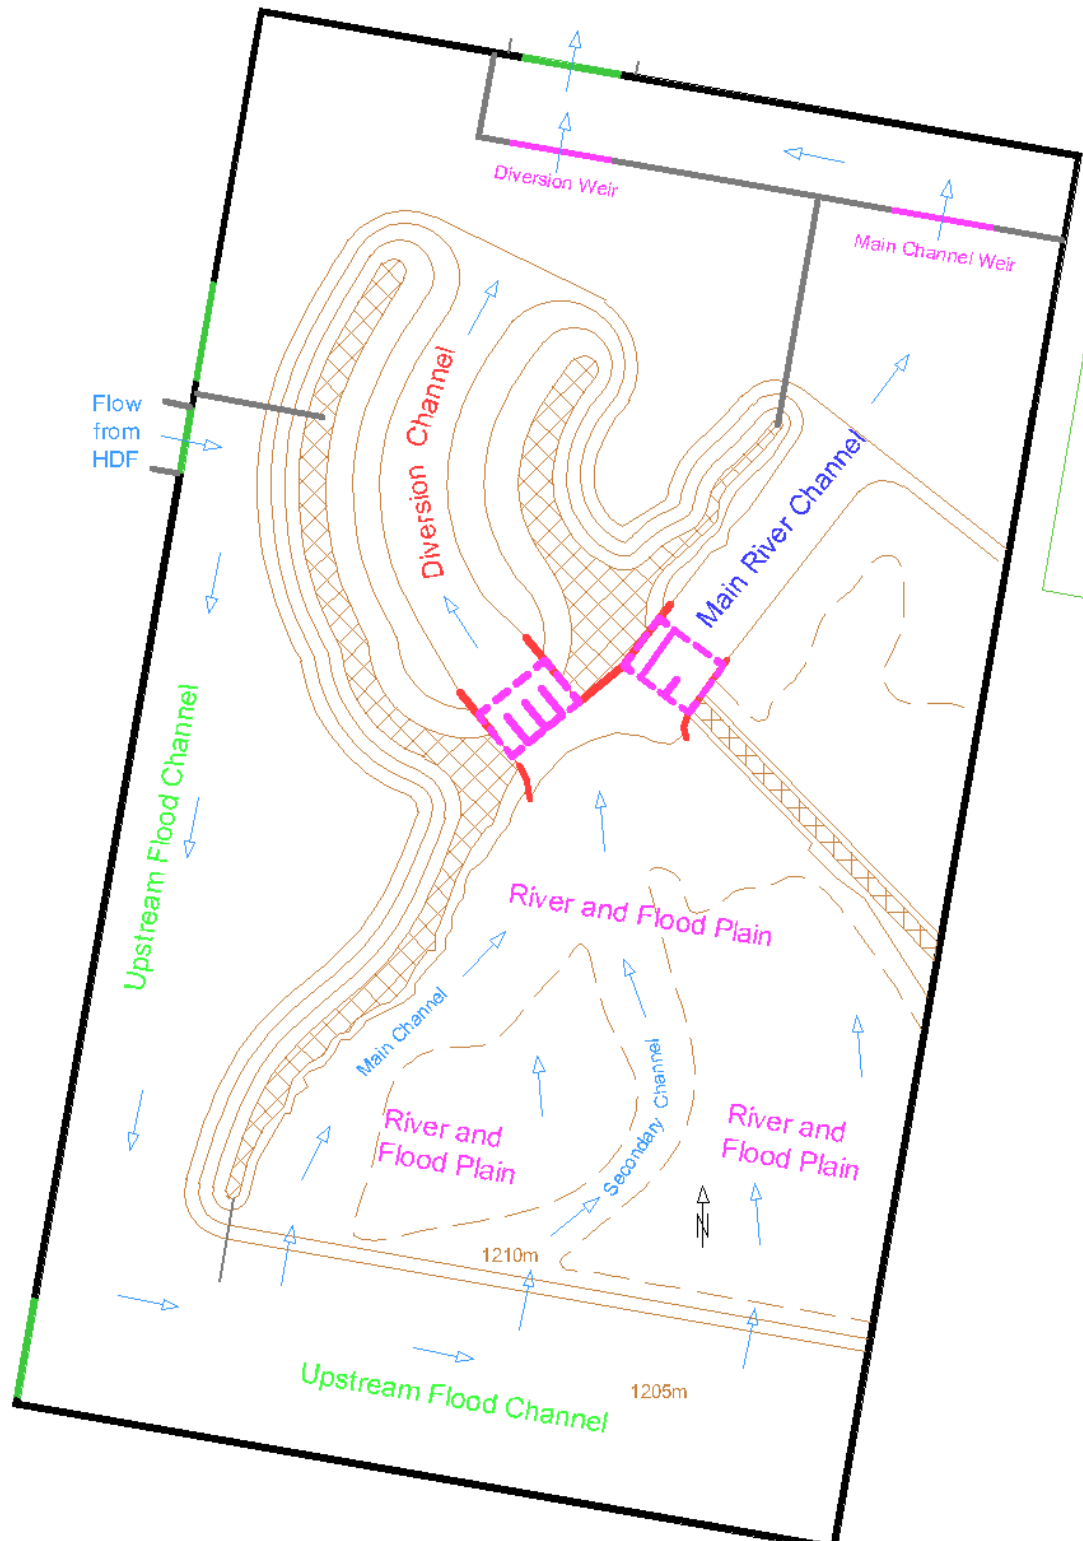
Figure 35. Simplified schematic showing the flow through the model.

A schematic showing the flow through the Springbank model is shown in Figure 35. The flow was supplied from the underground water storage reservoir (sump) and pumped into the HDF using a variable pitch pump. The flow was controlled by adjusting the vane pitch on the pump control panel. The HDF was connected to the LAB with masonry walls. Due to the high ground from the concrete bathymetry and temporary masonry walls installed in the LAB, the model was partitioned into four main areas: the upstream flood channel, the river and floodplain, the diversion channel (and settling pool), and the main river channel (and settling pool). The flow entered into the LAB and flooded the upstream flood channel. Once the volume of water was high enough, the river and floodplain began to flood and the flow was directed through the diversion inlet and service spillway structures by the topography. Flow through the diversion inlet flowed along the model diversion channel before dropping into a settling pool, and finally flowing over the diversion control weir. The tail-water elevation in the diversion channel was controlled by adjusting the level of the diversion weir. Similarly, the flow through the sluiceway/ service spillway flowed along the model river channel into a settling basin and over the main channel control weir. The control weirs are shown in Figure 36. Once the water spilled over the two weirs it was returned to the water reservoir sump for recirculation into the model (via the HDF). The water level elevations upstream of the diversion inlet and service spillway were controlled by the flow and the diversion/sluiceway/spillway gate settings.

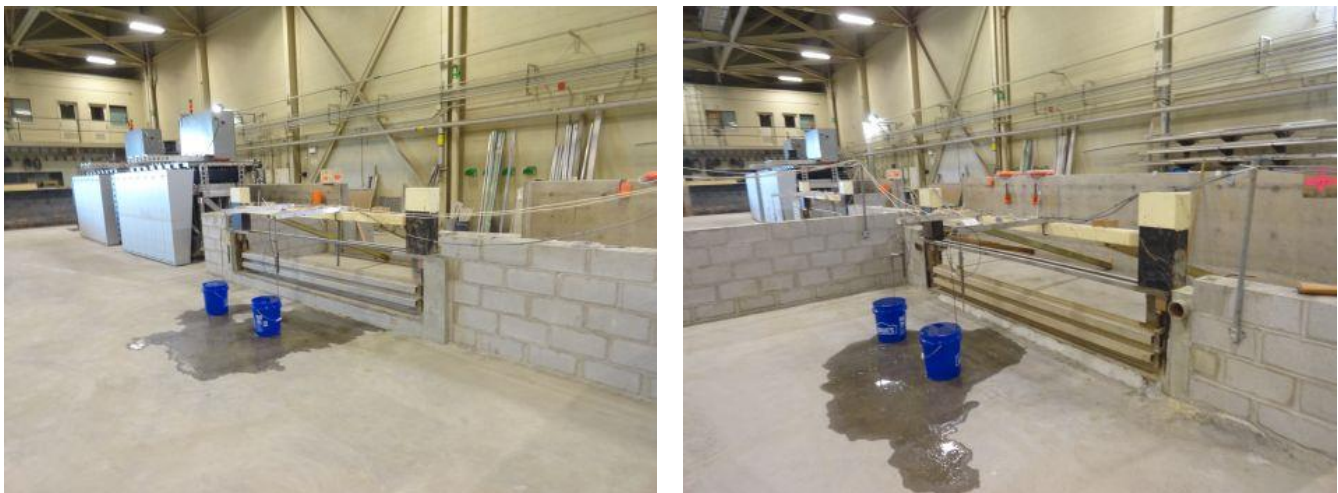
Figure 36. Diversion channel control weir (left) and main channel control weir (right).

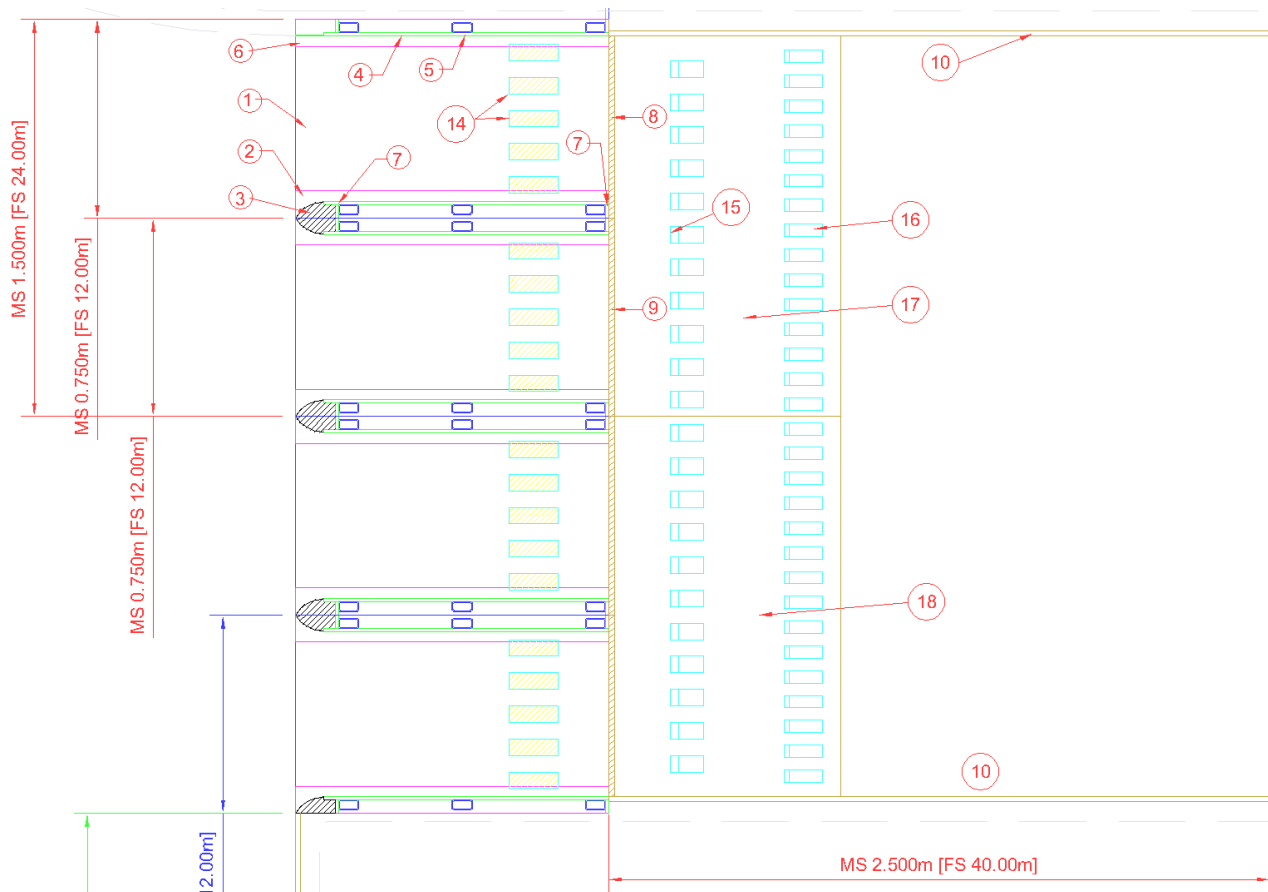
Figure 37. Example of a general assembly construction drawing of the model diversion. Note, MS and FS refer to Model Scale and Full Scale, respectively.

The prototype designs for the hydraulic structures were transferred to model scale ( $1/16^{\text{th}}$  the size) and construction shop drawings were developed by NRC-OCRE and approved by Stantec. Figure 37 presents an example of a shop drawing of the diversion. The location of all the structures and features in the model were laid out with precision using a total station. The retaining walls and side walls of the structures were made from marine plywood, PVC, or sheet metal.

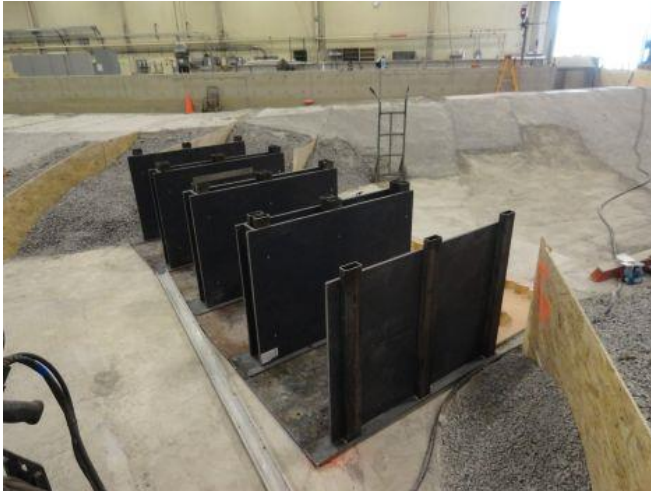
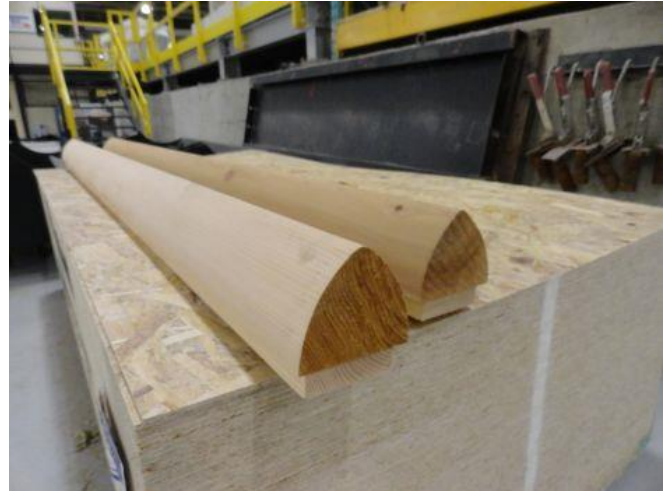
Figure 38. Left: diversion inlet pier struts and base plates installed in the basin. Right: precision milled hardwood pier noses after manufacture.

The diversion inlet structure was constructed on a  $\frac{1}{2}$ " steel baseplate, and the central piers were made from hollow structural steel that was welded to the baseplate, and the piers were clad with PVC. The pier noses were precision milled from hardwood to match the prototype designs. The concrete apron of the diversion inlet was made from concrete grout, and its construction was guided by the use of a template to precisely match the profile curves. Wooden chute blocks were cut and fastened to the concrete apron of the diversion inlet apron and stilling basin. The gates for the diversion inlet were not modelled in the original design - if the model diversion inlet was to be closed, marine plywood was fastened to the back of the pier to stop the flow through the diversion inlet bays. Photographs showing some of the stages of construction for the original diversion inlet structure are shown in Figure 38 to Figure 42.

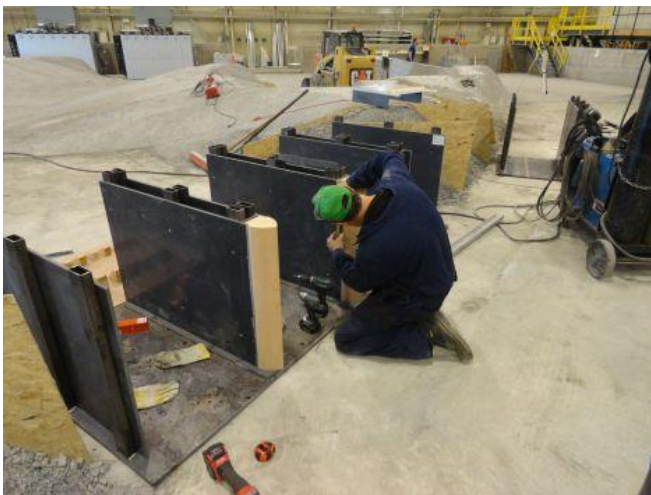
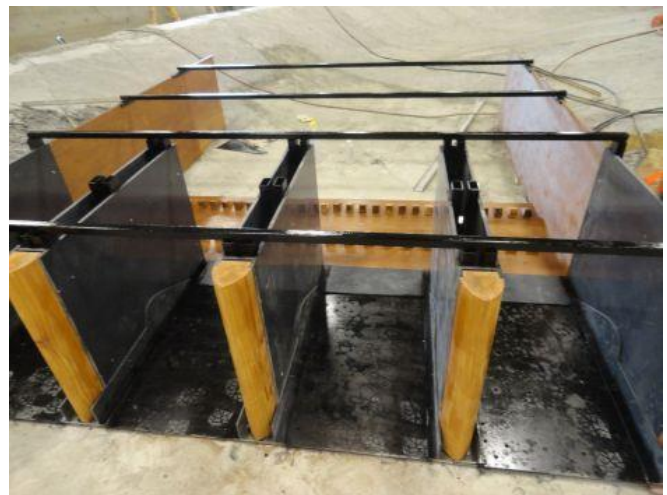
Figure 39. Left: installing the pier noses. Right: installing the support struts, rear retaining walls and rear stilling basin chute blocks.

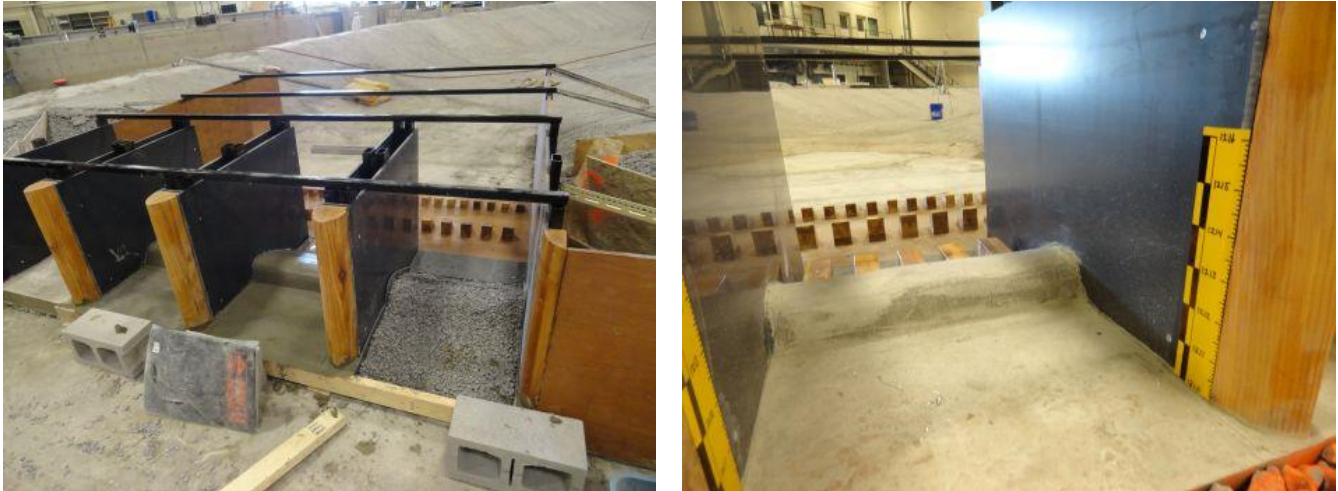
Figure 40. Left: forming the concrete apron. Right: concrete apron and front chute blocks installed.

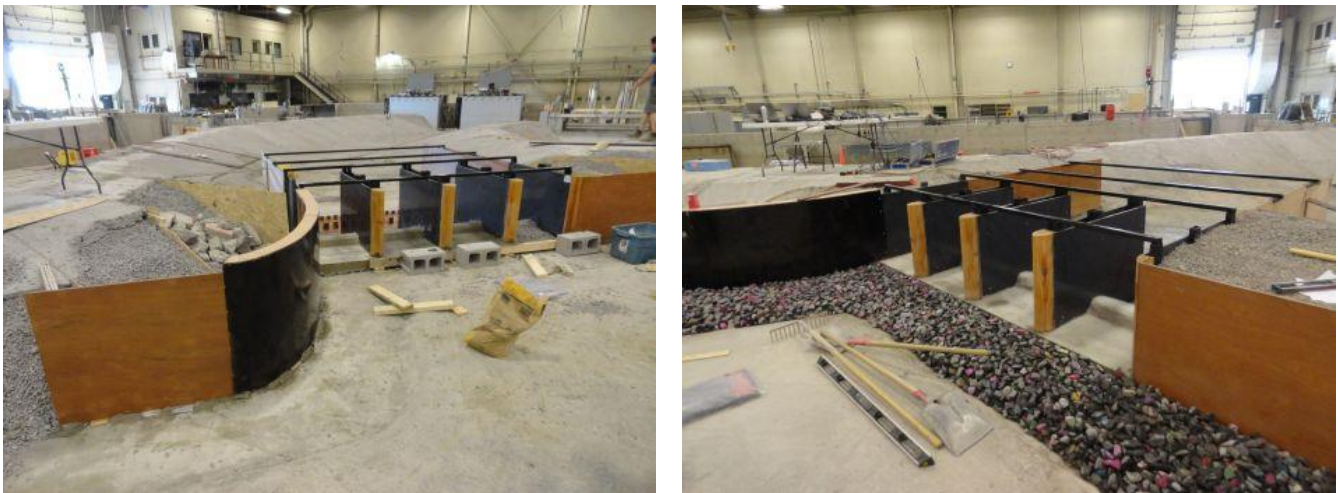
Figure 41. Left: retaining walls made from plywood and sheet metal. Right: installing the riprap apron material and the plywood retaining wall that spans between the diversion inlet and the sluiceway.

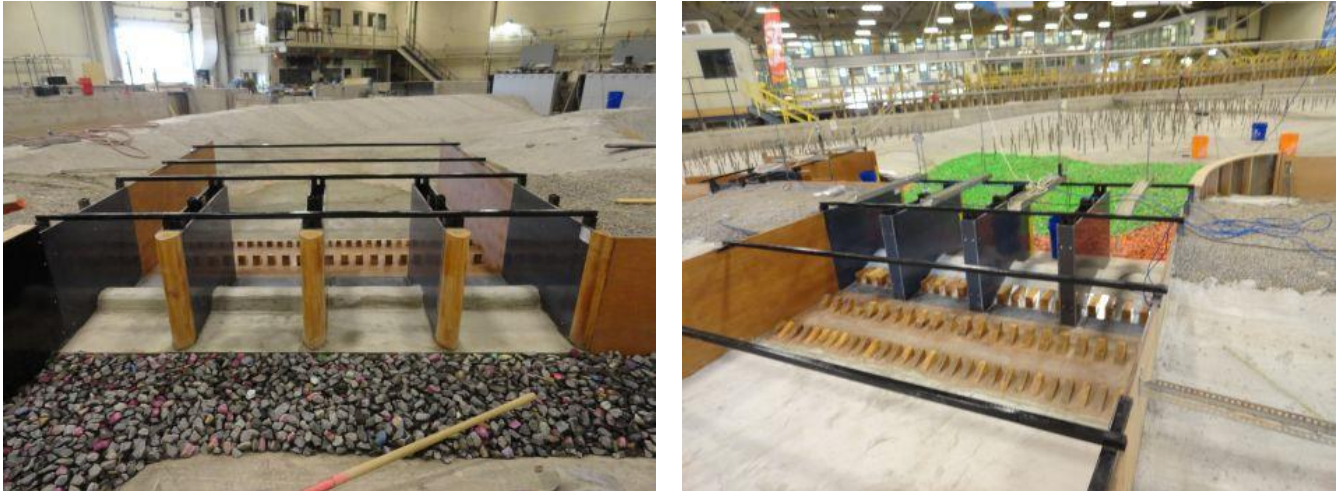
Figure 42. Left: diversion inlet looking downstream. Right: diversion inlet looking upstream (the 440kg riprap and 210kg riprap used in the mobile bed portion of the model was painted to aid in movement detection).

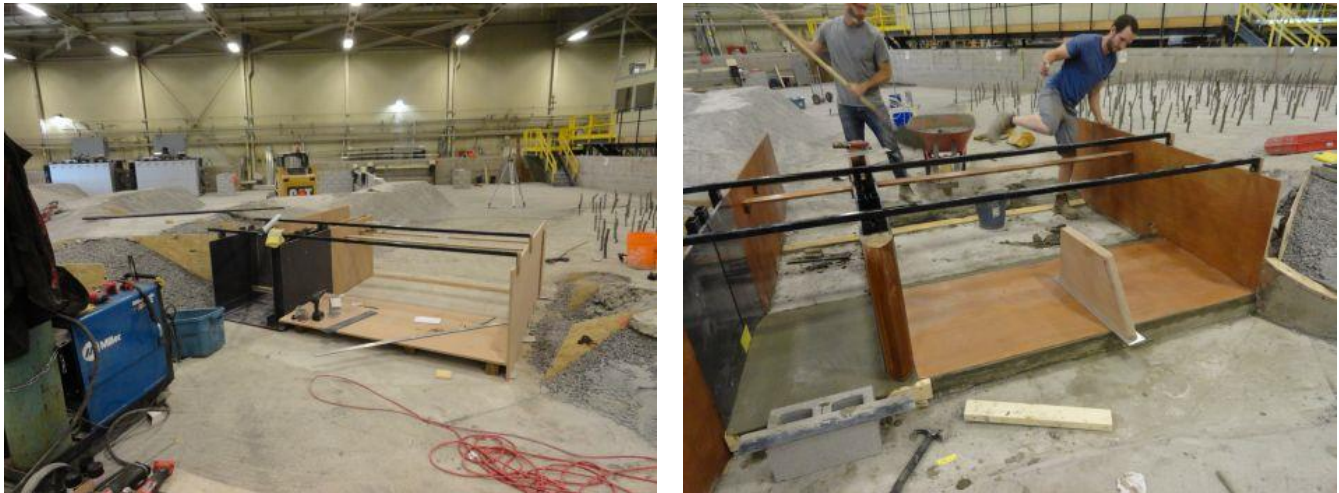
Figure 43. Left: sluiceway and service spillway installation in the model. Right: pouring the concrete apron through the sluiceway, installing the pier nose and the angled central pier on the service spillway.

The sluiceway and service spillway were constructed similarly to the diversion. The sluiceway section was built on a steel baseplate with hollow structural steel members clad with PVC sheet to form the interior pier. The sluiceway concrete apron was cast in concrete to match the curved profile of the design. The radial sluiceway gate was modelled with a lift gate made from clear acrylic plastic. The bottom 1m of the lift gate was cut to match the curved radial gate profile to give the flow through the opening the proper character. The base of the service spillway was made from plywood, as was the angled central pier that divided the Obermeyer crest gates. The sluiceway pier was constructed on a ½" steel baseplate, clad with PVC, and fitted with the precision milled hardwood pier nose. The concrete apron of the diversion inlet was made from concrete grout, and its construction was guided by the use of a template to precisely match the profile. Obermeyer gates set to specific elevations were pre-constructed from sheet metal facing supported by wooden ribs, and the gates were screwed to the service spillway base to allow rapid installation and removal in the model. A wooden end sill was fastened to the concrete apron of the sluiceway/service spillway stilling basin. Photographs showing some of the stages of construction for the original diversion inlet structure are shown in Figure 43 to Figure 45.

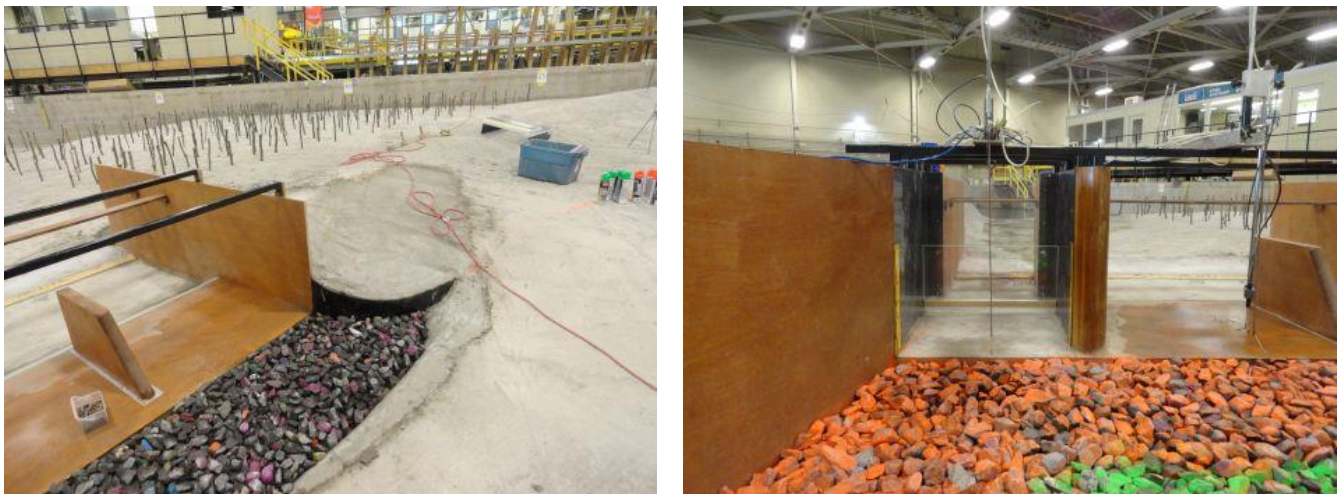
Figure 44. Left: the riprap apron was installed, and the (black) curved retaining wall on the RHS of the service spillway was tapered to match the profile of the floodplain berm. Right: view of the finished sluiceway with the clear plastic gate lowered and riprap painted orange.

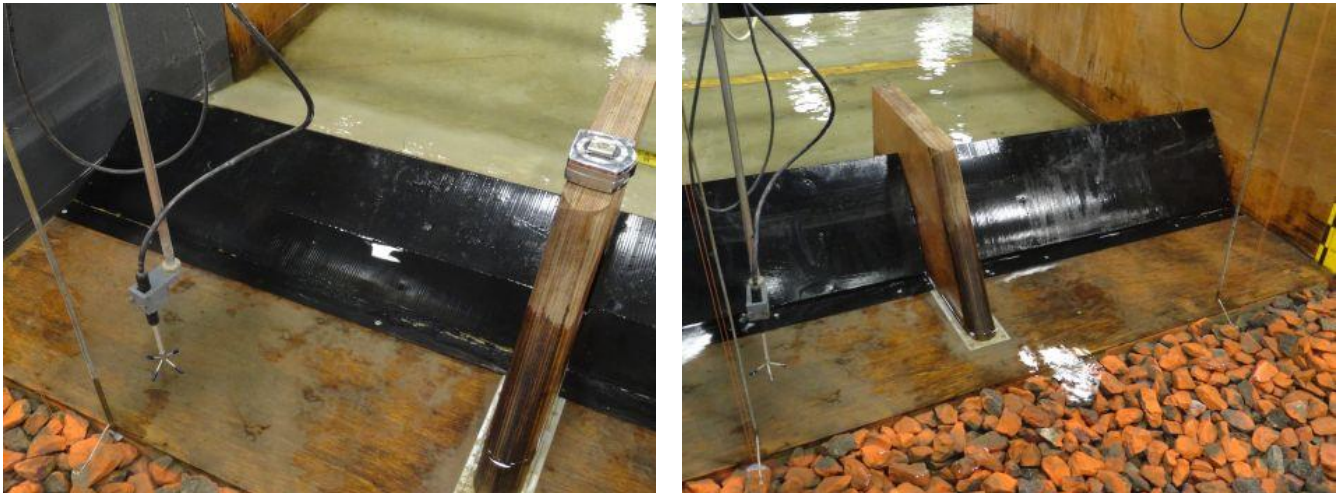
Figure 45. Obermeyer gates were made from sheet metal plate fastened to curved ribs to match the gate profile.

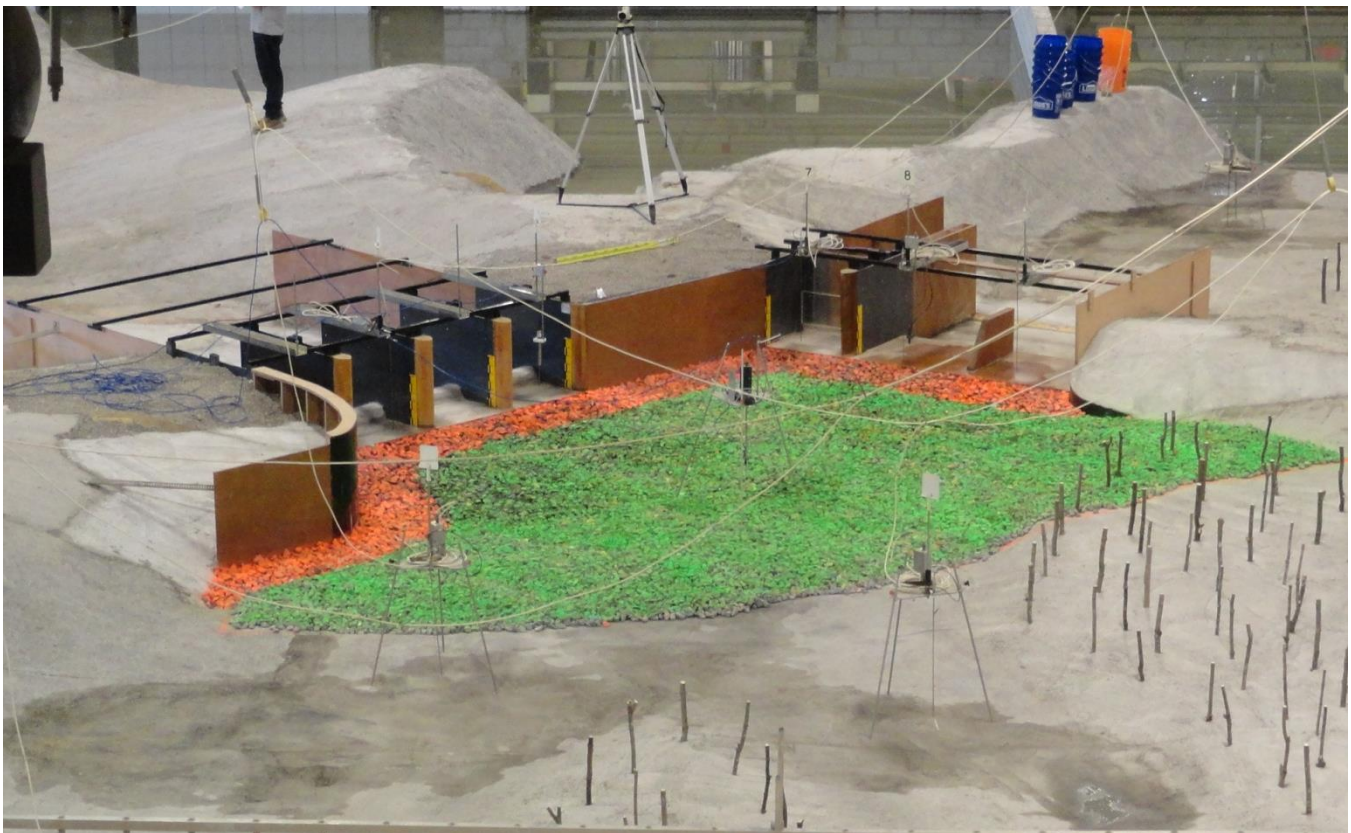
Figure 46. Front view of the original design for the diversion inlet and sluiceway/service spillway structures in the model. For the initial tests where mobile sediments were not investigated, the mobile bed area was filled with 210kg riprap and painted green.

Figure 46 and Figure 47 show front and rear views of the original design after construction.

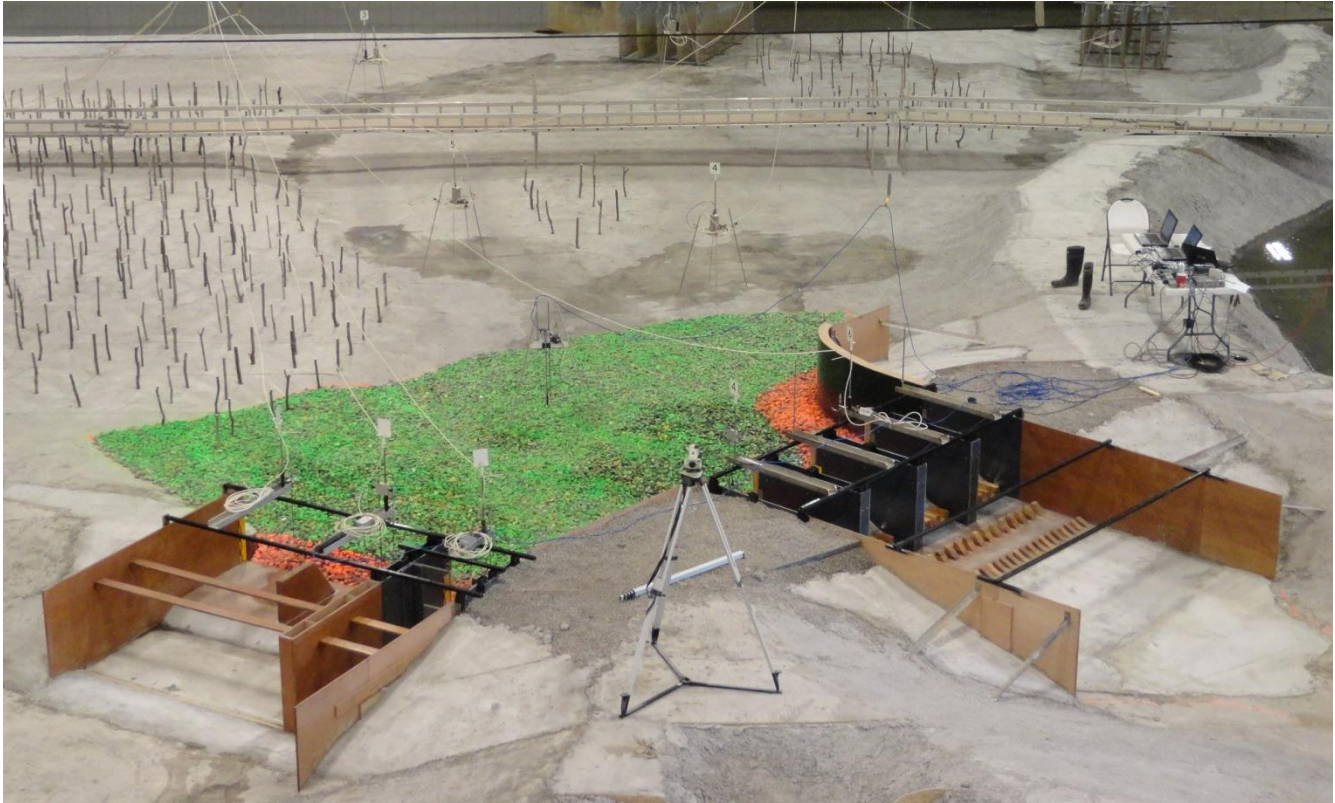
Figure 47. Rear view of the original diversion inlet and sluiceway/service spillway structures.

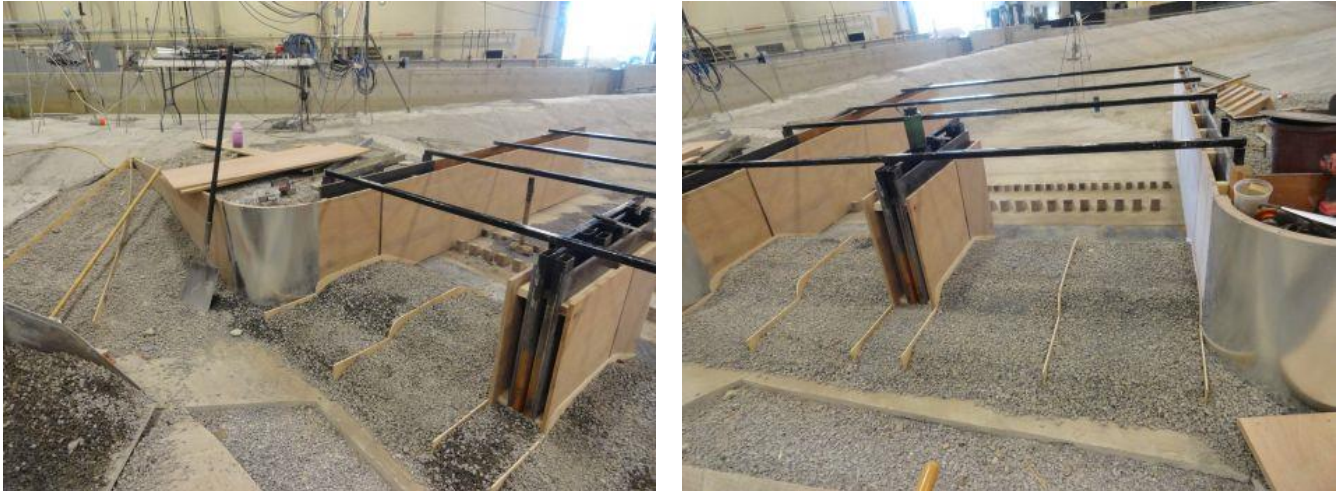
Figure 49. Installation of the narrower sidewalls, curved retaining walls, and preparations for pouring the concrete apron at the diversion.

The model diversion inlet structure still used the same design basis with the structure and central pier mounted on a baseplate. The original design side walls had inserts installed to make the total diversion inlet breath opening narrower. The wider central pier had steel support members clad with PVC and an allowance for four different types of pier noses to be quickly installed during the testing. The diversion inlet lift gate was modelled with marine plywood, and as before the concrete apron was modelled with concrete and the chute blocks were made from hardwood and fastened to the concrete apron and stilling basin. Photographs showing some of the stages of construction for the revised diversion inlet structure are shown in Figure 49 to Figure 53.

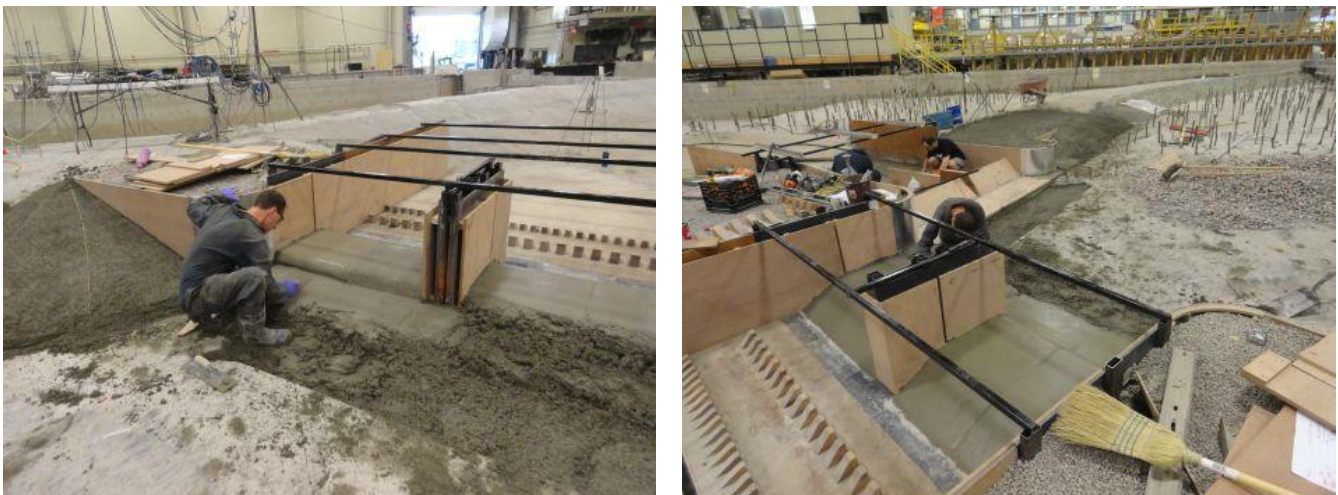
Figure 50. Pouring the concrete for the embankment, diversion inlet apron, and the bottom of the new riprap pit.

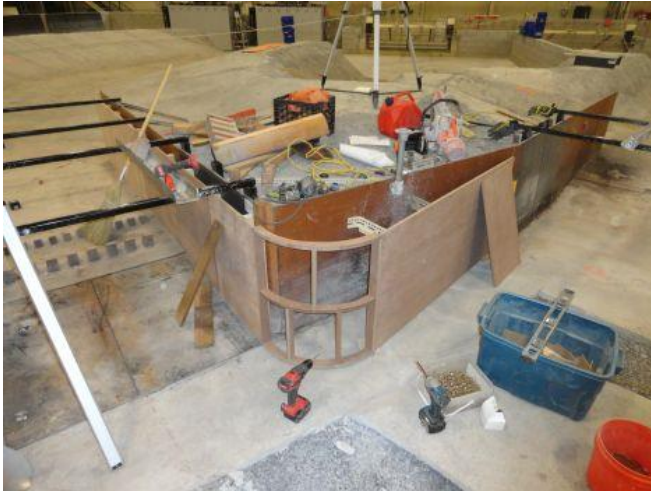
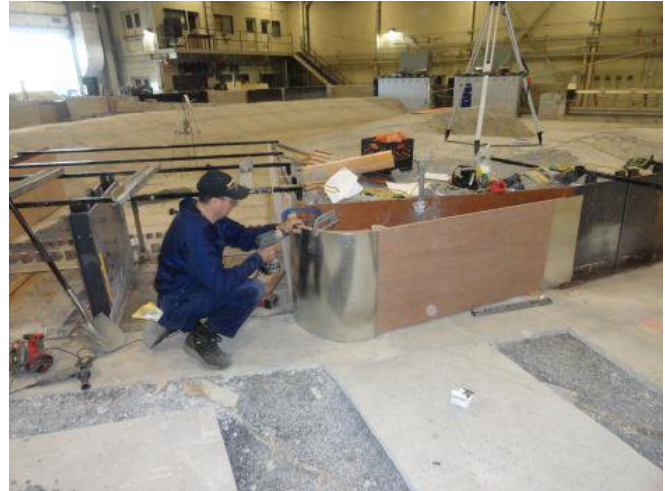
Figure 51. Installing the modified central retaining wall between the diversion inlet and service spillway.

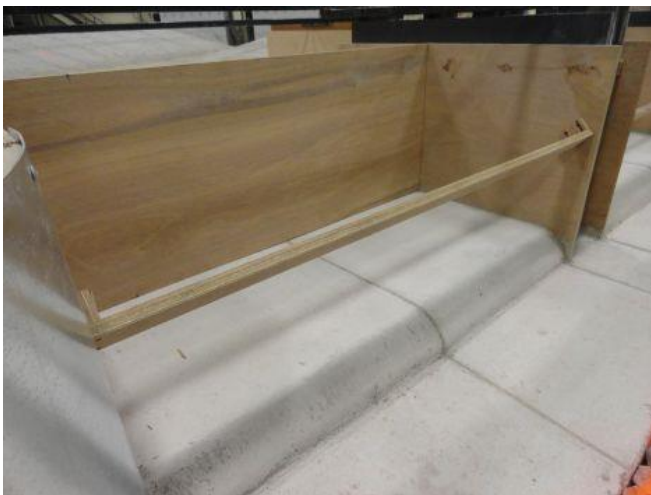
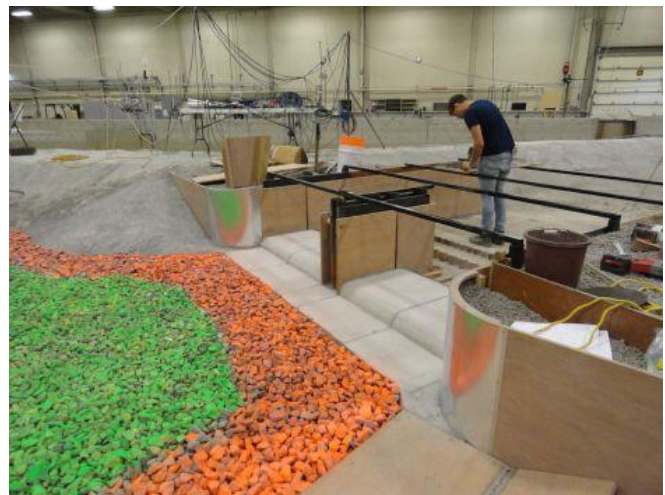
Figure 52. Left: diversion inlet concrete apron and breast wall (the lift gate is closed). Right: installation of the 440kg riprap (orange) and the 210kg riprap stone used to model the mobile-bed portion of the model (green).

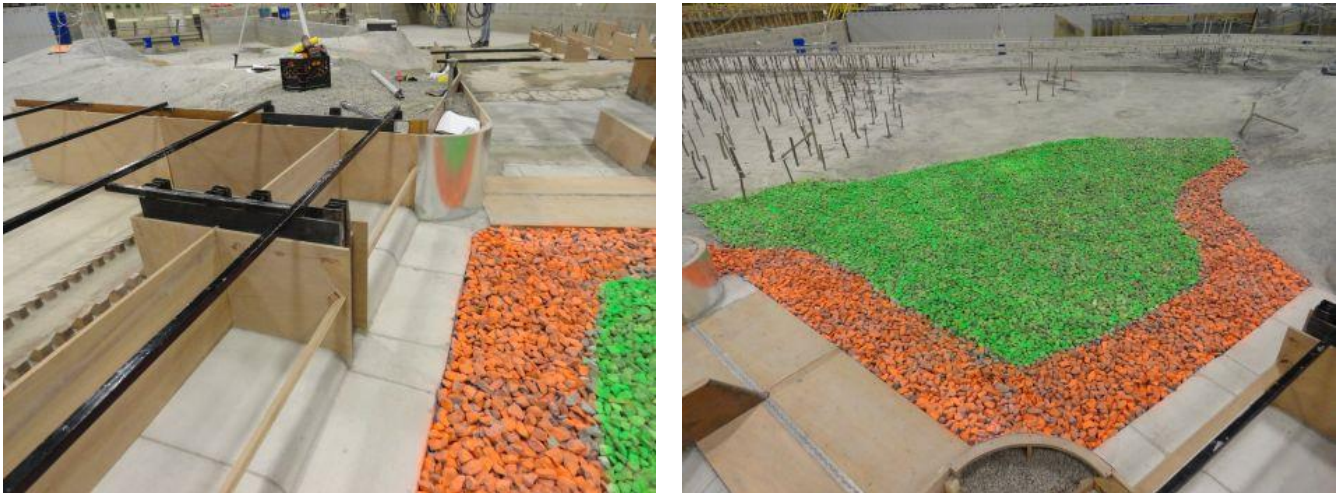
Figure 53. Left: diversion inlet structure with lift gates lowered (no pier nose installed yet). Right: Upstream view of the floodplain as viewed from the revised structures.

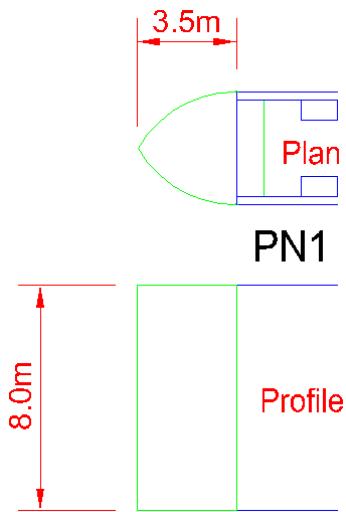
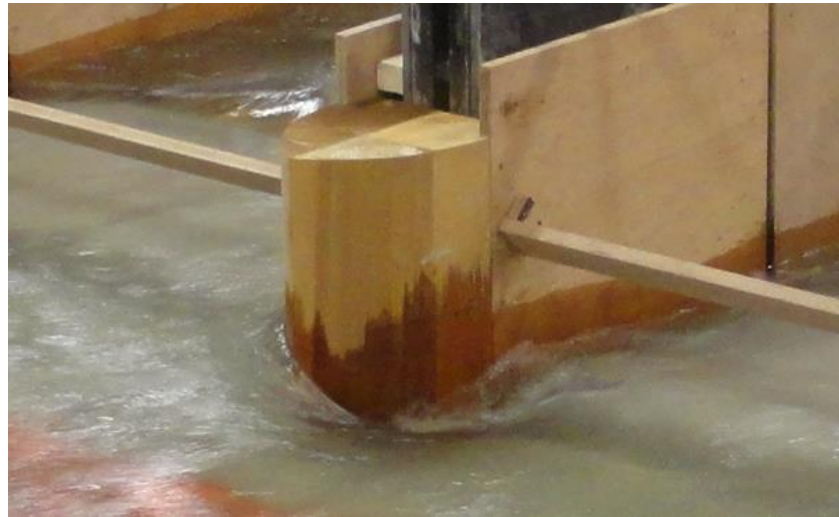
Figure 54. Pier Nose 1 design schematic and implementation in the model.

- Pier Nose 1 – curving arrowhead plan shape, apex 3.5m from the front edge of the diversion, 8m tall (see Figure 54).
- Pier Nose 2 – same curving arrowhead plan shape, apex 9.5m from the front edge of the diversion, 8m tall (see Figure 55).
- Pier Nose 3 – same curving arrowhead plan shape, adverse 1:4 slope placing the apex 8m from the front edge of the diversion inlet at the top and 6m at the bottom, 8m tall (see Figure 56).
- Pier Nose 4 – circular 1.8m diameter plan shape on the nose, 2:1 sloping profile, and was slightly shorter at 7m high off the concrete apron (see Figure 57).

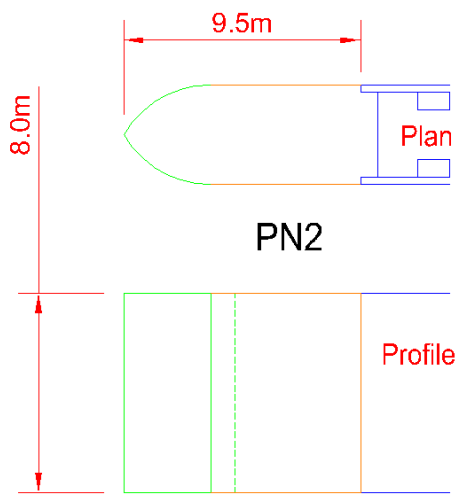
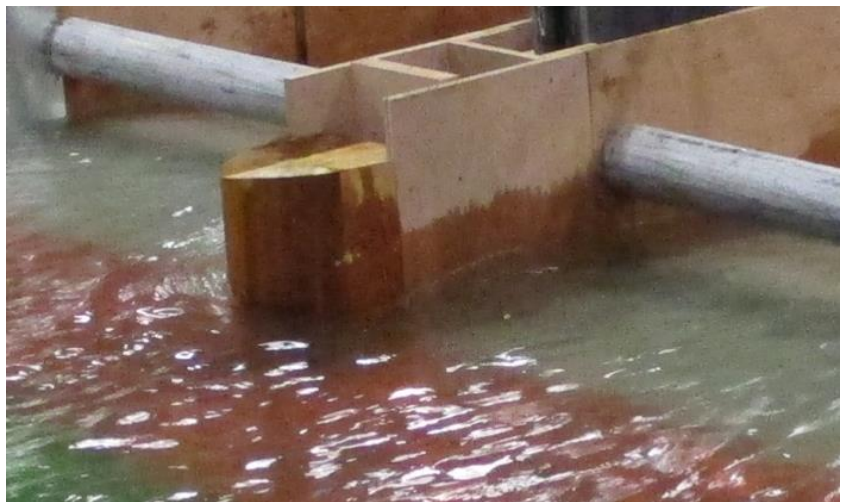
Figure 55. Pier Nose 2 design schematic and implementation in the model.

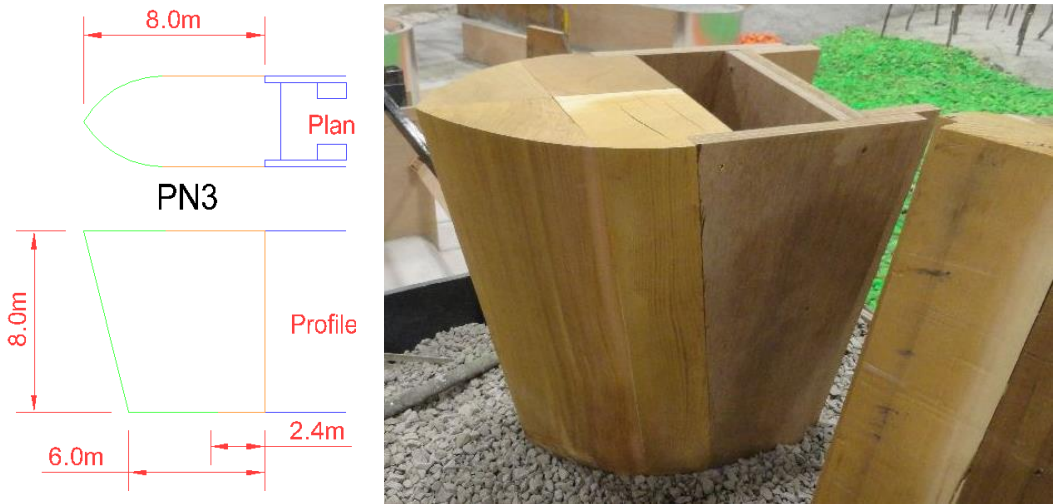
Figure 56. Pier Nose 3 design schematic and photograph before installation.

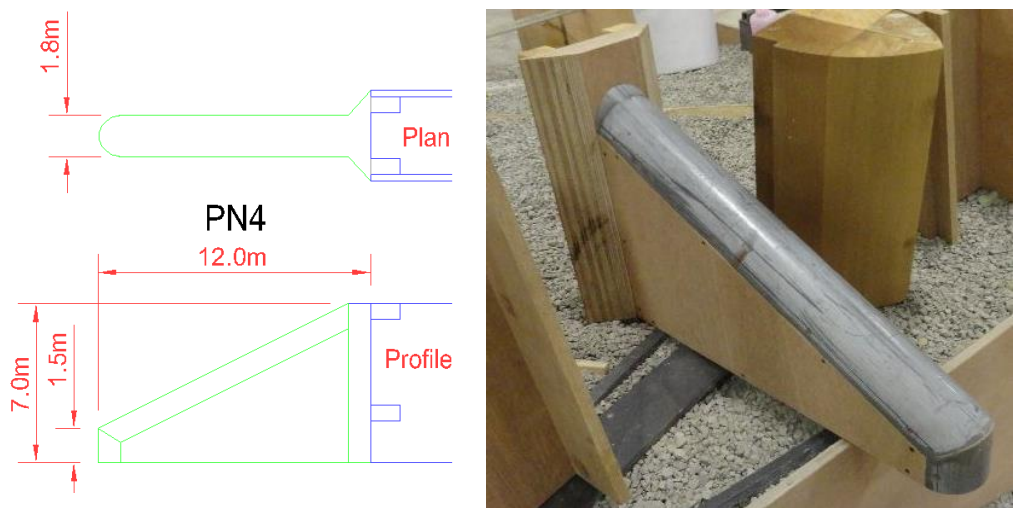
Figure 57. Pier Nose 4 design schematic and photograph before installation.

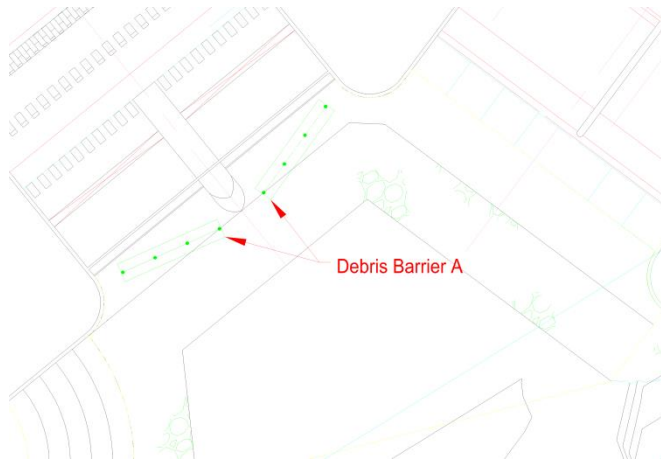
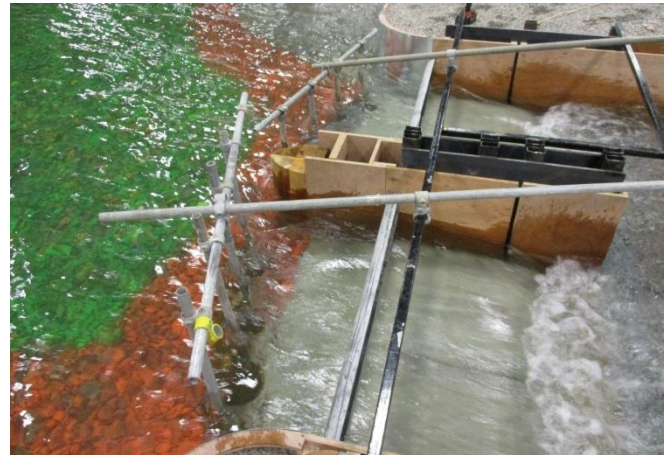
Figure 59. Debris Barrier A layout schematic and implementation in the model.

- Debris barrier A – two sets of four 600mm diameter piles spaced on 5m (centers) and 6m tall, each set of four were placed in the diversion inlet bays (see Figure 59).
- Debris barrier B – eight 600mm diameter piles spaced on 5m (centers) and 6m tall, each set of four were placed in a line starting at the LHS of the diversion inlet (see Figure 60).
- Debris barrier C – eight 600mm diameter piles spaced on 5m (centers) and 6m tall, similar alignment to barrier B but with a slightly larger gap at the LHS of the diversion inlet (see Figure 61).
- Debris barrier D – nine 600mm diameter piles spaced on 5m (centers) and 6m tall, each set of four were placed in a line starting at the RHS of the diversion inlet (see Figure 62).

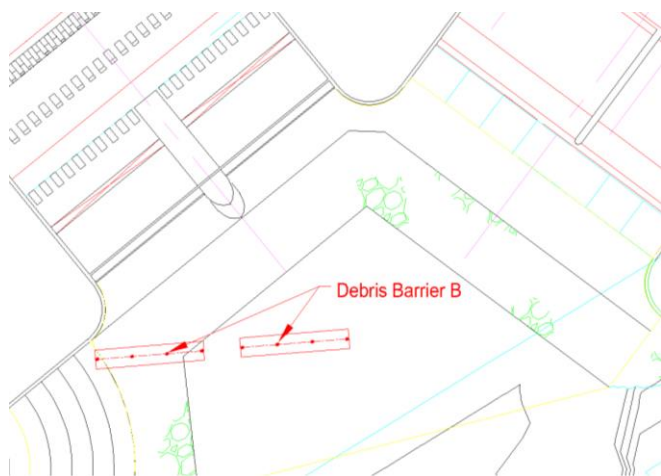
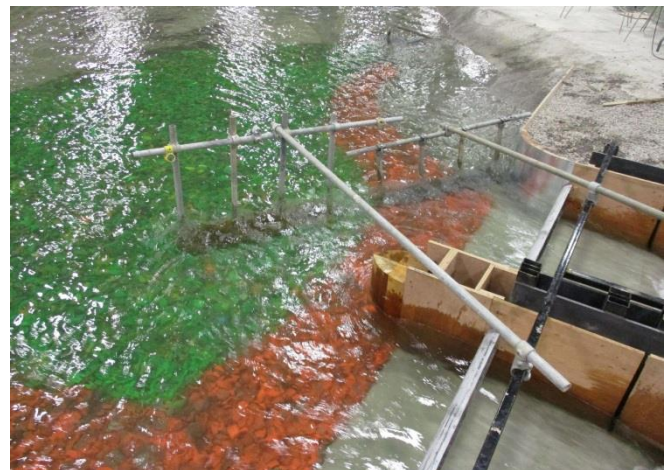
Figure 60. Debris Barrier B layout schematic and implementation in the model.

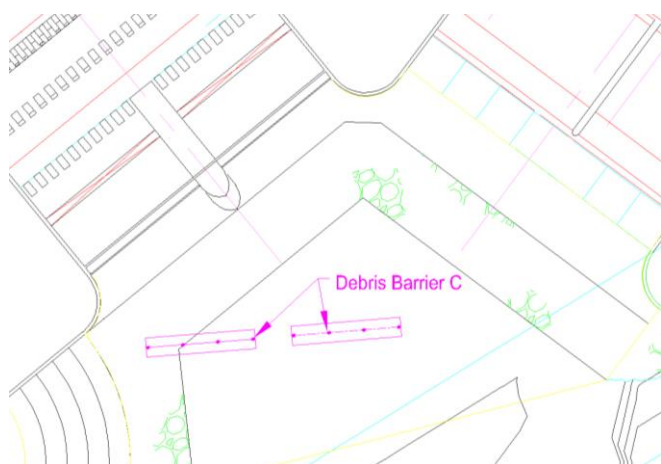
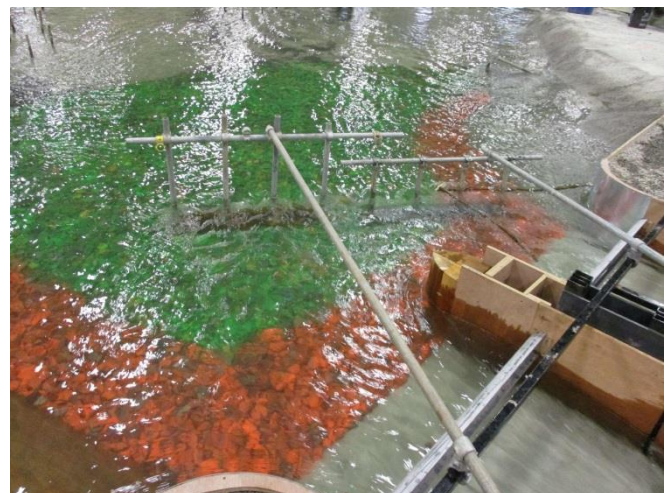
Figure 61. Debris Barrier C layout schematic and implementation in the model.

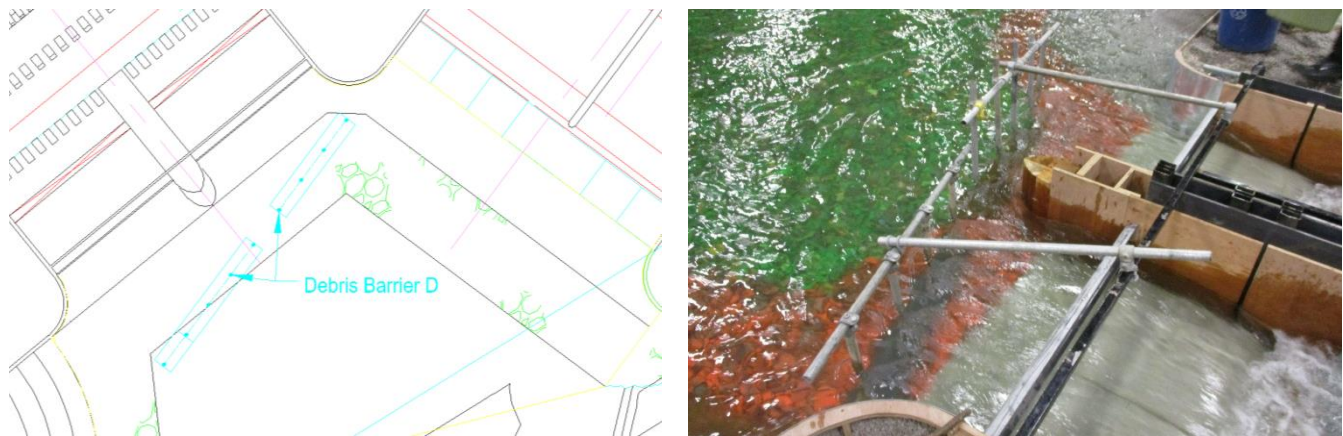
Figure 62. Debris Barrier D layout schematic and implementation in the model.
