**ALBERTA TRANSPORTATION SPRINGBANK OFF-STREAM RESERVOIR PROJECT  
RESPONSE TO CEEA INFORMATION REQUEST PACKAGE 3, AUGUST 31, 2018**

**APPENDIX IR13-1 NATIONAL RESEARCH COUNCIL CANADA  
PHYSICAL MODEL STUDY REPORT**

## Physical Model Study of the Springbank Off-stream Storage Project Diversion Structure on the Elbow River

Paul Knox, Andrew Cornett, Mitchel Provan  
Ocean, Coastal and River Engineering  
NRC Technical Report: OCRE-TR-2016-028

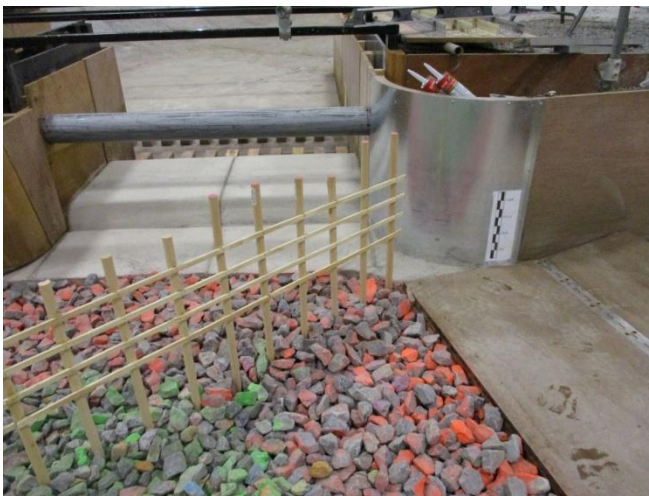
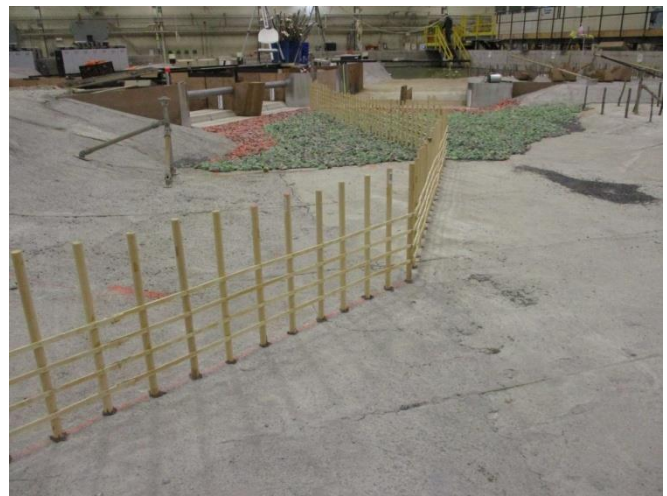
Figure 65. Debris Barrier E implementation in the model.

Debris barrier E (see Figure 63) featured three straight legs: moving from upstream, leg AB was 46m long, leg BC was 41m, and leg CD was 90m. The profile designs for the barrier are shown in Figure 64. The wall was to be made from pipe piles 300mm in diameter and spaced on 2m centers, and guide rails made from timber were to be set at elevations of 1216m, 1215m, 1214m and 1213m. These designs were replicated to scale in the model, and Figure 65 shows the barrier being constructed.

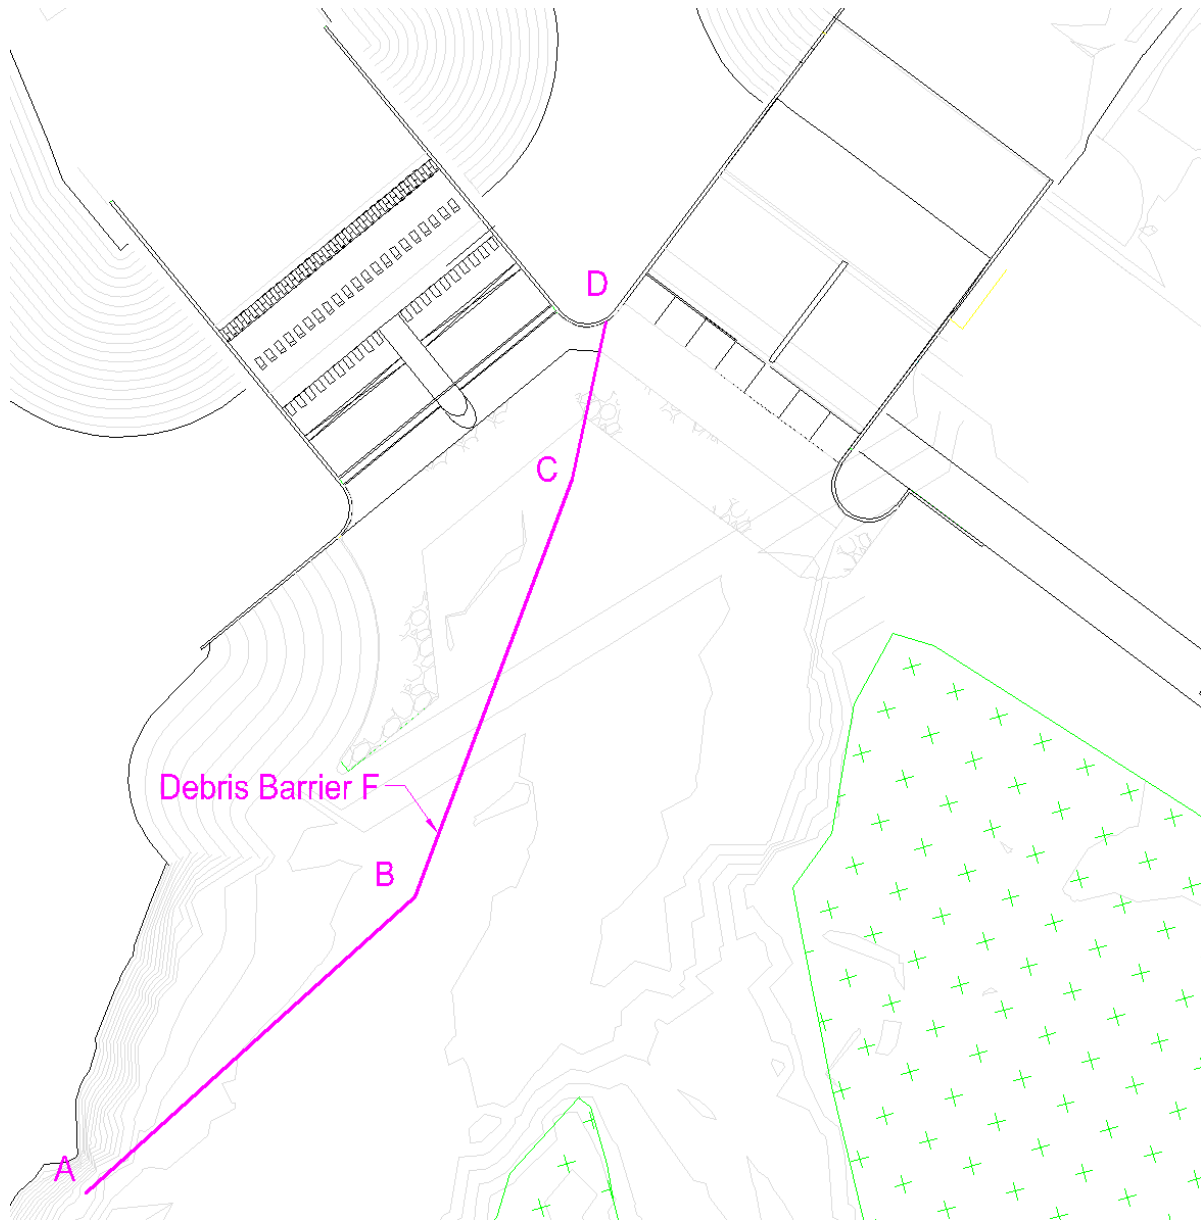
Figure 66. Debris Barrier F layout schematic.

Debris barrier F was similar to E, with guide rails between elevations of 1213m and 1216m, however the guide rails were set on a tighter spacing (0.5m) and the alignment stayed closer to the left bank of the river channel to provide less obstruction (refer to Figure 66 and Figure 67).

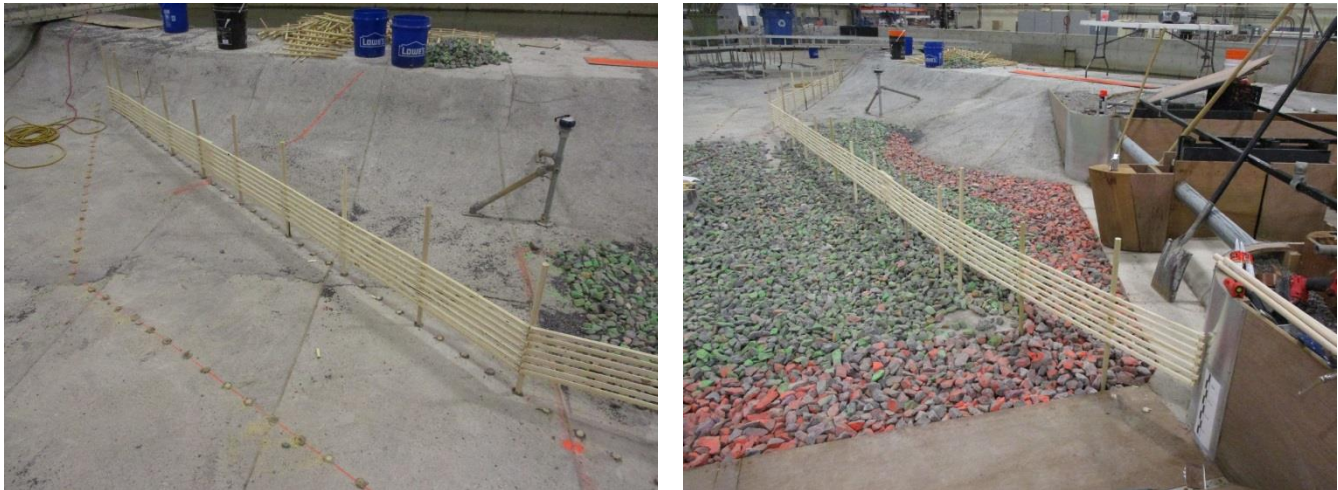
Figure 67. Debris Barrier F construction in the model.

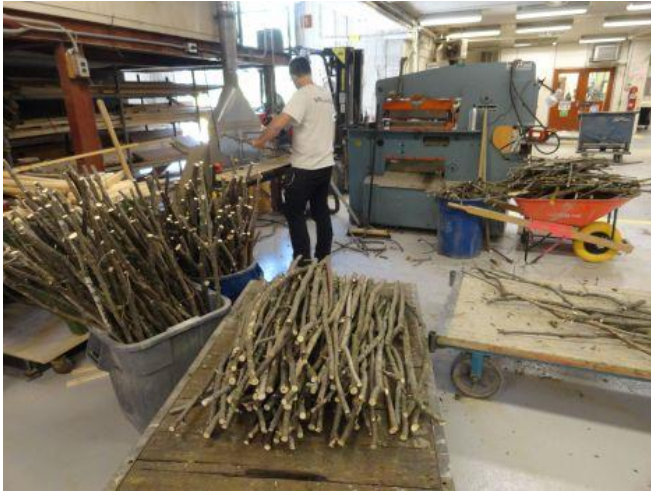
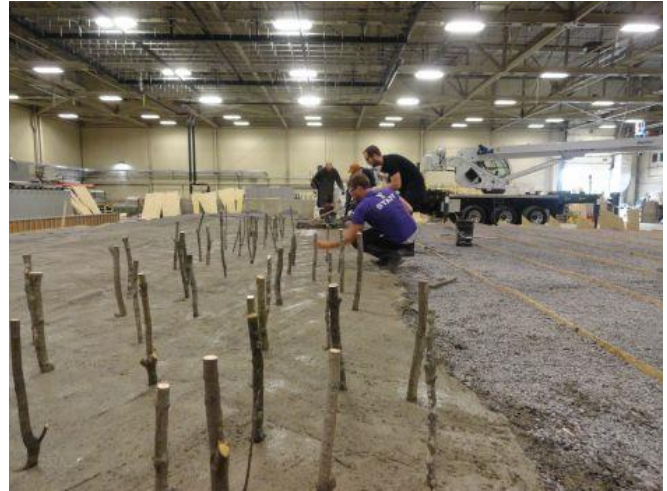
Figure 68. Left - woody debris preparation, right – standing trees cast into the model concrete.

The standing forests in the model floodplain were also modelled using tree branches to the same size specifications. The model trees were cast directly into the concrete with a random placement density specified by Stantec of one tree every 50m<sup>2</sup>. Figure 68 to Figure 70 present photographs documenting the preparation and use of the woody debris in the model.

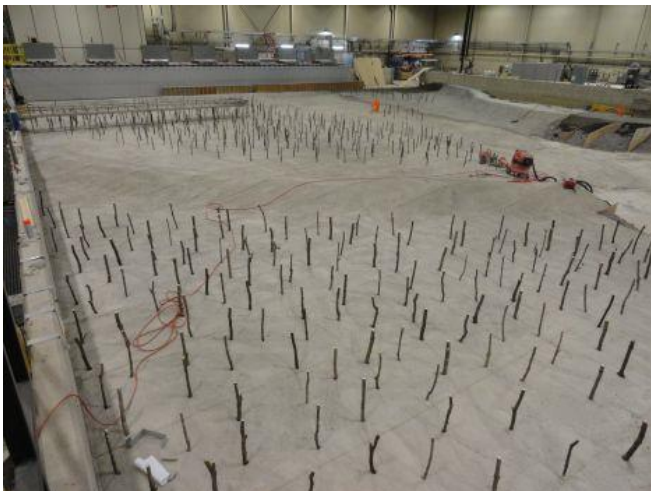
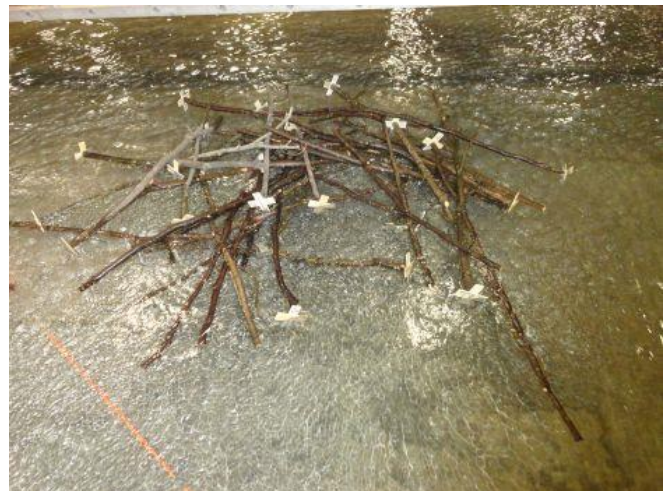
Figure 69. Left – trees cast into the concrete representing the forested floodplain, right – debris rafts in the model including debris with root wad X's at their base.

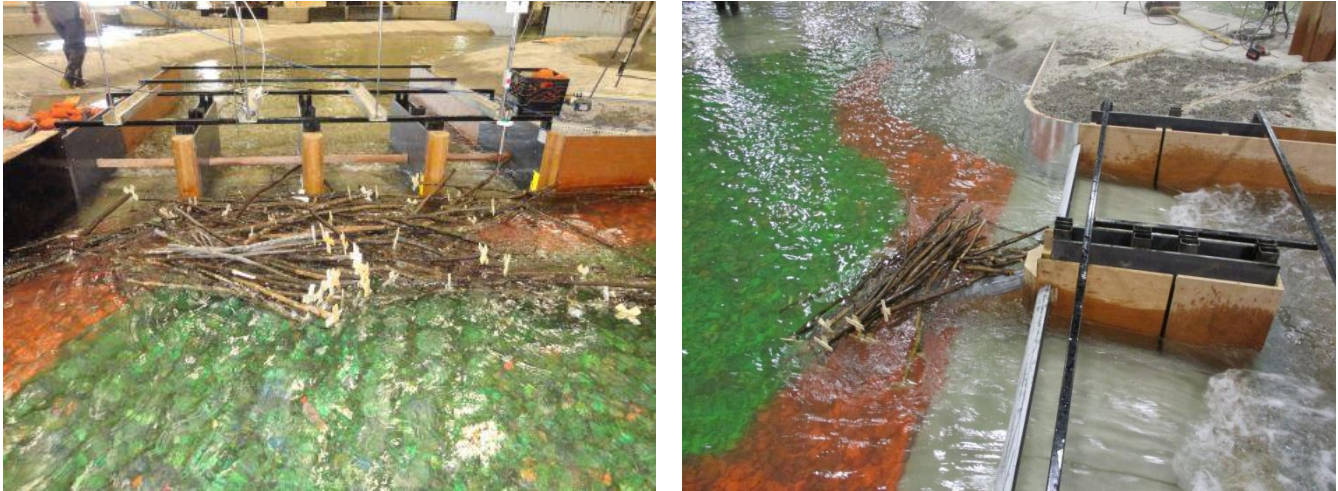
Figure 70. Woody debris interacting with the structures: left – the original diversion, right – the revised diversion inlet with pier nose 4.

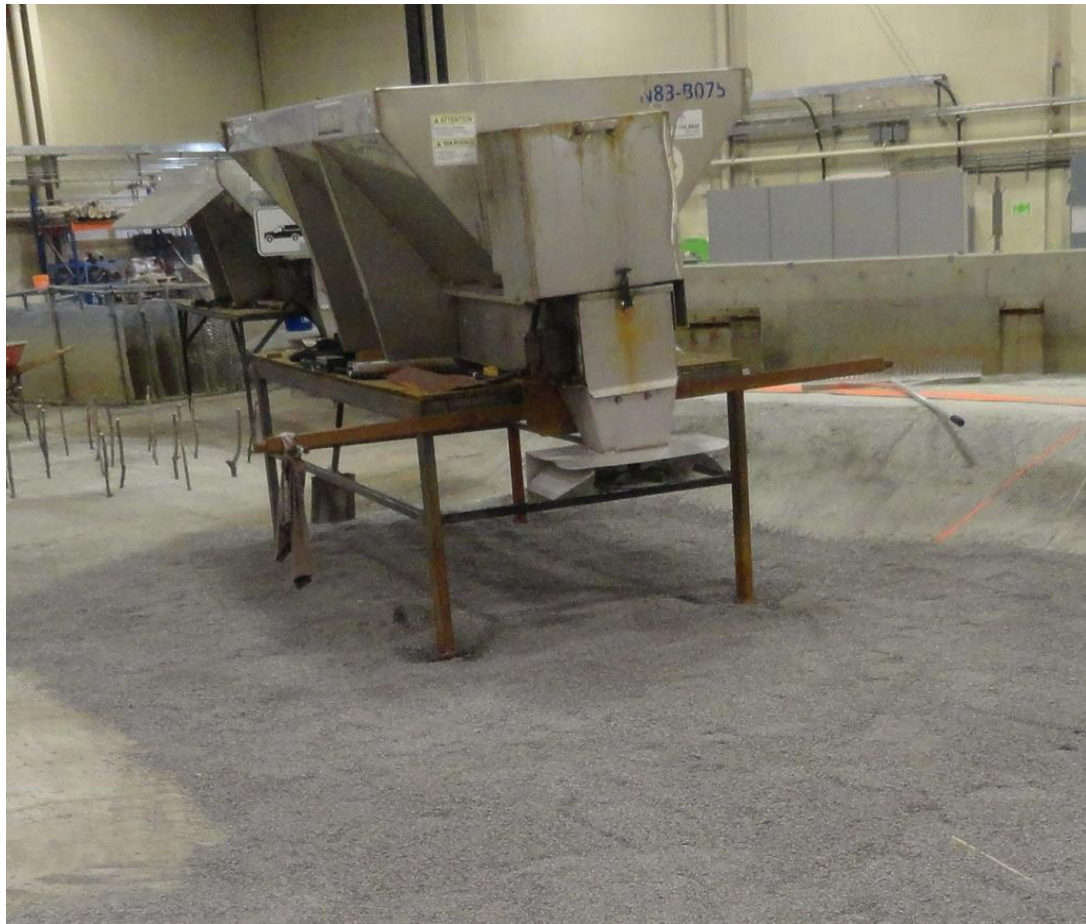
In order to match the very high sediment loads in the river, motorized spreaders were used to seed the flow with the model sediment (refer to Section 3.2.3 for the model sediment scaling). The spreaders were borrowed from the City of Ottawa (they are normally used to spread road salt) and mounted on steel support frames. Three different spreaders were used for this study and were given the following names: battery spreader, 3360 spreader and B750 spreader (shown in Figure 71). The loading rate of each spreader was calibrated prior to testing to match the sediment loading rates provided by Stantec. The calibration process included filling a spreader with a known quantity of sediment and running the spreaders until they were empty. The spreader motor and conveyor belt did not have a throttle, so the delivery rate was adjusted via the gate opening (small, medium or large) at the end of the conveyor. The delivery rates for all three spreaders for the various gate openings are shown in Table 2. Based on the calibration results the spreaders had loading rates ranging from 280 kg/s to 1800 kg/s (full scale).

Figure 71. Rock Spreader B075.

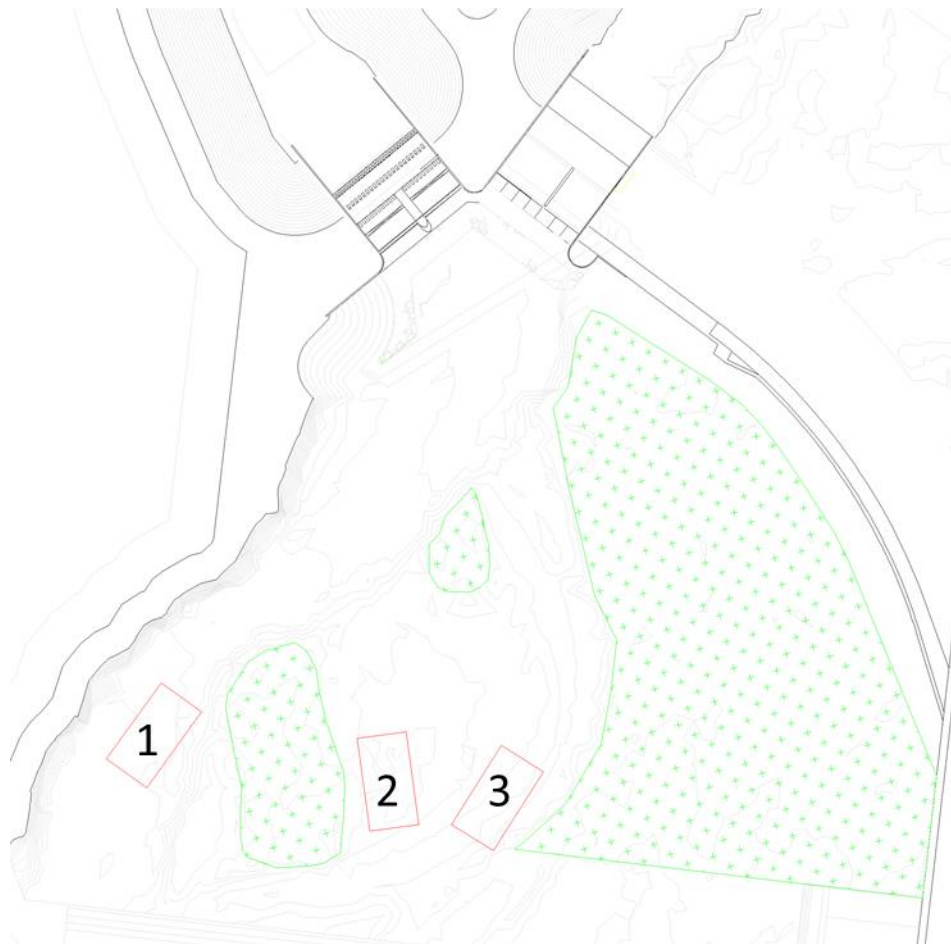
For the sediment testing runs, each spreader was set up in one of three locations in the upstream floodplain for the 320 m<sup>3</sup>/s, 760 m<sup>3</sup>/s and 1240 m<sup>3</sup>/s flood events (refer to Figure 72). The 320 m<sup>3</sup>/s flow condition test run used the battery spreader in location 1. For the 760 m<sup>3</sup>/s flow, the battery spreader was moved to location 3 and the B750 spreader was placed in location 1. The 1240 m<sup>3</sup>/s

used the same spreader configuration as the 760 m<sup>3</sup>/s test with the addition of the 3360 spreader in location 2.

Figure 72. Spreader Locations.

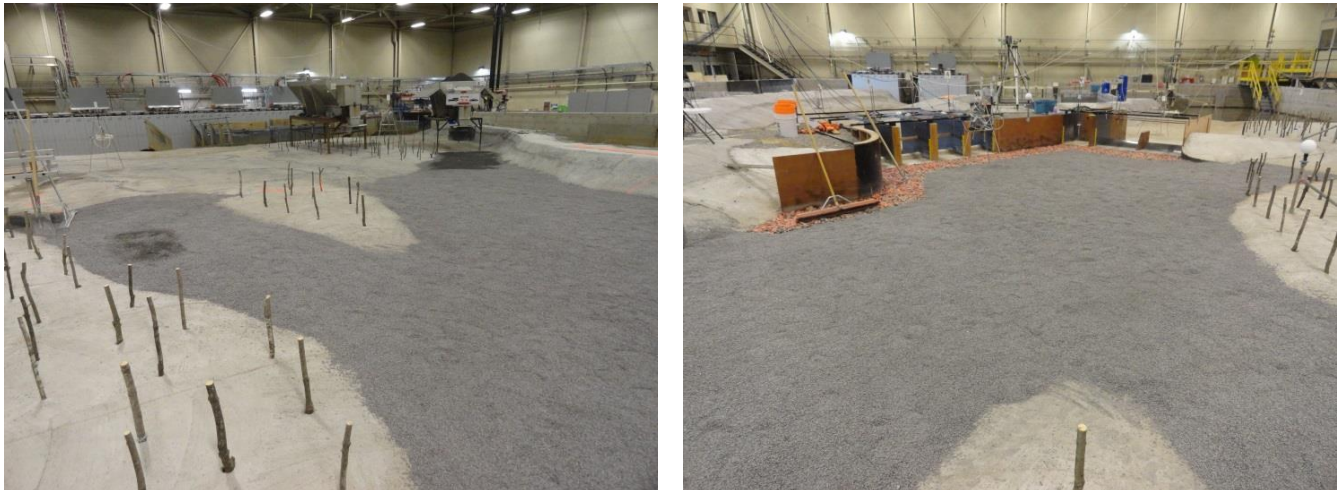
Before the first sediment test, the model was preloaded with sediment along the main channel, secondary channel and in the forebay (see Figure 73). The preloaded sediment was 1m deep in front of the structures and 0.5m deep along the main and secondary channels.

Figure 73. Preloaded sediment in the main channel and secondary channel (left) and in front of the structures (right).

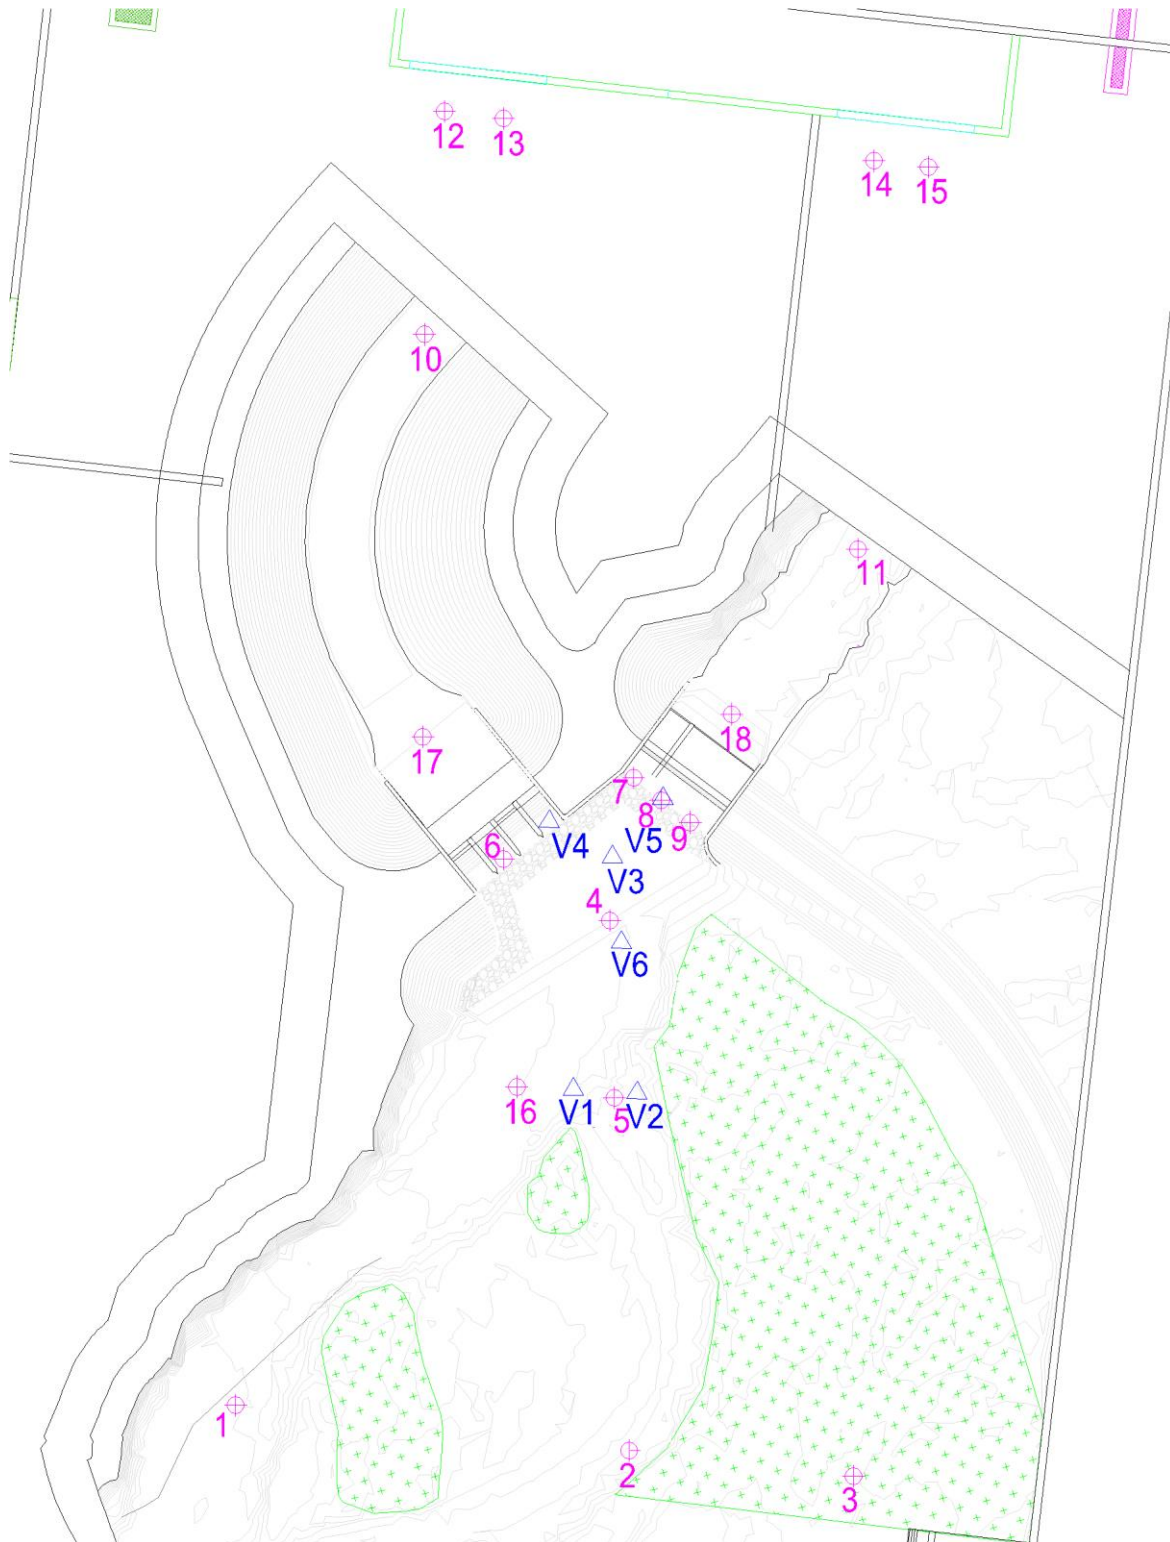
Figure 74. Instrumentation layout 2 – water level probes are shown in pink and velocity probes are shown in blue.

The model was equipped with instruments and video cameras for measuring water levels and velocities in multiple locations of interest. Water level and velocity gauges were deployed through the model domain and adjusted during the modelling to areas of local interest. Two video cameras and two fixed still photography overhead cameras were mounted in the ceiling providing overhead views to track the trajectory of floating debris, floating tracers and coloured dye injected into the model. Also, cameras mounted on tripods were used to video and photograph the performance of the structures. These tools were used to document the water levels, velocities, circulation patterns, and sediment and debris interactions near the new structures for each flow condition. The discharge in the diversion channel and the downstream river channel were measured from the head over the two downstream weirs. There were five different configurations for all of the instruments in the model. These are shown in Figure 74 to Figure 77, and the layout used for each test series is shown in Table 3.

There were four main water level gauge layouts used for the study, as shown in Figure 74 - Figure 77.

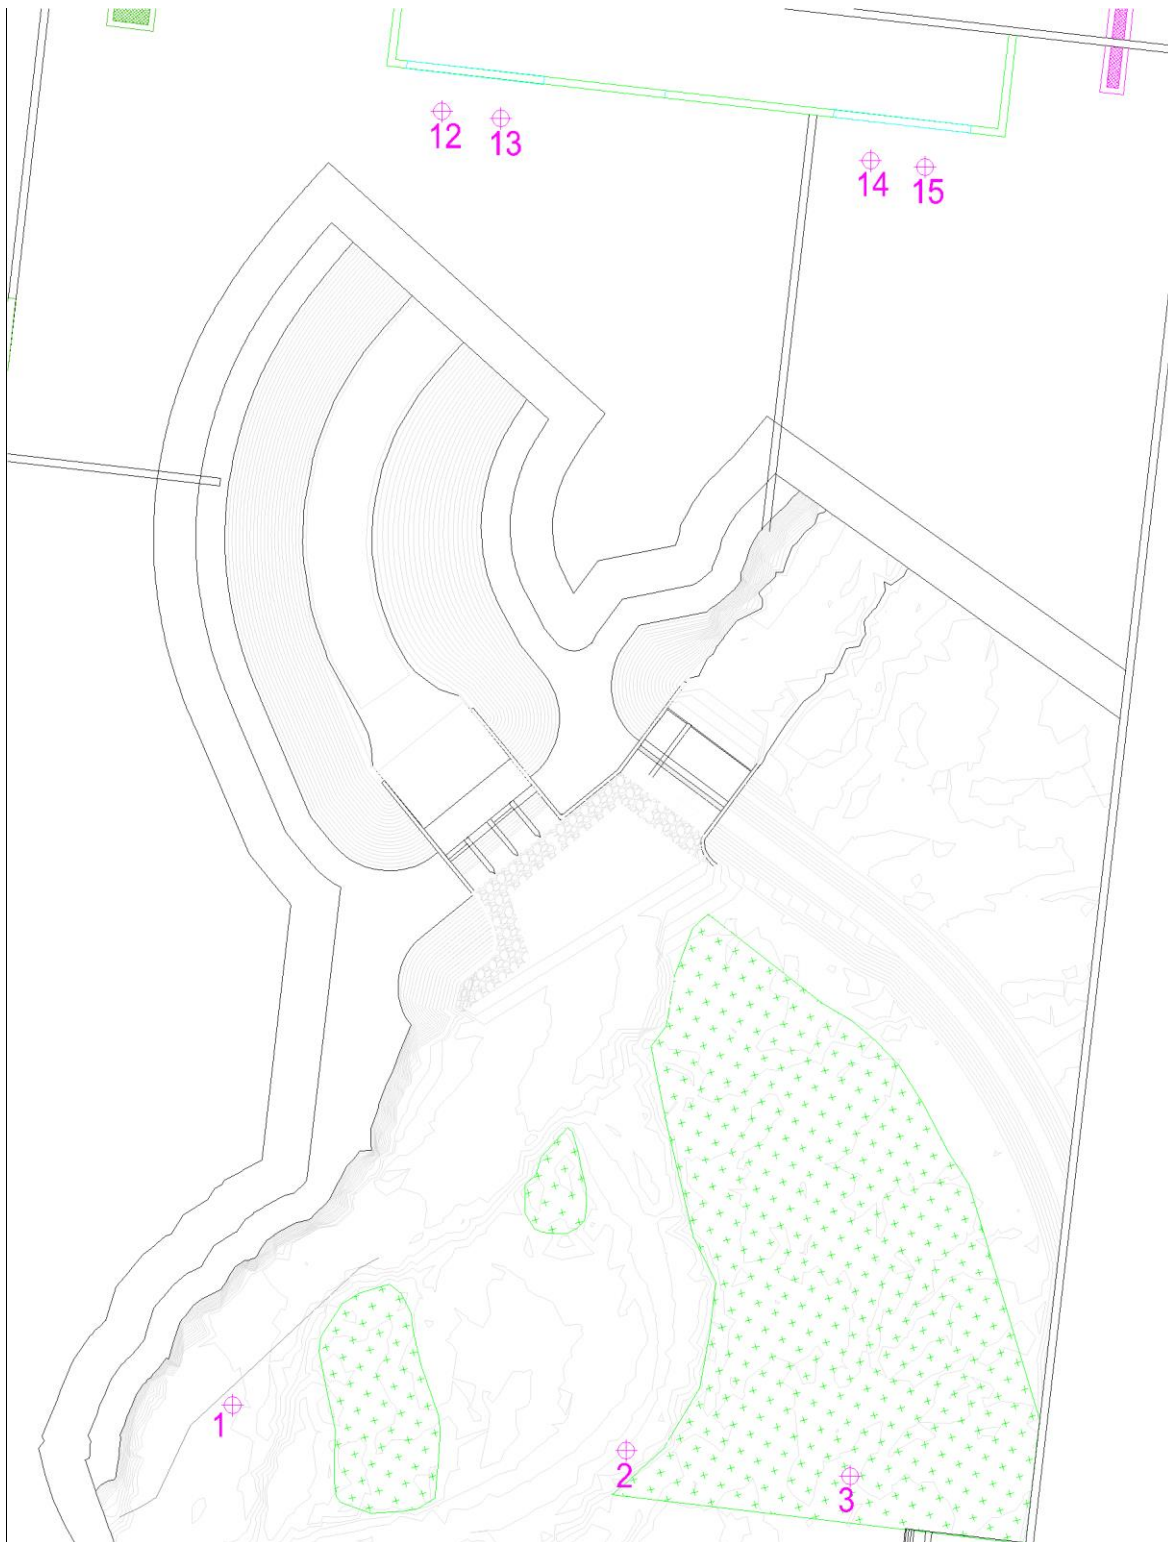
Figure 75. Instrumentation layout 3 – water level probes are shown in pink and velocity probes are shown in blue.

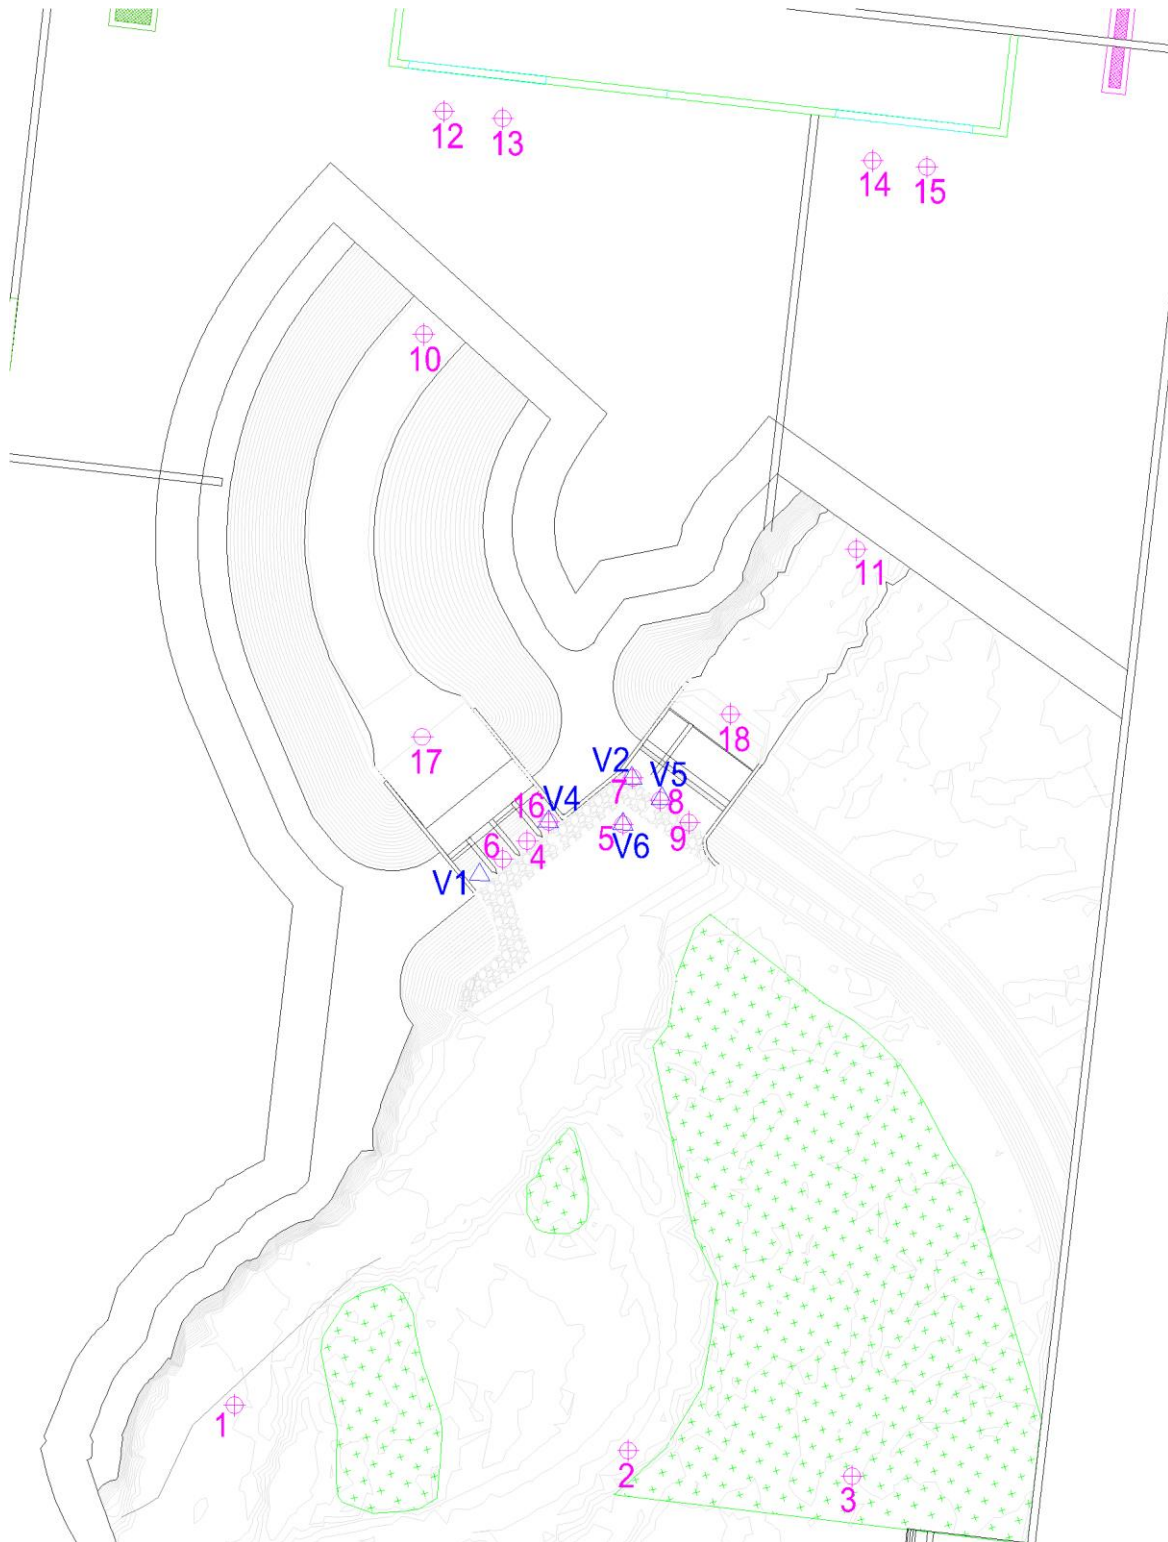
Figure 76. Instrumentation layout 4 – water level probes are shown in pink and velocity probes are shown in blue.

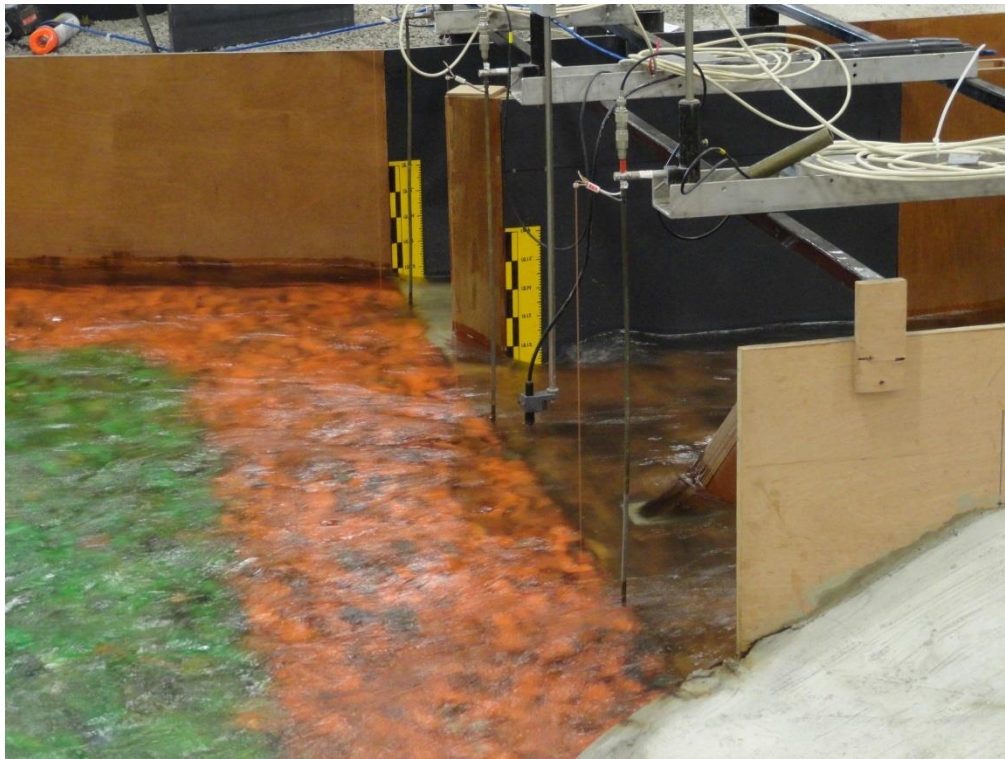
Water levels in the model were measured at many different locations using 18 capacitance-type water level gauges developed by Akamina Technologies (see Figure 78). These probes operate by sensing the change in capacitance that occurs as a portion of the insulated wire becomes submerged. The signal is directly proportional to the percentage of the wire that is wetted, regardless of whether the wetting is continuous (caused by “green water”) or intermittent (as in the case of spray). This type of gauge has been shown to exhibit a highly linear and stable relationship between water level and voltage. They typically feature calibration errors of less than 0.5% over a 100mm calibration range. This error represents an accuracy of  $\pm 0.5\text{mm}$  at model scale or  $\pm 8\text{mm}$  at full scale. The water level probes were calibrated several times throughout the test program by changing their elevation with respect to a fixed water level. The calibration constants remained stable throughout the test program.

Figure 78. Capacitance water level gauges.

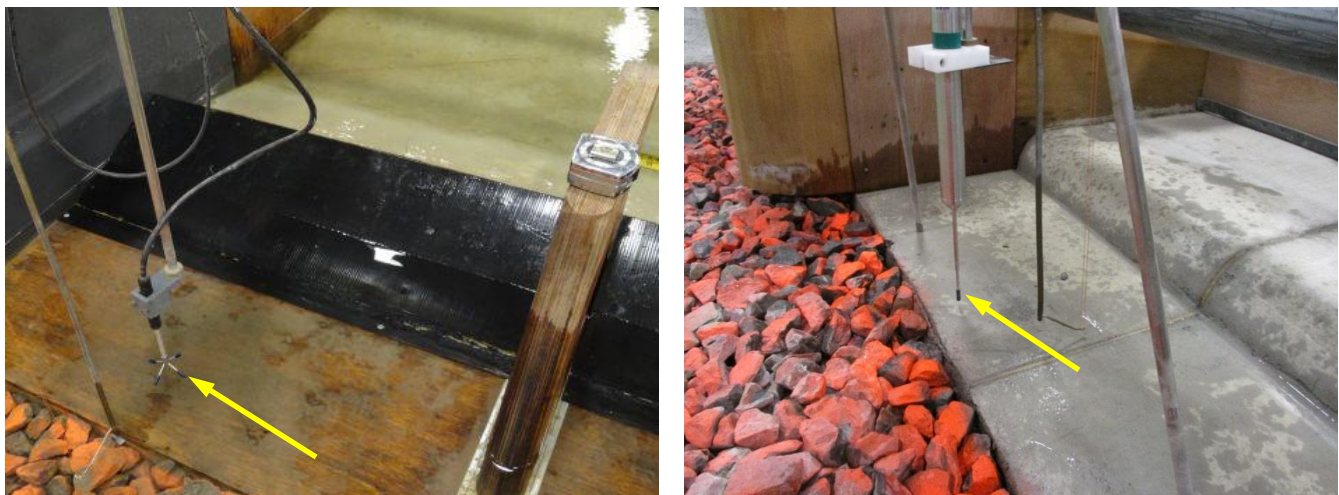
Two different types of instruments were used to measure velocities within the model, four 2-axis electromagnetic current meters developed by Alec Technologies and two 3-axis acoustic Doppler velocimeters made by Vectrino (ADV's) were utilized (see Figure 79). The height of the current meters above the river bottom was adjusted to be mid-depth for each flow condition. However the ADV sensors require 5cm (model scale) depth below the sensor for accurate readings, therefore they were not used during some of the lower flows since the depths were insufficient.

Figure 79. Three-axis acoustic Doppler velocimeter (left) two-axis electromagnetic current meter (right).

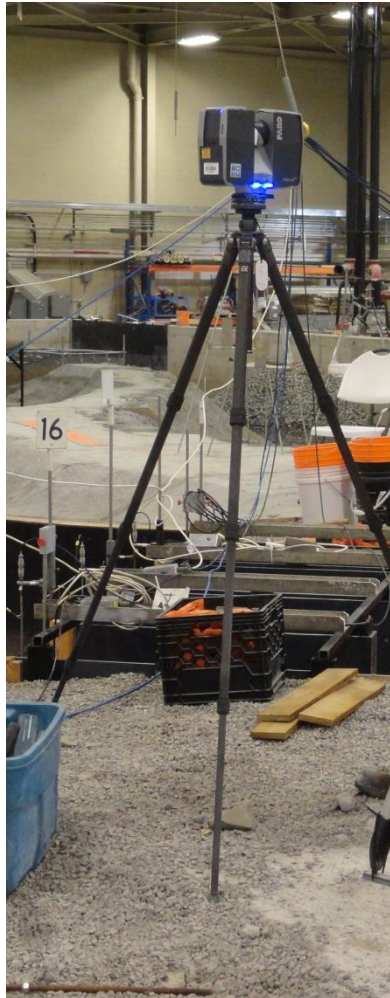
A FARO 3D laser scanner (see Figure 80) was used to measure the elevation of the mobile bed before and after each sediment run. The FARO scanner uses a laser to take detailed measurements of millions of points in order to capture three-dimensional environments. After each sediment run, multiple scans were completed at different locations around the mobile bed. Each scan captured approximately 5.6 million points at a resolution of 6.1mm between points at 10m from the scanner.

The multiple scans were stitched together to produce a single image of the mobile bed. Using the captured three-dimensional images, erosion/accretion patterns and volumetric sediment motion quantities were calculated by subtracting the pre and post sediment run FARO scans.

Figure 80. FARO 3D Laser Scanner.

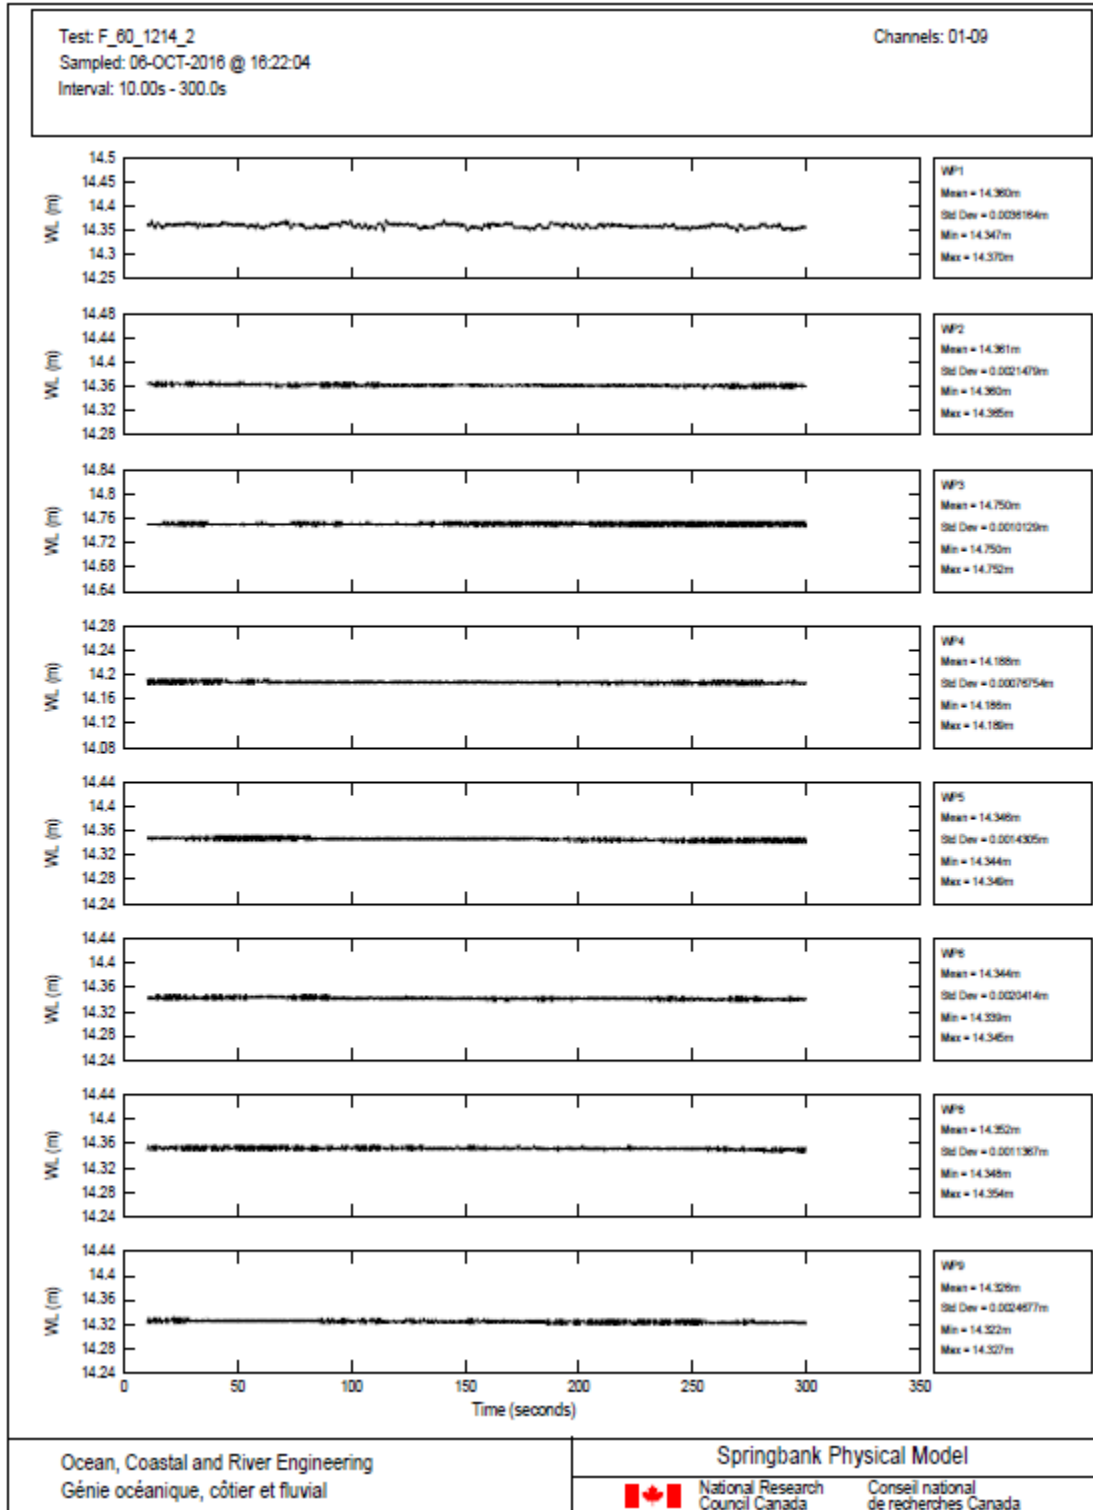
Figure 81 shows an example of the water level plot used in this study. It shows the water level time histories measured at eight water level gauges and lists some key derived parameters describing the water levels at each location. All of the water level data collected during the study was analysed and plotted in this manner, and the results were shared with Stantec on a regular basis.

Figure 81. Typical water level analysis plot used in this study.

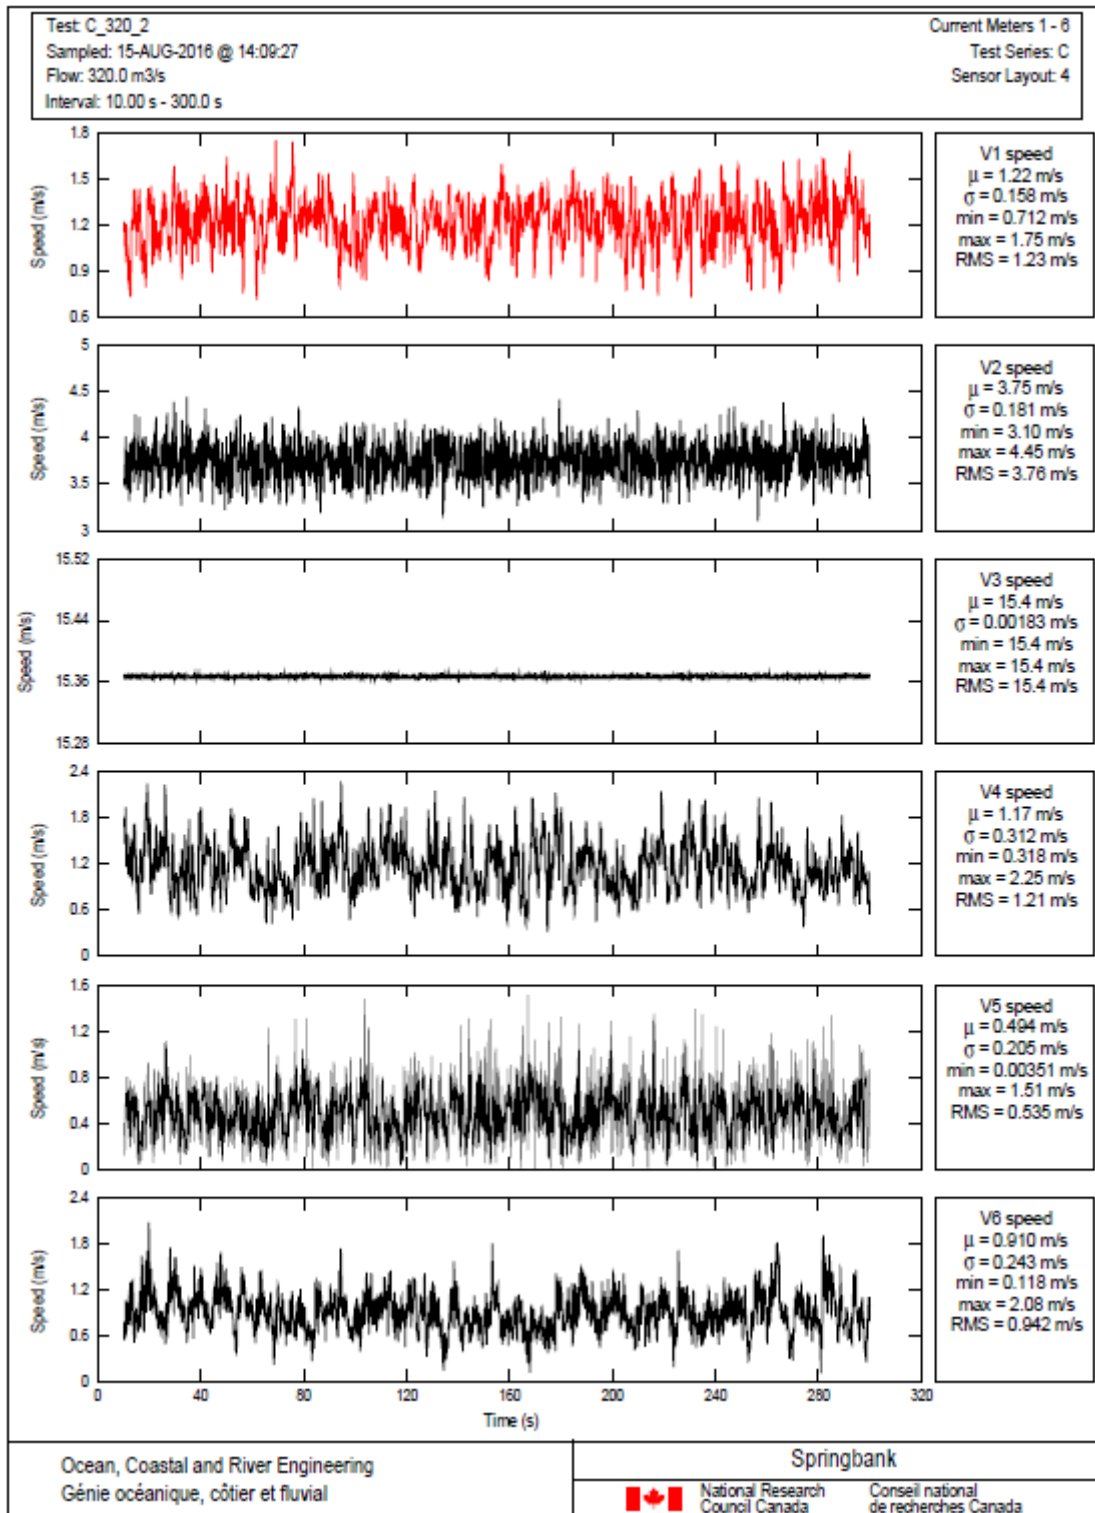
- Next, a statistical analysis program was applied to compute key statistics for the time series data.
- Key statistics and parameters from the analysis were collected in a single ASCII file that was subsequently imported into a spreadsheet program.
- Finally, several plots were generated to visually illustrate the velocity data for each test. Figure 82 shows an example of the velocity data plot that was used in this study. It shows the time histories for several measured and derived parameters (in black), the low-frequency part of each signal (in red), along with several key statistics

All of the velocity data collected during the study was analysed and plotted in this manner, and the results were shared with Stantec on a regular basis.

Figure 82. Typical velocity analysis plot used in this study.

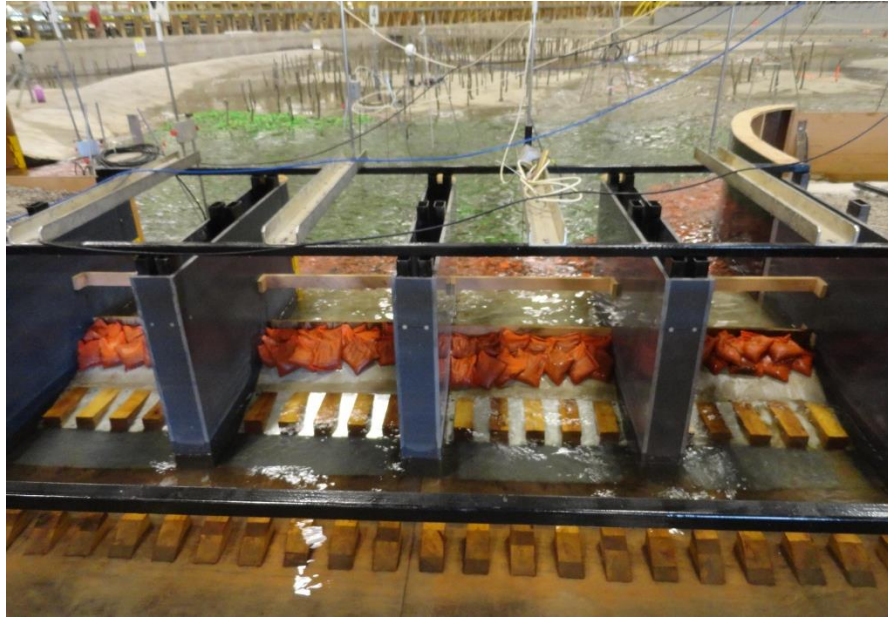
Figure 84. Blockage of the diversion channel inlet for  $160 \text{ m}^3/\text{s}$  flow condition.

Similar to the  $60 \text{ m}^3/\text{s}$  flow condition, the intention for the  $160 \text{ m}^3/\text{s}$  flow condition was to have the entire  $160 \text{ m}^3/\text{s}$  flow pass through the sluiceway and service spillway. Instead of modelling the diversion inlet gates, the flow through the diversion inlet was blocked by inserting wooden slats and sandbags into each bay opening (as shown in Figure 84).

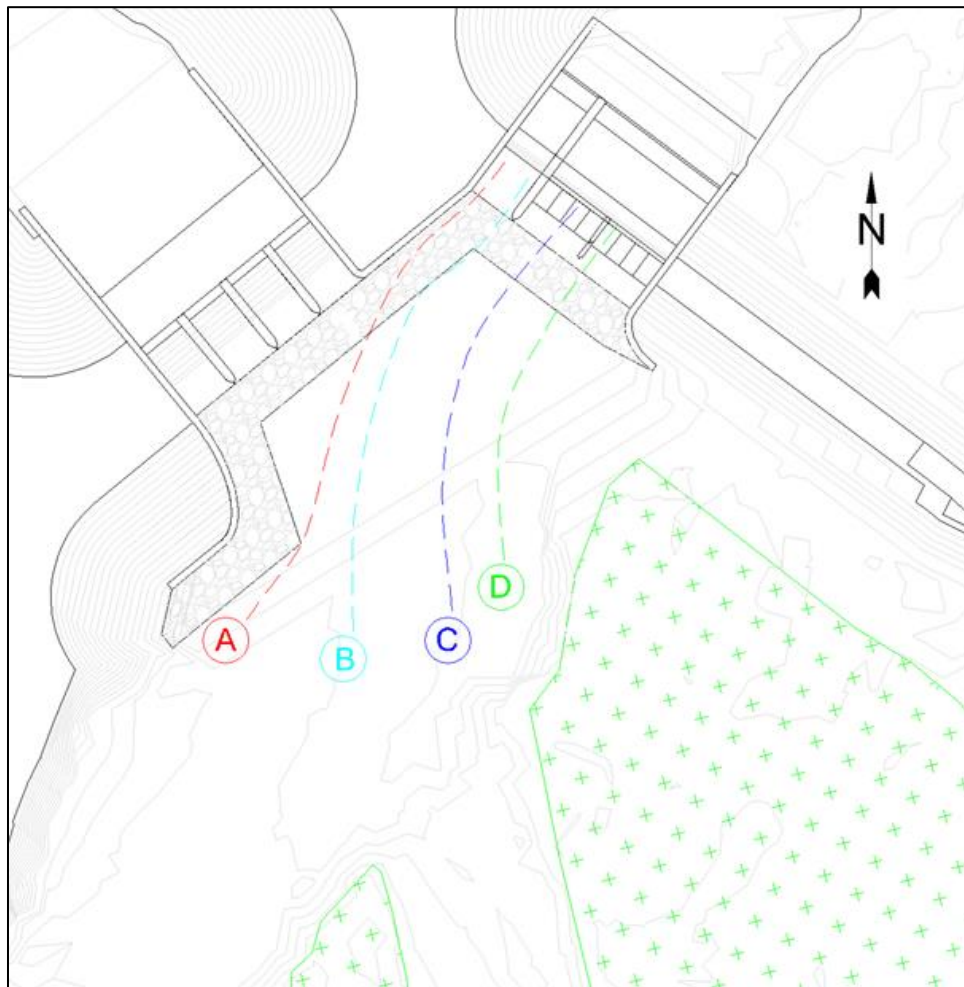
Figure 85 shows a summary of the flow pathways that were observed by deploying drogues in the model at various points. The drogues followed similar flow paths as observed during the  $60 \text{ m}^3/\text{s}$  flow condition. Drogues inserted in the main channel (points A and B) travelled through the sluiceway while those released in the secondary channel (points C and D) travelled through the LHS service spillway (from point C) and the RHS service spillway (from point D).

Figure 85. Flow pathways for the 160 m<sup>3</sup>/s flow condition.

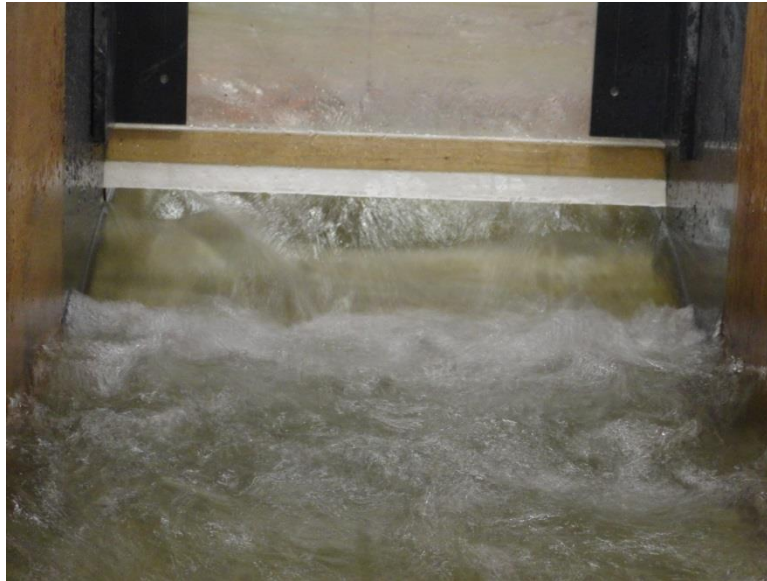
The gate settings specified by Stantec for the 320 m<sup>3</sup>/s flow condition were intended to divert 160 m<sup>3</sup>/s through the diversion channel, with the remainder passing through the service spillway to the downstream river channel. The measured flow split in the model was close to the intended targets, with 165 m<sup>3</sup>/s passing through the diversion inlet structure and 156 m<sup>3</sup>/s flowing through the service spillway/sluiceway. It was observed during testing that the sluiceway gate setting provided by Stantec (1212.1 m) did not have an influence on the flow travelling through the sluiceway. Even though the water level approximately 12m upstream of the sluiceway gate was measured at 1212.76 m (WP7), the flow accelerated substantially as it entered the sluiceway and the local water level

decreased accordingly. This allowed the flow to travel below the sluiceway gate without touching it, as shown in Figure 86 below.

Figure 86. Unobstructed flow passing under the sluiceway gate ( $320 \text{ m}^3/\text{s}$ ).
