**ALBERTA TRANSPORTATION SPRINGBANK OFF-STREAM RESERVOIR PROJECT  
RESPONSE TO CEEA INFORMATION REQUEST PACKAGE 3, AUGUST 31, 2018**

**APPENDIX IR13-1 NATIONAL RESEARCH COUNCIL CANADA  
PHYSICAL MODEL STUDY REPORT**

## Physical Model Study of the Springbank Off-stream Storage Project Diversion Structure on the Elbow River

Paul Knox, Andrew Cornett, Mitchel Provan  
Ocean, Coastal and River Engineering  
NRC Technical Report: OCRE-TR-2016-028

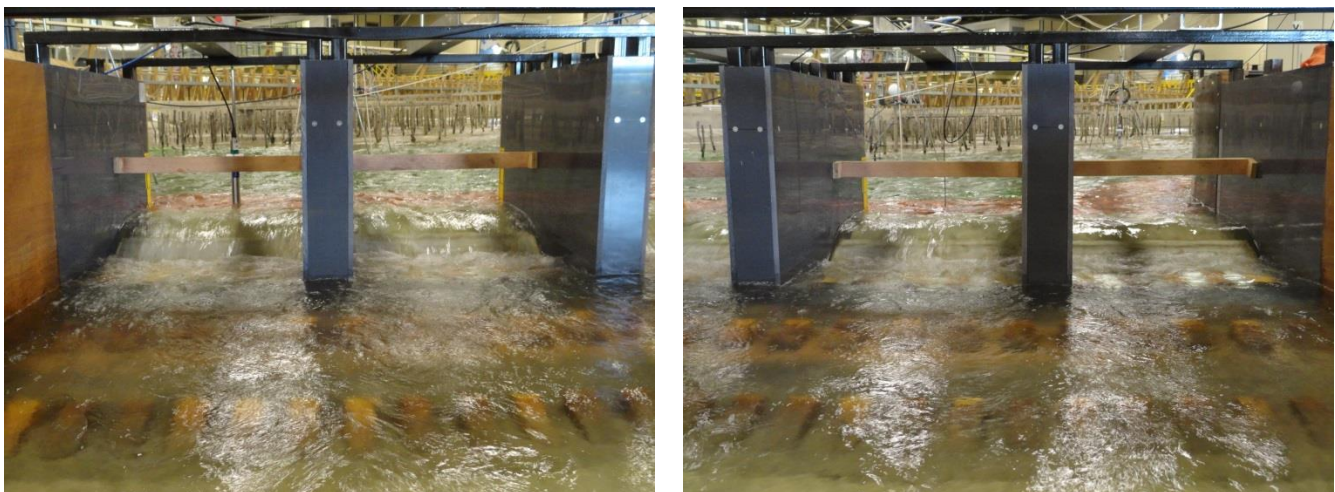
There was an uneven flow distribution through the four diversion inlet gate bays, with progressively lower flows moving from east to west (see Figure 87). This was evident from the position and strength of the hydraulic jumps immediately downstream from each of the diversion inlet bays. The hydraulic jumps for the two western bays were smaller and occurred closer to the concrete crest, while the hydraulic jumps for the two eastern bays were larger and occurred further downstream from the sill crest; indicating greater discharge.

Figure 87. Flow through the diversion inlet viewed from downstream - two eastern bays (left) and two western bays (right).

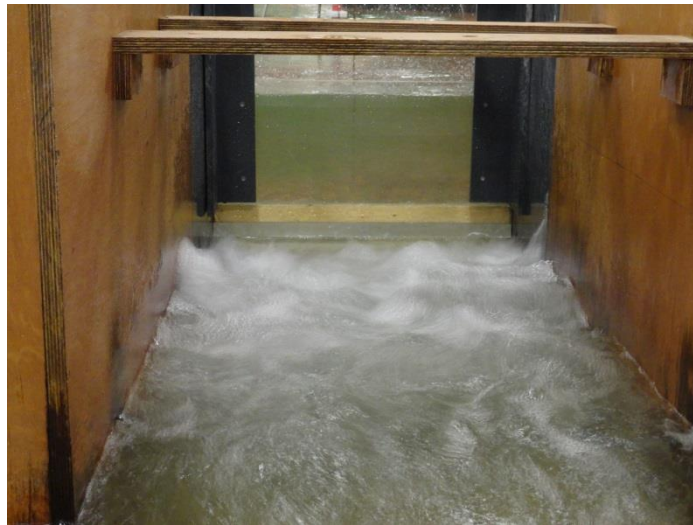
The sluiceway gate was set at an elevation of 1210.7 m, which created approximately 4.7 m of head on the upstream side of the sluiceway gate (see Figure 89). An uneven flow distribution was observed flowing over the Obermeyer gates within the service spillway. The left hand side of the service spillway appeared to be passing more flow compared to the right hand side. This imbalance in the service spillway flow distribution may be a result of the recirculation zone that was observed near the curved wall on the RHS of the service spillway.

Figure 89. Supercritical flow passing under the sluiceway gate viewed from downstream (with approximately 4.7 m of head on the upstream side of the gate).

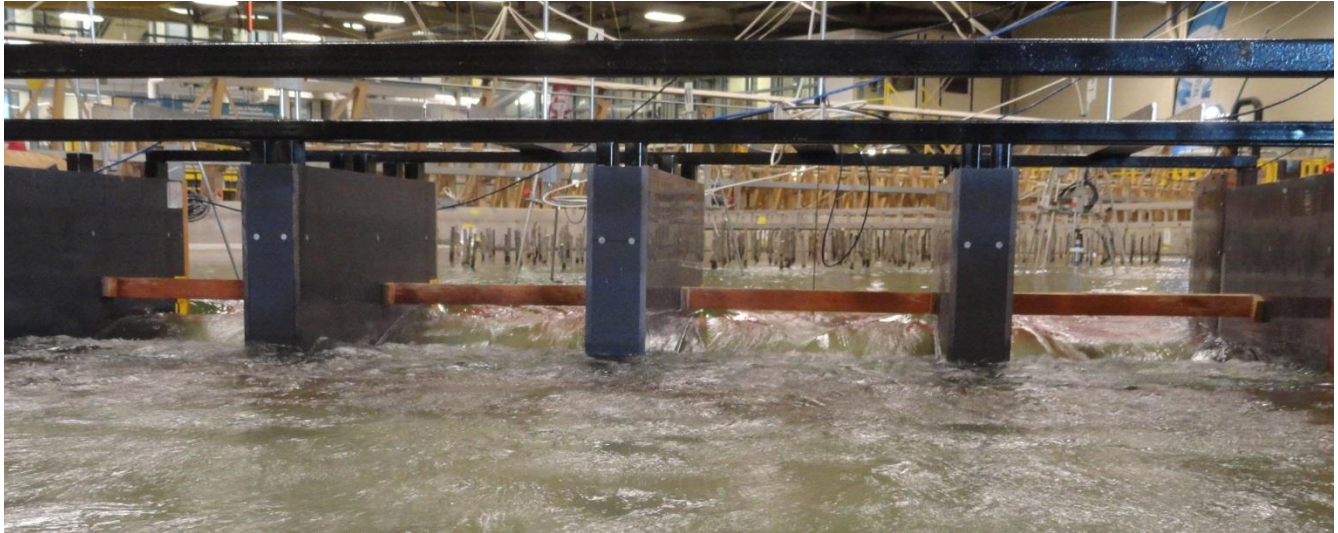
The flow through the four diversion inlet bays was more evenly distributed for this condition compared to the 320 m<sup>3</sup>/s flow scenario. The hydraulic jumps downstream of the diversion inlet gates all appeared relatively uniform in strength and location, as shown in Figure 90.

Figure 90. Turbulent flows downstream of diversion inlet gates.

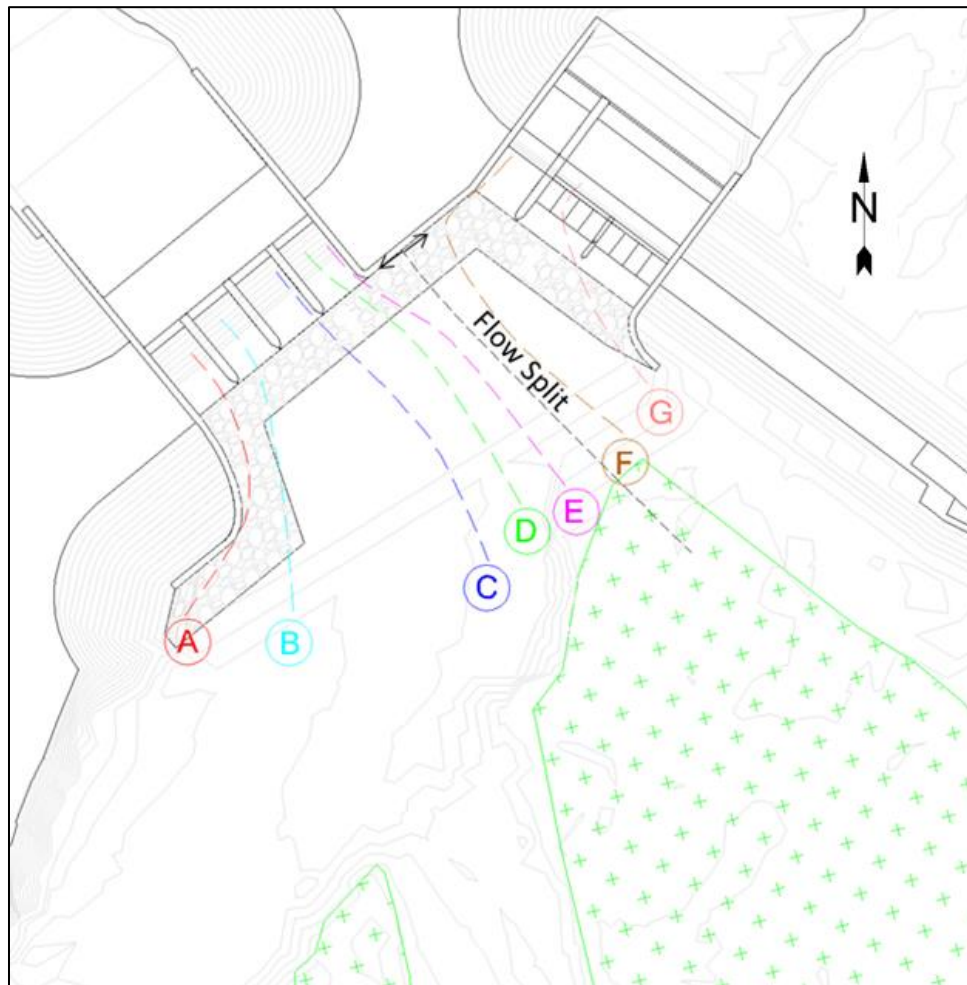
Figure 91 shows a summary of the flow pathways that were observed by releasing drogues into the model at various locations in the upstream floodplain. Drogues placed in the main channel (locations A and B) travelled through the two western diversion inlet bays. Drogues placed at location A tended to hug the curved retaining wall. Drogues released along the western side of the large treed area (locations C, D and E) all flowed through the two eastern diversion inlet bays. The flow split line for this flow condition was located much closer to the sluiceway compared to the 320 m<sup>3</sup>/s flow condition. The larger flow draw from the diversion (~600 m<sup>3</sup>/s) directed all flow from the main and secondary upstream river channels through the diversion channel, while the sluiceway and service spillway only received flow from the northern part of the treed area beside the floodplain berm. Drogues released at location F travelled west across the opening of the service spillway until they hit the retaining wall between the diversion inlet and sluiceway, before eventually making their way through the sluiceway. Drogues released near the floodplain berm (location G) would travel past the RHS of the service spillway before moving downstream through the LHS. One drogue released on the flow split line travelled along the line to the retaining wall where it was trapped in a small recirculating eddy that formed very close to the wall.

Figure 91. Flow pathways for the 760 m<sup>3</sup>/s flow condition.

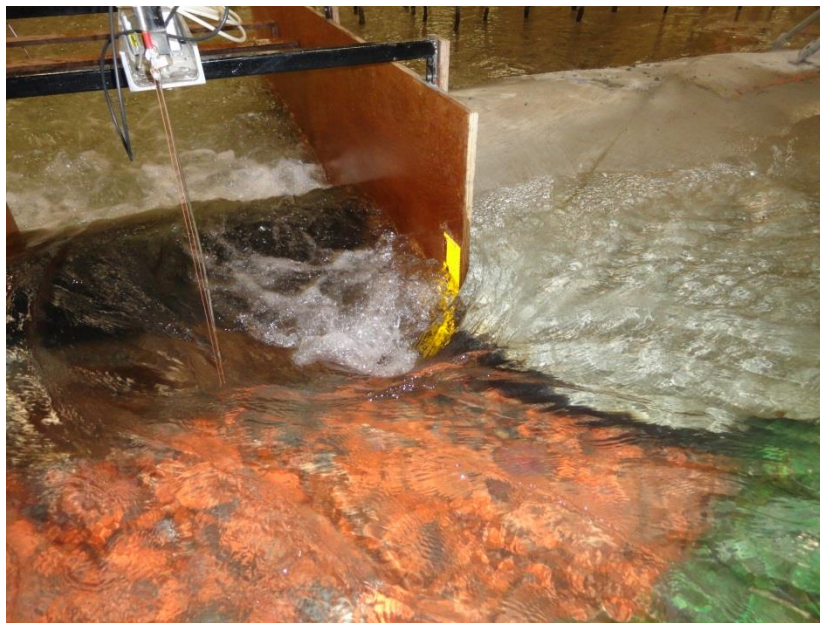
For these conditions the water level was slightly lower in the RHS of the service spillway than in the LHS, suggesting lesser discharge passing through the RHS. This was due in part to the flow recirculation caused by the flow spilling over the curved RHS retaining wall /abutment. The upstream flow travelling roughly parallel to the floodplain berm would accelerate in wrapping around the upstream end of the RH side wall, creating a zone of flow recirculation beside the RH side wall (see

Figure 92). Some rip-rap was displaced below the zone of local flow acceleration and recirculation, near the interface between the rip-rap and the concrete apron.

Figure 92. Local flow acceleration and recirculation at the right hand side of the service spillway.

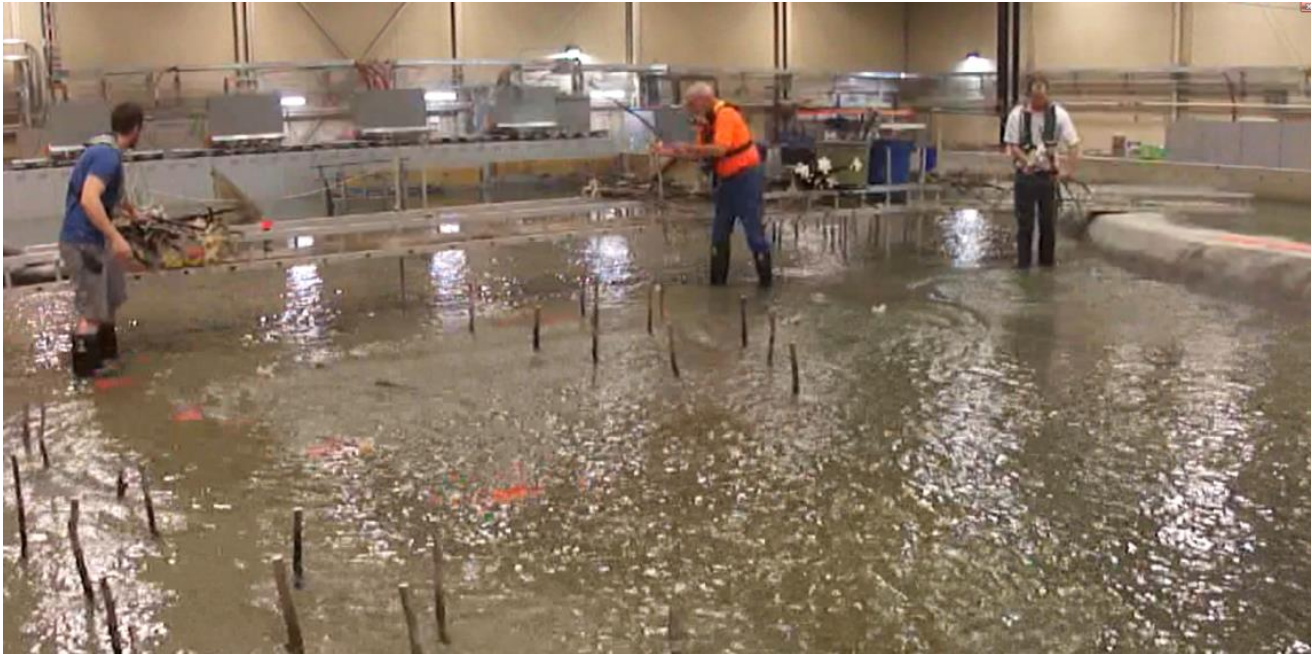
Test series B (TSB) investigated the interaction of water-borne woody debris with the two flow control structures, for both the 760 m<sup>3</sup>/s and 1240 m<sup>3</sup>/s flow conditions. The test program for TSB is summarized in Table 5. One set of gate settings was modelled with the 1240 m<sup>3</sup>/s flood (the same settings modelled in TSA), while two different gate settings were studied with the 760 m<sup>3</sup>/s flood. In one case the same settings modelled in TSA were used, while for the second case, the situation in which the service spillway Obermeyer gates were lowered to 1211.8 m (the setting used with the 1240 m<sup>3</sup>/s flow condition) was modelled. Model scale woody debris simulating uprooted conifer trees was introduced into the upstream flow at specific locations and the interaction of the debris with the structures was observed and recorded. The model debris was introduced in several ways: as individual trees released in series, as small rafts comprised of 10 trees arranged in random patterns, and as larger rafts comprised of 40 model trees arranged randomly. The final step in each debris test was to load the model with numerous model trees (approximately 100 trees in 60 seconds) released in three locations (main channel, secondary channel and a point between the two; see Figure 94).

Figure 94. Debris loading locations for 100 trees in 60 seconds.

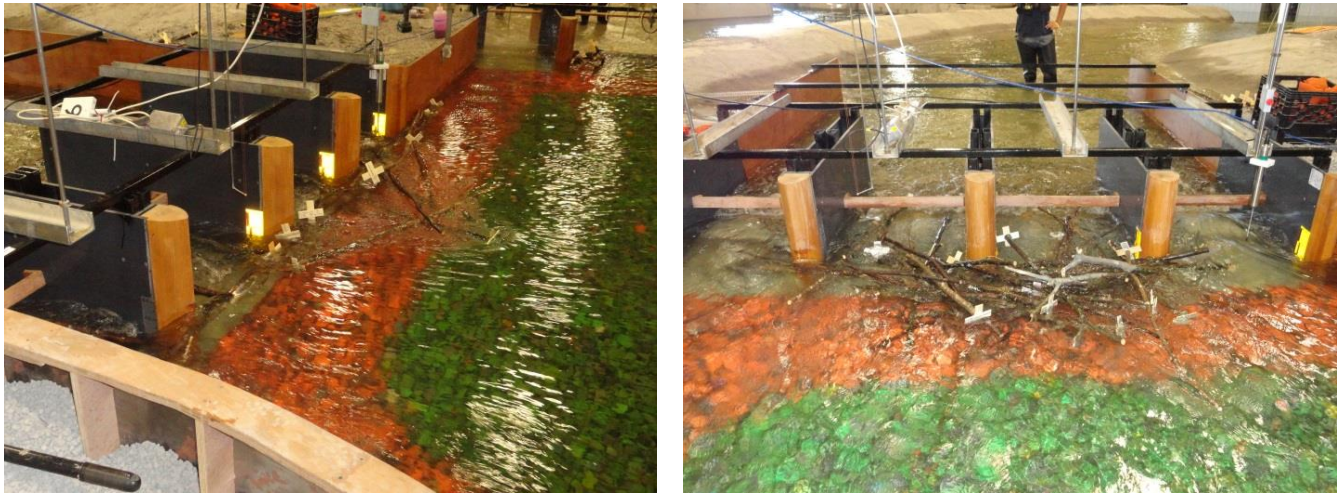
The debris generally followed the streamlines that had been mapped out using drogues and dye during test series A. Single trees were able to pass through the diversion inlet bays as long as they were oriented with the flow. Since the width of each diversion inlet bay was less than the length of the trees, the trees tended to catch on the piers whenever they approached a diversion inlet bay sideways. Trees with a root ball were more frequently caught than trees without root balls. Individual trees would sometimes rotate around the point of contact and then pass safely through the diversion. In other cases, the trees would end up spanning the width of the bay between two adjacent piers. Once one tree was caught on the piers it caused a snowball effect and the single tree would catch multiple trees regardless of their orientation (see Figure 95). Most of the trees in the larger rafts were caught on the piers with only a few individual trees passing through the diversion inlet bays.

Figure 95. Single trees (left) and a 40-tree raft (right) caught on the diversion inlet piers.

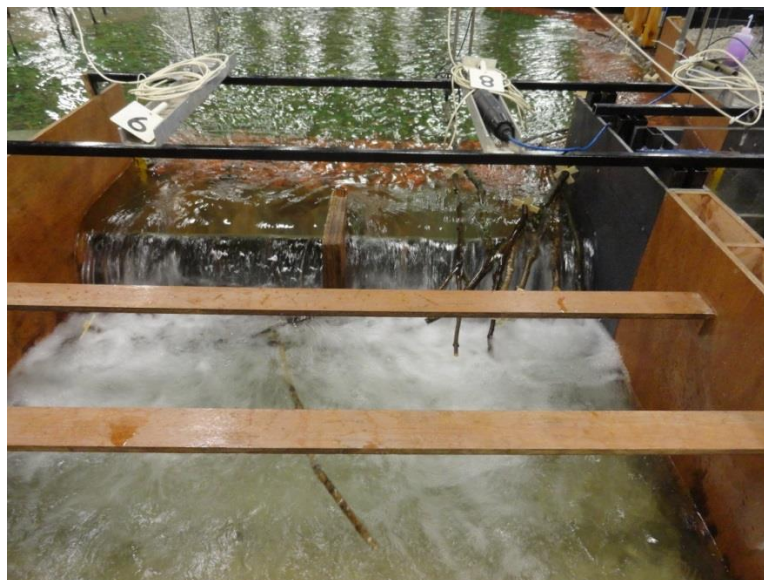
Individual trees frequently became snagged on the Obermeyer service spillway gates. Trees with roots were snagged more frequently than trees without roots. Trees without roots were sometimes able to pass over the gates and move downstream, however, some of the passing trees became trapped in the roller that formed immediately downstream of the gates. The head over the Obermeyer gates for the  $760 \text{ m}^3/\text{s}$  flow was not deep enough to pass much debris unobstructed. As at the diversion channel, once a single tree caught on the gate, the single tree would catch other trees causing a build-up that grew over time as more trees arrived from upstream (see

Figure 96. Woody debris caught on the Obermeyer gate and trapped in the downstream roller.

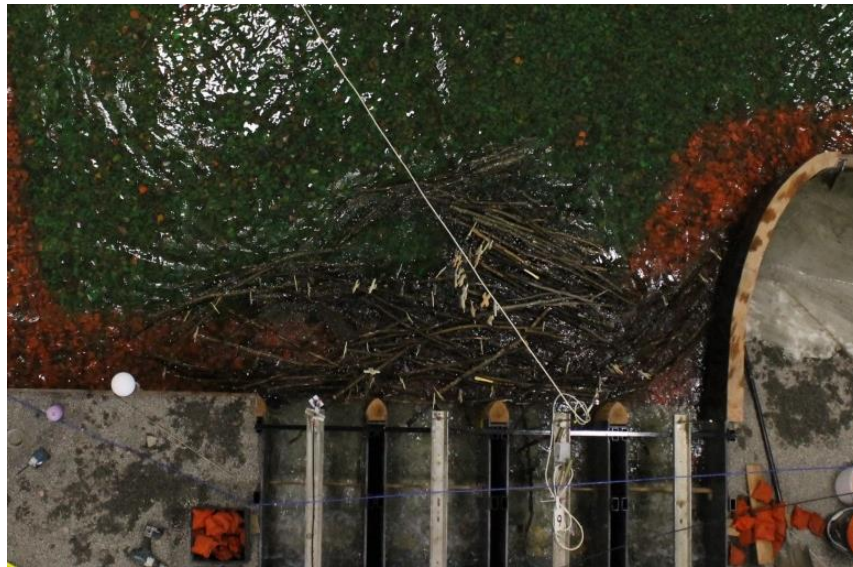
In the last debris test conducted for this flow condition, 122 trees were released into the upstream flow at a steady rate over 72 (model scale) seconds. Initially, some of the trees passed through the diversion inlet bays as long as they were aligned with the flow. However, once a single tree caught on the piers it trapped the majority of the following trees causing a large raft to form in front of the piers. Of the 122 trees released, 20 trees passed through the diversion inlet bays, while 102 were retained on the diversion inlet piers (16% passing rate). A further 80 trees were added to the existing debris raft/jam to create a large debris raft comprised of approximately 180 trees (see Figure 97). This large debris raft/jam decreased the flow through the diversion channel by approximately  $100 \text{ m}^3/\text{s}$  (~18% reduction).

Figure 97. Debris jam of approximately 180 trees.

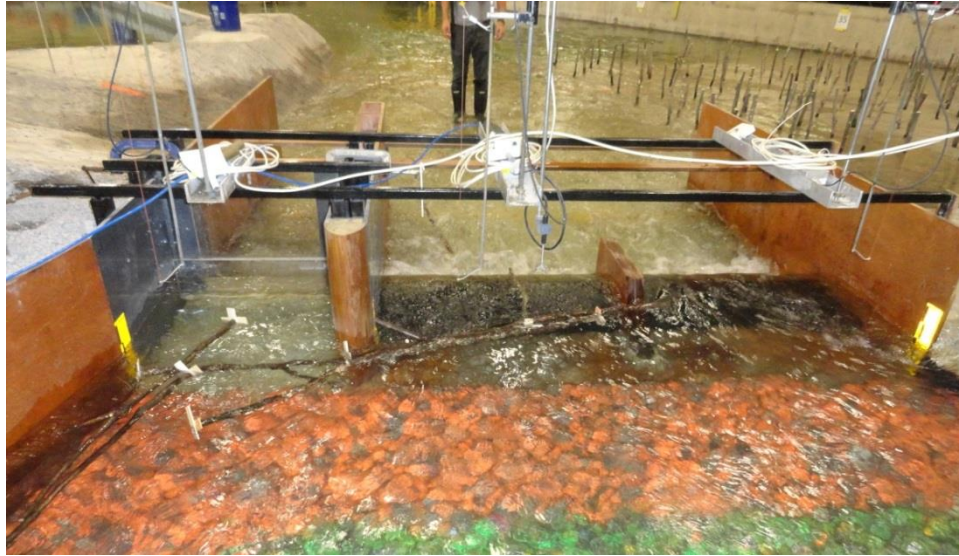
Lowering both of the Obermeyer gates to 1211.8 m elevation increased the rate at which debris was able to pass through the service spillway. For this gate arrangement the combined discharge was  $783 \text{ m}^3/\text{s}$ , with  $448 \text{ m}^3/\text{s}$  passing through the diversion and  $335 \text{ m}^3/\text{s}$  passing through the service spillway, a 57:43 split. With more flow going down the sluiceway/ service spillway than before ( $335 \text{ m}^3/\text{s}$  compared to  $160 \text{ m}^3/\text{s}$  for the higher gate setting) more trees were directed towards the service spillway (and away from the diversion channel) and the higher head above the Obermeyer gates allowed more of the trees, but not all, to pass through without getting caught on the gate crests. As before, longer trees and trees with roots were more frequently snagged, either on the gate crest or by spanning across adjacent piers (see Figure 98).

Figure 98. Debris caught in the service spillway/sluiceway with lower (1211.8m) Obermeyer gate setting.

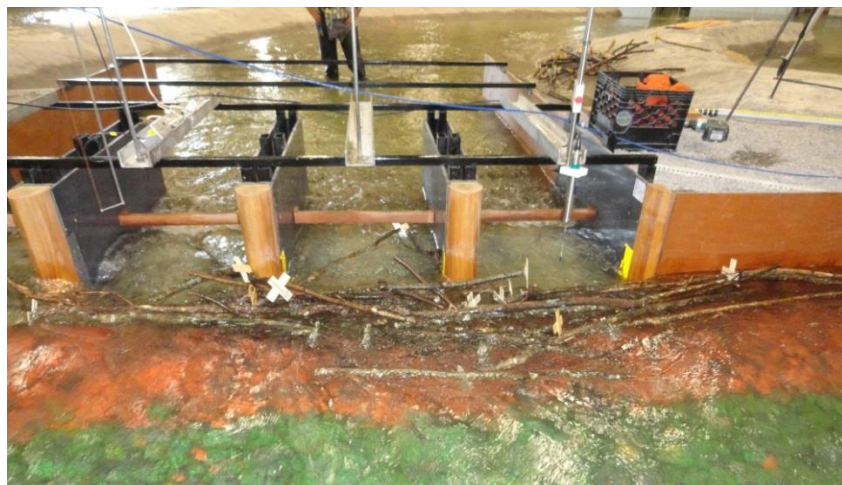
Although the flow for the 1240 m<sup>3</sup>/s condition was much more evenly distributed between the two structures, the debris behaviour at the upstream face of both structures was similar to that observed for the 760 m<sup>3</sup>/s flow condition. Single trees passed through the diversion inlet bays until one was caught on the piers, which caused the subsequent trees to become snagged leading to formation of sizeable debris raft at the pier noses (see Figure 99).

Figure 99. Collection of debris snagged on the diversion inlet piers.

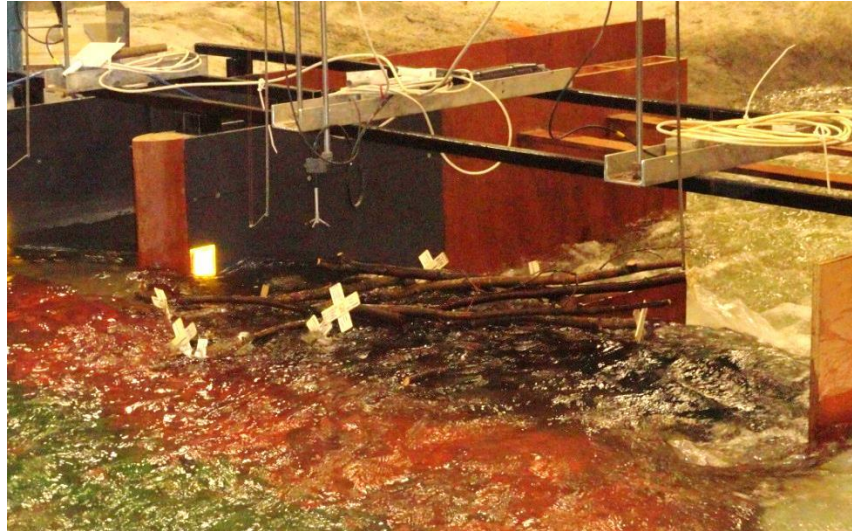
trees that made it over the Obermeyer gates became trapped in the downstream roller. The rafts of trees that were released into the upstream flow were not able to orient themselves with the flow direction and therefore got caught in the service spillway, particularly between the two piers (see Figure 100).

Figure 100. Tree raft snagged on piers in the service spillway.

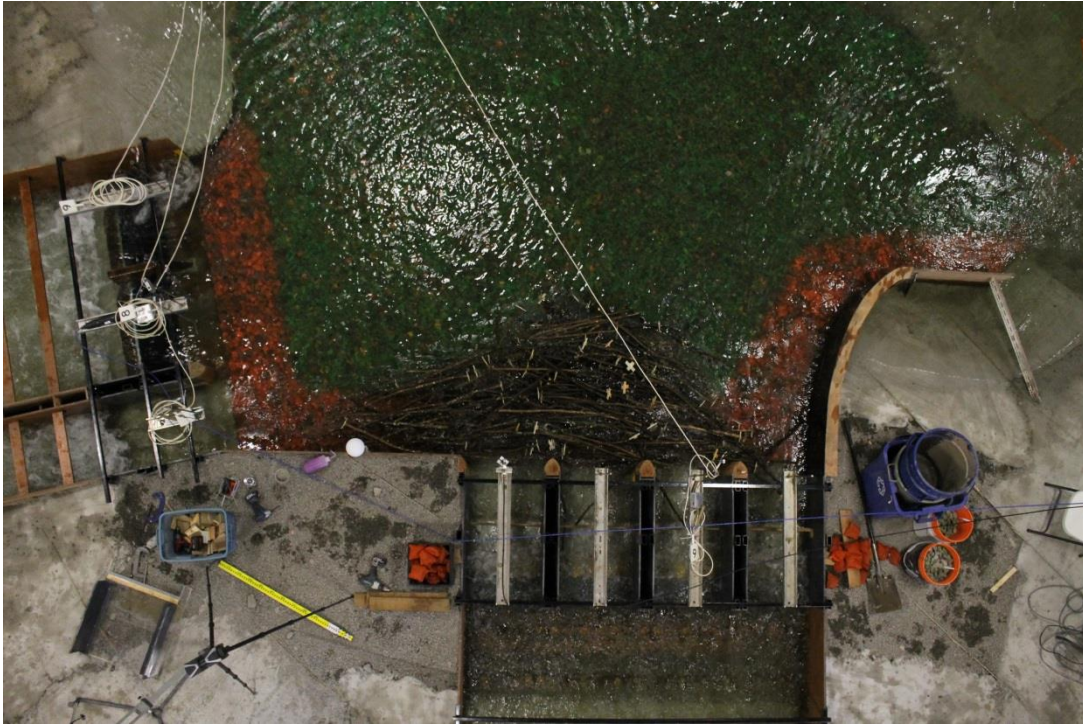
Following these tests with individual trees and tree rafts, the model was loaded with approximately 100 trees released steadily over 60 (model scale) seconds. This triggered the formation of a large debris jam at the entrance of the diversion channel. An additional 100 trees were added to the debris jam to create a jam comprised of approximately 200 trees (see Figure 101). This debris jam decreased the flow passing through the diversion channel by approximately  $60 \text{ m}^3/\text{s}$  (10%).

Figure 101. Debris jam of approximately 200 trees.

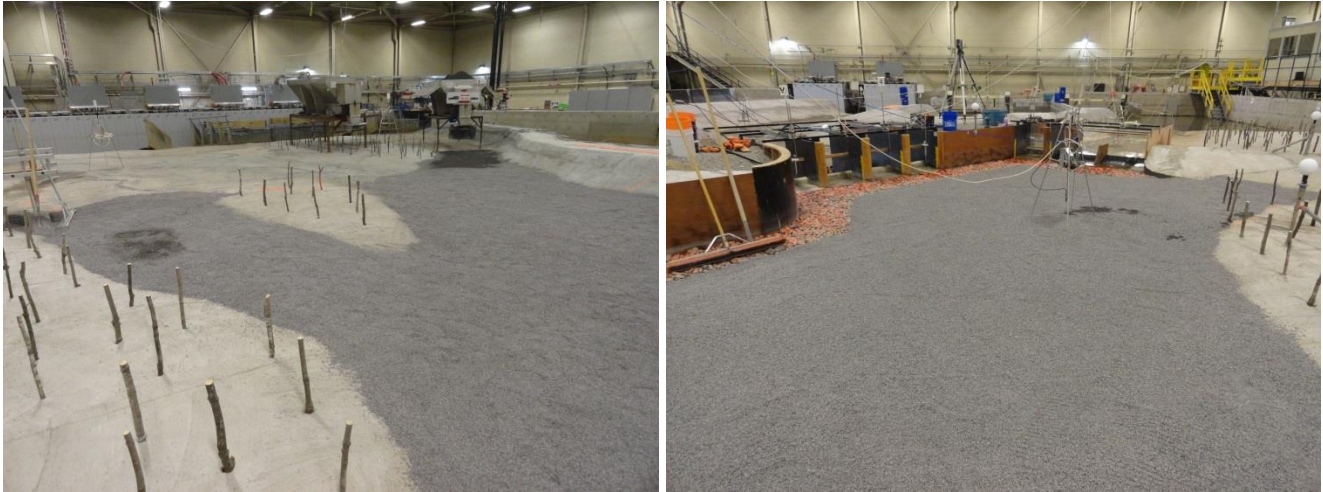
For these tests the upstream riverbed was preloaded with sediment (see Figure 102), and additional sediment was delivered through sediment spreaders installed in the upstream part of the model as described in Section 3.4.5. One spreader was operated in the main upstream channel for the experiment with  $320 \text{ m}^3/\text{s}$  discharge, two spreaders were operated in the main and secondary upstream channels during the experiment with  $760 \text{ m}^3/\text{s}$  discharge, and three spreaders were operated during the  $1240 \text{ m}^3/\text{s}$  flow experiment. The sediment in the forebay area (the area immediately upstream from the two structures) was not re-shaped between each experiment, so the final bedforms at the end of the  $1240 \text{ m}^3/\text{s}$  flow experiment were the result of erosion, transport and deposition accumulated during each flow condition. The sediment in the river channels further upstream was re-shaped (through a combination of shovelling and raking) between each test to smooth out irregularities and achieve a quasi-uniform preloading condition. The spreaders were re-loaded with additional sediment between each experiment.

Figure 102. Initial sediment preloading in the upstream (left) and forebay (right) areas.

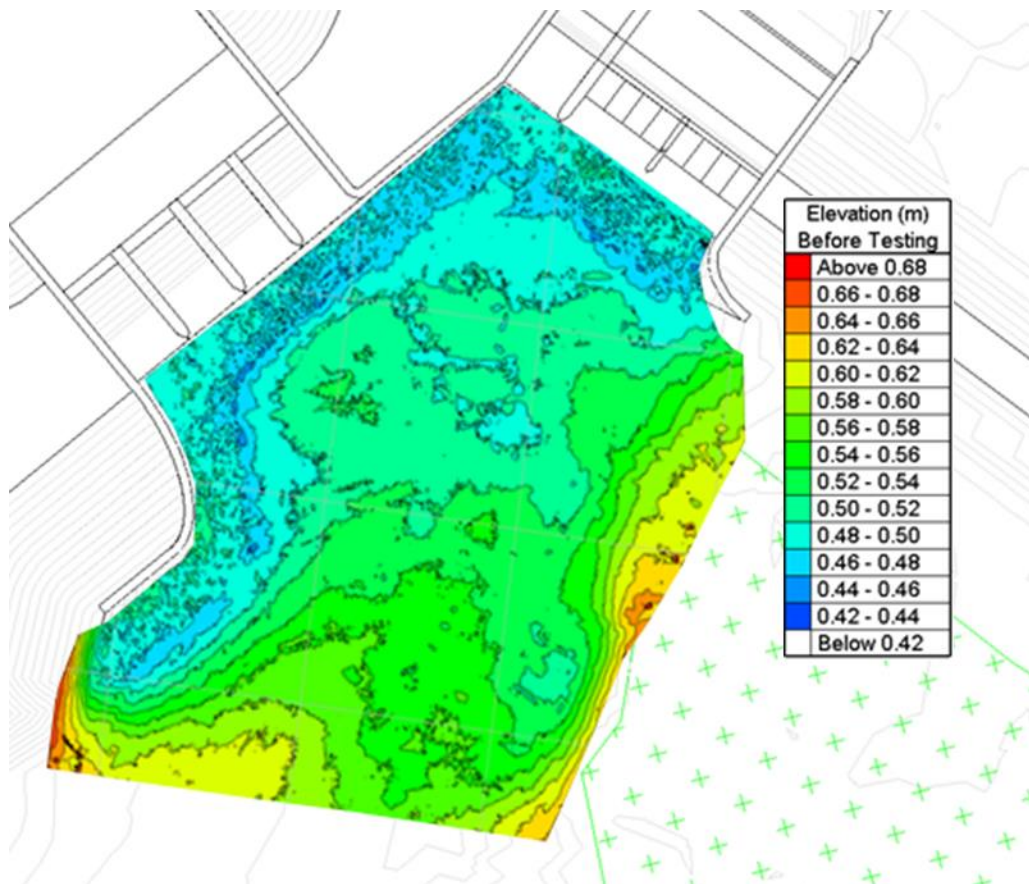
Before the first test and after each subsequent test, the model was drained and a 3D laser scanner (described in Section 3.5.3) was used to document the shape of the mobile riverbed in the forebay area. For each survey, at least four scans from four different points of view were recorded. The information from each scan was then combined to create a single 3D point cloud describing the shape/geometry of the riverbed in the forebay area. The bed elevations defined by the point cloud were then mapped onto a high-resolution rectangular grid. Elevation data from successive surveys could then be differenced to define the changes that occurred during each experiment, as well as the cumulative changes overall. Finally, a series of maps was prepared to illustrate the riverbed morphology and morphology changes observed in the physical model. Figure 103 shows the initial condition of the mobile bed in the forebay area before the first experiment. As with all the images presented in this report derived from the laser scans, the elevations in Figure 103 are in model scale meters with the basin floor as the reference datum (0m elevation). In addition to the laser scans, multiple video clips and photographs were recorded to document the appearance of the mobile bed sediments before and after each experiment.

Figure 103. Initial elevation of the mobile bed in the forebay area.

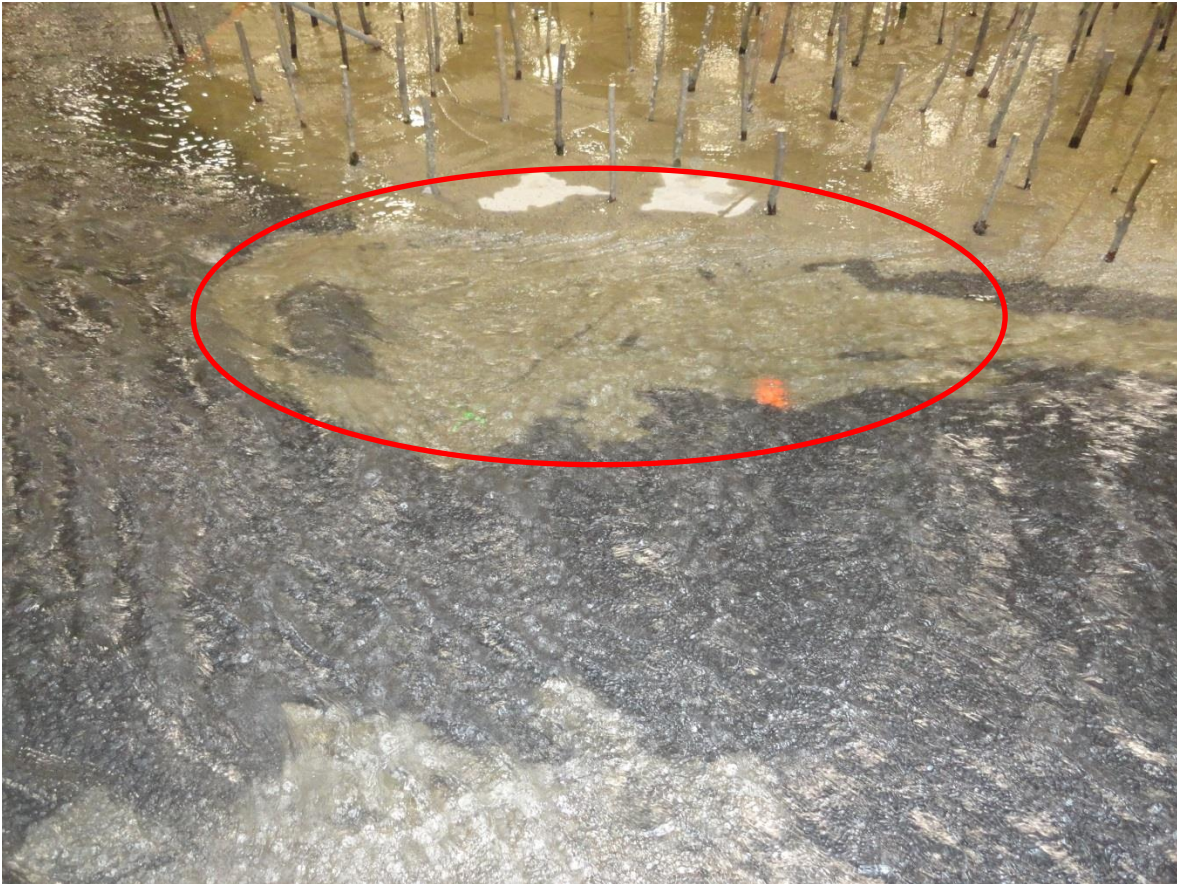
The 320 m<sup>3</sup>/s flow was able to mobilize and transport sediments from the main and secondary upstream channels downstream into the forebay area. However, no sediment deposition was observed on top of the riprap immediately upstream of each flow control structure. The sediment that had been placed on the bottom of the river channels was eroded in locations of greater flow velocity, exposing the underlying concrete bathymetry (see Figure 104). Some of the material delivered by the spreader was broadcast downstream, however, a pile of sediment also formed directly below the outlet. Every few minutes during the experiment, this lump of sediment was pushed and raked downstream as well as shovelled over to the secondary river channel. The sediment

in the secondary channel was quickly transported downstream and was continually re-placed with sediment shovelled from the main channel. The flow in the main river channel was also sufficient to mobilize and transport sediment downstream.

Figure 104. Erosion of sediment in secondary upstream flow channel (circled)

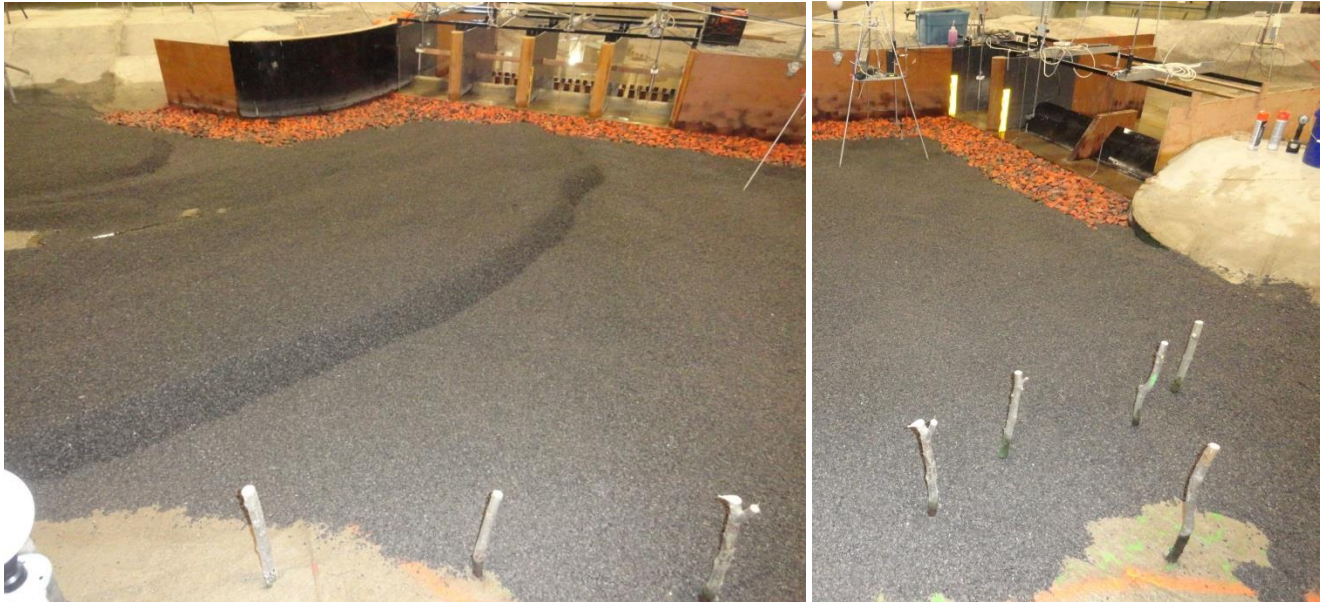
Figure 105 and Figure 106 shows conditions in the forebay area at the end of testing. A large elongated lobe of deposition formed extending all the way from the downstream end of the secondary (right) river channel (where it transitions to the forebay area) to the edge of the riprap in front of the diversion inlet structure. A second lobe of deposition formed in the lower part of the main channel that extended into the upstream part of the forebay area. A zone of erosion formed between these deposition lobes, roughly where the flows from the main and secondary channels joined each other and mixed together (see Figure 106). No sediment was observed passing through either structure at this flow rate and no sediment was observed downstream of either structure once the model was drained.

Figure 105. Deposition and erosion in the forebay area after 320 m<sup>3</sup>/s flow condition.

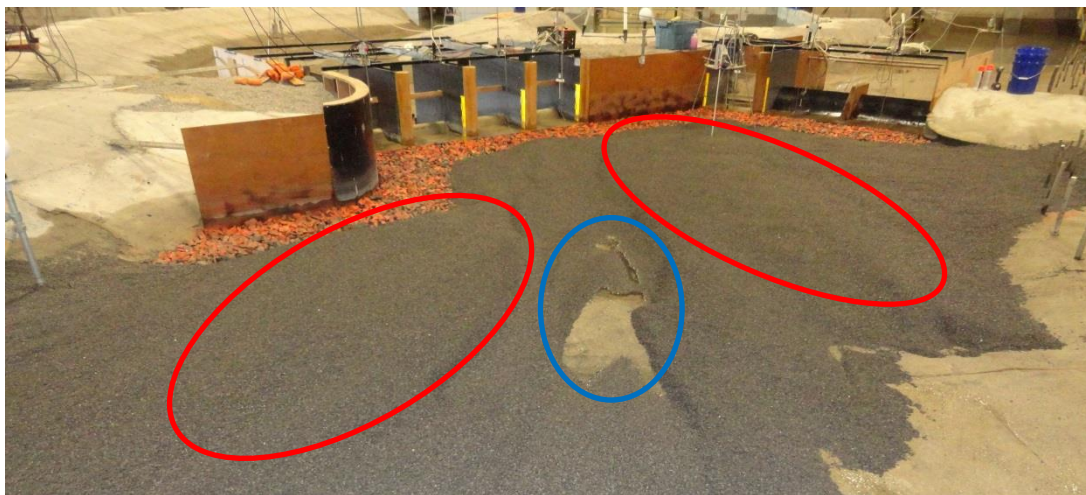
Figure 106. Riverbed morphology in the forebay area following the 320 m<sup>3</sup>/s flow condition; deposition zones in red, erosion zones in blue

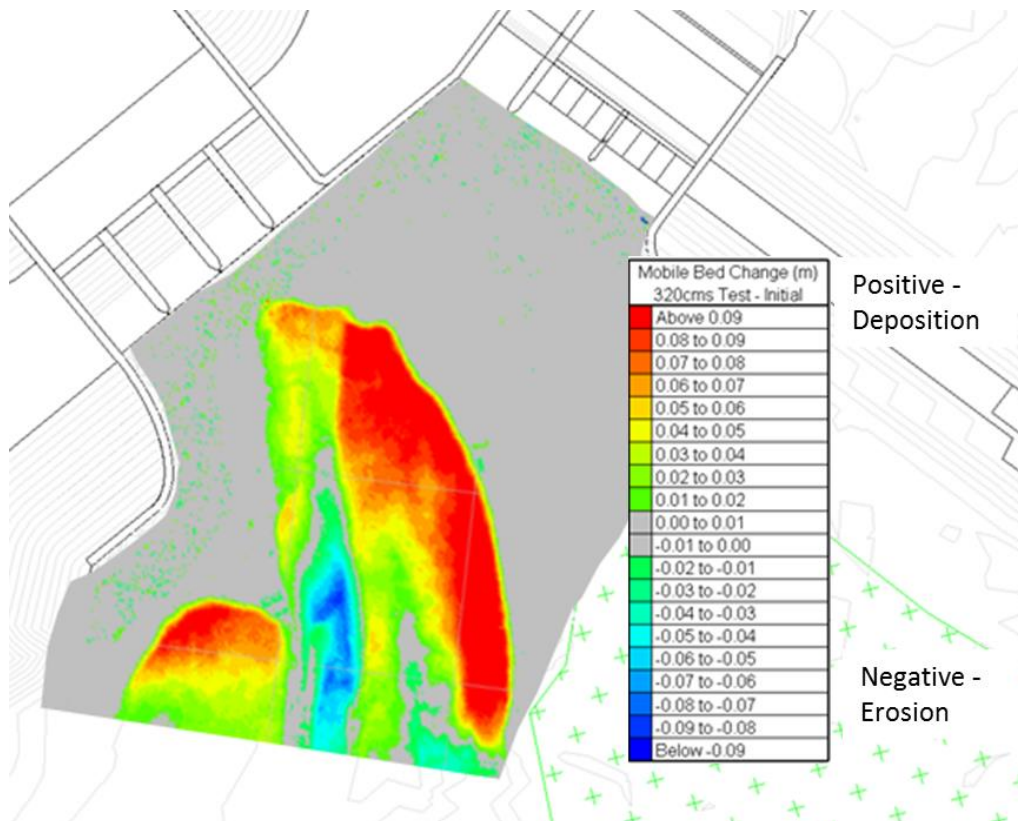
The map of bed elevation in the forebay area derived from the 3D laser scans taken after the experiment is presented in Figure 107, while Figure 108 shows the change in bed elevation due to the 320 m<sup>3</sup>/s flood. In Figure 108 hot colours (oranges and reds) indicate deposition and cool colours indicate erosion. (Note that all elevations in these figures are in model scale meters.) These images clearly show the zone of erosion that formed between the two large lobes of deposition. The scan data indicates that the elongated right dune reached a height of 1.6m (0.1m model scale) above the surrounding bed elevation while the left dune was slightly lower.

Figure 108. Change in bed elevation in the forebay area during the 320 m<sup>3</sup>/s flow condition.

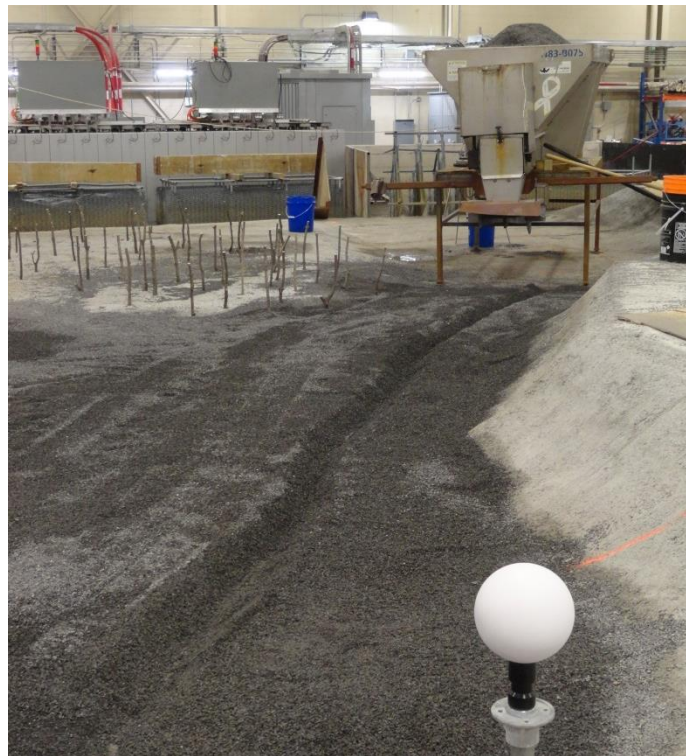
In preparation for the next experiment with 760 m<sup>3</sup>/s discharge, the main and secondary upstream river channels were again pre-loaded with sediment while the sediment in the forebay area was left untouched. The new sediment was placed to achieve a smooth transition between existing and new material; hence the sediment depth was not always spatially uniform. Moreover, a pilot channel was formed in the bed of the main river channel as seen in Figure 109.

The battery-powered spreader was re-filled with new sediment and moved to the upstream part of secondary channel, and the larger B750 spreader was filled and positioned in the upper part of the main flow channel (see Figure 109). The opening for the B750 spreader was set to the small setting and the opening for the battery powered spreader was set to the medium opening (to avoid seizing the spreader) providing an expected full scale loading rate of approximately 720 kg/s for the B750 spreader and 500 kg/s for the battery powered spreader.

Figure 109. “Pilot channel” formed in the bed of the main river channel.

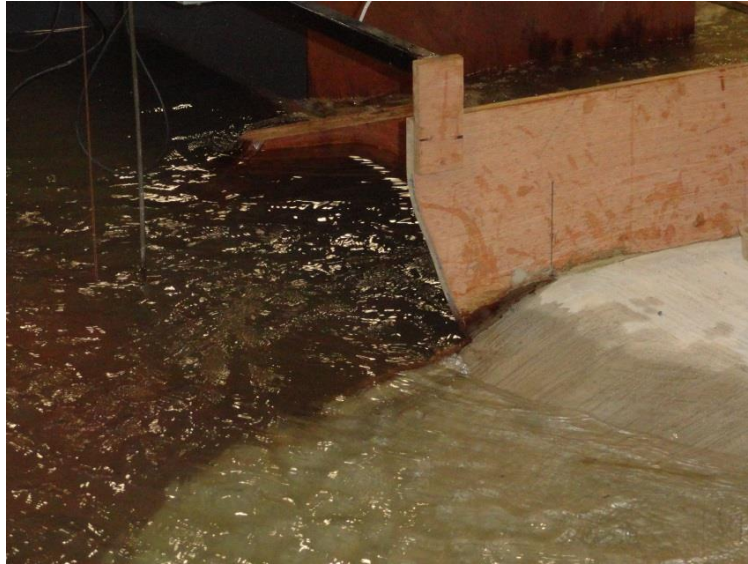
The structure gate settings were set as described in Section 5.1.4. A small section of the retaining wall at the right hand entrance to the service spillway was cut out before testing began to improve flow conditions at the service spillway entrance (see Figure 110). After first verifying that the 760 m<sup>3</sup>/s flow condition had been reached, the spreaders were run for 136 mins (34 mins model scale) and 184 mins (46 mins model scale) respectively, until the sediment hoppers were empty

Figure 110. Cut-out section of retaining wall at RHS of service spillway.

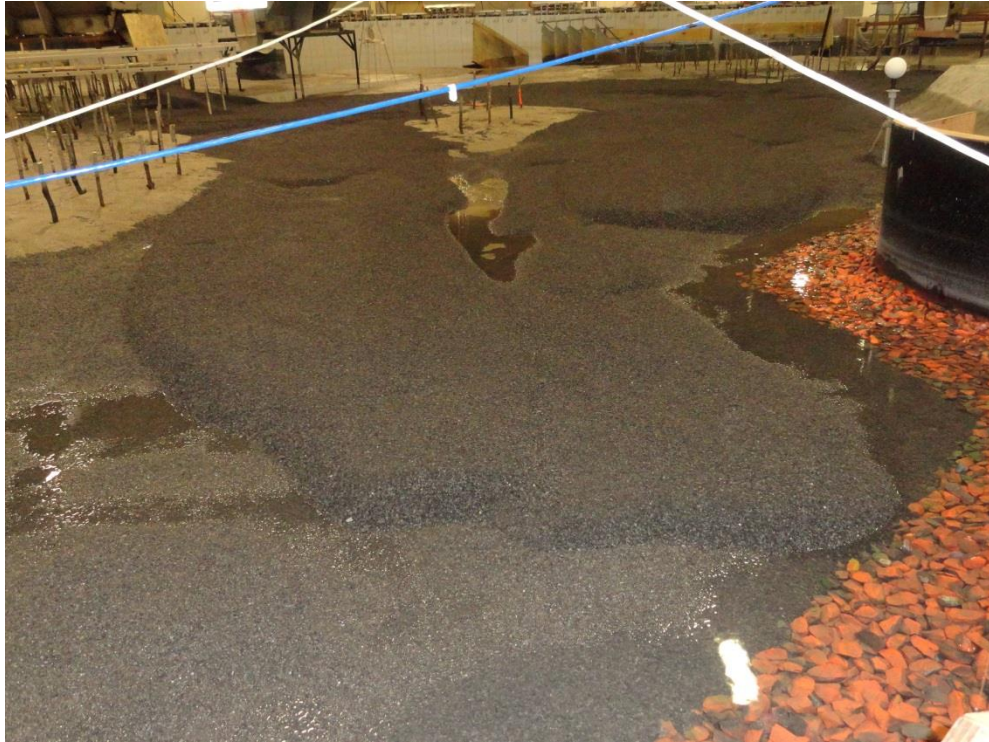
Visual observations during and after testing indicated that there was very little sediment transport and virtually no change in the bed morphology in the forebay area (see Figure 111). Almost all of the sediment delivered by the spreaders remained where it had been deposited by raking and shovelling. These visual observations were confirmed by the 3D scanning results shown below in Figure 112 and Figure 113. The scan results showed some minor changes throughout the mobile bed ranging from 80-176mm (5-11mm model scale), but no significant changes to the mobile bed occurred during the  $760 \text{ m}^3/\text{s}$  flow condition.

Figure 111 shows the mobile riverbed in the forebay area at the end of the experiment with the  $760 \text{ m}^3/\text{s}$  flow condition.

Figure 111. Riverbed in the forebay and upstream areas after the 760 m<sup>3</sup>/s flow condition.

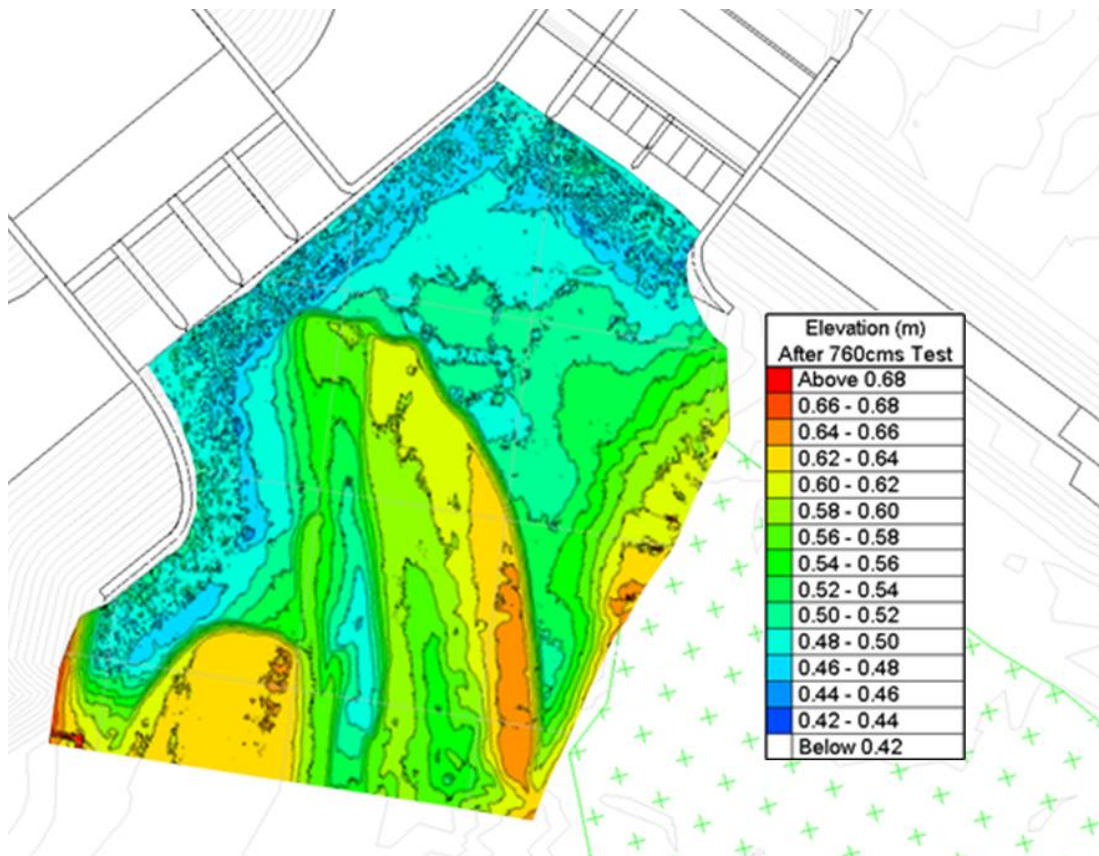
Figure 112. Bed elevation in the forebay area after 760 m<sup>3</sup>/s flow condition.

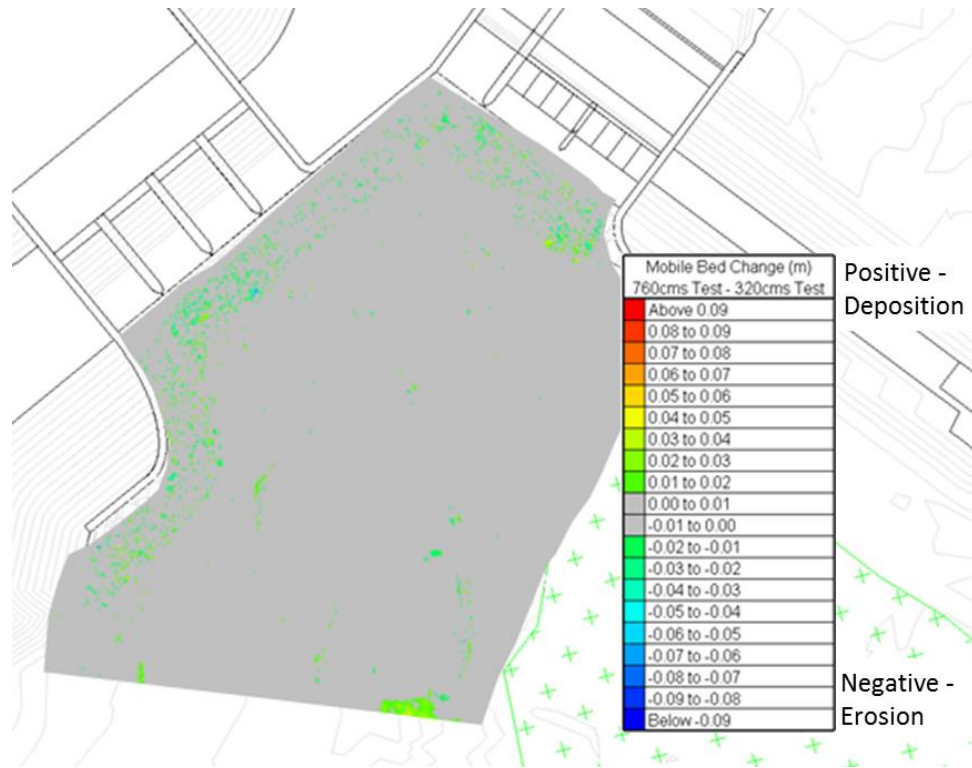
Figure 113. Change in bed elevation in the forebay area during the 760 m<sup>3</sup>/s flow condition.

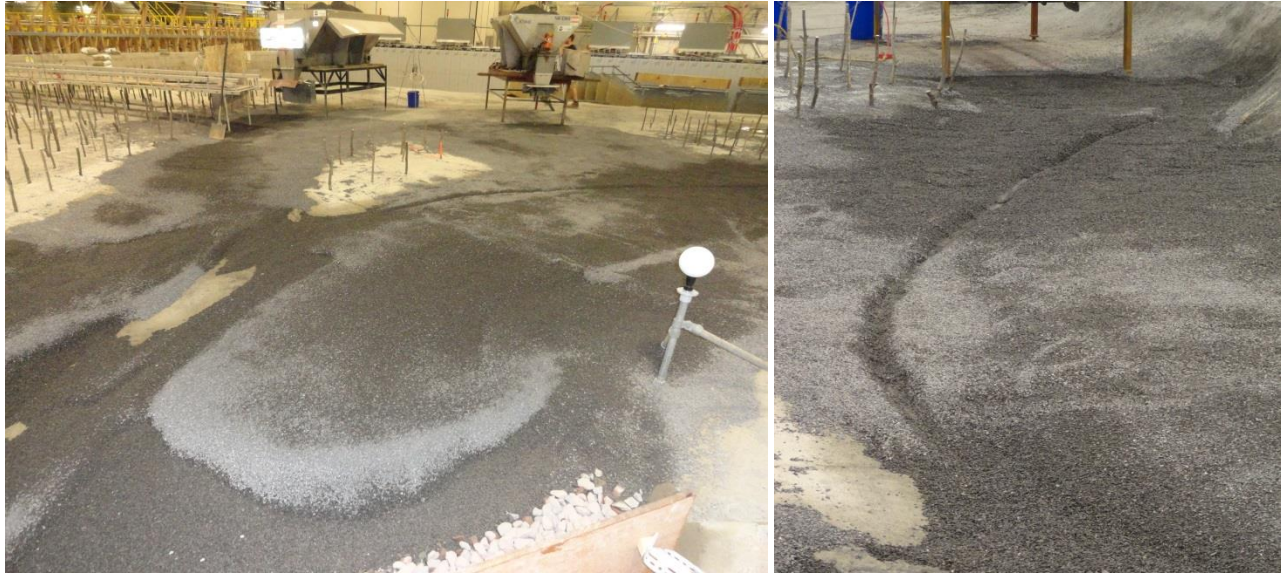
Figure 114. Initial upstream mobile bed conditions prior to the 1240 m<sup>3</sup>/s flow condition.

In preparation for the next experiment with 1240 m<sup>3</sup>/s discharge, the structure gates were configured as described in Section 5.1.5. Some of the sediment that was deposited in the upstream river channels during the previous test was removed and a quasi-uniform sediment preloading condition was restored (see Figure 114). The sediment in the forebay area was not touched. As before, a small “pilot channel” was formed in the bed of the main (left) upstream flow channel.
