**ALBERTA TRANSPORTATION SPRINGBANK OFF-STREAM RESERVOIR PROJECT  
RESPONSE TO CEEA INFORMATION REQUEST PACKAGE 3, AUGUST 31, 2018**

**APPENDIX IR13-1 NATIONAL RESEARCH COUNCIL CANADA  
PHYSICAL MODEL STUDY REPORT**

## Physical Model Study of the Springbank Off-stream Storage Project Diversion Structure on the Elbow River

Paul Knox, Andrew Cornett, Mitchel Provan  
Ocean, Coastal and River Engineering  
NRC Technical Report: OCRE-TR-2016-028

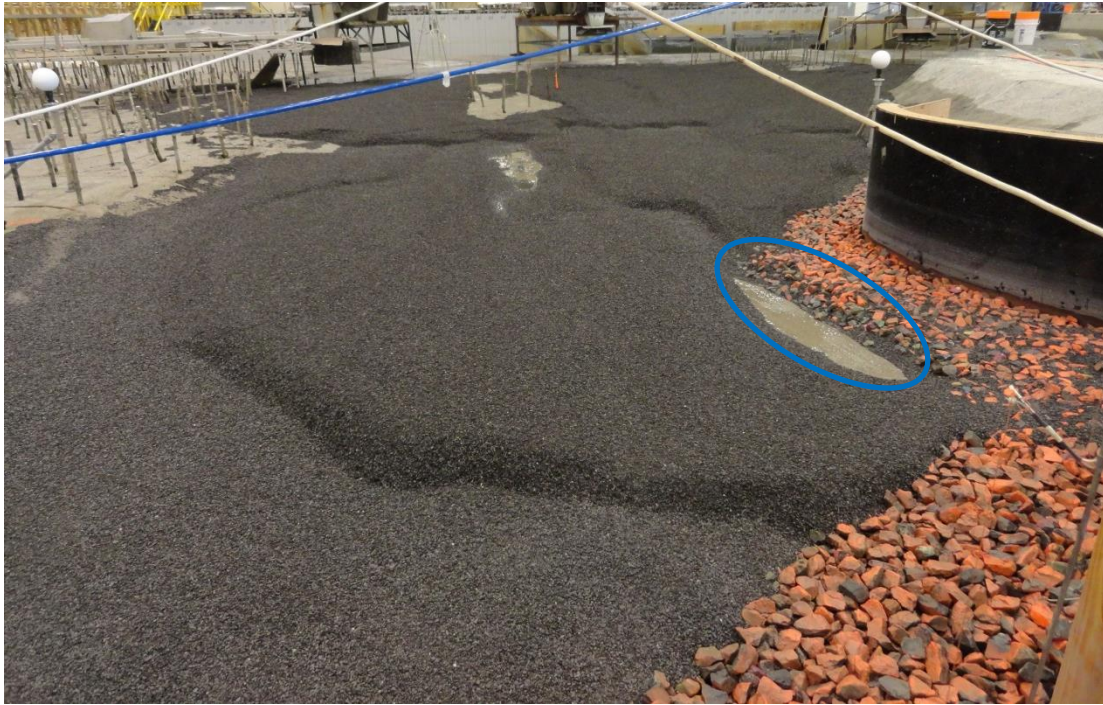
Figure 115. General view of the mobile bed in the forebay area after the 1240 m<sup>3</sup>/s flow condition (new scour hole highlighted).

Figure 115 shows the general condition of the riverbed in the forebay area at the end of testing. During the most recent test a sizeable new scour hole was formed beside the edge of the riprap apron protecting the toe of the curved guide wall on the LHS of the diversion inlet structure (see Figure 116). Some of the sediment eroded from this scour hole was deposited on the surrounding riprap apron, while a small quantity was also transported to the downstream side of the diversion inlet structure. The riprap itself did not appear to have been damaged in this area. While the riprap remained stable at the diversion inlet structure, the 1240 m<sup>3</sup>/s flood was able to dislodge approximately eighteen 440 kg stones from the riprap on the RHS of the service spillway structure, forming a scour hole in that location, see Figure 117. The 1240 m<sup>3</sup>/s flow condition was the only flow condition that transported any appreciable quantity of sediment through the two structures; however, the volume

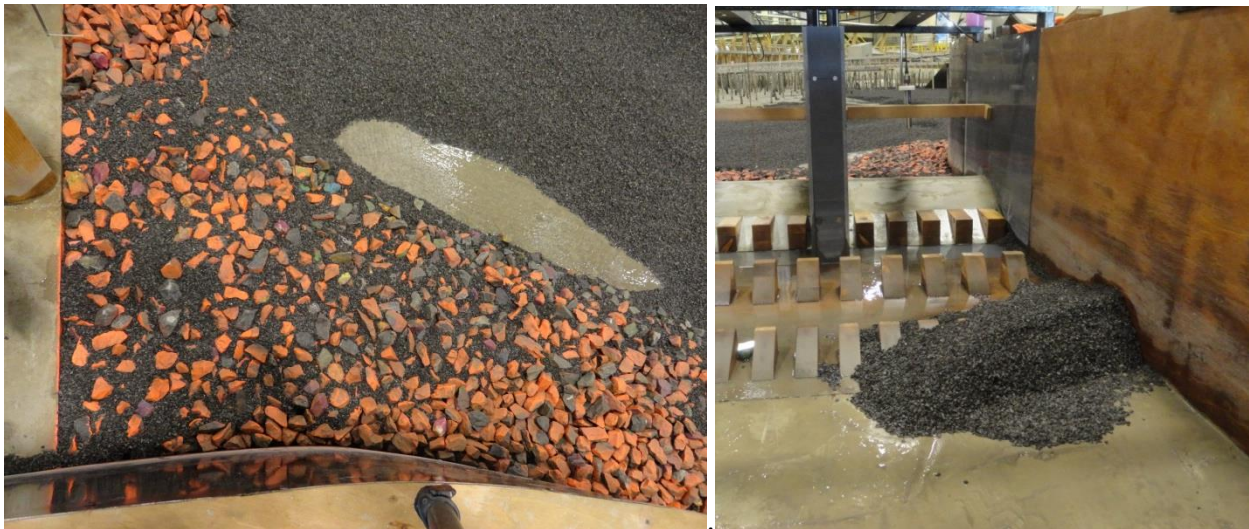
Figure 116. Scour hole on the upstream side of the diversion inlet structure (left) and corresponding sediment deposition on the downstream side (right).

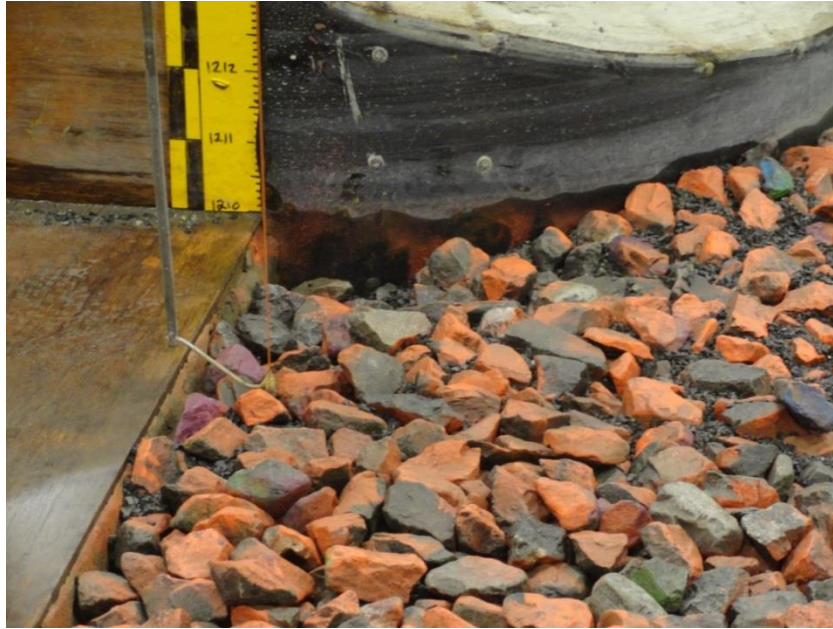
Figure 117. Scouring of the 440kg rip-rap at RHS of the service spillway inlet.

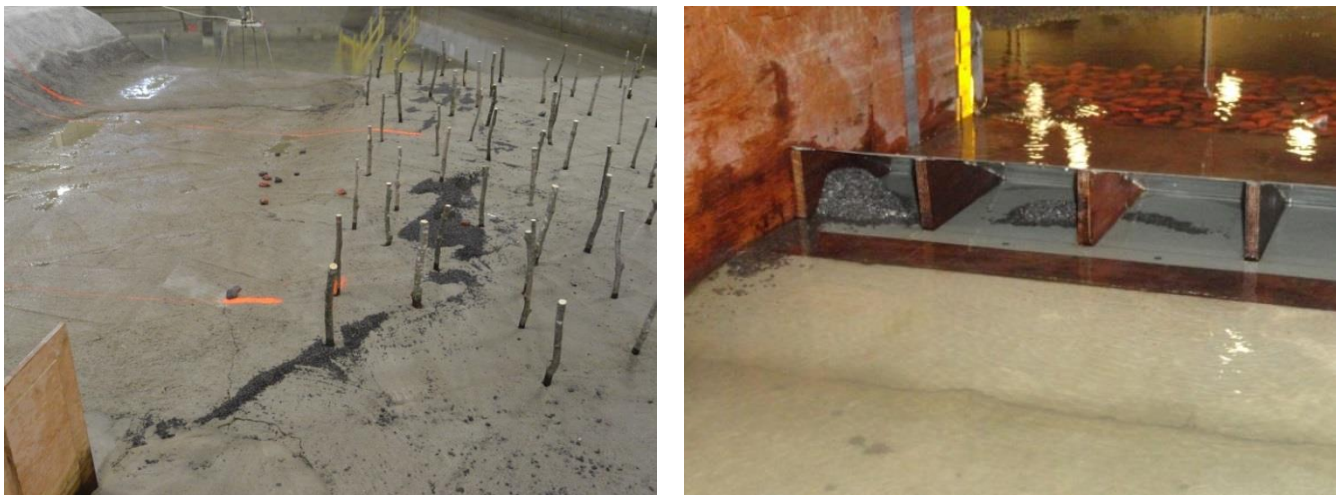
Figure 118. Sediment deposited downstream of the service spillway structure along the RHS of the channel (left) and underneath the Obermeyer gates (right).

of sediment passing either structure was very small. Figure 118 shows the small amount of sediment that was discovered beneath the service spillway Obermeyer gates and along the RHS of the river channel downstream of the service spillway.

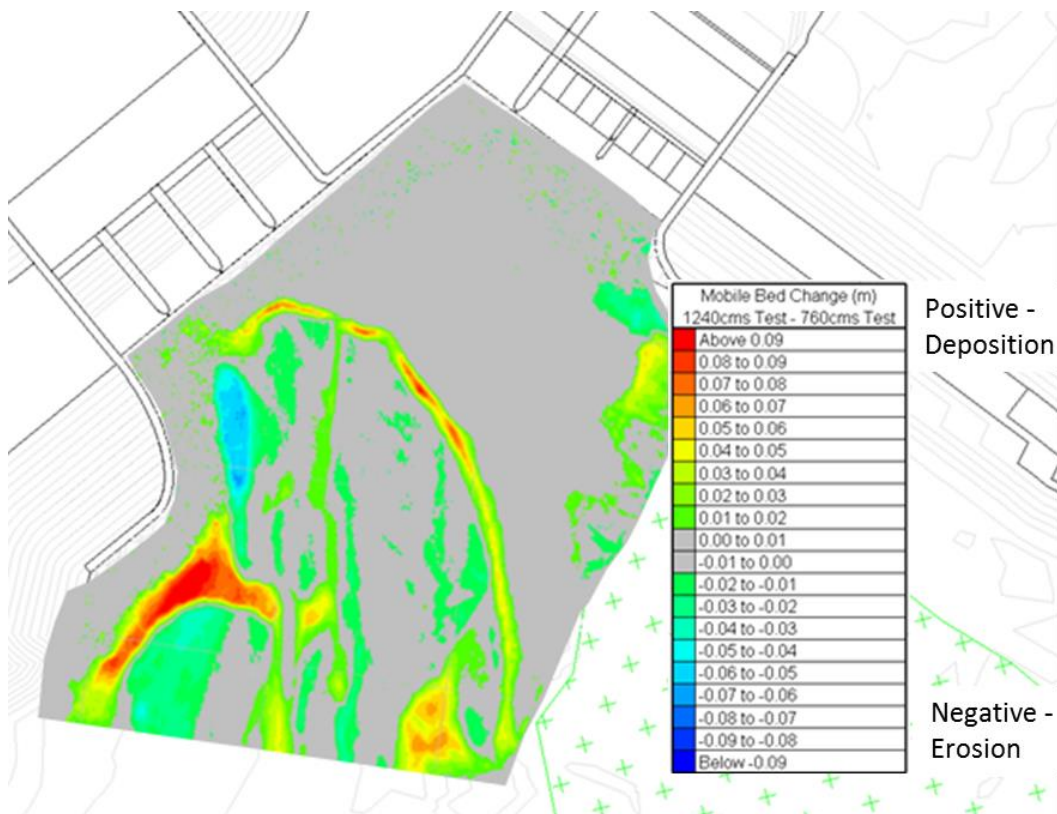
Figure 120. Change in bed elevation during the 1240 m<sup>3</sup>/s flow condition.

The final bed elevation in the forebay area is shown in Figure 119 while the change in forebay bed elevation due to the  $1240 \text{ m}^3/\text{s}$  flow condition alone is shown in Figure 120. Finally, the cumulative change in forebay bed elevation produced by the three floods is presented in Figure 121. The large elongated lobe of sediment originally deposited in the forebay area during the  $320 \text{ m}^3/\text{s}$  flow condition migrated a bit further downstream (less than 2 full scale meters) so that it now overlaps the upstream edge of the riprap in front of the diversion inlet structure (see Figure 115 and Figure 120). The other large lobe of sediment that had previously formed in the lower part of the left river channel also migrated slightly further downstream. As shown in Figure 120, elevation of these deposits did not appear to change in any significant way.

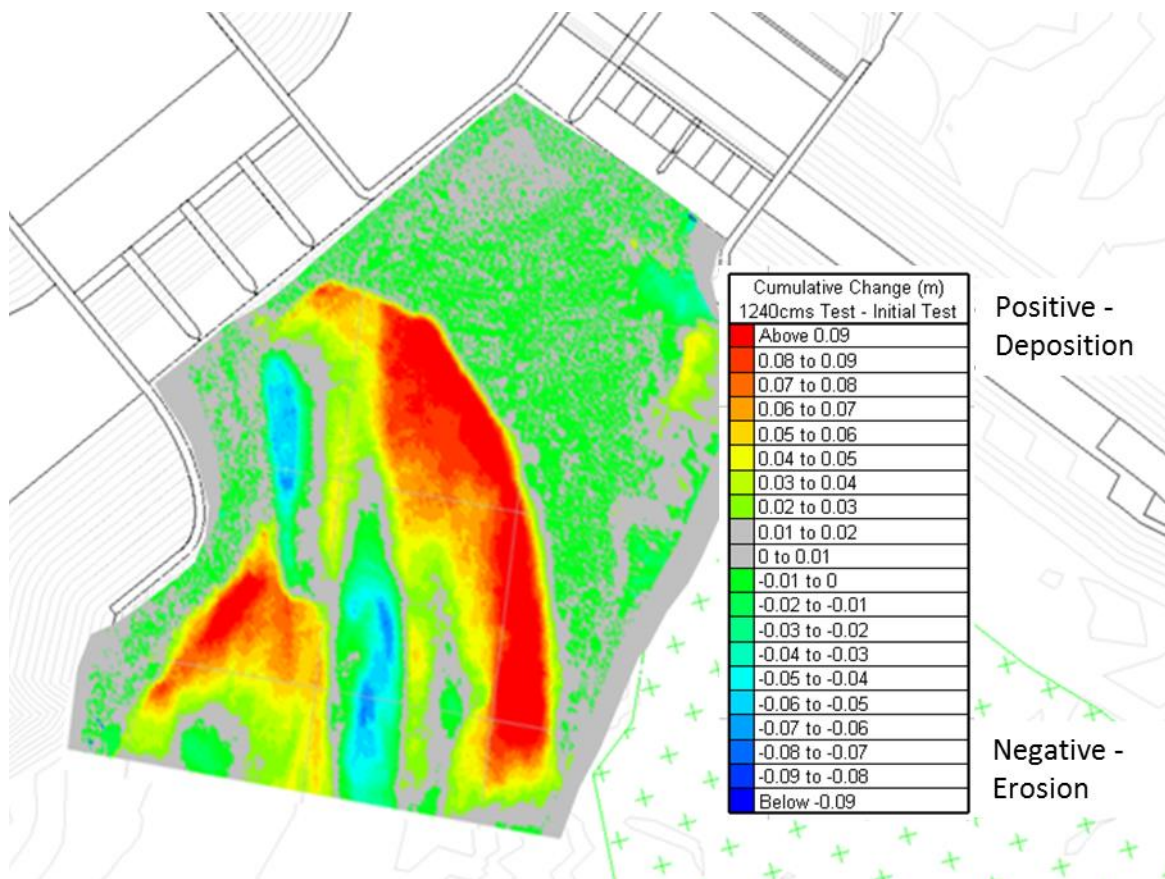
Figure 121. Cumulative change bed elevation during experiments with 320, 760 and 1240 m<sup>3</sup>/s discharge.

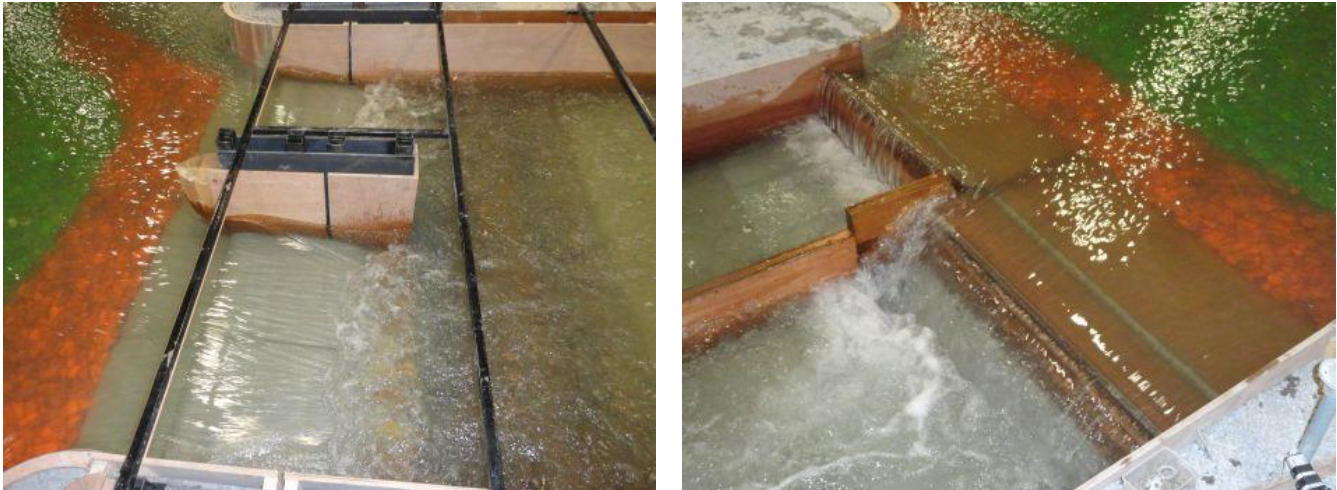
Figure 123. Flow conditions at the structure during the 760 m<sup>3</sup>/s event with the Obermeyer gates set to 1213.4m (LHS) and 1215m (RHS). Left - facing southwest at the diversion, right - facing southeast at the service spillway.

The pier nose 1 design drawings are shown in Section 3.4.3.3, and the main characteristics feature a curving arrow-head plan-shape with the apex of the point being 3.5m upstream of the front of the diversion/breast wall. Figure 123 shows pictures of the flow conditions at the diversion inlet and the service spillway. There was a slight wake on the RHS of the diversion inlet stemming from pier nose 1, however the hydraulic jump was relatively stable on both sides of the pier. On the service spillway, water barely spilled over the RHS gate as it was set to 1215m, and the waterfall was more energetic on the LHS.

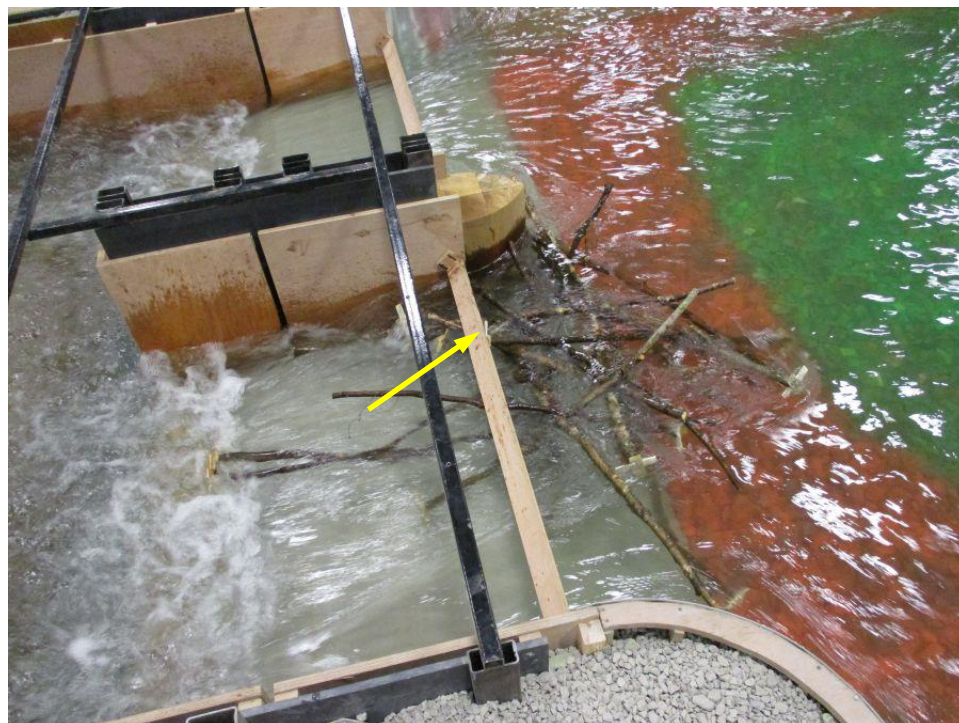
Figure 124. Debris collecting on Pier Nose 1 and root wads catching on the breast wall (arrow).

Debris was deployed at several points in the floodplain and tracked through the model. Again, refer to Figure 122 for the debris insertion locations and pathways, and Table 13 presents a summary the debris tests for pier nose 1. Model trees placed in the main river channel west of the small island of trees (locations A-C) passed through the LHS of the diversion, while debris inserted to the north of the small tree island (D) or in the secondary channel (E) passed through the RHS of the diversion. A percentage of the trees were caught in the pier nose, particularly those from the larger debris rafts (packs of 10 and 40 trees). The trees and their roots were caught on the pier nose itself as well as the breast wall (see Figure 124). The close proximity of the pier nose apex and the breast wall provided an area where a piece of debris could bridge and catch at two points simultaneously. The model representation of the breast wall was simply a flat piece of plywood set to the correct elevation. The sharp edges of the model plywood breast wall likely contributed to catching onto the root wads. Since the prototype breast wall is curved, the model breast wall was replaced with a 4" diameter (model scale) section of pipe after this test series (see Figure 125).

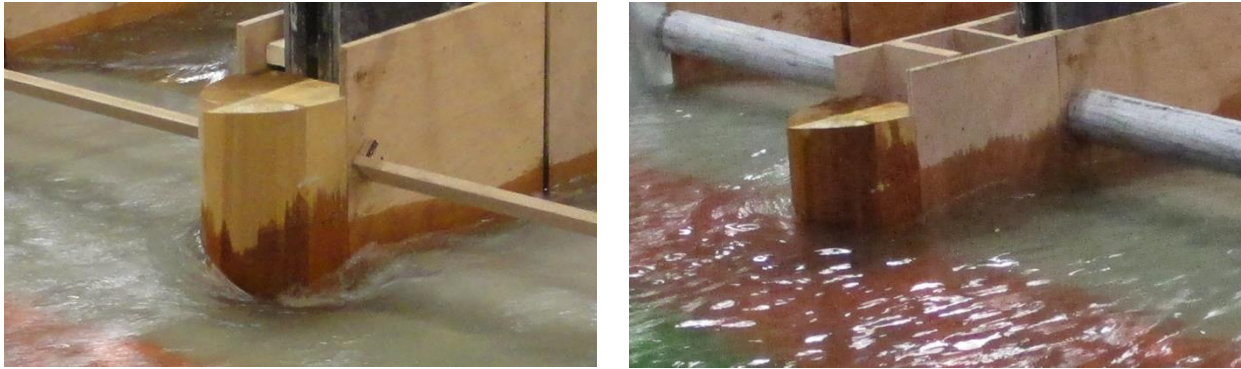
Figure 125. Flat breast wall on Pier Nose 1 (left) and curved breast wall (right) used for all future debris tests (Pier Nose 2 shown).

Design sketches for pier nose 2 are shown in Section 3.4.3.3. This structure re-uses the nose from pier nose 1 however the apex of the pier nose was offset 6m upstream placing it 9.5m upstream of the breast wall (see Figure 125 for a comparison). Figure 126 presents the flow conditions at the diversion channel and the service spillway. The flow conditions in each section of the diversion inlet were similar - there was a slight wake on the RHS of the diversion inlet stemming from pier nose 2, however the hydraulic jump was relatively stable on both sides of the pier. On the service spillway the flow patterns were the same as with pier nose 1 - water trickled over the higher RHS gate, and the waterfall was more energetic on the LHS.

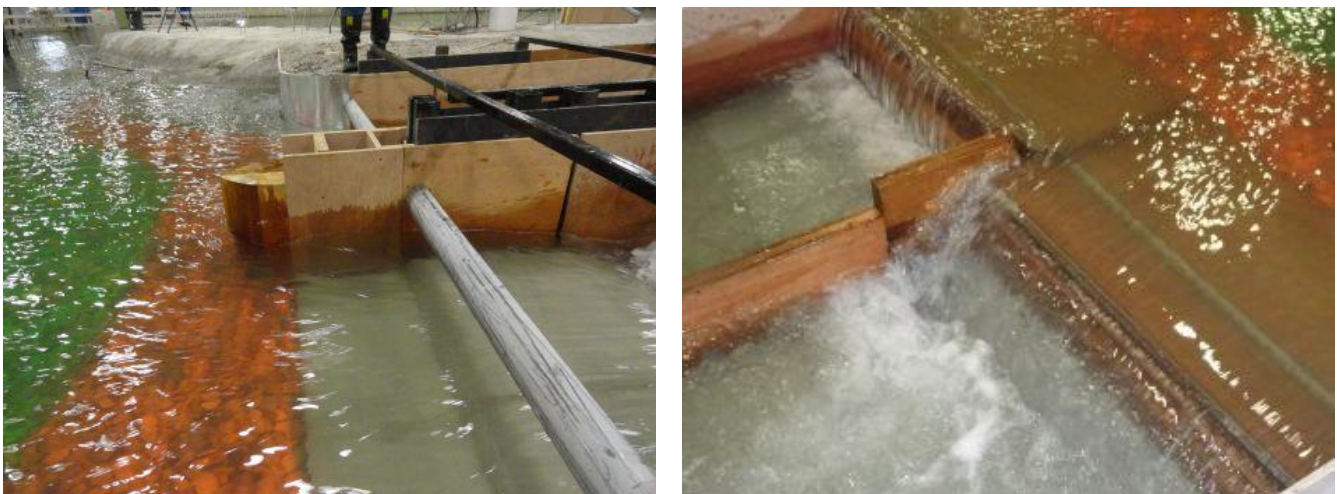
Figure 126. Flow conditions at the structure during the 760 m<sup>3</sup>/s event with the Obermeyer gates set to 1213.4m (LHS) and 1215m (RHS) and Pier Nose 2 installed. Left - facing southwest at the diversion, right - facing southeast at the service spillway.

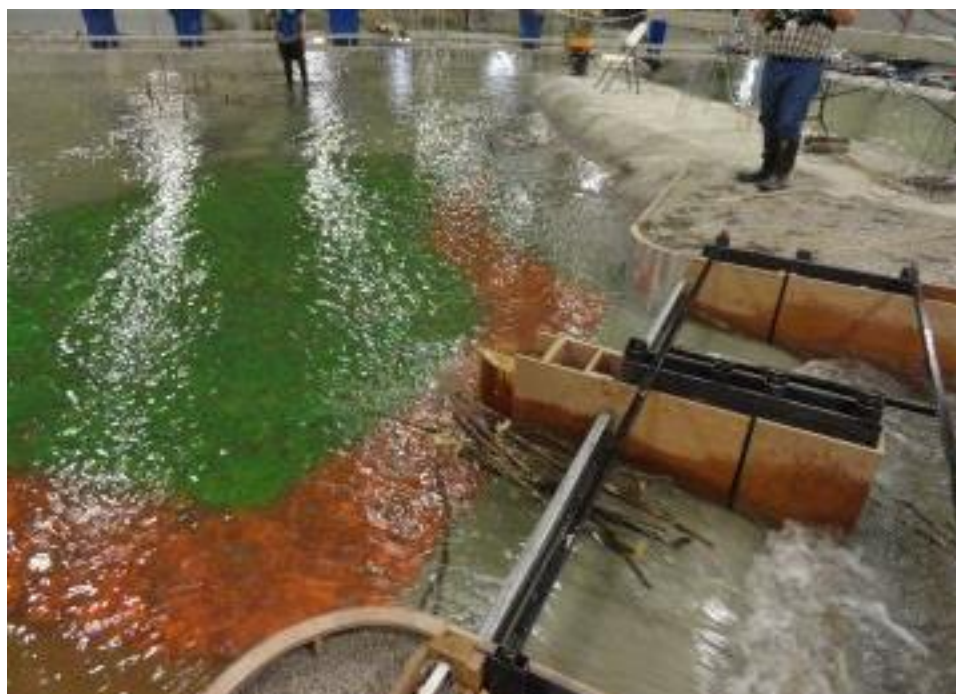
Figure 127. Debris pivoting around Pier Nose 2 while passing through the diversion.

As before, debris was deployed at several points in the floodplain and tracked through the model. Again, refer to Figure 122 for the debris insertion locations and pathways and Table 14 shows a summary of the debris behaviour and performance of the structures in the model with pier nose 2 installed in the diversion. Pier nose 2 was much more effective at passing the debris as no trees remained stuck on the pier during the testing (they only stalled on the pier nose for a short time). Since the apex of pier nose 2 was 6m further upstream than pier nose 1, and the breast wall now a truer curved representation of the prototype, the trees from these debris tests pivoted around the pier nose and passed through the diversion inlet without catching on the breast wall (see Figure 127).

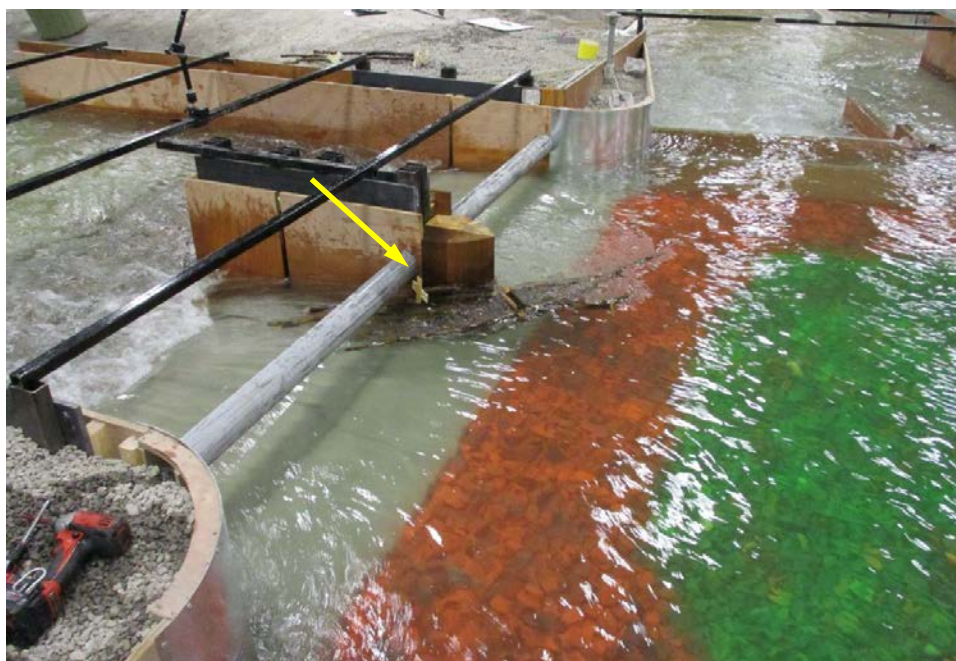
Figure 128. Debris collecting on Pier Nose 1 and root wads catching on the curved breast wall (arrow).

Pier nose 1 was re-installed on the model to see if the new curved breast wall improved its performance. Table 15 shows the fate of a 40-tree raft released from the central channel in the floodplain (position D). Less debris was collected on the pier nose than with the original pier nose 1, suggesting the new breast wall offered some improvement, but it did not perform as well as pier nose 2. A percentage of the debris still remained caught on the nose and bridged over to the breast wall (see Figure 128).

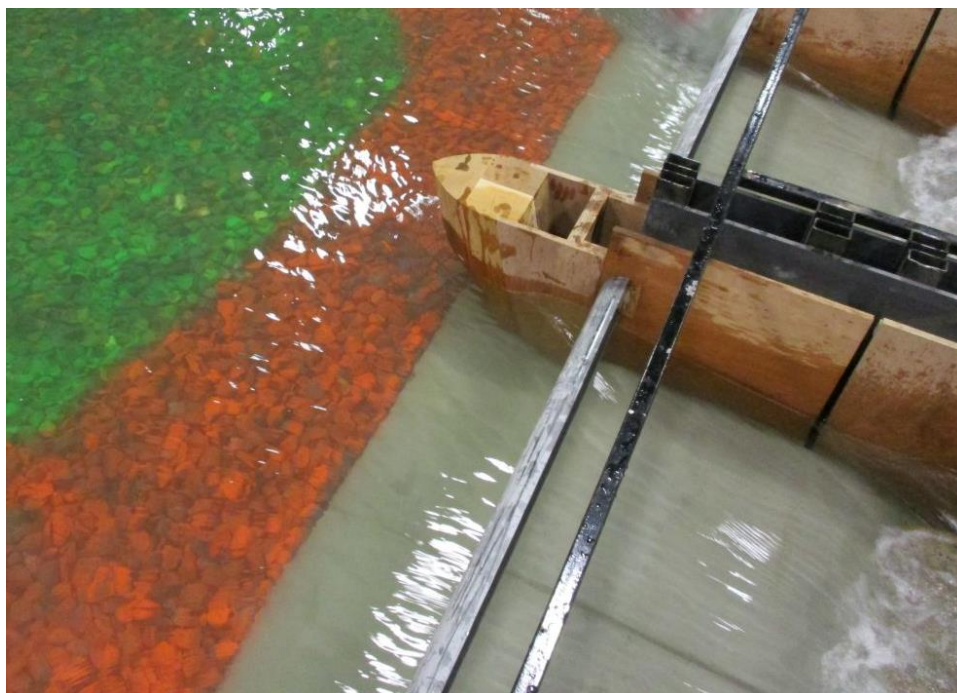
Figure 129. Flow conditions at the diversion inlet with Pier Nose 3 installed.

Design sketches for pier nose 3 are shown in Section 3.4.3.3. This nose featured the same curved arrowhead plan-shape of pier nose 1 and 2, however the profile is set on an adverse 1:4 slope. Therefore the apex is 8m upstream of the breast wall at the top of the pier nose and 6m upstream of the breast wall at the base. Figure 129 shows pictures of the flow conditions at the diversion inlet with pier nose 3 installed. The flow conditions at the diversion inlet and the service spillway were similar to those seen with pier nose 2.

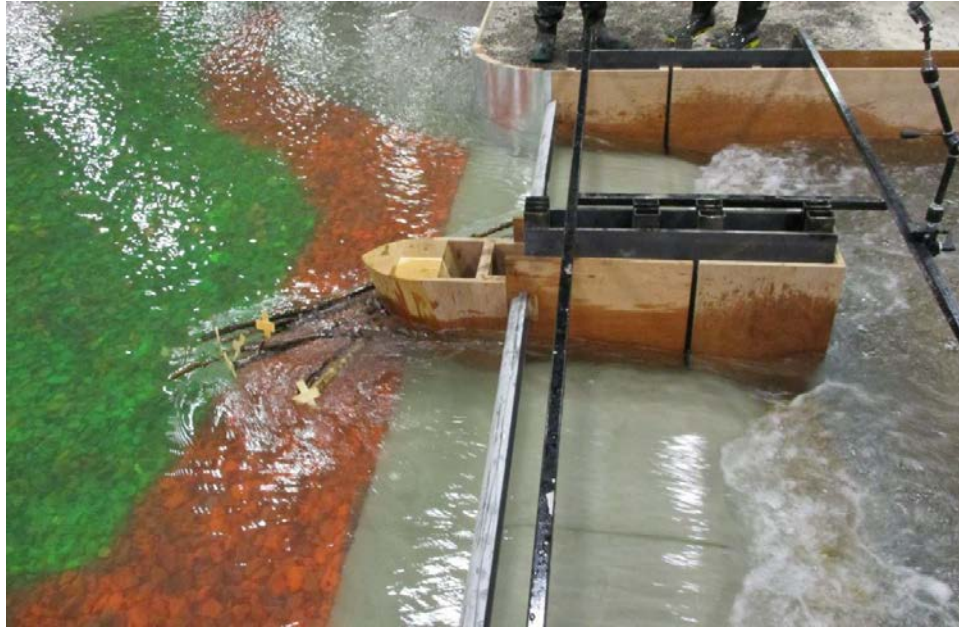
Figure 130. Debris caught on Pier Nose 3.

As before, debris was inserted at several points in the floodplain and tracked through the model. Again, refer to Figure 122 for the debris insertion locations and pathways. Table 16 shows a summary of the debris behaviour and performance of the structures in the model with pier nose 3 installed in the diversion. Pier nose 3 outperformed pier nose 1, and was similar to pier nose 2 (the nose being further upstream and away from the breast wall) in terms of its ability to pass debris through the diversion. However, material released at the north of the small tree island (location) collected on pier. Since the nose had an adverse slope, debris rode down the face of the nose and became wedged below the water surface (see Figure 130).

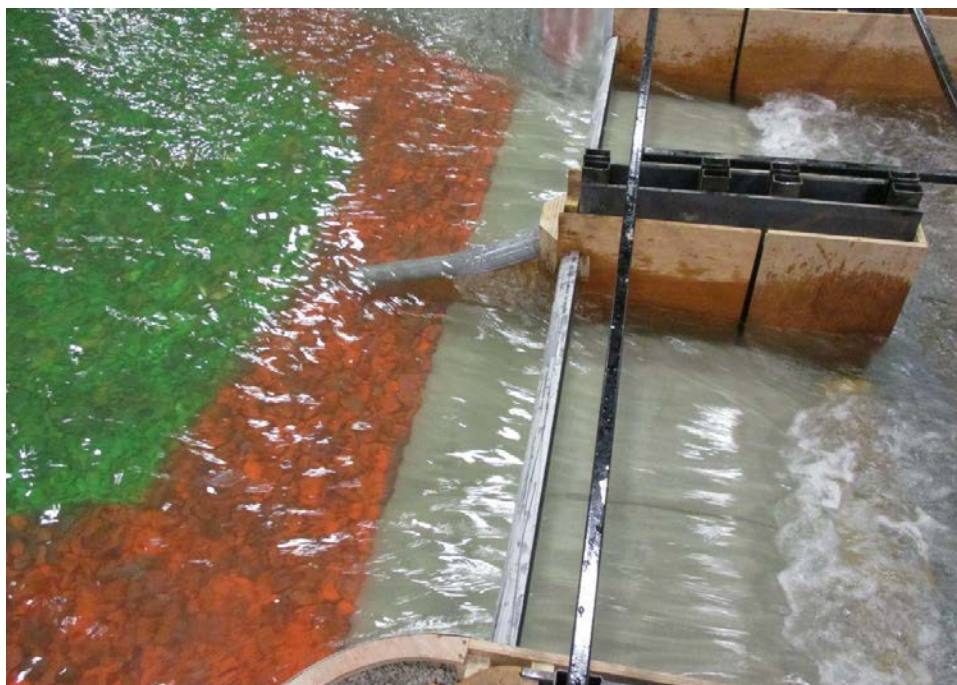
Figure 131. Flow conditions at the diversion inlet with Pier Nose 4 installed.

Designs for pier nose 4 are shown in Section 3.4.3.3 and it featured a semi-circular and narrower outer nose section that rose at a 2:1 slope. The bottom and top ends of the pier nose are 12m and 1m upstream of the breast wall, respectively. Figure 129 shows pictures of the flow conditions at the diversion inlet with pier nose 4 installed. The wake pattern emanating from the pier nose was rougher and more turbulent than that seen with any of the other pier noses, but otherwise the flow conditions at the diversion inlet and the service spillway were similar to those seen previously.

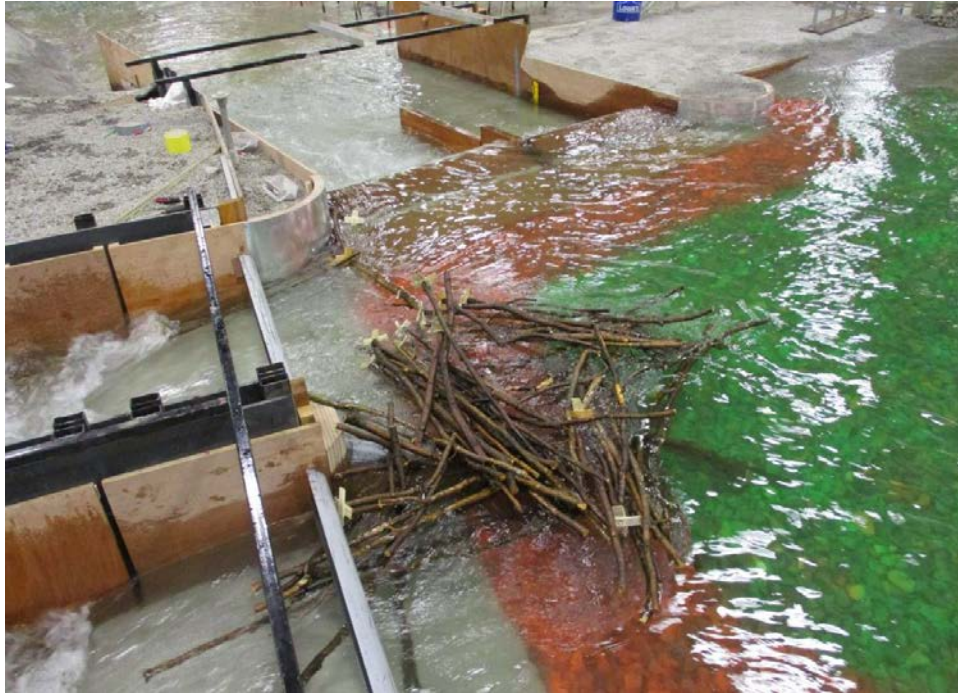
Figure 132. Debris caught on Pier Nose 4.

As before, debris was inserted at several points in the floodplain and tracked through the model. Again, refer to Figure 122 for the debris insertion locations and pathways. Table 17 shows a summary of the debris behaviour and performance of the structures in the model with pier nose 4 installed in the diversion. The sloping pier nose 4 was not effective at passing the tree debris. The trees rode up the sloping nose, and became stuck either directly on the nose or wedged against the breast wall (see Figure 132).

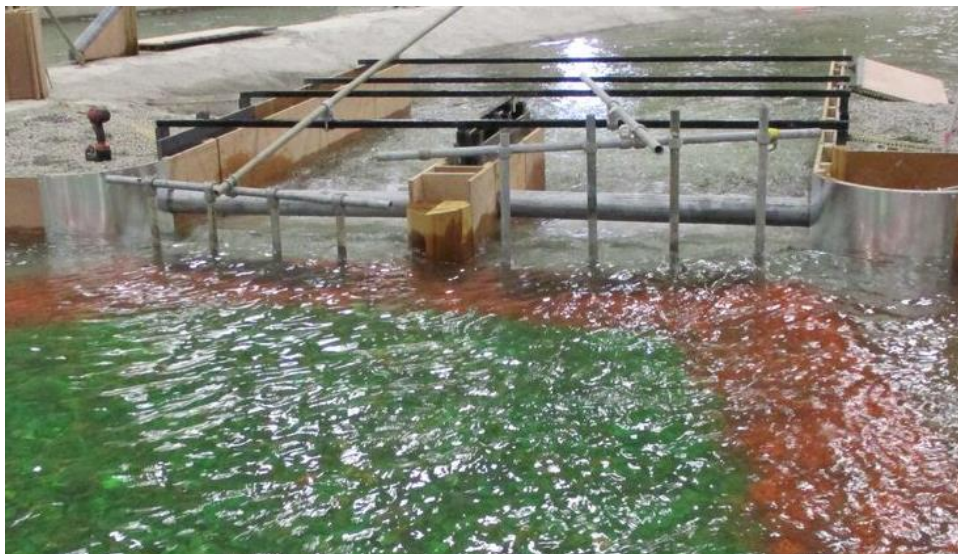
Figure 133. Debris barrier A.

The performance of four debris barriers fronting the diversion inlet was also investigated in test series D, and Section 3.4.3.4 shows the designs and layout of the different barriers. Debris barrier A featured four 600mm piles on 5m spacing across both of the diversion inlet bays spanning from the pier nose to the curved outer retaining walls (see Figure 133). Table 18 shows a summary of the

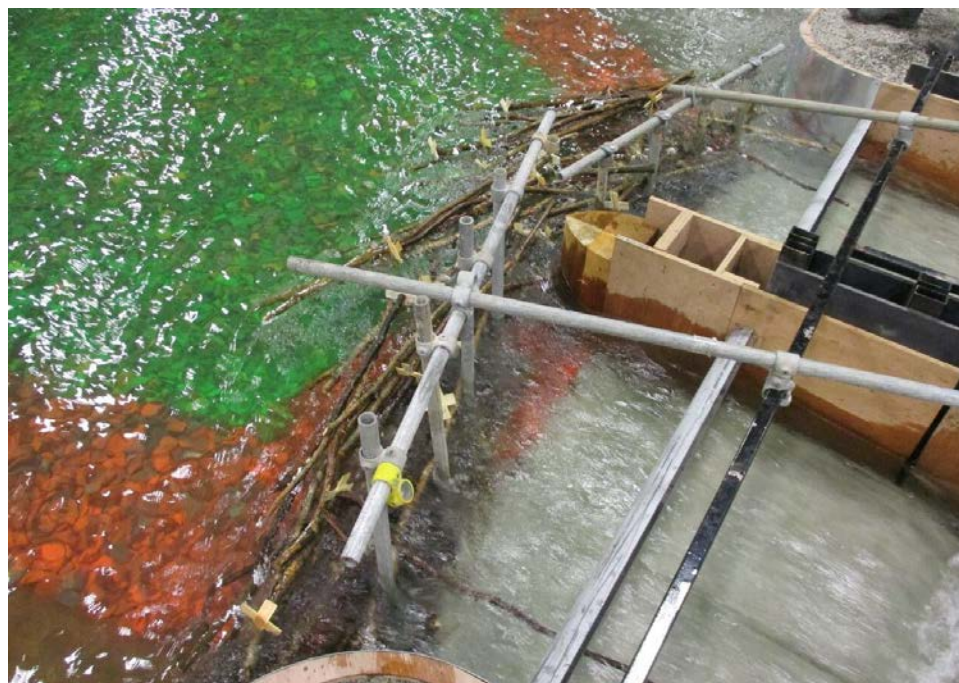
Figure 134. Debris caught on Debris Barrier A.

debris behaviour and performance of this debris barrier (refer to Figure 122 for a schematic showing the debris insertion points and pathways). Single trees from the individually deployed woody debris runs were able to pass through the debris barrier and pass through the diversion, but all of the rafted debris elements were retained on the barrier. At the end of the testing a large debris pile remained on the barrier (see Figure 134), and the 24m (LHS) Obermeyer gate was lowered from 1213.4m to 1210m in an effort to flush the trees from the face of the debris barrier. Only two of the trees were released and the vast debris raft remained intact on the debris barrier. The debris build-up the diversion inlet caused more flow to pass through the service spillway (a re-direction of approximately 40m<sup>3</sup>/s).

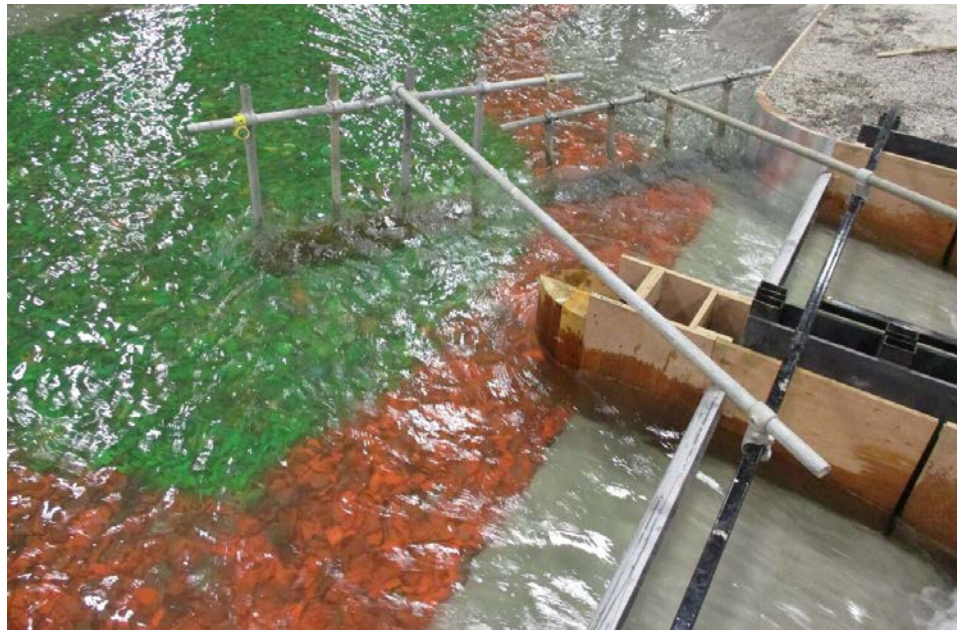
Figure 135. Debris barrier B.

Debris Barrier B utilized the same structure used previously (eight piles at 5m spacing) but the piles were aligned all in one row and set at an angle to the diversion inlet structure (see Figure 135 and refer to section 3.4.3.4 for the design and layout of the barrier). Table 19 shows a summary of the debris behaviour and performance of the debris barrier (refer to Figure 122 for a schematic showing the debris insertion points and pathways). This debris barrier was not as effective as barrier A, as some of the trees released from in front of the small island of trees and in the secondary channel (locations D and E) travelled around the end of the barrier and passed through the diversion. As the debris raft grew in front of the barrier the effective end point shifted to the east as more and more debris piled up in this direction (see Figure 136).

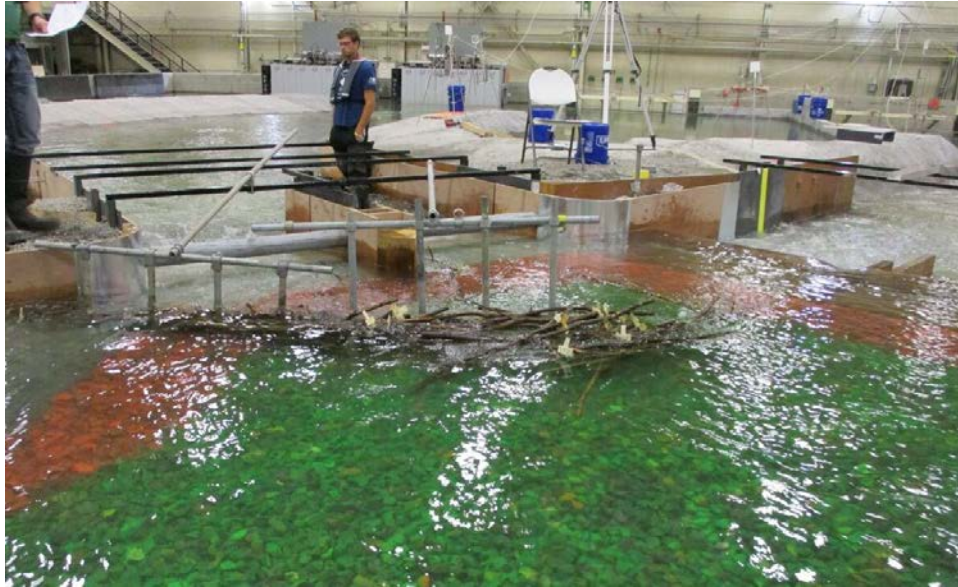
Figure 136. Debris caught on Debris Barrier B.

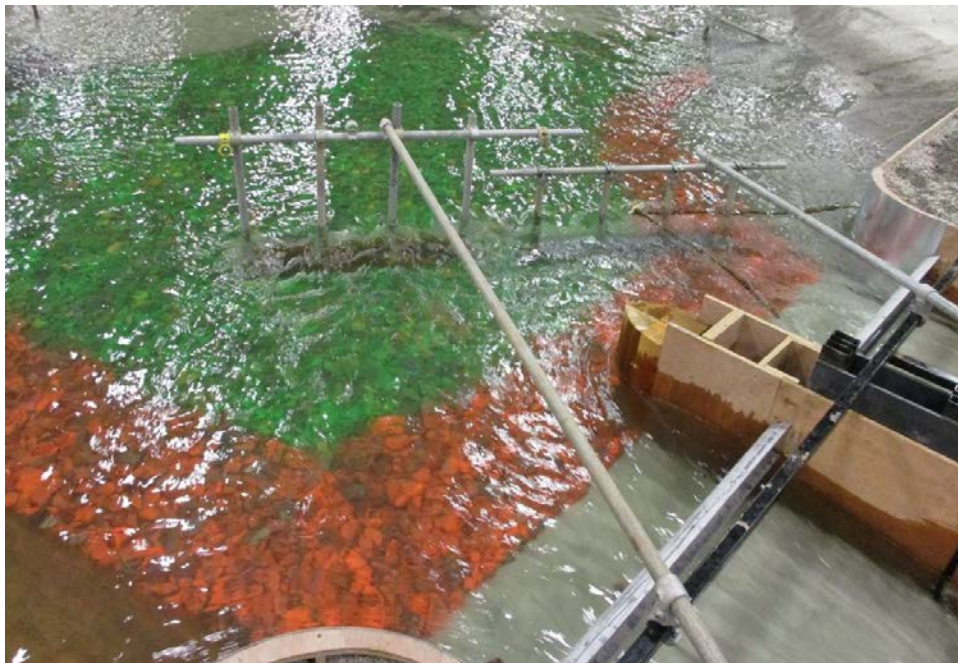
Figure 137. Debris barrier C.

Debris Barrier C utilized the same barrier structure and alignment angle used previously (8 piles at 5m spacing) but the piles were shifted along the alignment toward the southeast end point and leaving a larger gap at the left hand retaining wall of the diversion inlet (see Figure 137 and refer to section 3.4.3.4 for the design and layout of the barrier). Table 20 shows a summary of the debris behaviour and performance of the debris barrier (refer to Figure 122 for a schematic showing the debris insertion points and pathways). As with barrier B the trees released from in front of the small island of trees and in the secondary channel (locations D and E) travelled around the right-hand end of the

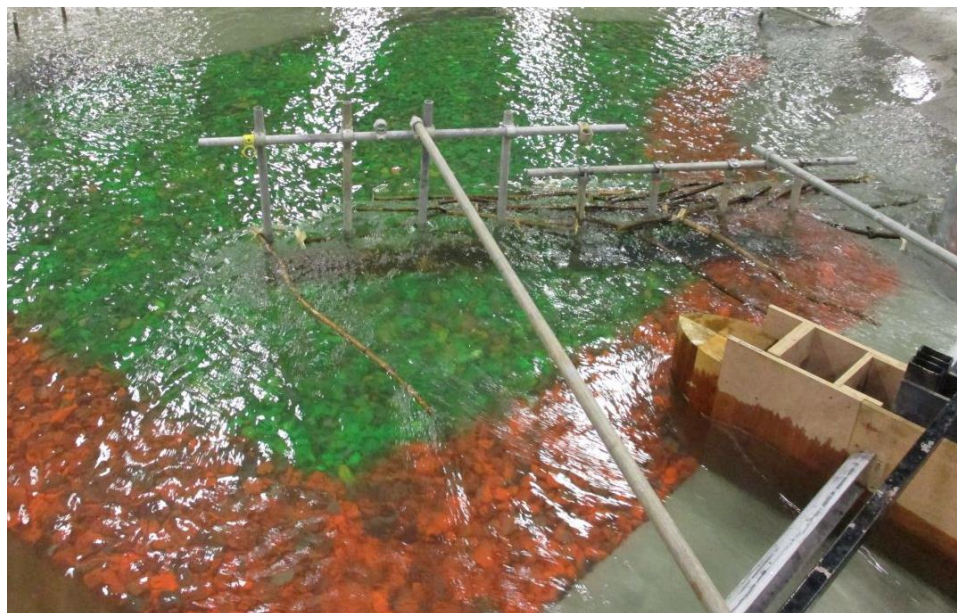
Figure 138. Debris caught on and passing around the end of Debris Barrier C.

barrier and passed through the diversion. As before, the debris raft caught on the barrier grew in length shifting the effective end point of the barrier towards the service spillway, however debris from the secondary floodplain channel still passed around the debris/barrier and passed through the diversion inlet (see Figure 138).

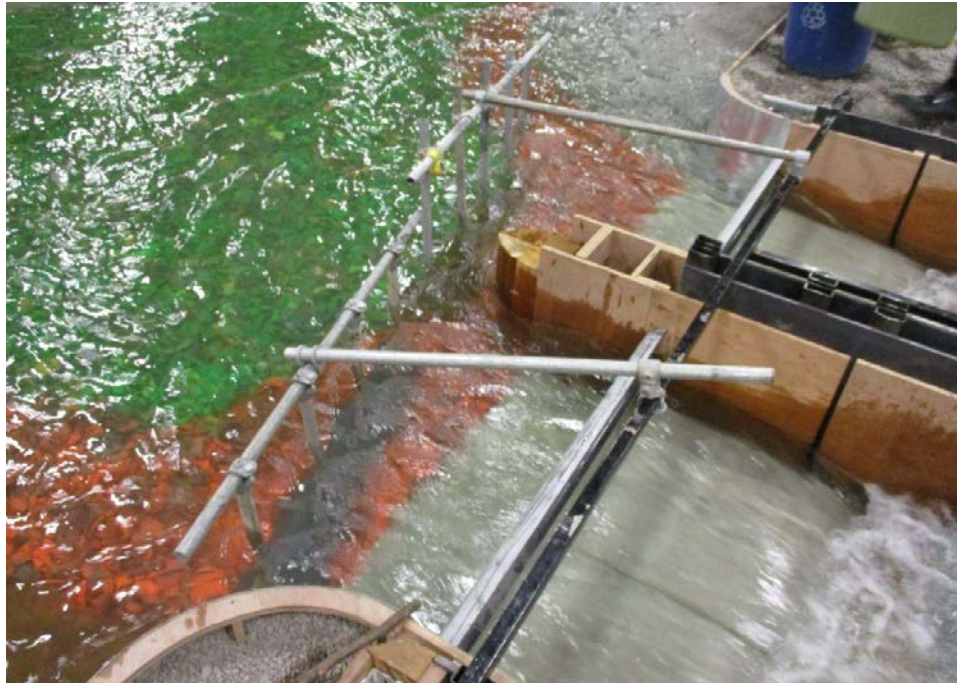
Figure 139. Debris barrier D.

Debris Barrier D utilized a similar barrier structure as before (piles spaced at 5m) however an additional pile was inserted giving nine piles for a 45m total barrier length. The barrier was angled such that it covered the RHS of the diversion inlet entirely and a portion of the LHS (see Figure 139 and refer to section 3.4.3.4 for the design and layout of the barrier). Table 21 shows a summary of the debris behaviour and performance of debris barrier D (refer to Figure 122 for a schematic showing the debris deployment points and pathways). Since the west end of the debris rack did not completely shelter the LHS of the diversion, debris inserted at location A in the main channel bypassed the barrier and passed through the LHS of the diversion. Otherwise, the barrier was effective at collecting the debris at locations B-E. A raft of debris was allowed to collect on the debris barrier and the diversion inlet gates were closed to investigate if the debris could be pulsed off the barrier and pass through the service spillway (see Figure 140). This was successful as only a small percentage (4%) of the trees remained on the barrier after closing the diversion.

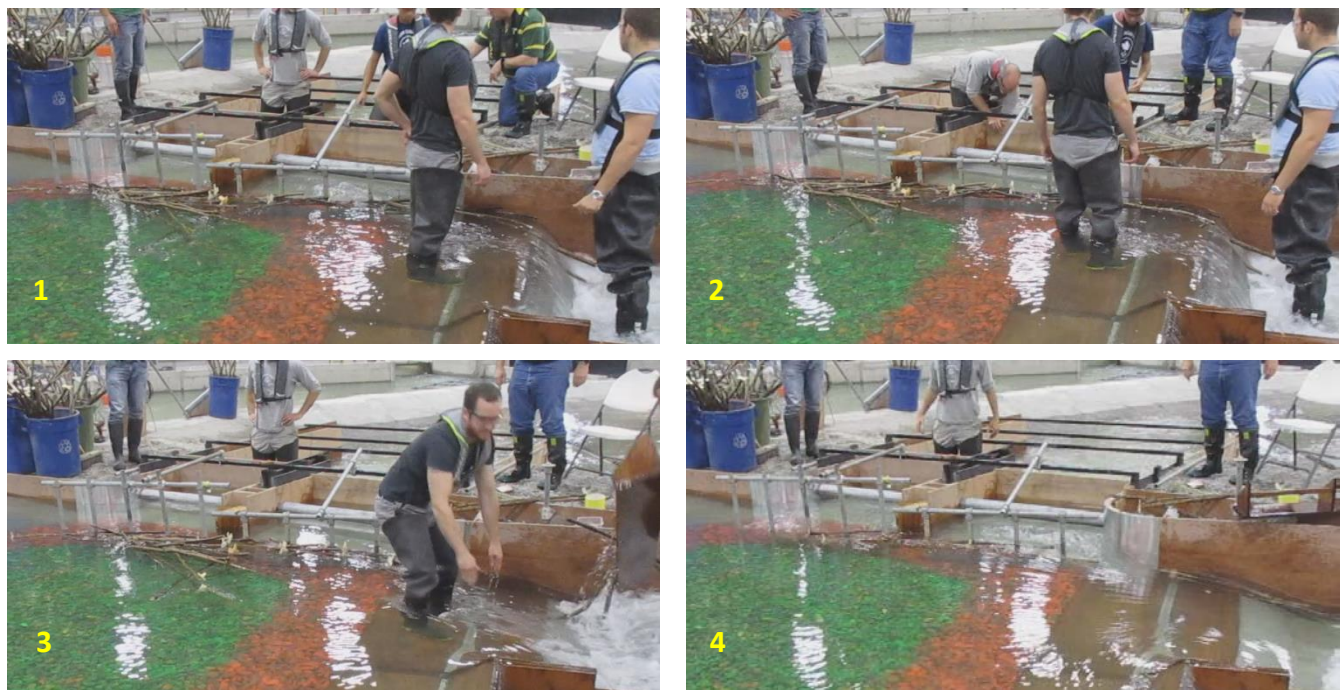
Figure 140. Debris caught on Debris Barrier D , the diversion inlet was closed and LHS Obermeyer gate was lowered to pulse the trees off the barrier.

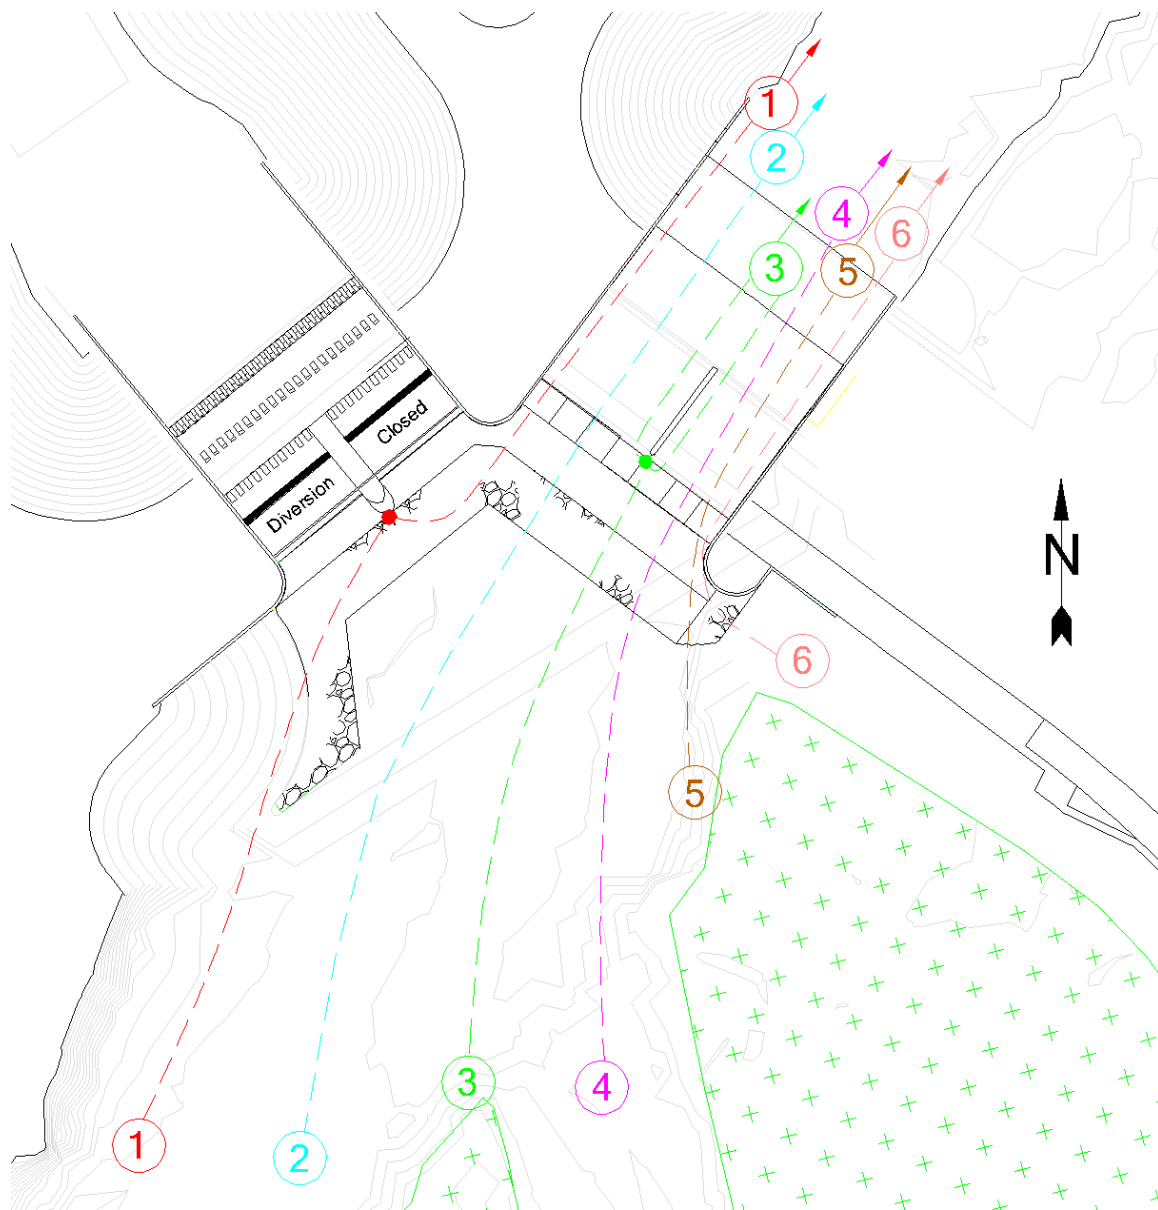
Figure 141. Debris pathways for TSD, 760 m<sup>3</sup>/s flow conditions with the diversion inlet gates closed.

Pier nose 3’s performance was investigated with the diversion inlet gates closed and both of the service spillway Obermeyer gates set to fully open (1210m). As before, the model tree debris was inserted into the model in one of six locations as shown in Figure 141 during the tests.

The split point for the debris to pass down either the LHS or RHS of the service spillway was to the north of the small island of trees in the floodplain (location 3 in Figure 141). The debris did not get caught on the central pier between the Obermeyer gates. With the flood flow restricted entirely to the service spillway, the flow patterns were fairly energetic, and the hydraulic jump on the RHS was relatively unstable as the wake from the central pier combined with the wake emanating from the circular retaining wall on the RHS of the service spillway (see Figure 142).

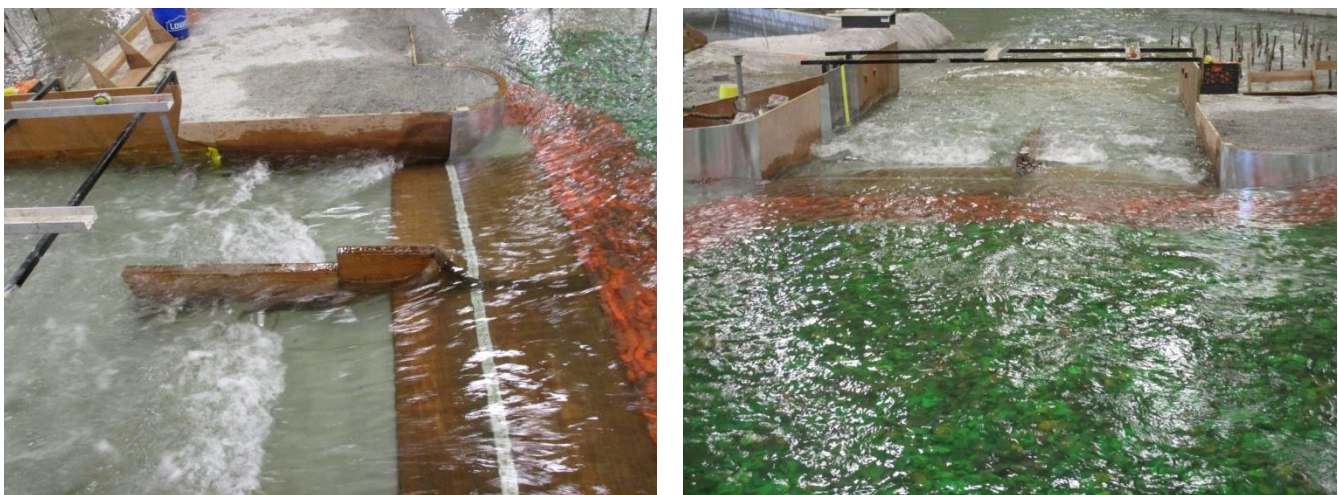
Figure 142. Flow patterns generated in the service spillway with the diversion inlet gates closed at  $760 \text{ m}^3/\text{s}$ .
