**ALBERTA TRANSPORTATION SPRINGBANK OFF-STREAM RESERVOIR PROJECT  
RESPONSE TO CEEA INFORMATION REQUEST PACKAGE 3, AUGUST 31, 2018**

**APPENDIX IR13-1 NATIONAL RESEARCH COUNCIL CANADA  
PHYSICAL MODEL STUDY REPORT**

## Physical Model Study of the Springbank Off-stream Storage Project Diversion Structure on the Elbow River

Paul Knox, Andrew Cornett, Mitchel Provan  
Ocean, Coastal and River Engineering  
NRC Technical Report: OCRE-TR-2016-028

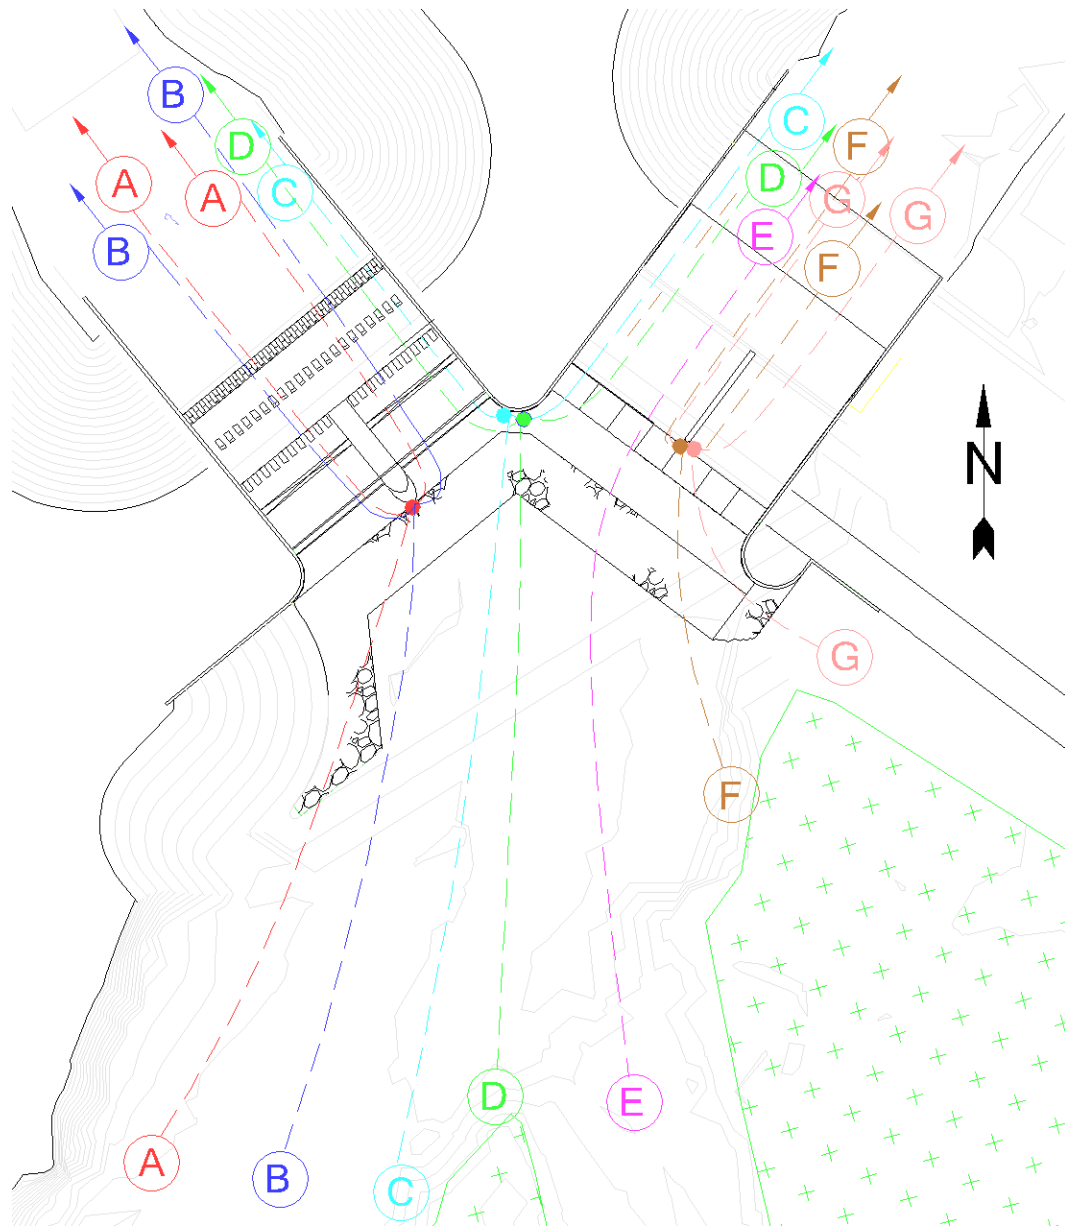
Figure 143. Debris pathways for the 1240 m<sup>3</sup>/s flow conditions with the diversion inlet gates open.

several points in the floodplain and tracked through the model (see Figure 143 for the insertion points and pathways). Table 23 shows a summary of the debris behaviour and performance of the model with pier nose 3 installed in the diversion. In general, the pier nose passed most of the debris through the diversion, with only a small portion of the trees of the 40-pack raft getting caught (see Figure 145).

The performance of Debris Barrier C and Pier Nose 3 under a flood flow of  $1240\text{m}^3/\text{s}$  was investigated (refer to section 3.4.3.4 for the design and layout of the barrier). For this test, approximately 80 trees were already in place on the barrier from the previous tests run at  $320\text{m}^3/\text{s}$  flow. The flow was increased to  $1240\text{m}^3/\text{s}$  and only three trees were removed from the debris raft collected on the barrier (see Figure 149). Additional debris was then inserted in the model in locations D, E, F, and G and the debris paths through the model were noted (see Figure 143 for the debris insertion locations

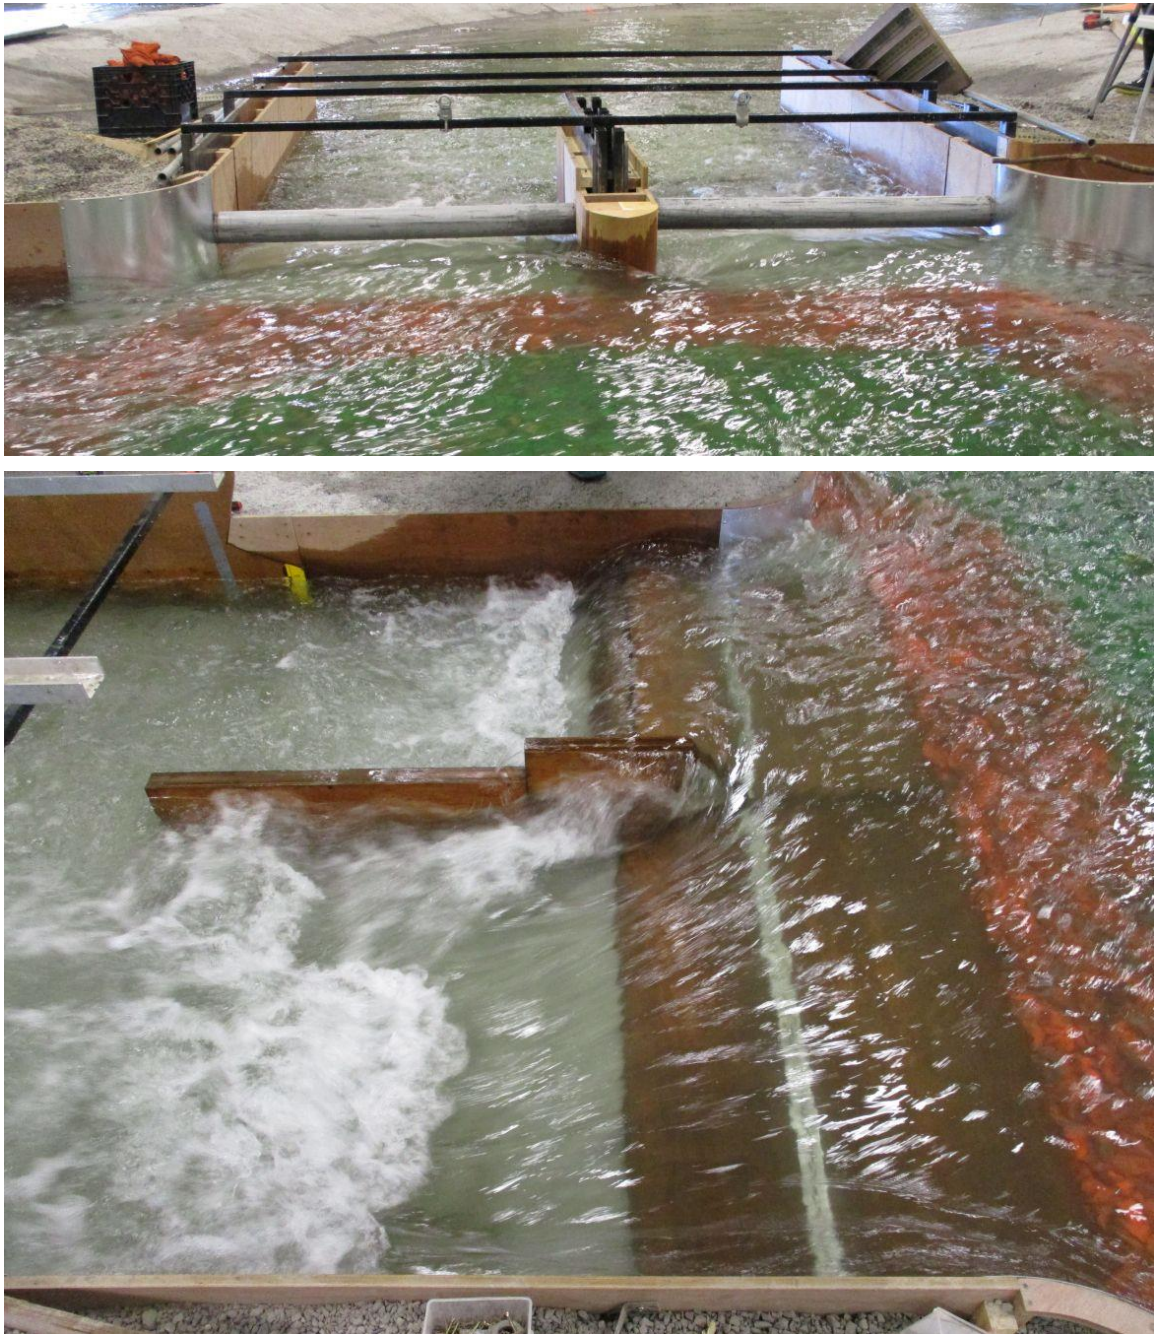
Figure 144. Flow conditions at the structure during the 1240 m<sup>3</sup>/s event. Top – facing downstream at the diversion, bottom - facing southeast at the service spillway.

The flow conditions through both the diversion inlet and the service spillway were very energetic for the 1240m<sup>3</sup>/s flood condition. Deep wakes stemmed from the LHS entrance wall and pier nose at the diversion inlet (see the top photograph in Figure 144). The hydraulic jump on the LHS of the service spillway was more unstable than the RHS, as the flows were higher and also the wake generated by the central pier affected the location of the jump (see Figure 144 – bottom). Debris was inserted at

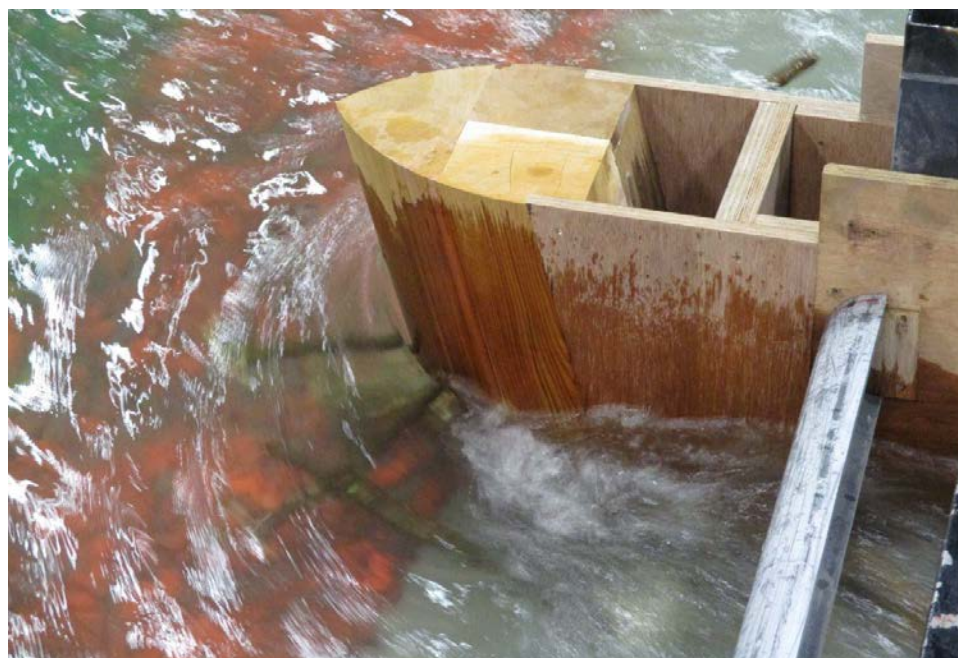
Figure 145. Debris caught on Pier Nose 3.

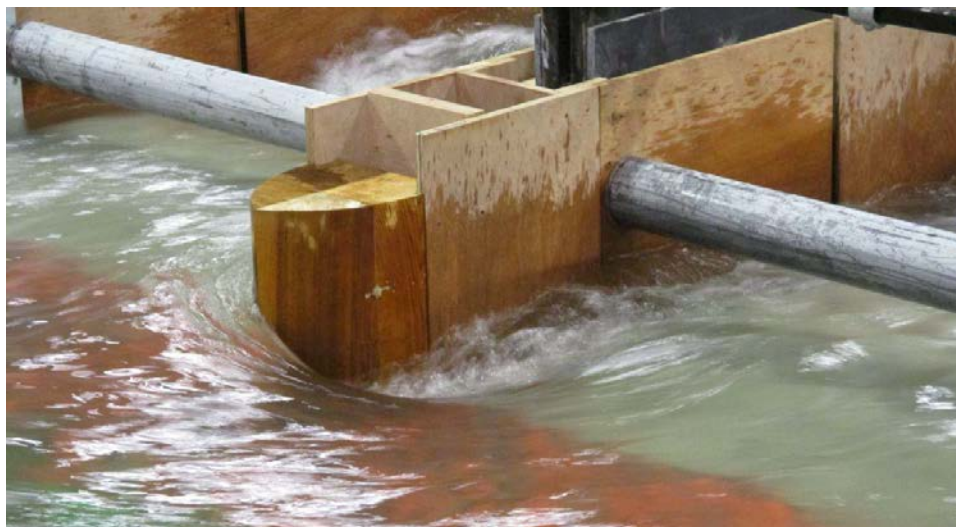
Figure 146. Wake emanating from pier nose 2 during the 1240 m<sup>3</sup>/s event.

The flow conditions through both the diversion inlet and the service spillway were similar for pier nose 2 and pier nose 3. The wake cast from pier nose 2 appeared to be slightly deeper and more turbulent (see Figure 146). As before, debris was inserted at several points in the floodplain and tracked through the model (see Figure 143 for the insertion points and pathways). Table 24 shows a summary of the debris behaviour and performance of the model with pier nose 2 installed in the diversion. When debris came from the left hand side of the main floodplain channel (location A) a small portion was caught on the pier nose (see Figure 147).

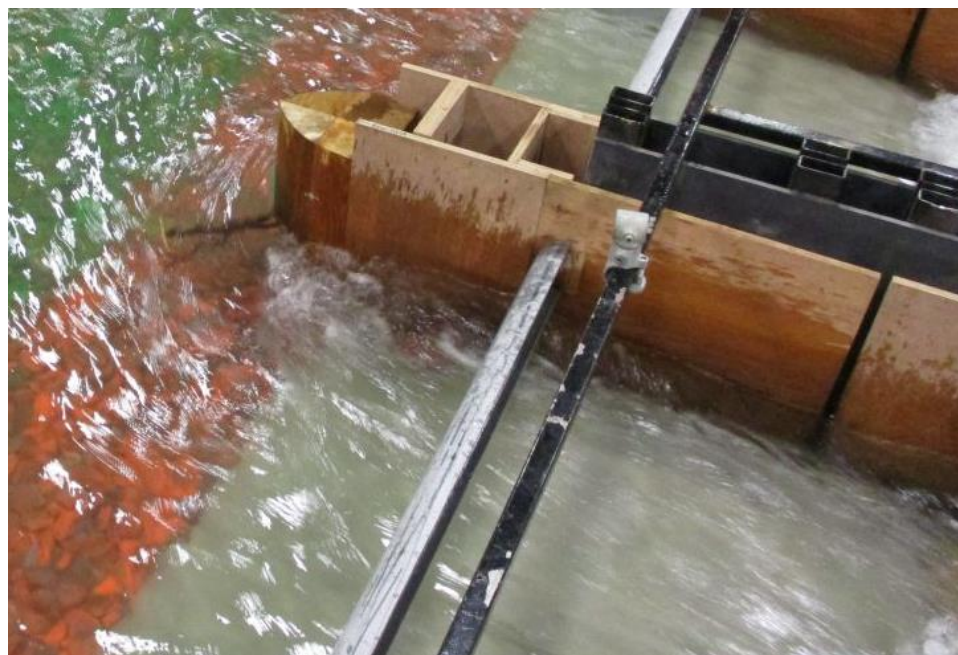
Figure 147. Debris caught on Pier Nose 2.

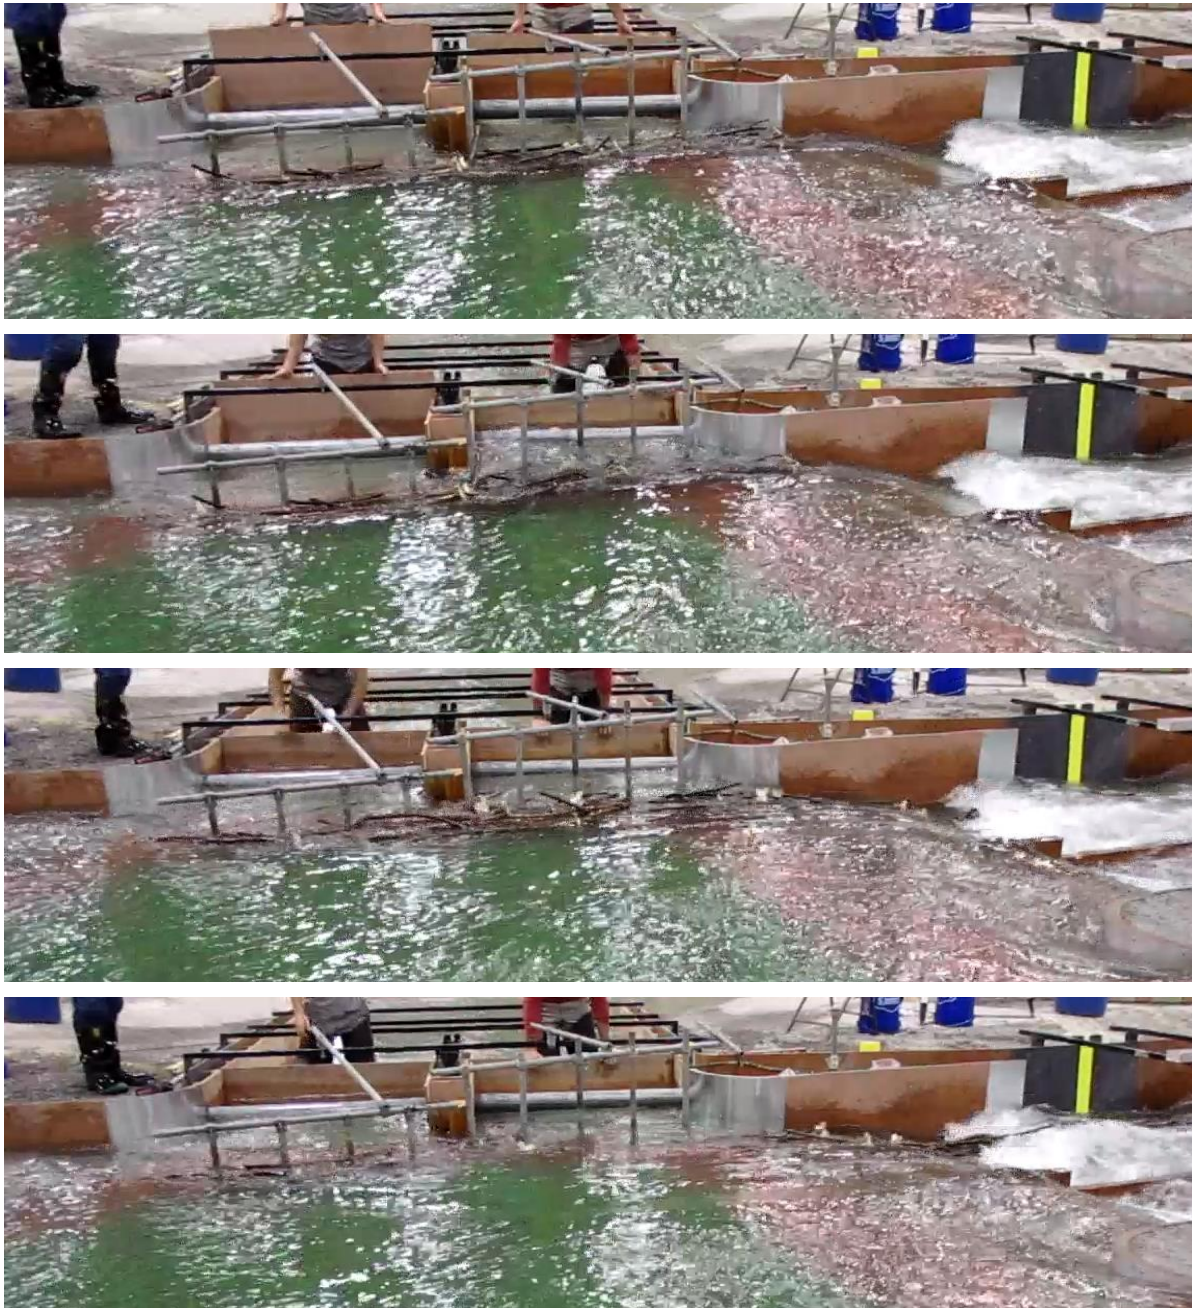
Figure 148. Diversion inlet gates being closed and the trees being removed from the barrier.

Debris Barrier D was re-installed in front of the diversion inlet and its performance at 1240m<sup>3</sup>/s was investigated (refer to section 3.4.3.4 for the design and layout of the barrier). As seen in previous tests with this barrier, since the west end did not completely shelter the LHS of the diversion, debris inserted at location A in the main channel bypassed the barrier and passed through the LHS of the diversion. Otherwise, the barrier was effective at collecting the debris at locations B-E. A raft of debris was allowed to collect on the debris barrier and the diversion inlet gates were closed to investigate if the debris could be pulsed off the barrier and pass through the service spillway (see Table 25 and Figure 148). This was successful as only a small percentage (8%) of the trees remained on the barrier after closing the diversion. It should be noted that the gates cannot be operated in this manner for an extended period of time without overtopping the auxiliary spillway.

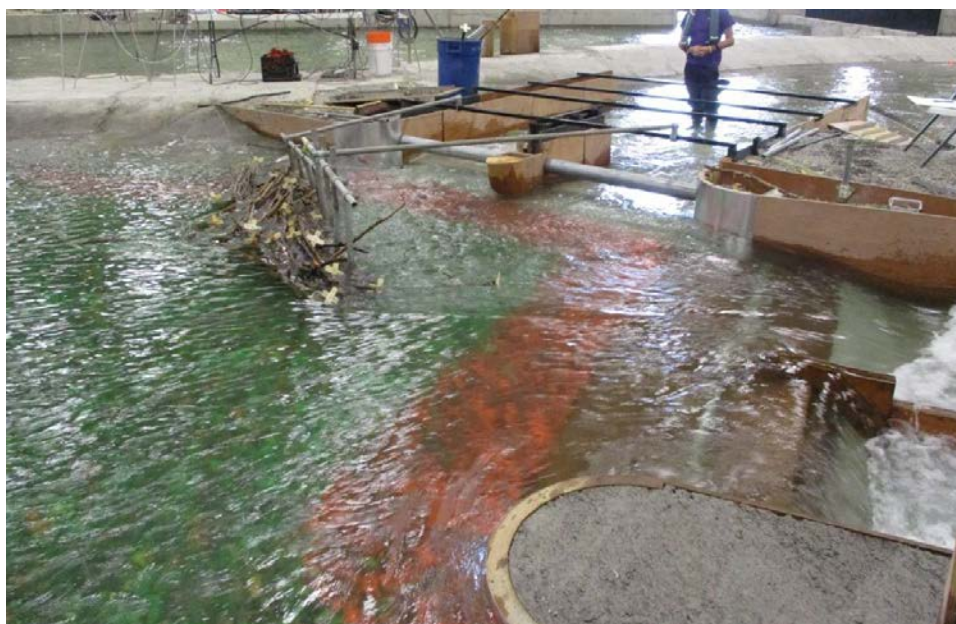
Figure 149. Debris collected on barrier C at the start of the tests.

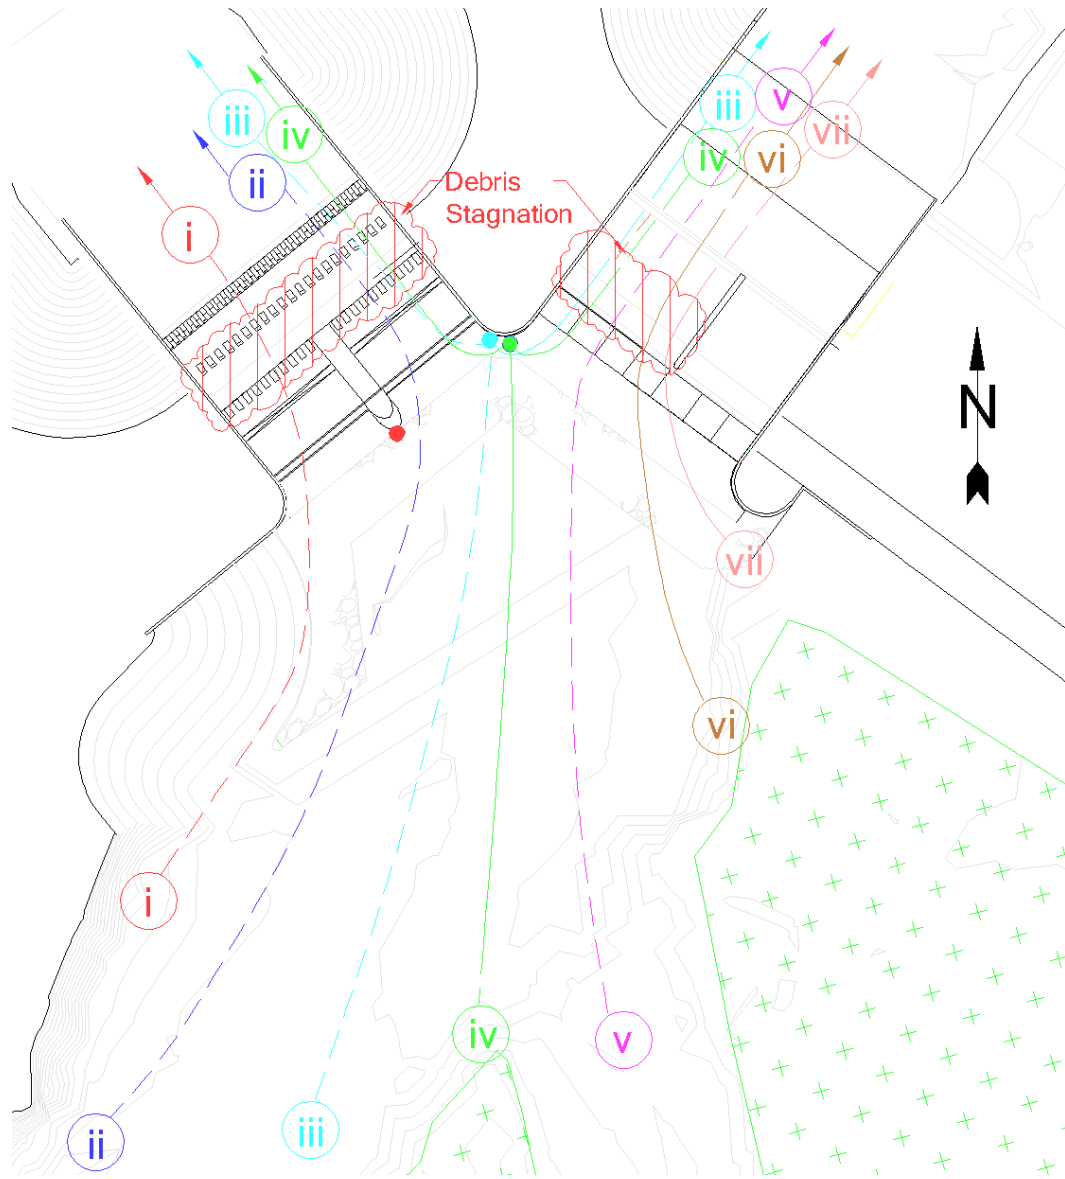
Figure 150. Debris pathways for the 320 m<sup>3</sup>/s flow conditions.

Debris Barrier D was re-installed in the model (refer to section 3.4.3.4 for the design and layout of the barrier) and debris was inserted into the model floodplain (refer to Figure 150 for a schematic showing the debris insertion points and pathways). The debris barrier was loaded with approximately 80 trees and the diversion inlet gates were closed to investigate if the debris collected on the barrier

Debris Barrier C was re-installed in the model (refer to section 3.4.3.4 for the design and layout of the barrier) and debris was inserted into the model floodplain (refer to Figure 150 for a schematic showing the debris insertion points and pathways). The debris barrier was effective at blocking tree debris from the left-hand side of the floodplain (locations i, ii, iii, and iv), but debris placed at locations v, vi and vii bypassed the barrier and flowed into the service spillway. Figure 155 and Table 30 illustrate the debris behaviour and summarize the performance of the debris barrier for this flow rate.

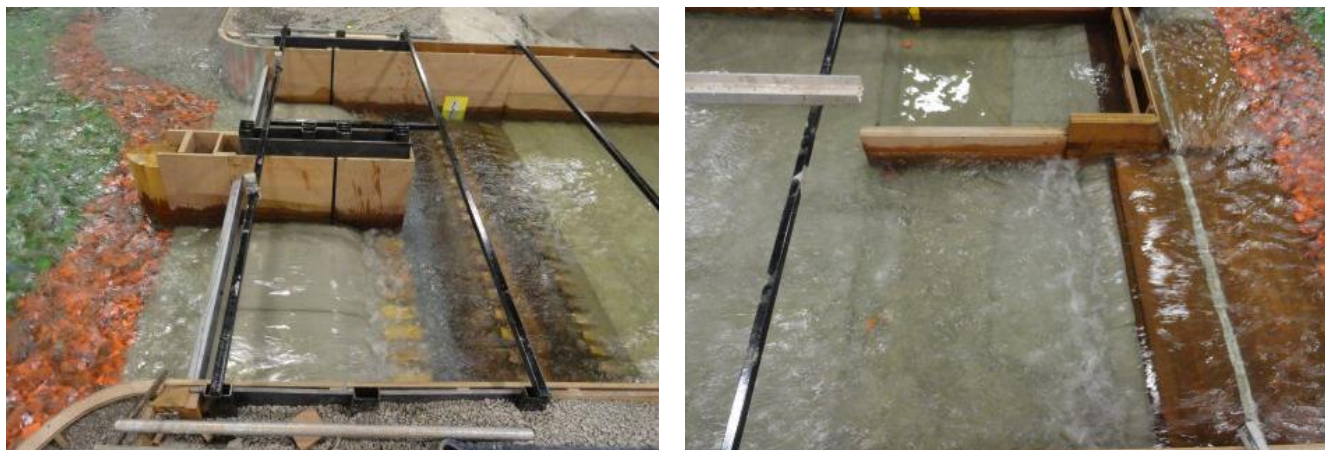
Figure 151. Flow conditions at the structure during the 320 m<sup>3</sup>/s event. Top – facing southwest at the diversion, bottom - facing southeast at the service spillway.

The flow conditions through both the diversion inlet and the service spillway were relatively benign for the 320m<sup>3</sup>/s flood condition. The flow depth through the diversion inlet and the chute blocks was shallow, and the hydraulic jump downstream of the LHS service spillway gate had little energy (see Figure 151). Debris was deployed at several points in the floodplain and tracked through the model (see Figure 150 for the insertion points and pathways). Table 27 shows a summary of the debris behaviour and performance of the structures in the model with pier nose 2 installed in the diversion. In general, the debris passed by the pier nose relatively unobstructed. However, there was often insufficient energy or depth to pass the debris over the chute blocks on the diversion inlet or through the hydraulic jump on the service spillway (see Figure 152). Of note, the tree debris stuck in the chute blocks in the diversion inlet often piled up where the diversion inlet gates would be closing, which may affect the gate operation (yellow arrow in Figure 152). At the end of the tests with the debris still caught in the structures, the LHS Obermeyer gate was raised to force all the flow through the diversion. The tree debris that was stuck in the hydraulic jump of the diversion inlet slowly floated down the channel, but the increased flow through the diversion inlet did not release the debris caught in the diversion inlet chute blocks.

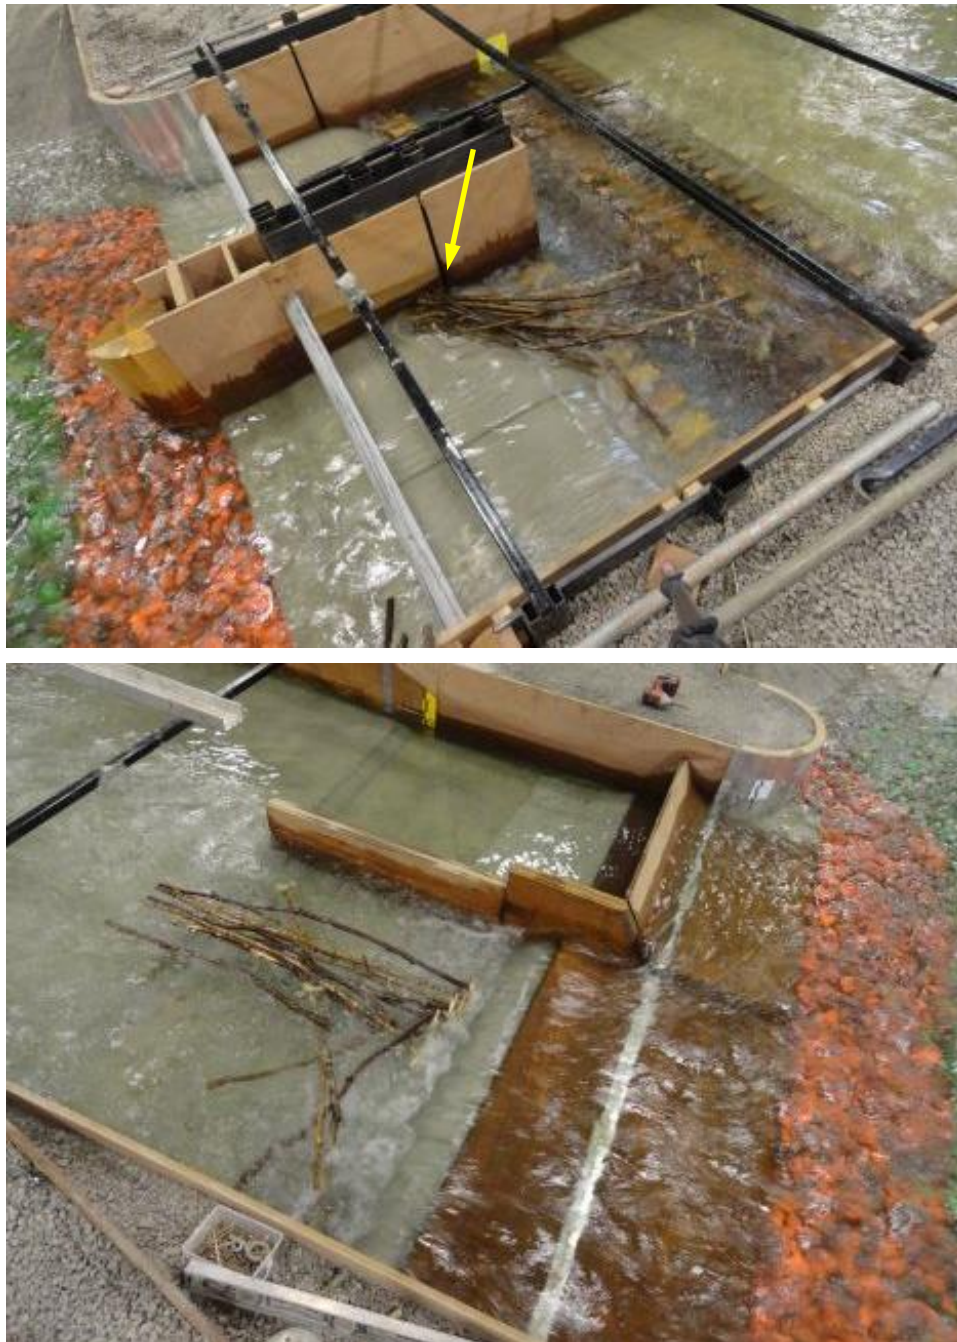
Figure 152. Debris caught in the structures during the  $320\text{m}^3/\text{s}$  flow condition with pier nose 2.

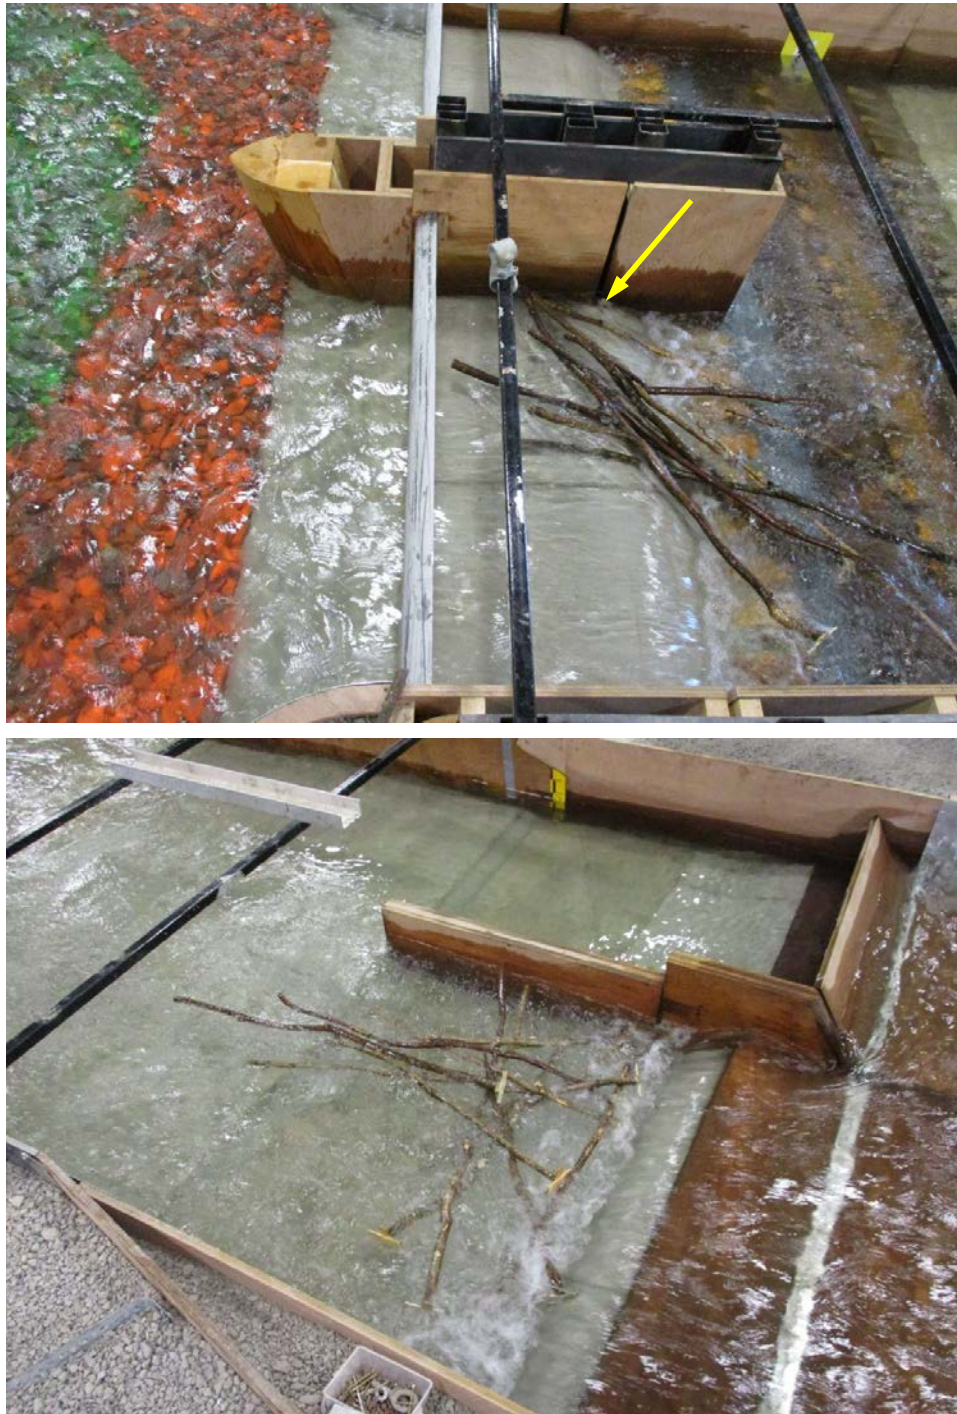
Figure 153. Debris caught in the structures during the  $320\text{m}^3/\text{s}$  flow condition with pier nose 3.

structures in the model with pier nose 3 installed in the diversion. No debris was caught on the pier nose. As with the other 320m<sup>3</sup>/s test, there was often insufficient energy to pass the debris over the chute blocks on the diversion, or fully through the hydraulic jump on the service spillway (see Figure 153). Of note, the tree debris stuck in the chute blocks in the diversion inlet often piled up where the diversion inlet gates would be closing, which may affect the gate operation (yellow arrow in Figure 153).

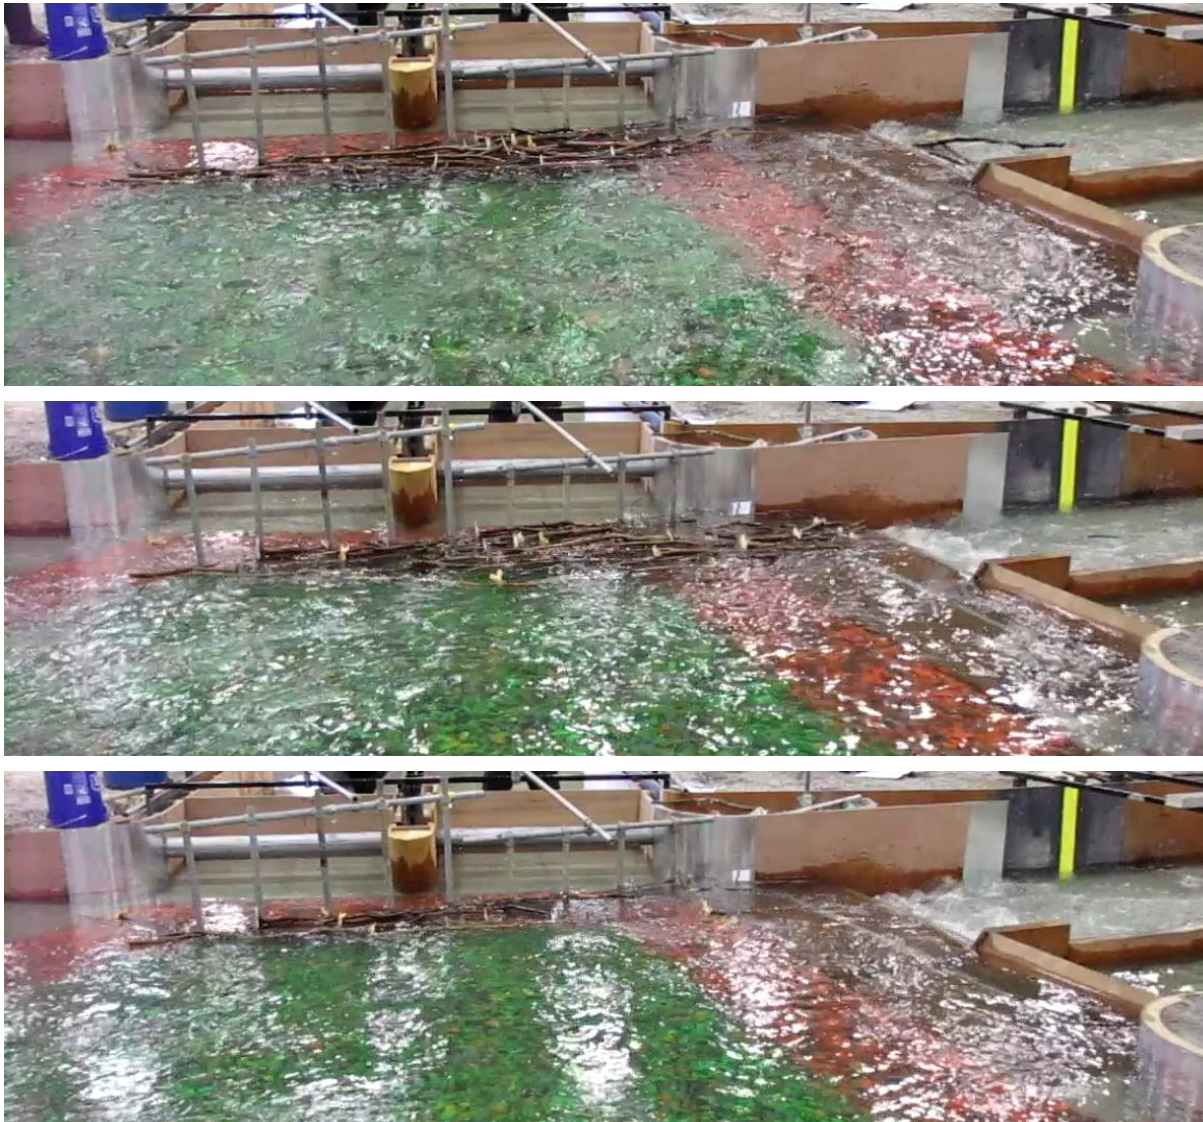
Figure 154. After closing the diversion inlet (top), and continuing to feed the upstream floodplain with trees (middle), 50% the debris caught on the debris barrier was eventually flushed through the service spillway (bottom).

would drift off and pass through the service spillway. After closing the diversion inlet gates the debris did not immediately flush off the barrier. However, as more debris was added to the floodplain approximately 50% of the debris was eventually released from the barrier and flowed through the LHS of the service spillway (see Figure 154 and Table 29)

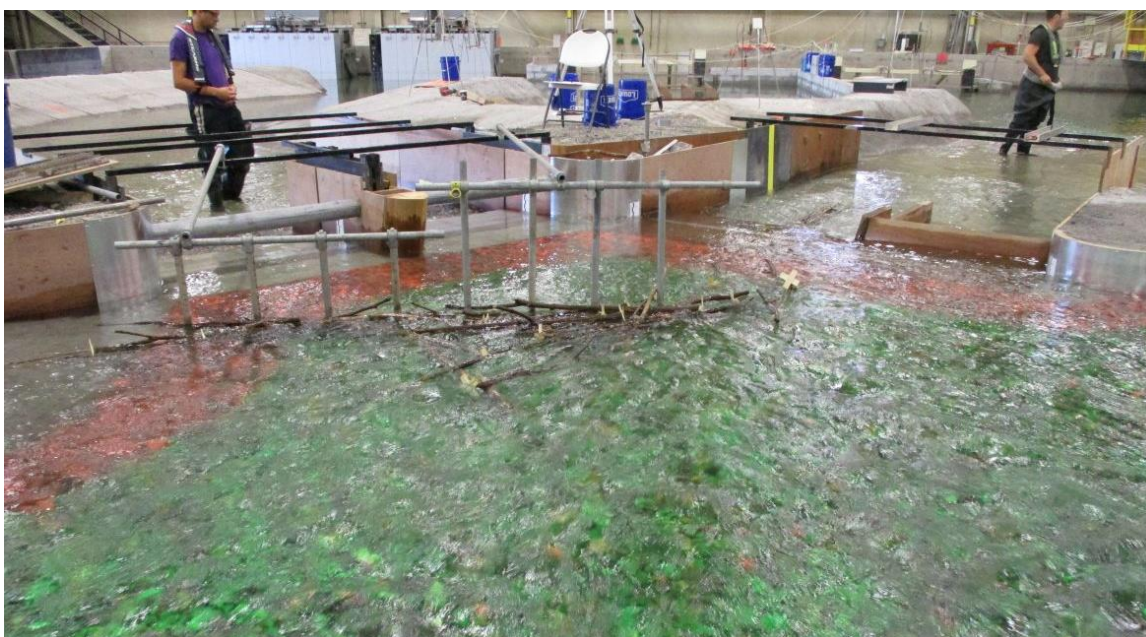
Figure 155. Model trees collecting on debris barrier C during the 320m<sup>3</sup>/s flow.

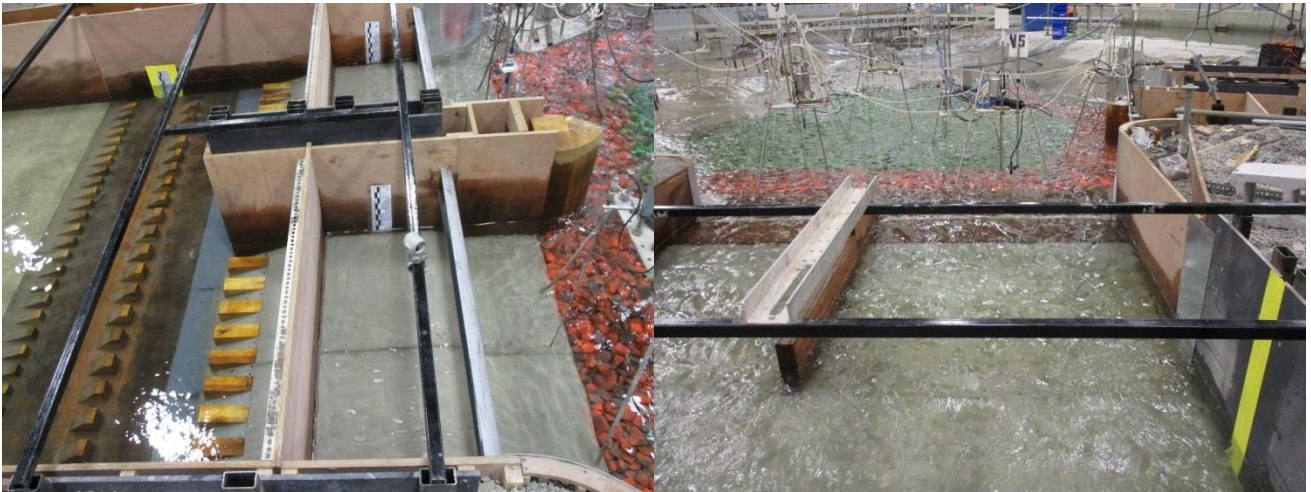
- Diversion inlet gates were fully lowered (closed).
- Left hand side service spillway Obermeyer gate – fully lowered (elev. 1210 m).
- Right hand side service spillway Obermeyer gate – fully lowered (elev. 1210 m).

Figure 156. Diversion inlet structure (left) and service spillway (right) during the 160 m<sup>3</sup>/s flow condition.

Similarly to the 60 m<sup>3</sup>/s flow condition, the 160 m<sup>3</sup>/s flow condition had all of the flow passing through the service spillway (refer to Table 31 for the flow splits and the water levels). Flow was blocked from travelling through the diversion channel by inserting wooden drop gates into each bay opening. The water levels in the service spillway (WP7 and WP8) were very close (11.78m and 11.80m). The tail-water elevation of 1211.18 m (WP11) was reasonably close to the target tail-water elevation of 1211.10 m provided by Stantec.

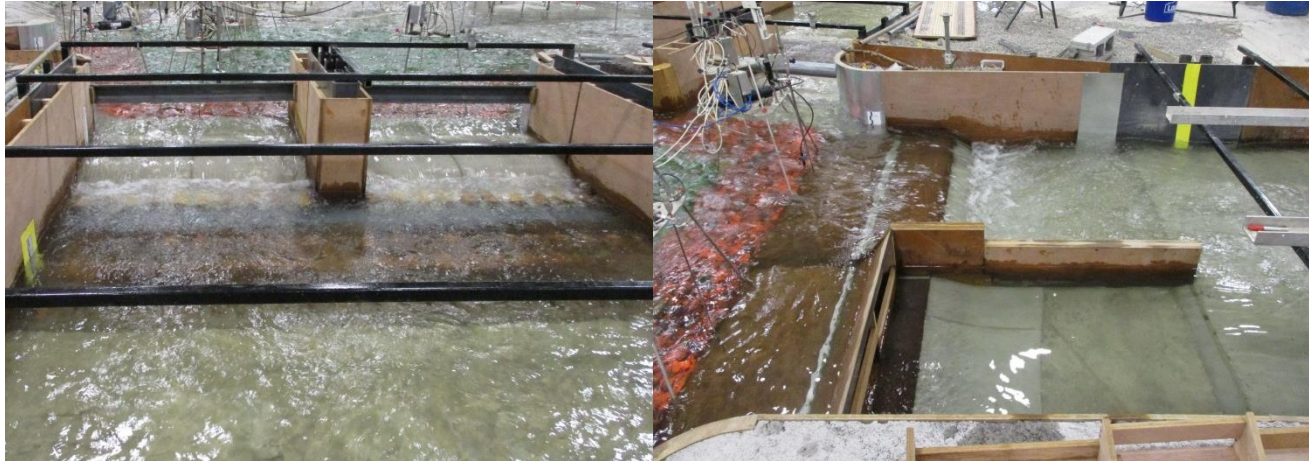
- Diversion inlet gates were fully raised (open).
- Left hand side service spillway Obermeyer gate set to 1211.05 m.
- Right hand side service spillway Obermeyer gate set to 1215 m.

Figure 157. Flow through the diversion inlet structure (left) and service spillway (right) during the 320 m<sup>3</sup>/s case (a) flood condition.

The gate settings did a reasonable job of splitting the incoming 320 m<sup>3</sup>/s flow between the diversion inlet and service spillway (172 m<sup>3</sup>/s and 153 m<sup>3</sup>/s, respectively). Refer to Table 31 for the flow splits and the water level measurements made in the model. As was seen in TSA, there was a slightly uneven flow distribution through the diversion inlet gate bays with the RHS seeing higher water levels (1213.17 m vs 1212.97 m). The tail-water elevation of 1211.83 m (WP10) in the diversion channel closely matched the target tail-water elevation provided by Stantec of 1211.80 m. Similarly, the service spillway tail-water elevation of 1211.23 m (WP11) was reasonably close to the target 1211.1 m, and the flow through the service spillway was evenly distributed between the LHS and RHS.

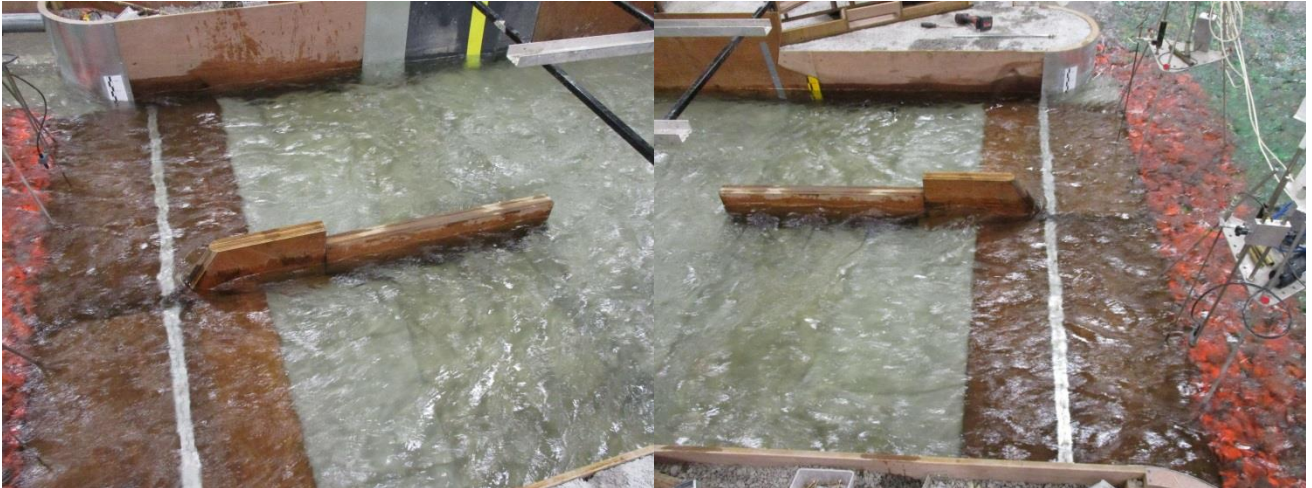
- Diversion inlet gates were fully lowered (closed).
- Left hand side service spillway Obermeyer gate set to 1210 m.
- Right hand side service spillway Obermeyer gate set to 1210 m.

Figure 158. Flow through the service spillway during the 320 m<sup>3</sup>/s case (b) flood condition with the diversion inlet closed.

The flow through the service spillway was fairly evenly distributed between the RHS and LHS as the water levels measured at the structure were 1212.44 m and 1212.45 m, respectively. Closing the diversion inlet gates raised the tail-water elevation downstream of the service spillway by 0.48 m to 1211.7 m.

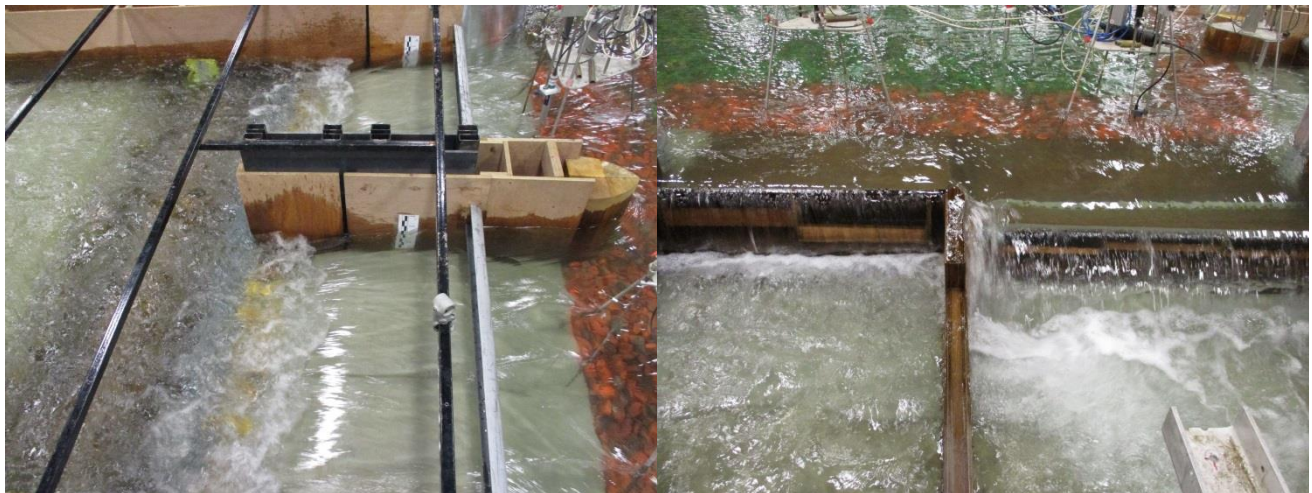
- Diversion inlet gates were fully raised (open).
- Left hand side service spillway Obermeyer gate set to 1213.4 m.
- Right hand side service spillway Obermeyer gate set to 1215 m.

Figure 159. Flow through the diversion inlet structure (left) and service spillway (right) during the 760 m<sup>3</sup>/s case (a) flood condition.

The target flow split for the 760 m<sup>3</sup>/s flow condition is to have 600 m<sup>3</sup>/s in the diversion channel and 160 m<sup>3</sup>/s in the main channel. The gate settings provided by Stantec provided a flow split that reasonably matched the targets; the recorded flow over the diversion channel weir was 575 m<sup>3</sup>/s and the recorded flow over the main channel weir was 191 m<sup>3</sup>/s (the total flow was 766 m<sup>3</sup>/s - refer to Table 31 for the flow splits and the water levels). The head at the upstream end of the each bay of the diversion inlet (WP6 and WP7) were very even between the LHS and RHS (1215.27 m and 1215.25 m). This was also the case upstream of the service spillway (WP8 and WP9 each read 1215.55 m). The flow barely crested the RHS crest gate on the service spillway (elevation 1215 m).

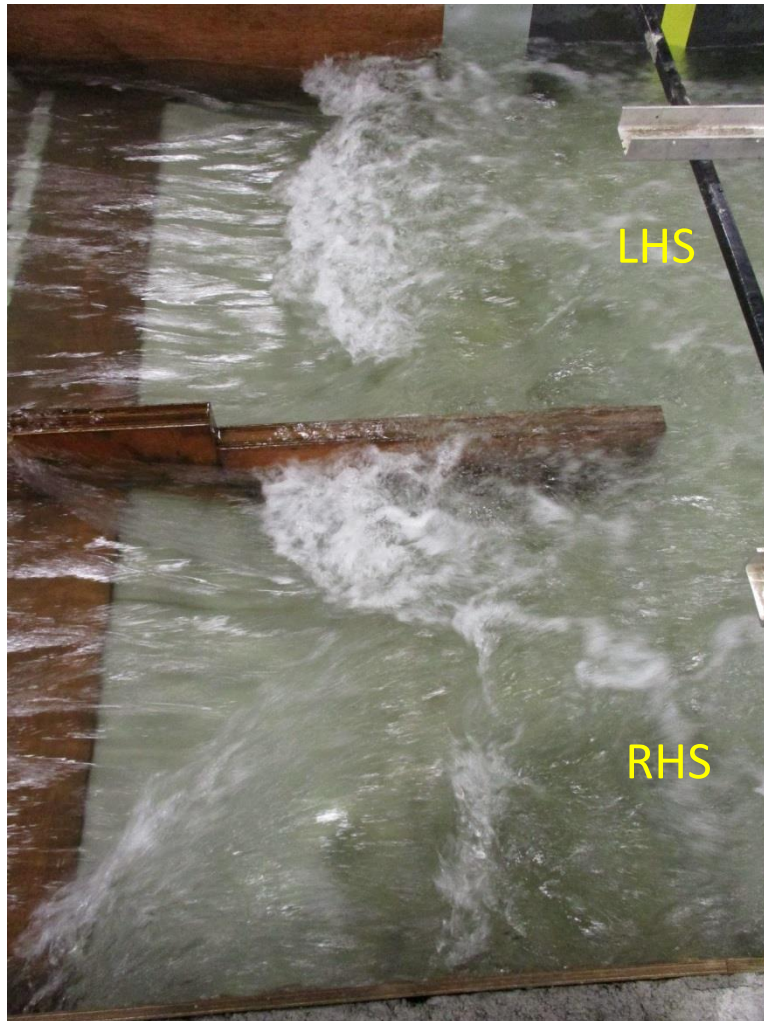
As described in Section 5.4.2, with the diversion inlet gate closed the 760 m<sup>3</sup>/s flow through the service spillway was fairly energetic and turbulent (see Figure 160). The hydraulic jumps on both the LHS and RHS were influenced by the wakes emanating from the circular abutment wall on the RHS and the central dividing pier on the LHS. Figure 161 shows the relatively unstable hydraulic jump on the RHS with a closer look at the depth of the wake stemming from the RHS circular abutment wall at the entrance of the structure. Table 31 presents the water level information for the various gauges. This data shows slightly more head on the LHS (WP8 – 1214.24 m) than on the RHS (WP9 – 1214.17 m) of the service spillway. The currents downstream of the service spillway were observed to be relatively higher along the training wall on the LHS indicating a potential for scour and erosion at this location.

Figure 160. Flow through the service spillway (right) during the 760 m<sup>3</sup>/s case (b) flood condition with the diversion inlet closed.

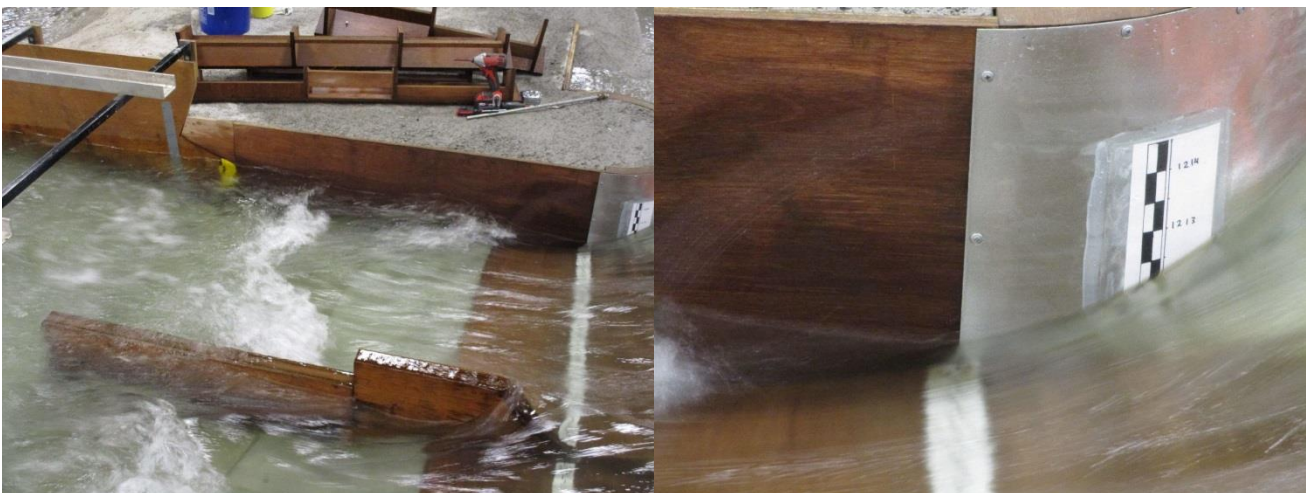
Figure 161. Flow through the diversion inlet structure (left) and service spillway (right) during the 760 m<sup>3</sup>/s case (b) flood condition.

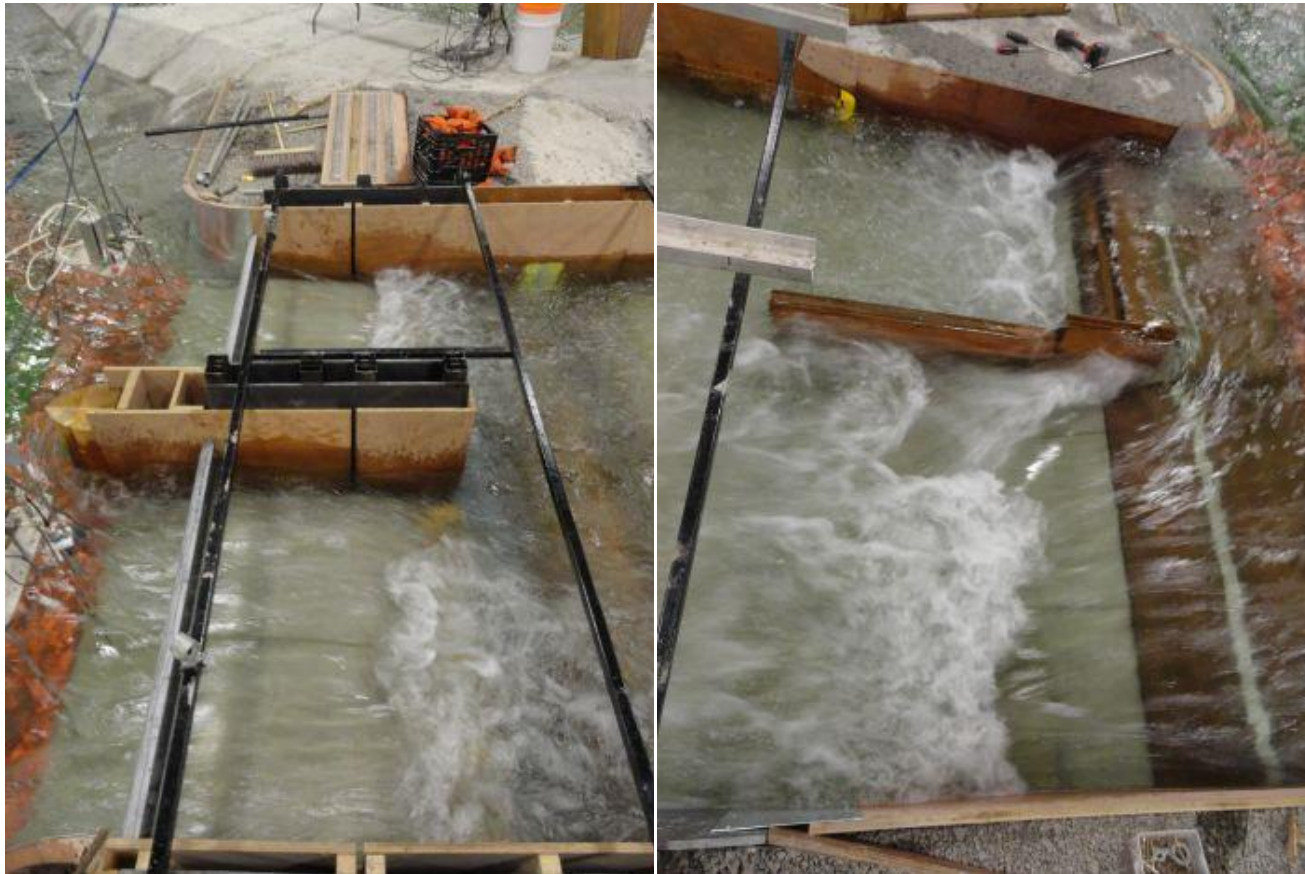
- Diversion inlet gates were fully raised (open).
- Left hand side service spillway Obermeyer gate set to 1210 m.
- Right hand side service spillway Obermeyer gate set to 1213.15 m.

Figure 162. Flow through the diversion inlet structure (left) and service spillway (right) during the 1240m<sup>3</sup>/s case (a) flood condition.

The target flow split for the 1240 m<sup>3</sup>/s flow condition sent 600 m<sup>3</sup>/s through the diversion channel and 640 m<sup>3</sup>/s through the main channel service spillway. The gate settings provided by Stantec provided a flow split that matched the targets very well; the recorded flow over the diversion channel weir was 607 m<sup>3</sup>/s and the recorded flow over the main channel weir was 668 m<sup>3</sup>/s (the total flow was 1275 m<sup>3</sup>/s - refer to Table 31 for the flow splits and the water levels). The water level in the LHS of the service spillway (WP8) was slightly lower compared to the right hand side (WP9), while the water levels were relatively even across the diversion inlet structure. The flow through the diversion inlet appeared to be relatively even and the hydraulic jump was stable (see the left hand side of Figure 162). In the service spillway there was much more flow through the LHS since the Obermeyer gates were lower leading to relatively higher velocities than the RHS. The hydraulic jump was influenced by the wake stemming from the central pier between the service gates (see the right side

of Figure 162). High velocities were observed along the LHS training wall of the service spillway indicating the potential for erosion or scour at this location. The modification to the RHS retaining wall, changing the plan shape to a circular design, showed an improvement on the entrance flows over the straight wall design used in test series A-C (see Figure 163).
